## 3.0 L-Bar, New Mexico, Disposal Site

### 3.1 Compliance Summary

## **3.4 Inspection Results**

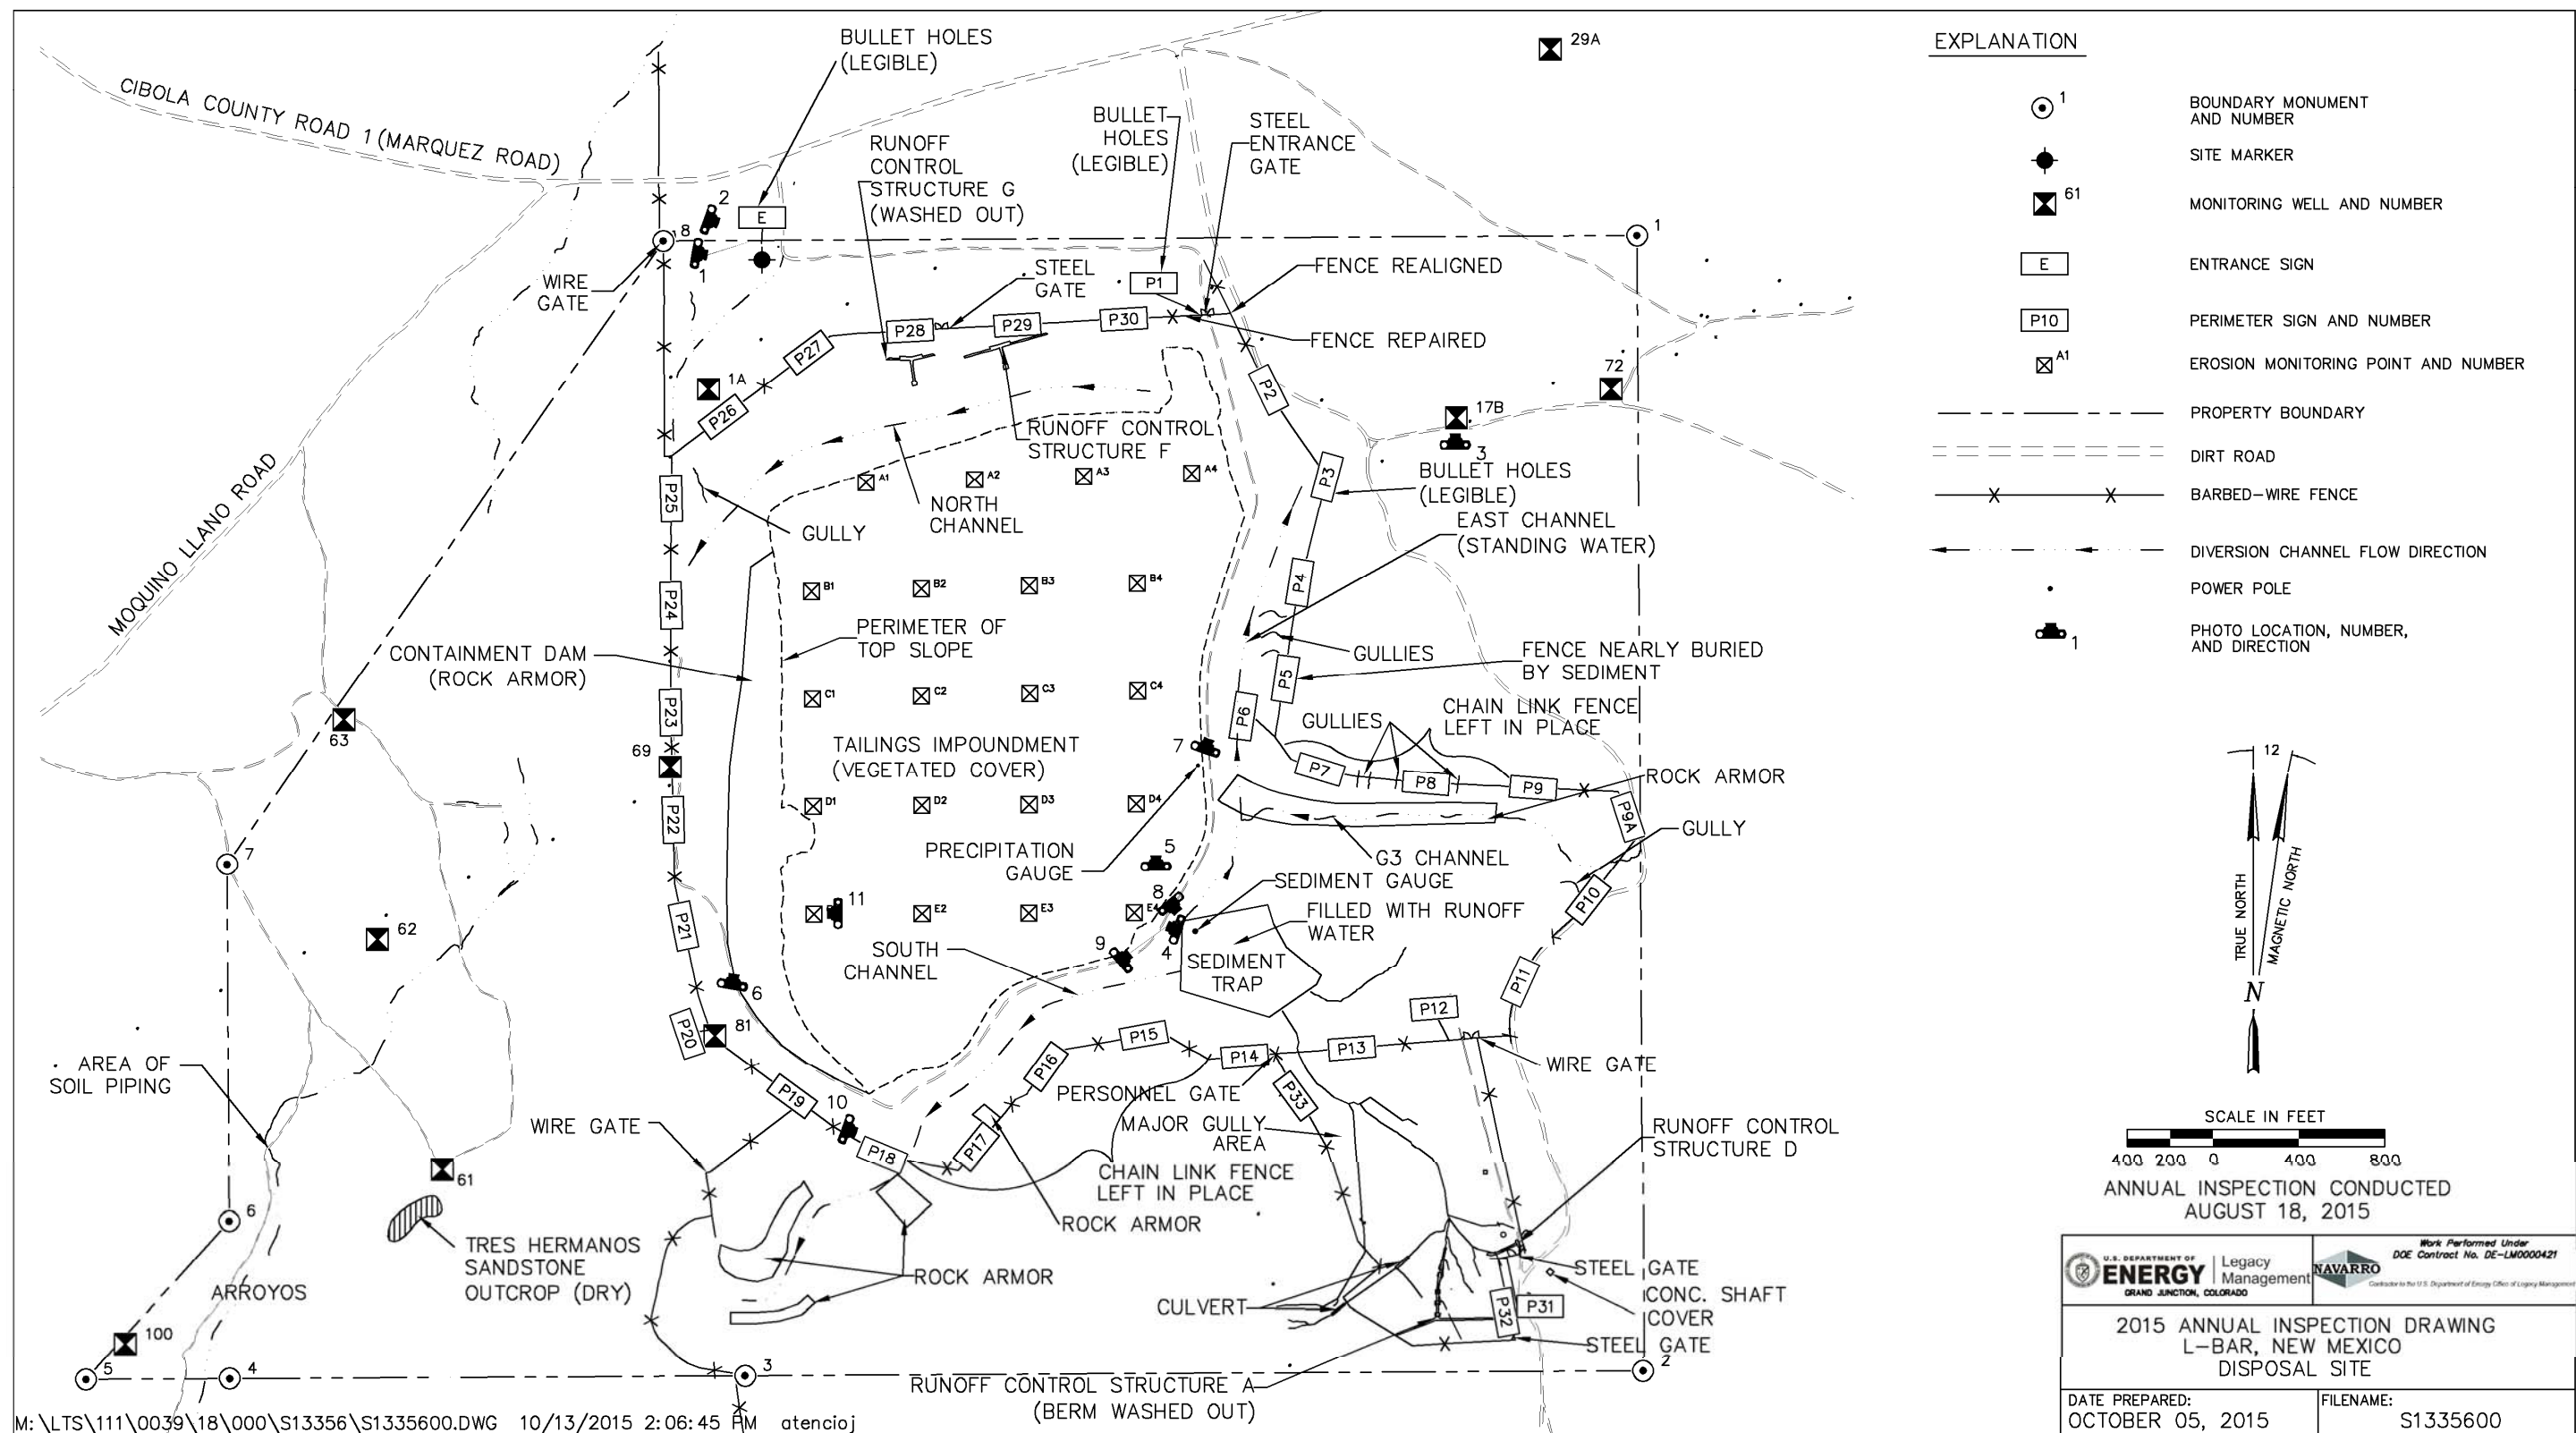
The locations of site surveillance features are shown on Figure 3-1. Inspection results and recommended maintenance activities associated with site surveillance features are included in the following subsections. Photographs to support specific observations are identified in the text and on Figure 3-1 by photograph location (PL) numbers.

In accordance with the EMP, the former licensee installed a grid of 20 evenly spaced monitoring points on the cover in November 2003. These points are shown on Figure 3-1. The locations were initially measured in December 2003 to establish a baseline data set.

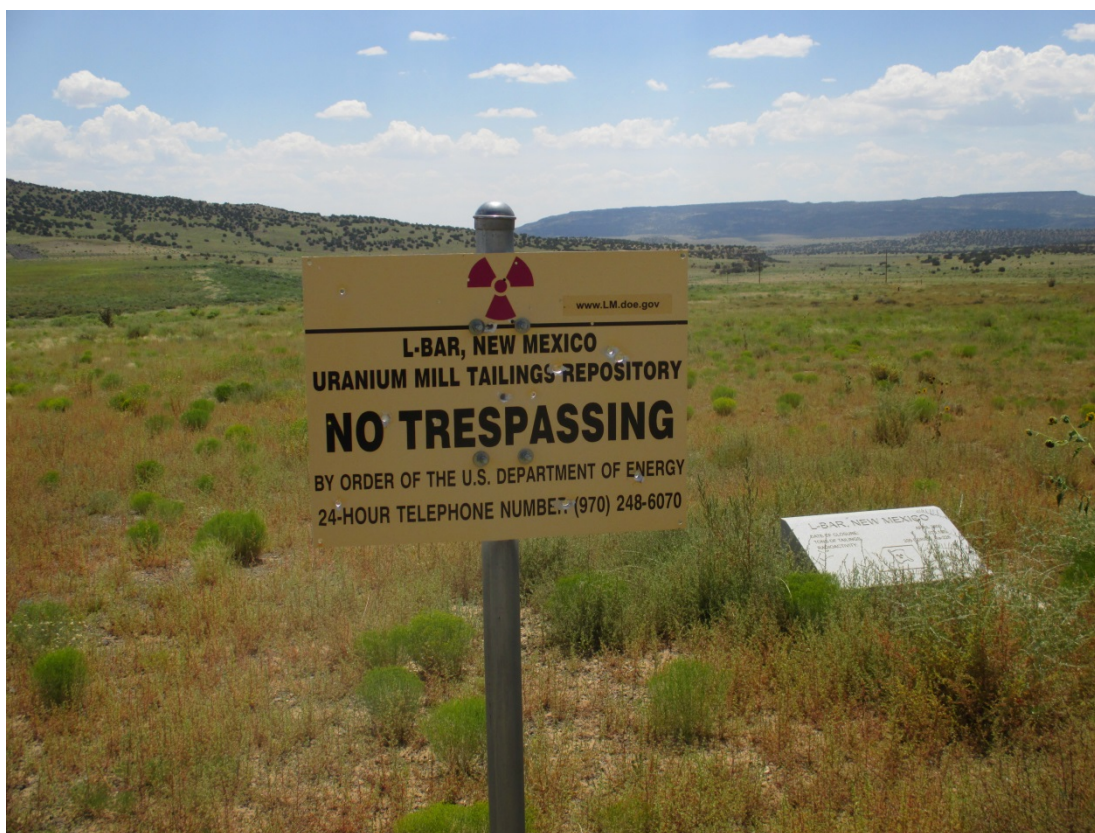
The entrance sign is located on the main site access road near the site marker. It has several bullet holes but was legible (PL-1). Thirty-four warning or perimeter signs are attached to a barbed-wire fence that surrounds the disposal site structures. The perimeter signs were in good condition; however, the trefoil decal on some of the signs is peeling off and will need to be replaced in the near future.

BAR 8/2015. PL-1. Entrance sign and site marker.

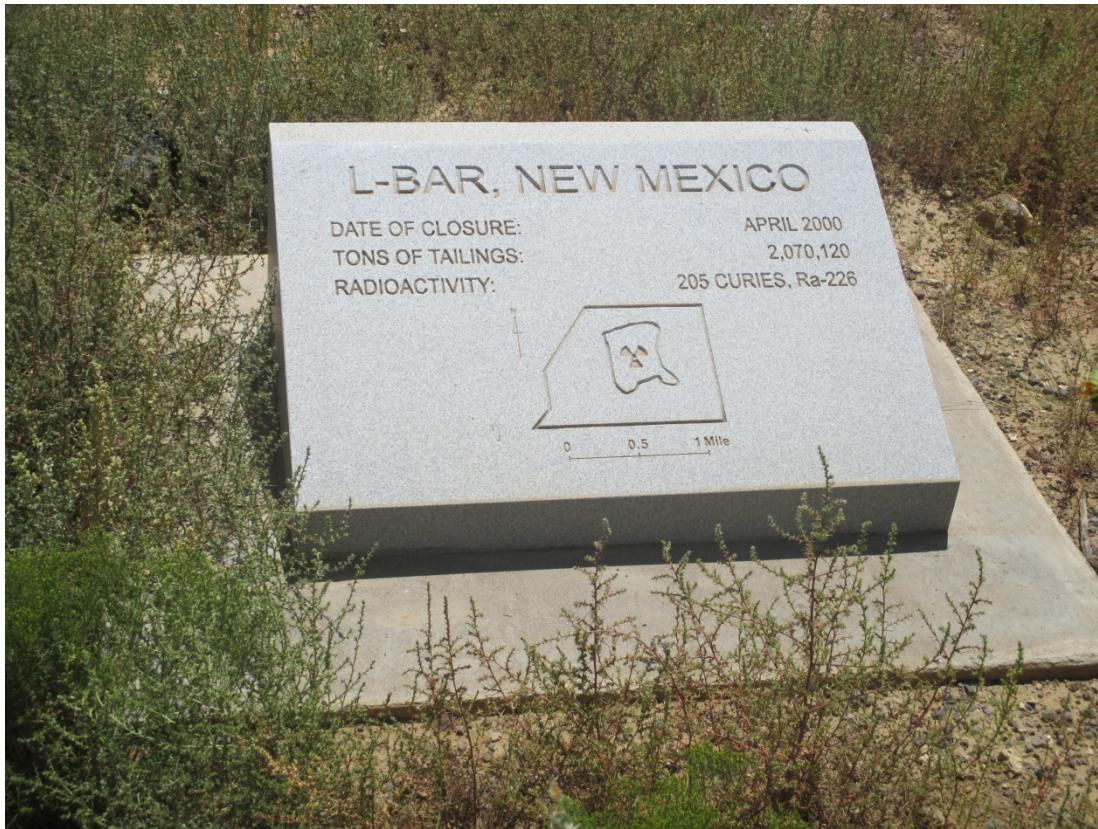
A granite site marker is located north of the disposal cell adjacent to the site access road. The marker was in excellent condition (PL-2).

*BAR 8/2015. PL-2. Site marker.*

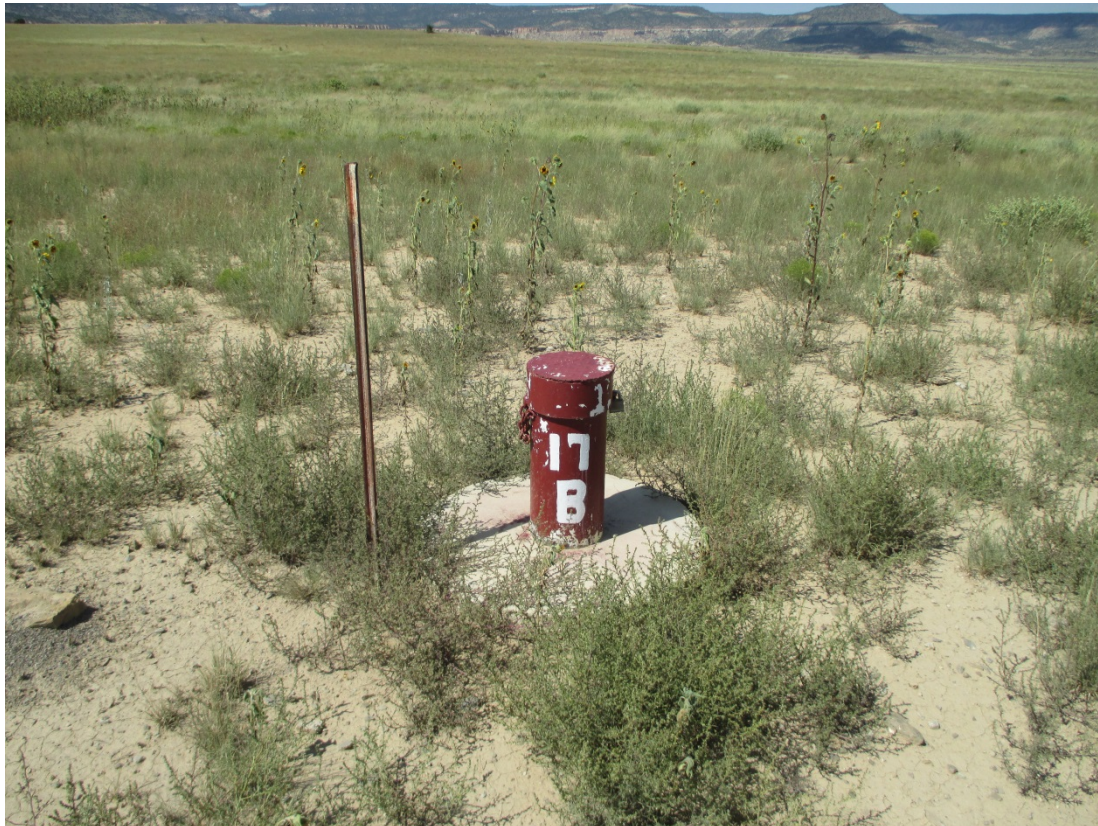
The site groundwater-monitoring network consists of 10 wells. Nine of the wells are located on DOE property; monitoring well 29A is located outside the northeast corner of the site. Most of the wells were checked during the inspection and they were locked and in good condition (PL-3). Some well locations do not have established access roads or tracks but are accessible by 4-wheel drive vehicle if the ground is dry.

*BAR 8/2015. PL-3. Monitoring well 17B.*

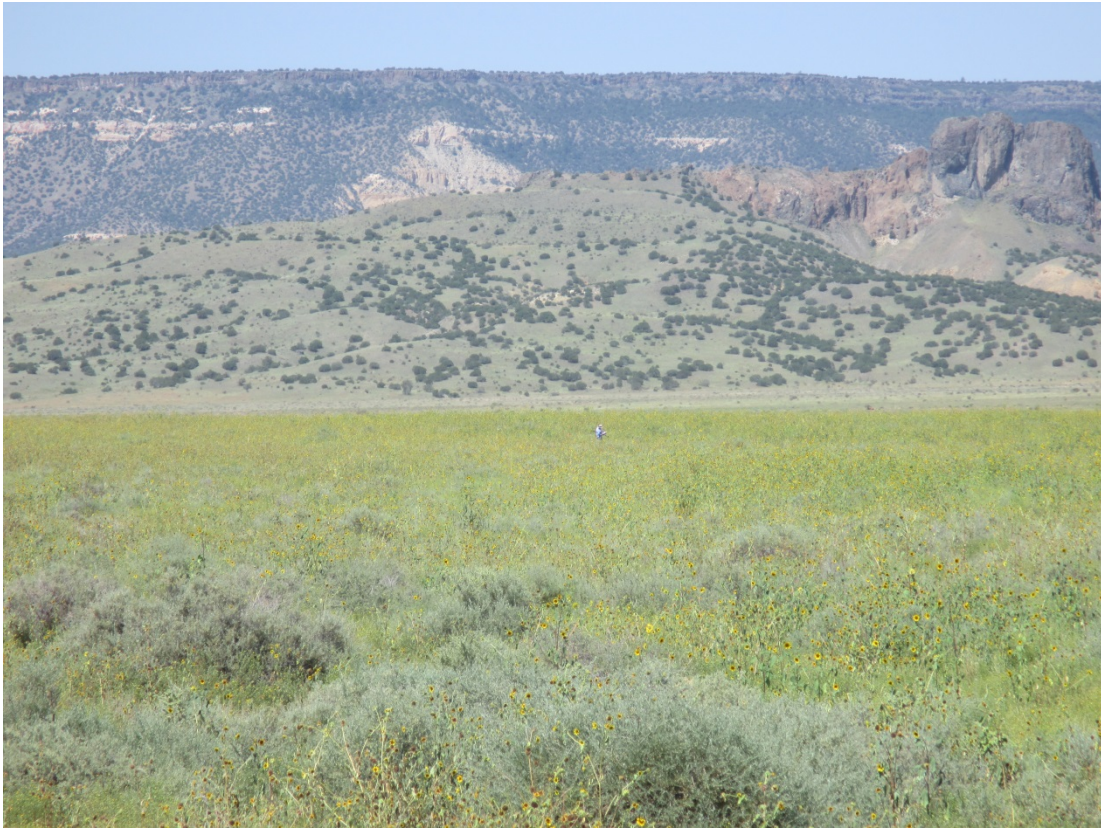
*BAR 8/2015. PL-4. Vegetation on tailings impoundment top slope.*

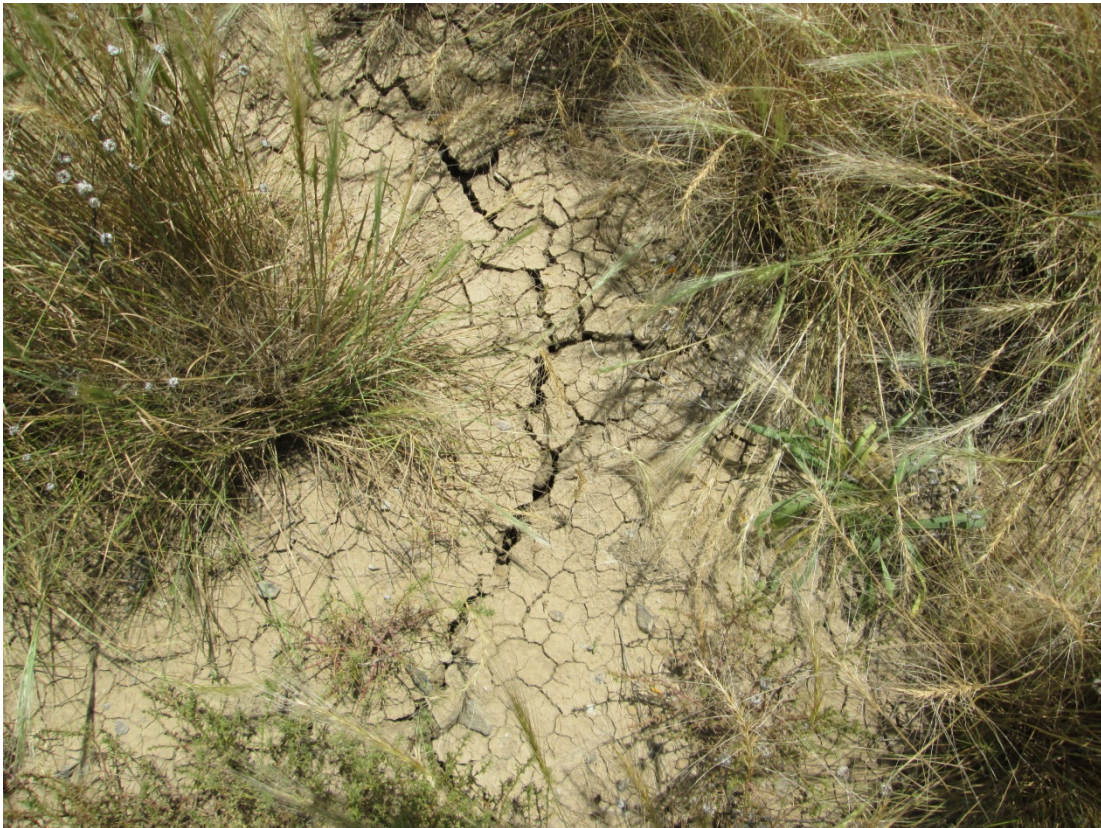
Cracks are usually present in the surface soil of the tailings impoundment cover (PL-5). They are confined to the upper couple of feet of the cover soil and appear to result from drying of the gypsum-rich soil after precipitation events. The cracks tend to heal as they fill with windblown sediment and as perennial vegetation continues to establish.

*BAR 8/2015. PL-5. Desiccation cracks on the tailings impoundment top slope.*

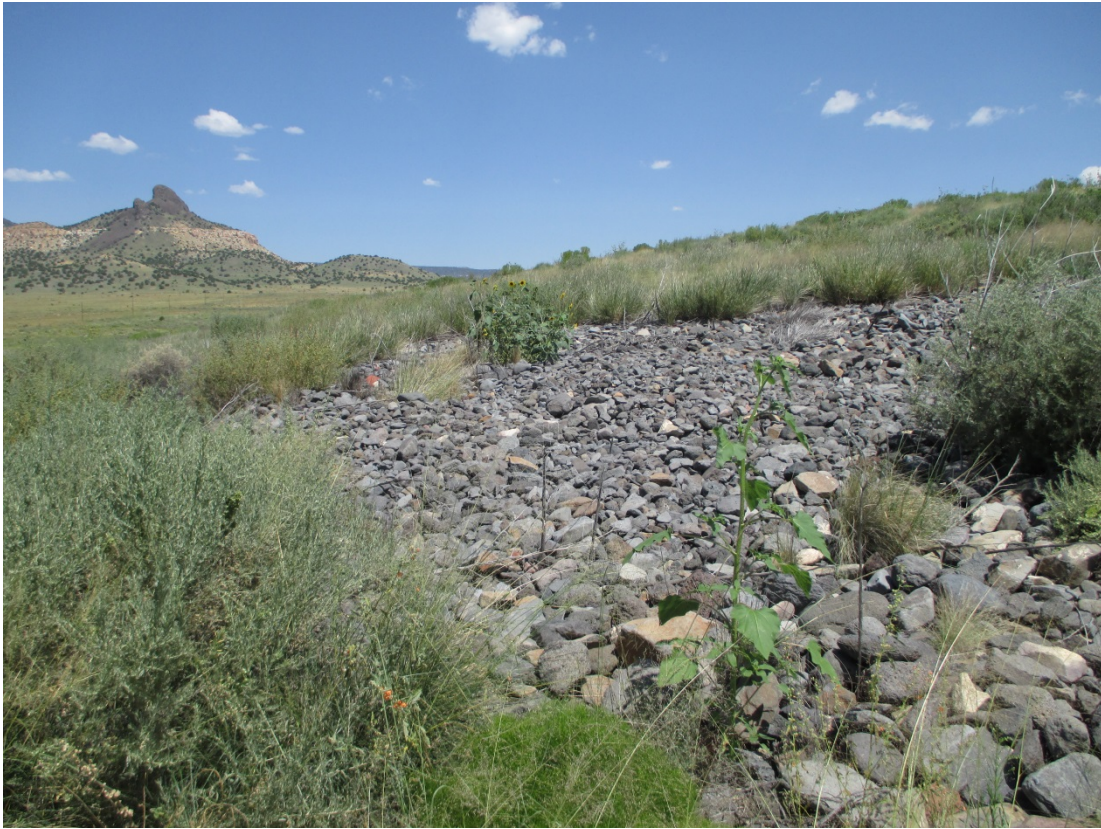
*BAR 8/2015. PL-6. Rock-armored slope of containment dam.*

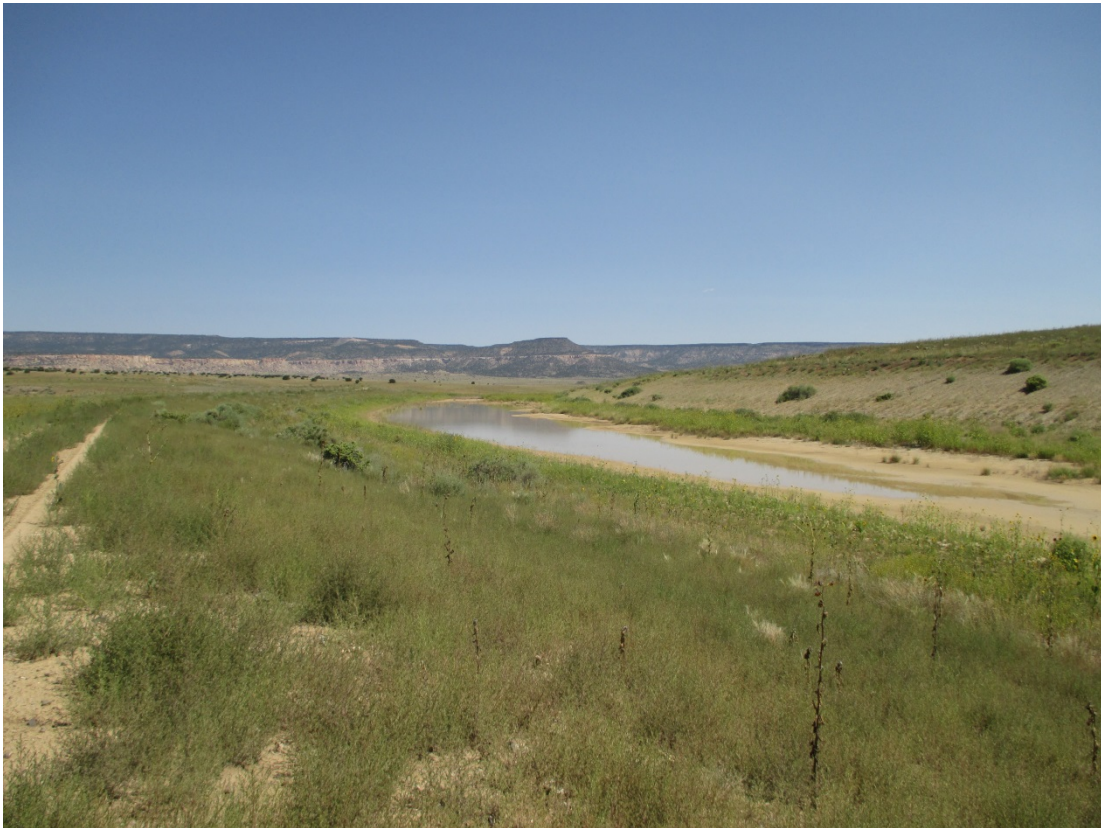
Runoff from an upgradient watershed east of the tailings impoundment is designed to be conveyed away from the site to a northeastward-flowing drainage via the east diversion channel. The east channel is separated from the impoundment by a dike. Gullies are present along the east slope of the east channel, but the erosion and sediment deposition are not impairing the function of the channel. Some of the gullies that pass under the adjacent perimeter fence are deep enough to potentially allow livestock access, and one gully threatens to undermine a fence corner near perimeter sign P6; this section of fence will be bypassed by the planned fence realignment. Standing water was present in the east channel due to recent rainfall events (PL-7).

*BAR 8/2015. PL-7. Ponded water in east diversion channel.*

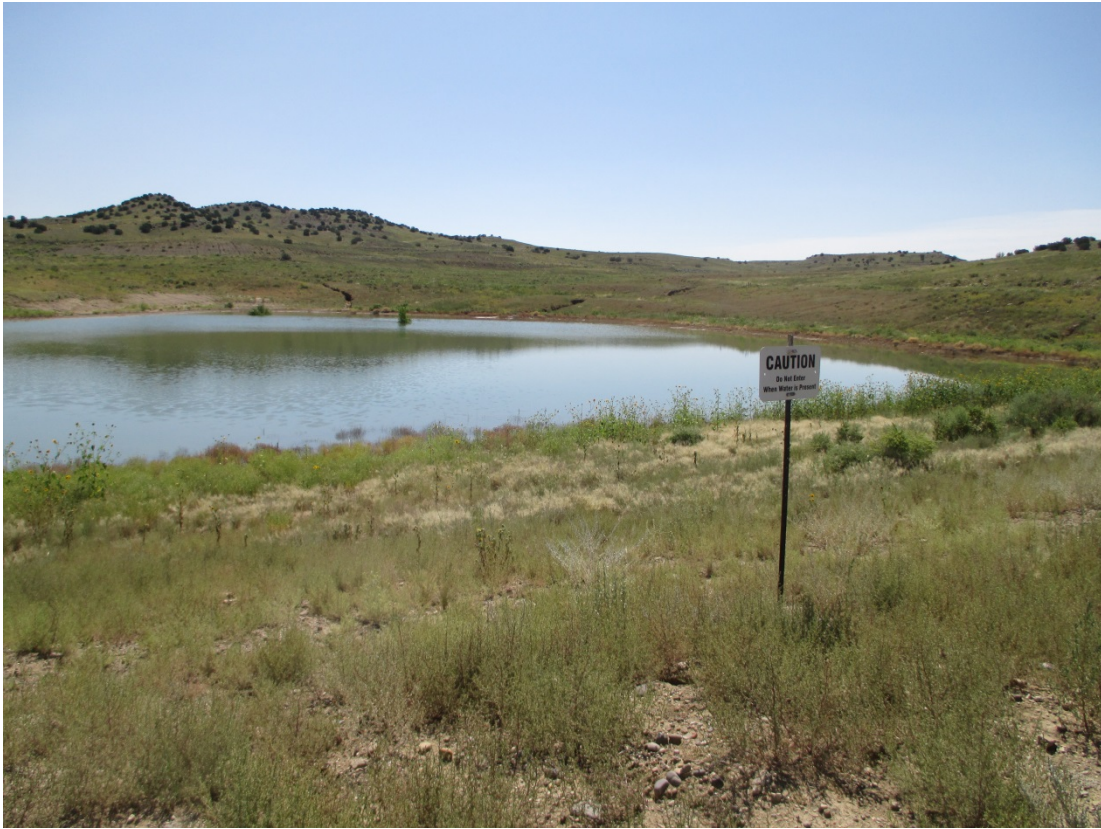
Some erosion was expected to occur in a watershed that encompasses the southeast portion of the site and adjacent property. Storm runoff from this watershed discharges into a sediment trap, where the sediment load is expected to settle out. If a runoff event overtops the sediment trap, the flow is diverted to the east channel. The sediment trap was nearly full of runoff water at the time of the inspection, and there was evidence that it had recently spilled into the east channel as designed (PL-8 and PL-9).

*BAR 8/2015. PL-8. Ponded water in sediment trap.*

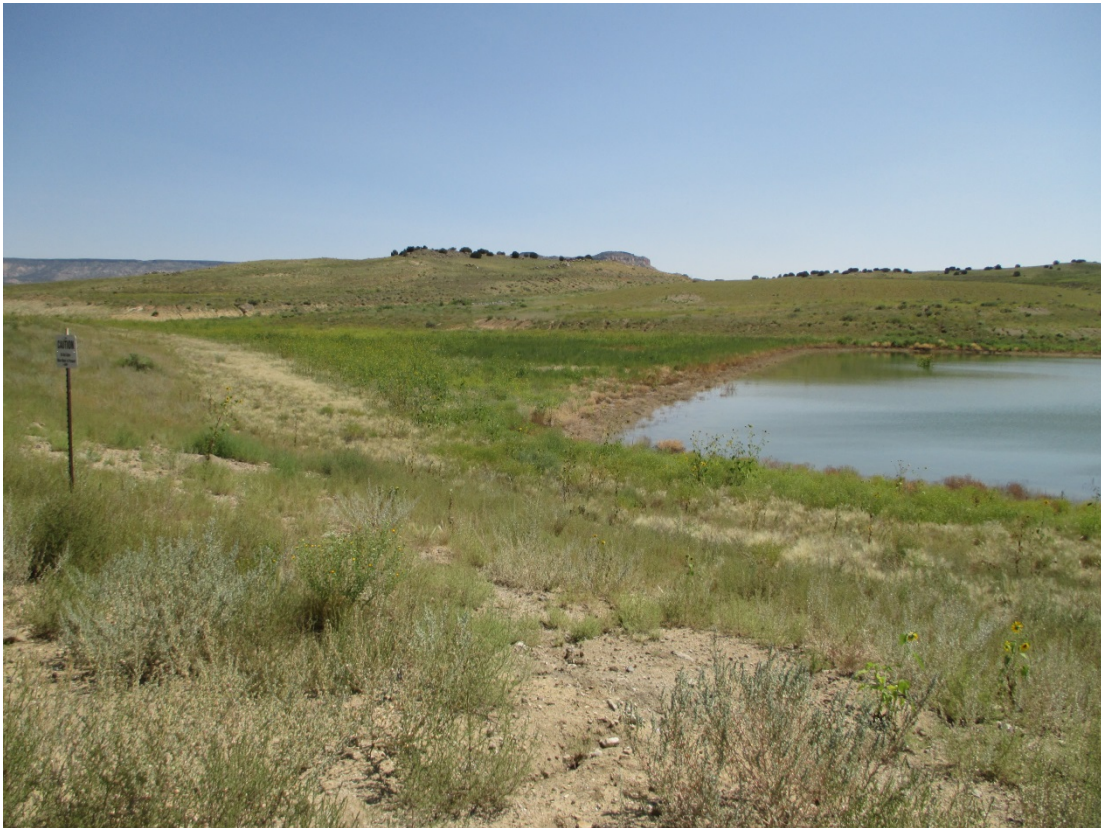
*BAR 8/2015. PL-9. Area where ponded water in sediment trap spilled into east diversion channel.*

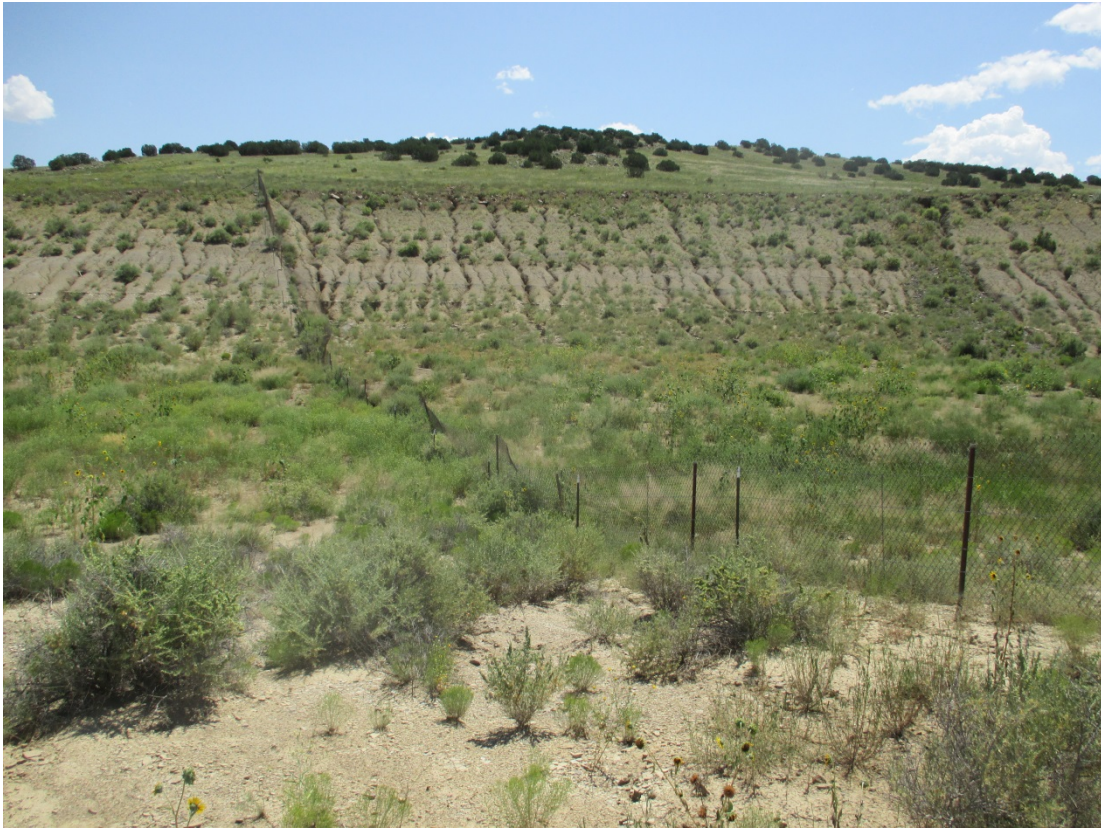
The south diversion channel diverts storm runoff from the higher terrain immediately south of the tailings impoundment toward the channel outlet to the west. Two riprap aprons are present on the north-facing slope (south bank) to inhibit erosion along natural drainage paths. Minor erosion is occurring on the unprotected slope surfaces, resulting in sediment accumulation in the channel (PL-10). The erosion and sediment deposition are not impairing the function of the channel.

*BAR 8/2015. PL-10. Slope erosion and sediment deposition in the south diversion channel.*

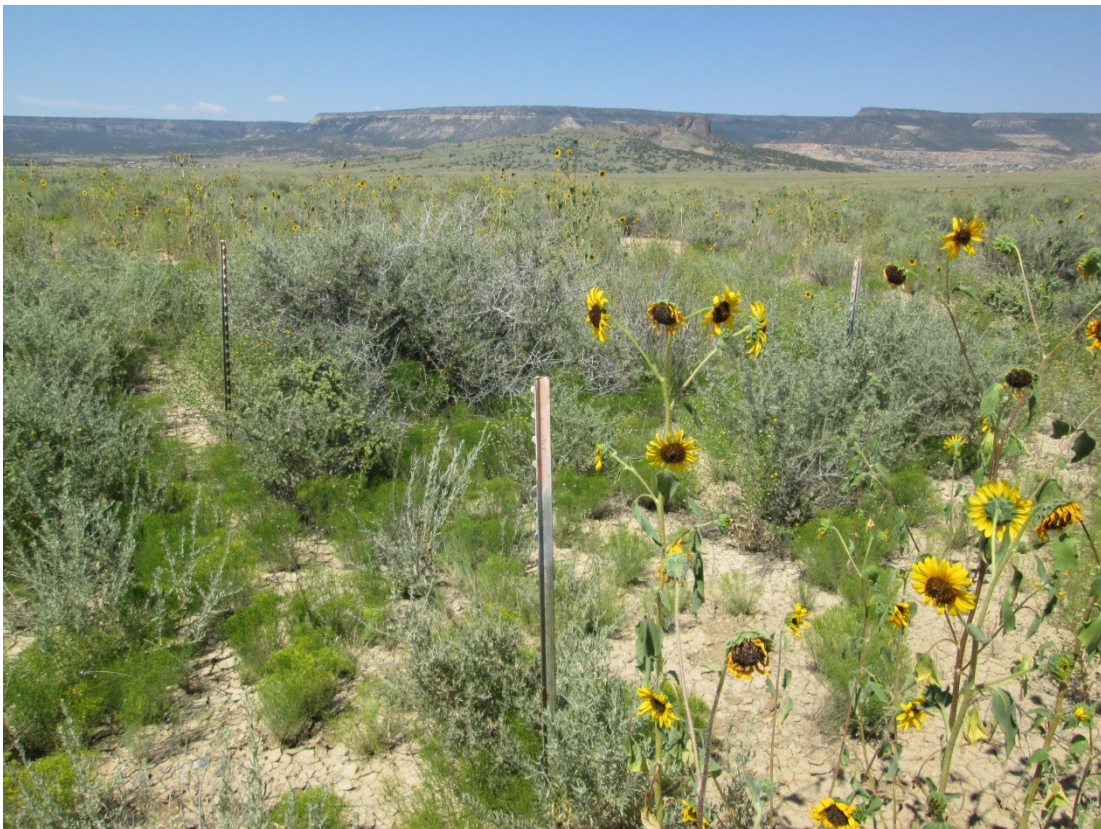
DOE established 10 vegetation monitoring locations to measure the progress of revegetation over time. Plots were established at existing erosion monitoring points to streamline measurement activities at the site (monitoring points A1, A3, B2, B4, C1, C3, D2, D4, E1, and E3). At each location, three t-posts were used to form three corners of the plot; the fourth point was projected south of the three t-posts to form a parallelogram covering approximately 100 square feet (ft<sup>2</sup>) (PL-11).

*BAR 8/2015. PL-11. Erosion monitoring point and vegetation plot E1.*
