Post-Closure Report for Closed *Resource Conservation and Recovery Act* Corrective Action Units, Nevada National Security Site, Nevada

For Calendar Year 2016

**POST-CLOSURE REPORT FOR CLOSED
RESOURCE CONSERVATION AND RECOVERY ACT
CORRECTIVE ACTION UNITS,
NEVADA NATIONAL SECURITY SITE, NEVADA
FOR CALENDAR YEAR 2016**

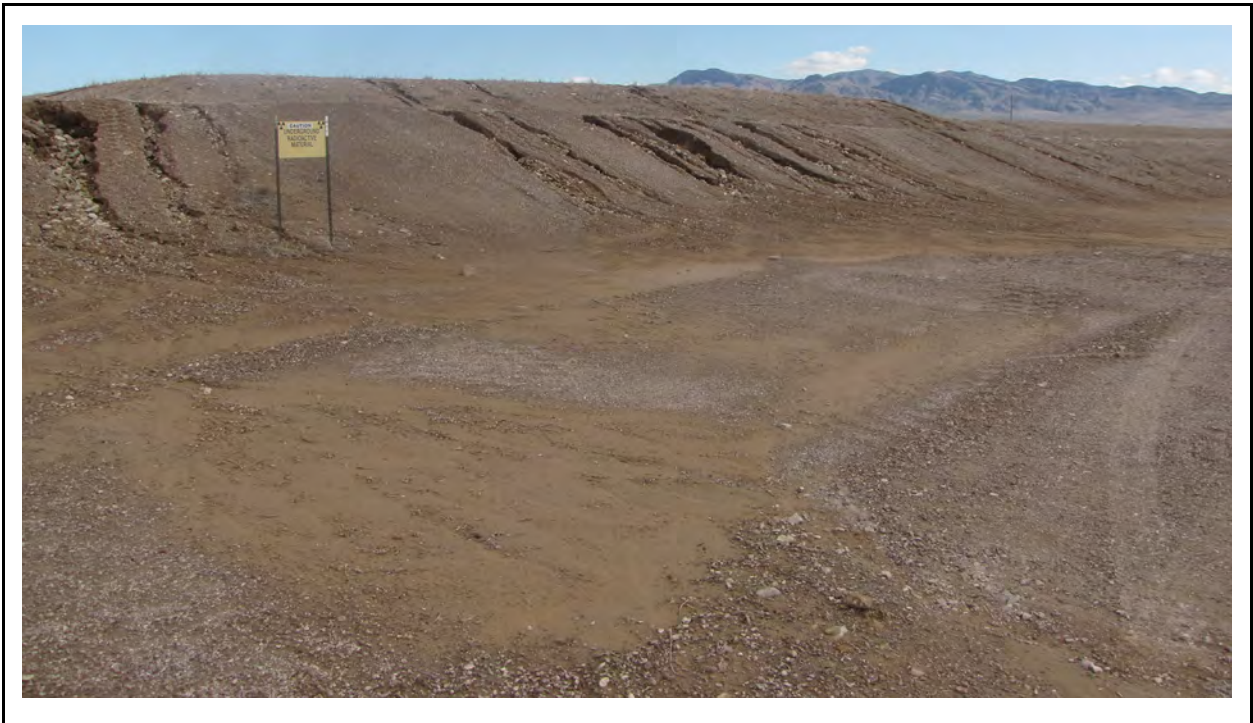
Figure 1-1
Example of Runnels on Slope of South Landfill Cover, Looking East (10/19/2015)

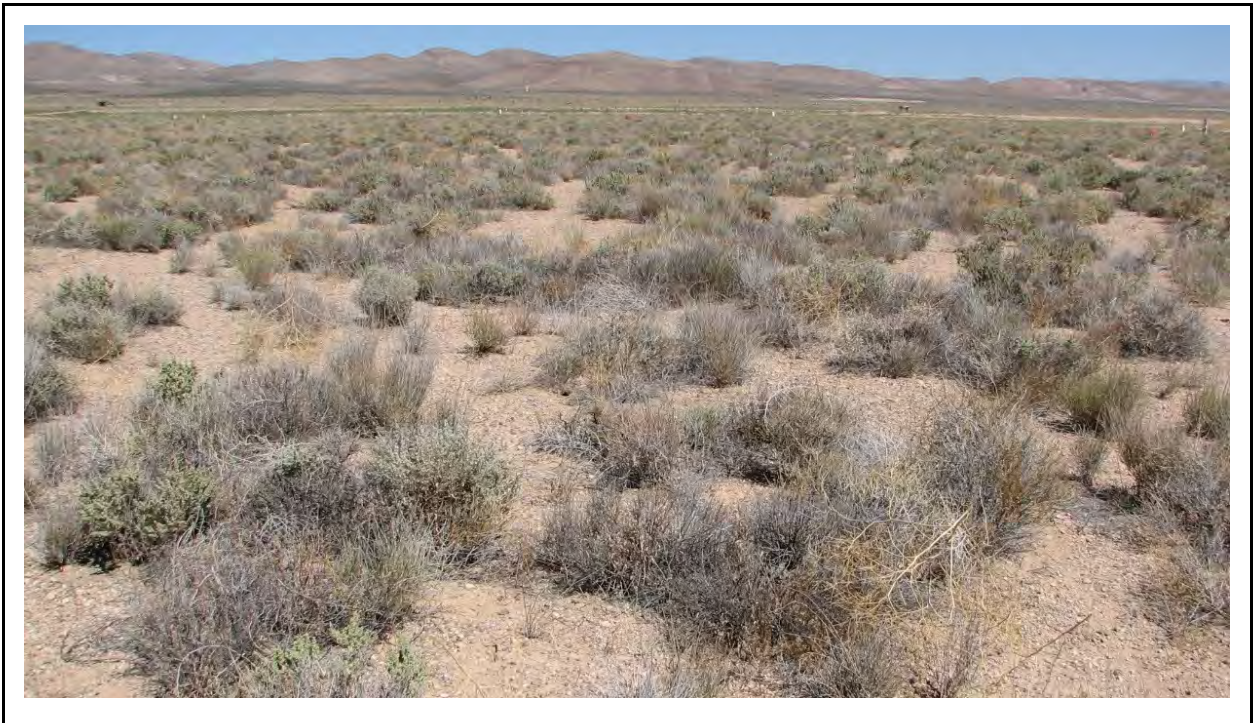
Figure 2-1

Overview of Plant Community Established on the CAU 110 over the Last 16 Years

The small mammal activity on the closure cover appeared to be less than in FY 2015. Plant growth and seed production—not only on the closure cover but also in the surrounding plant communities—was much greater than it was in FY 2015 and, as a result, small mammal populations should have increased. Trapping of small mammals is not recommended at this time.

The vegetative cover on the CAU 110 cover cap appears to be stable and in excellent condition. The plants on the cap showed good growth in FY 2016 because of the increase in precipitation. There were signs of flowering and setting of seed in FY 2016 by all species, and the majority of the plants appeared healthy. The annual forb component of the plant community reappeared in FY 2016 because of the increase in precipitation. This component of the plant community fluctuates with the amount and timing of precipitation. The area surrounding the cover that was not seeded continues to be covered with noxious weeds ([Figure 2-2](#)).

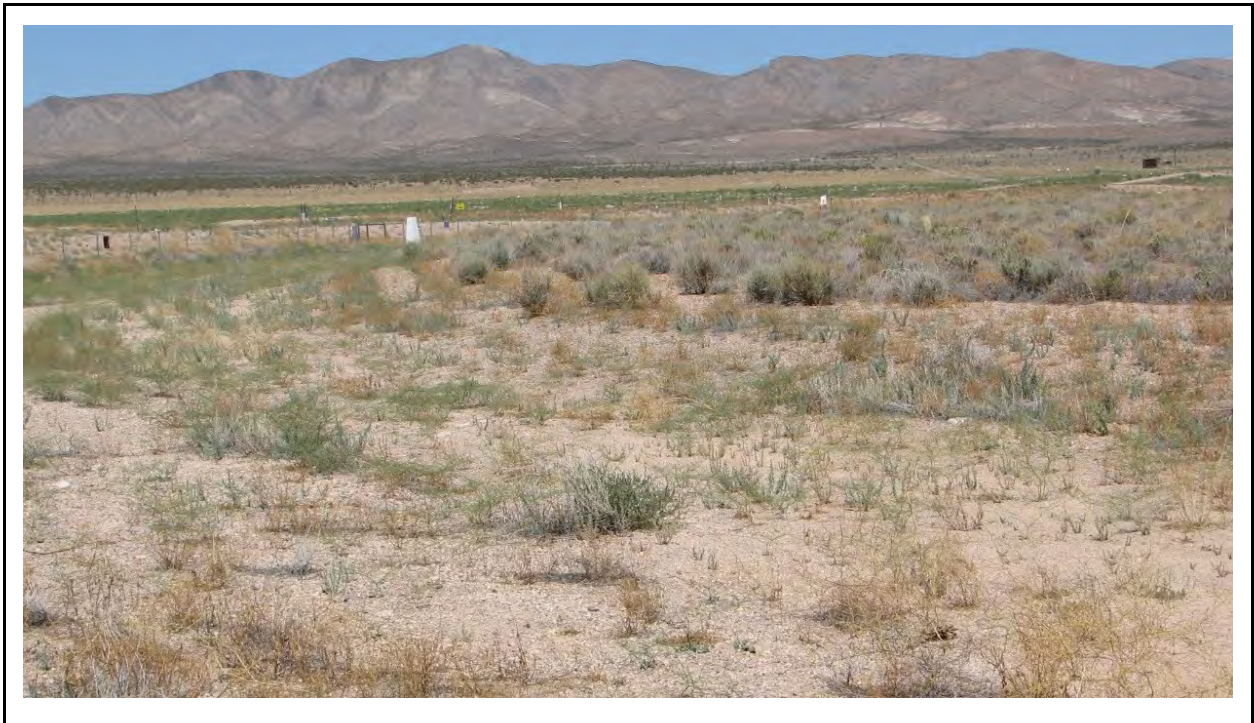
Figure 2-2
Unseeded Area Occupied by Noxious Weeds
Note: Cover cap is in the upper right of photo.

An annual subjective evaluation of the plant community will continue, and the next detailed quantitative vegetation survey will be conducted in the spring of 2018.

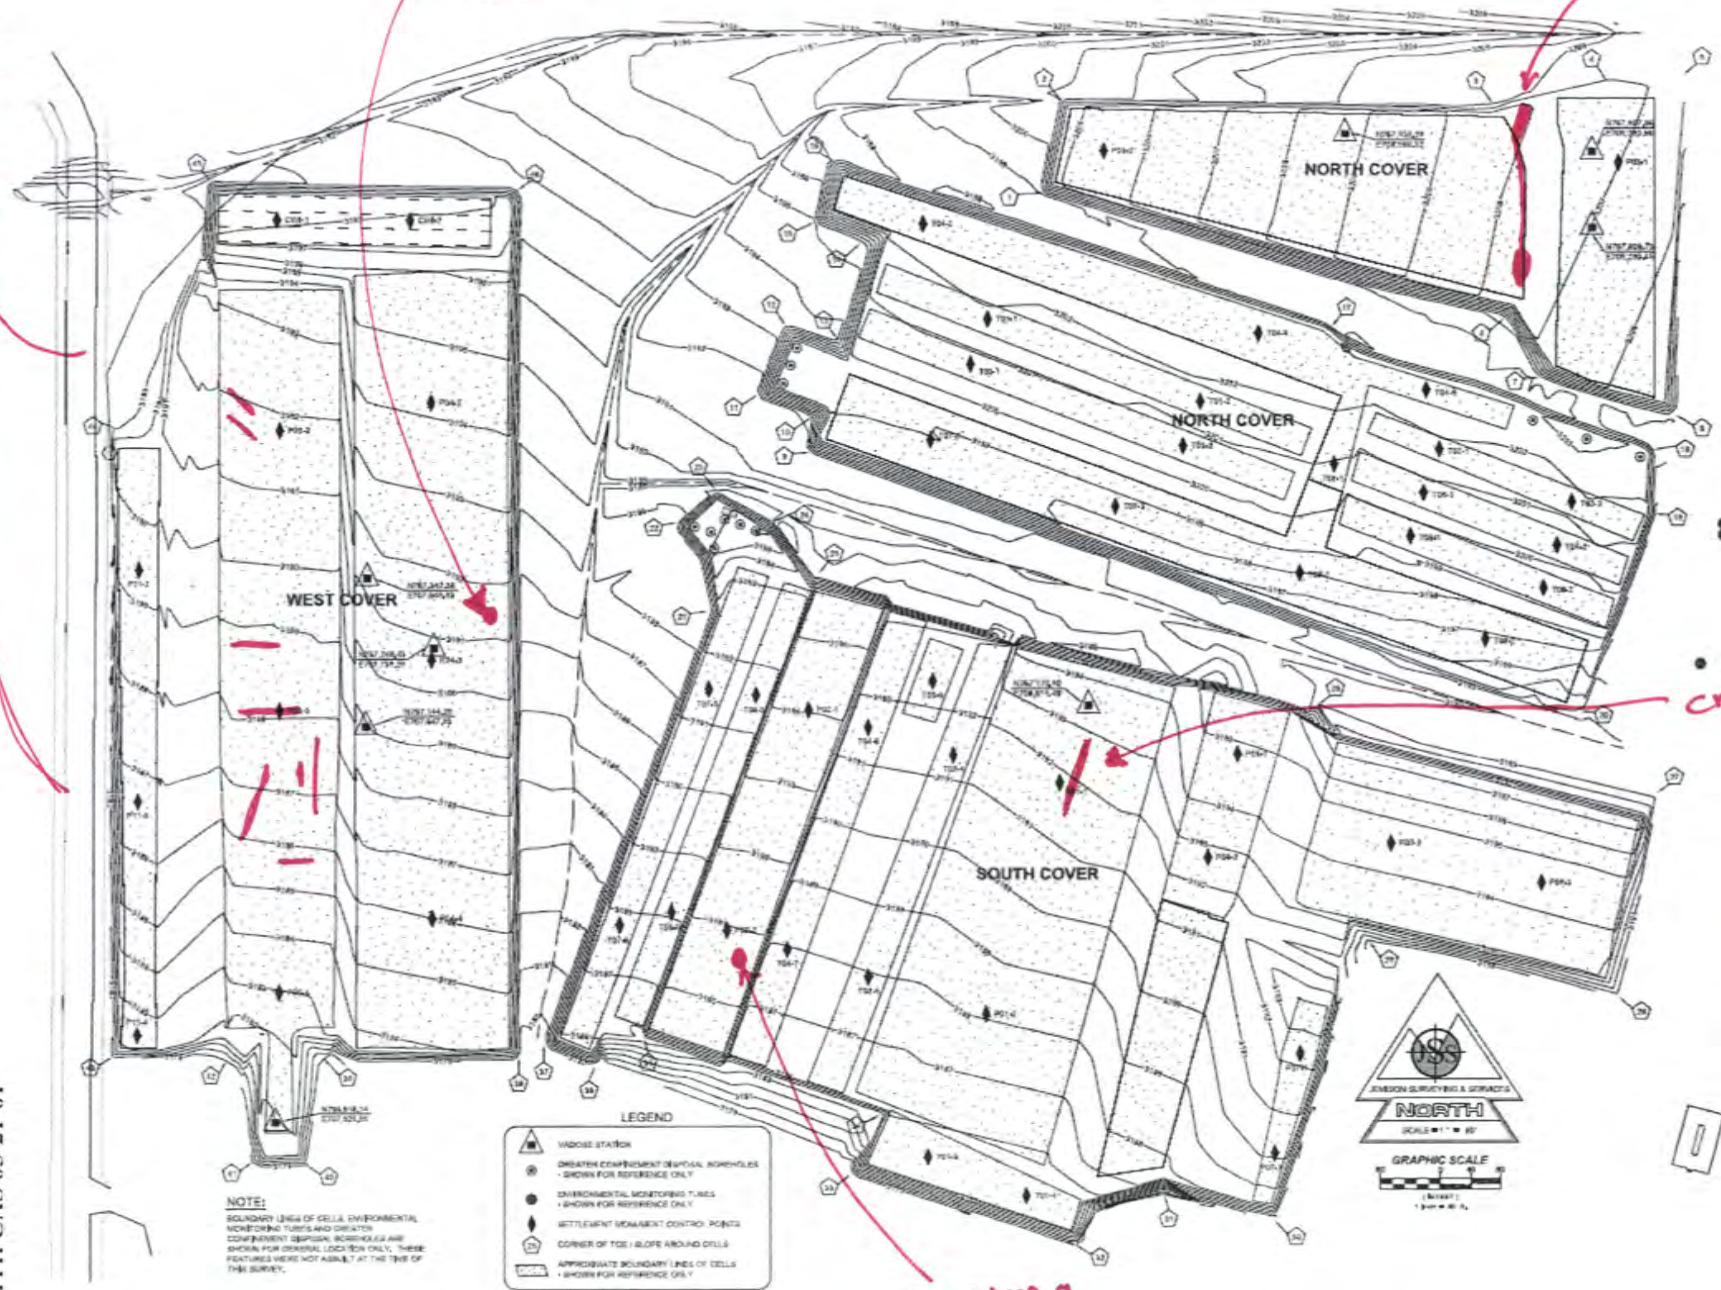
3 cracks
totaling
77.5 m long
each
crack
71 m long
15 cm deep

small cracks,
monitor.

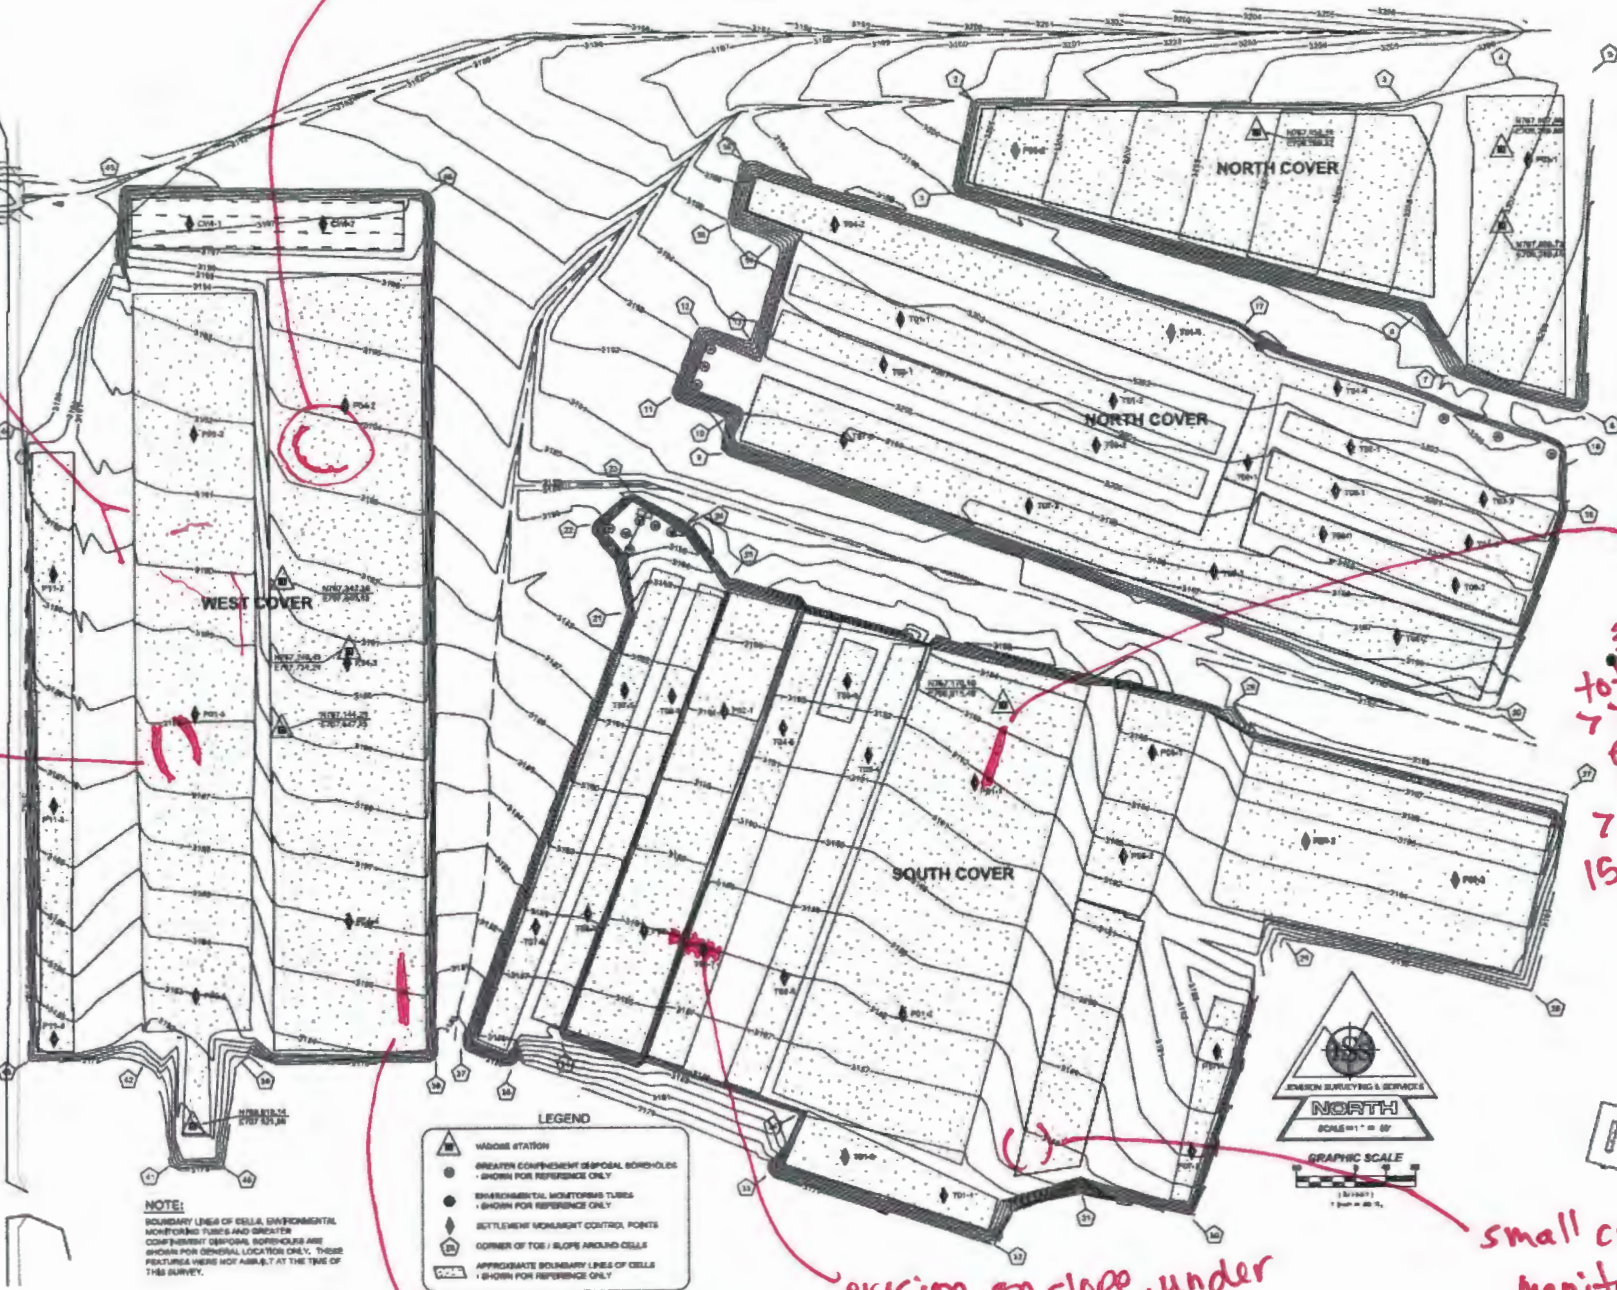
crack > 1 m long
15 cm deep

erosion on slope, under
irrigation hose.
housekeeping / monitor

ALL 3 LOCATIONS ARE CRACKS > 1m LONG & 15 cm DEEP
AREA AROUND #3 SHOULD BE MONITORED FOR SMALLER CRACKS
