LA-UR-17-23209

Title: Learning Team Breach of a Posted Barricade to Connect an Instrument to Power

Organization: MST-7, NEN-1, and DESHF-STO	Topic: Learning Team Breach of a Posted Barricade to Connect an Instrument to Power
How did it happen? How did it go?	
<p>On February 15, 2017, a DESHF-STO HPFC (health physics field coordinator) was asked by an NEN-1 employee if they could move an instrument, a radiation dosimetry system, from A166A to another lab at TA-35 Building 2. The HPFC walked the job down and discovered the instrument was connected to power. The instrument had not been connected to power previously. See photo 1. The instrument is located within an RCA (radiological control area). Entry to connect the instrument to power the instrument requires contacting RP. RP personnel had not been contacted as required as stated in the RCA posting. See photo 2.</p>	
<p>Background: In November 2015, two radiation dosimetry systems were located in close proximity to one another in Room A143. Instrument 1 had an alpha/gamma source (241Am) and a beta source (90Sr). Instrument 2 has a beta source (90Sr). Employee 1 contacted Employee 2 and asked to borrow Instrument 1. When Employee 1

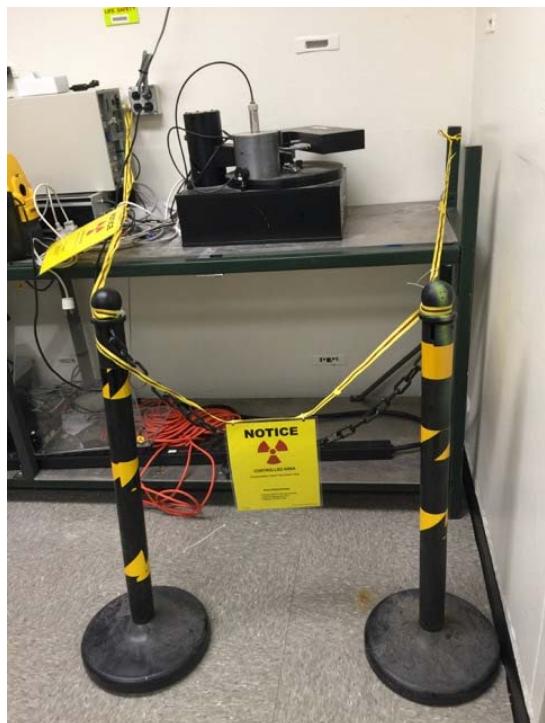
Photo 3

<p>An RCT then surveyed the outside of Instrument 2 for contamination. However, the inside of Instrument 2 could not be opened for an internal survey because a transformer to supply power was not available. Instrument 2 was moved to room A166A where the RCT barricaded the area as a radiation control area (RCA) and posted a sign. See Photo 1. Employee 2 told the RCT they would order a transformer. The RCT asked to be contacted when the instrument would be ready for survey.</p>	
<p>Employee 2 ordered and received the transformer to supply power to Instrument 2 in late February 2016. Employee 2 assumed, based on their conversation in late 2015, they were authorized and connected the transformer instrument 2. See Photo 3.</p>
