Nitrile O-ring Cracking: A Case of Vacuum Flange O-ring Failures

American Glovebox Society Conference
(2016)

Craig Dees

Craig Dees, Idaho National Laboratory

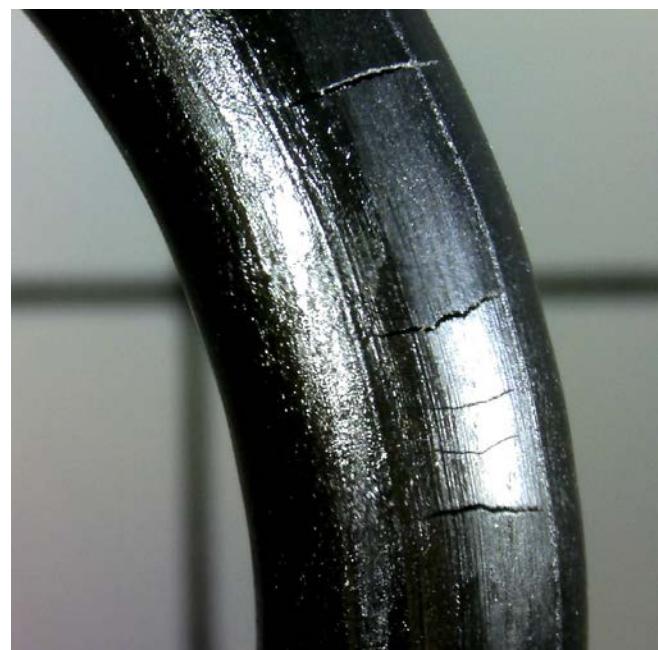
Figure 1: Minor Cracking

The cracked O-rings ranged in service age from 8 months to 4 years. The cracking appears on the outside diameter of the O-ring and is absent on the inside O-ring diameter. The material shelf life provided by the O-ring manufacturer was 5 years. Although the manufacturer provided little information on the service life, it was anticipated that the O-rings would provide at least 5 years of service in this low pressure inert gas environment.

A broad range of surface cracking severity was noted, the most significant cracking extended through about half of the material thickness, see Figure 1 and Figure 2. Two general observations can be made related to the severity of the surface cracking. First, O-rings installed for longer periods of time exhibited more significant cracking. Second, well lubricated O-rings exhibited less cracking compared to O-rings of the same age which were installed dry. The dry O-rings are an apparent oversight by the installer as all of the O-rings should have been lightly lubricated at the time of installation. The O-ring surface cracking is visually comparable to ozone or weather deterioration in nitrile material.

Consideration should be given to O-ring materials better suited for continuous air exposure, such as Viton®, for general purpose glovebox applications. An O-ring material for all glovebox applications cannot be stated, and the final material decision should consider any application specific concerns.

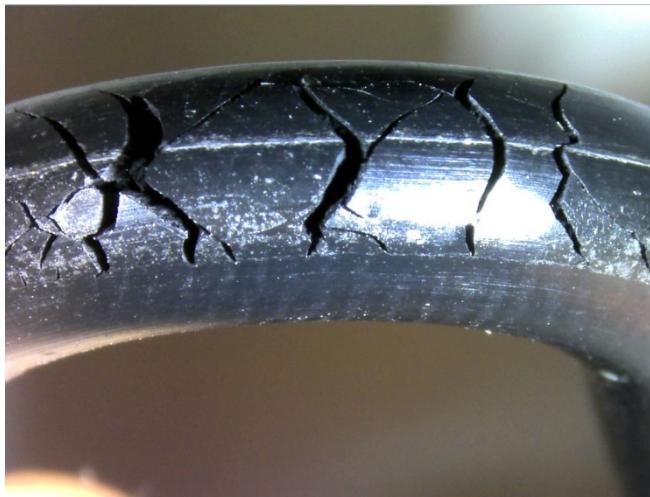
Figure 2: Significant Cracking

The location of the cracking, on the outside diameter, is consistent with the O-ring surface exposed to room air, whereas the inside diameter

is exposed to the glovebox environment, typically inert argon gas.

O-ring samples were sent to two independent O-ring manufacturers for evaluation. (1) (2) The manufacturers generally agreed that the cracking was caused by loss of plasticizer by outgassing, a common issue with nitrile material, and likely not as a result of excessive ozone. Both manufacturers suggested avoiding the nitrile material for applications where the O-ring is continuously exposed to air. The evaluations from the O-ring manufacturers support a conclusion that the O-ring cracking is a result of material and application incompatibility rather than previously unidentified environmental conditions. Careful maintenance and regular O-ring replacement would be a necessary prerequisite for successful nitrile O-ring use in applications where extended exposure to air is anticipated.

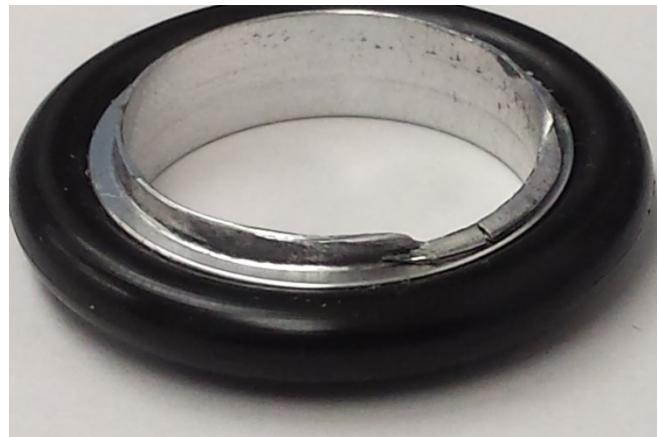
Other installation issues and poor practices were noted, some ISO-KF connections exhibited damaged centering rings or compression marks on the nitrile O-ring material, see Figure 3. The damaged centering rings are a clear indication of flange misalignment and inattentive installation practices. The compression marks are another symptom of improper lubrication, the O-ring material appears to compress unevenly due to friction when the flanges are clamped together.

Figure 3: Centering Ring Damage

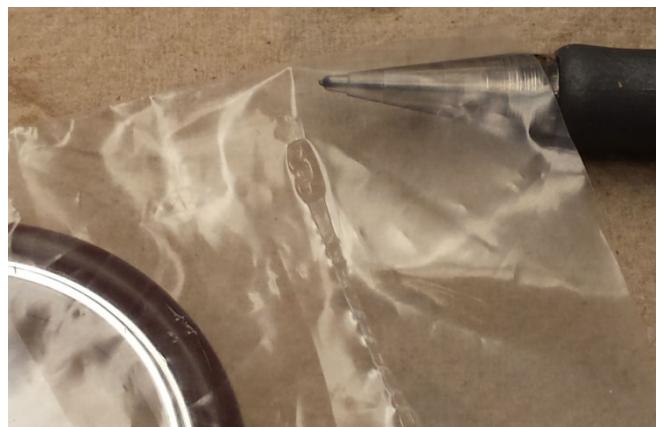
A review of the storage and installation techniques showed additional opportunities for improvement. The O-ring in ISO-KF flange connections are mounted on a metal centering ring which aid in positioning the O-ring and align the two mating flanges. In most cases the O-rings were purchased preinstalled on the metal centering ring, and typically stored four to six months prior to installation. The stretched

condition is undesirable, ideally the O-ring would be left in a natural condition until installation.

Figure 4: Unsealed Packaging

Another potential concern was identified in the O-ring packaging. The O-rings, preinstalled on a metal centering ring, were individually packaged but the packaging was not air tight as shown in Figure 4. This storage condition left the O-rings in a stretched condition, exposed to air, for extended periods of time and is considered a contributing factor to the observed rapid cracking in the nitrile material.
