# Characterization of Blistering and Delamination in Depleted Uranium Hohlräume

K. J. M. Blobaum, M. Stadermann, J. Fair, N. Teslich,  
M. Wall, R. Foreman, N. Hein, H. Streckert, A. Nikroo

August 31, 2012

Fusion Science and Technology

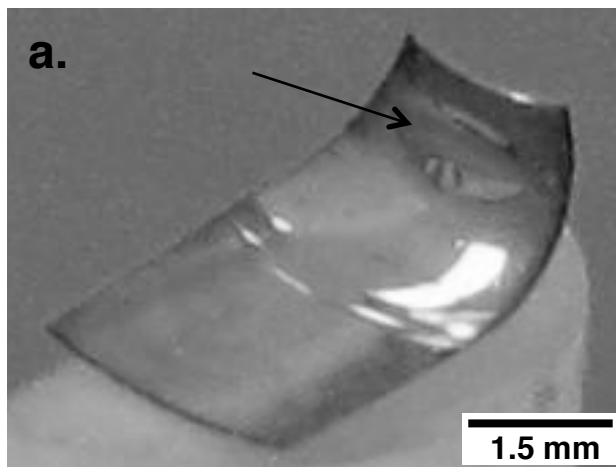
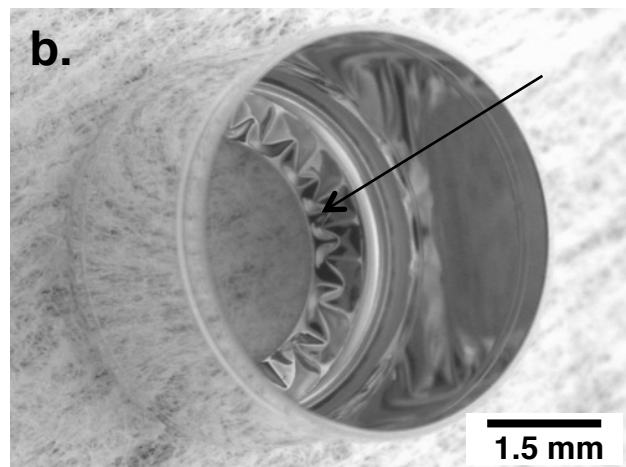
Figure 2

The majority of blisters form on the hohlraum “radius,” which is the curved region where the cylindrical barrel transitions to the flat laser entrance hole (LEH) end (see Figure 1). Given the geometry of this region, it is expected that the stress state of sputtered films is different here than along the barrel, or at the LEH. Residual stress in the deposited layers likely plays a role in enhanced blister formation at the radius. Examples of blisters at the radius are shown in Figure 2.

Figure 2: Optical images of DU hohlraums showing blistering on the interior, at the radius. The blister shown in (a) is a single isolated blister, while the blistering in (b) is a rippled delamination that extends around the circumference of the hohlraum.

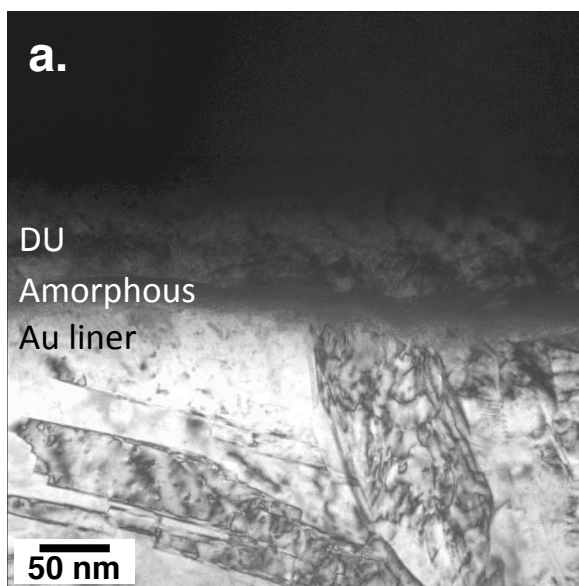
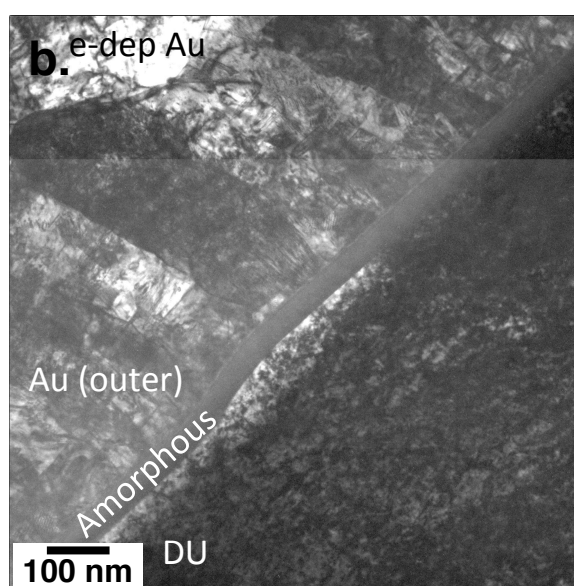
Figure 3 shows TEM images of a FIB liftout from an as-deposited DU hohlraum that was still on the Al mandrel and had not been exposed to a chemical etch. The liftout was extracted perpendicular to the cylinder surface so that the interfaces between the Au and DU layers could be examined in cross section. Intermixed, amorphous Au/DU layers are observed at both Au/DU interfaces. The amorphous layer between the Au liner and the DU is  $100 \pm 5$  nm thick and the layer between the DU and outer Au is  $40 \pm 5$  nm thick. Compositional analysis of the layer at the Au liner/DU interface indicates that the composition varies nearly linearly.

Figure 3: TEM images of the DU/Au interfaces in an as-deposited hohlraum. At the interface, there is an amorphous, intermixed layer. The amorphous layer between the Au liner and DU (a) is  $100 \pm 5$  nm thick; the layer between the outer Au layer and DU is  $40 \pm 5$  nm thick. In (b), columnar Au grains are evident in the sputtered layer; the beginning of the electrodeposited Au layer is visible in the upper left corner.

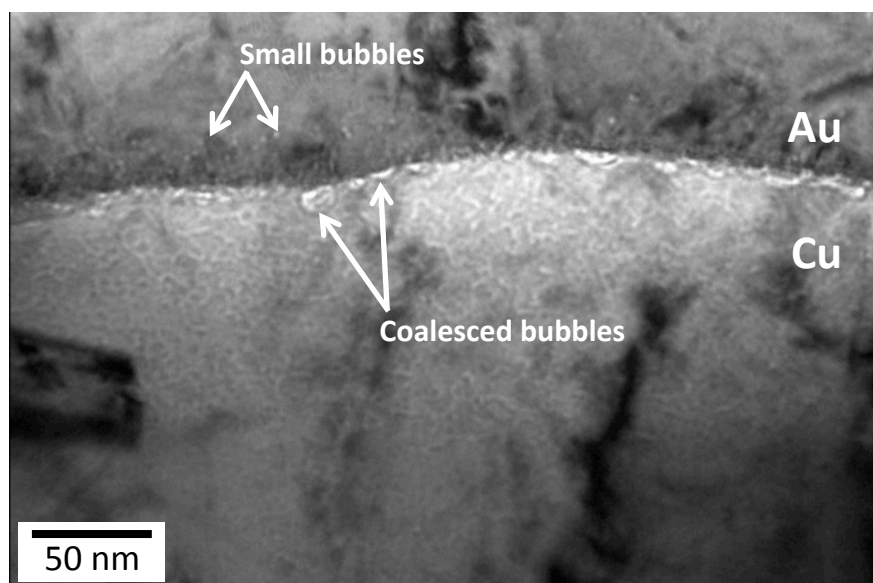
Figure 4

At the Au liner/Cu interface, there are small bubbles (diameter  $\sim 2$  nm) in the gold layer and larger bubbles ( $\sim 10$  nm) extending from the interface into the Cu layer (Figure 4). In the Au layer, the bubbles are primarily located near the Au/Cu interface, with their number density decreasing sharply as the distance from the interface increases. These bubbles are likely filled with argon sputter gas, which is incorporated during deposition. It is possible that the elevated temperatures during deposition allowed bubbles to migrate toward the lower energy Au/Cu interface, where they coalesced on the grain boundaries. Another reason for the enhanced bubble density at the interface may be the roughness of the ion-milled Cu surface, which allows more Ar to adsorb and become trapped as Au islands form and grow together.<sup>21</sup>

Figure 4: TEM image of the sputtered copper/sputtered gold liner interface. Small bubbles (white circles) are seen in the gold layer near the interface. At the interface, and extending into the copper layer, larger bubbles are present.

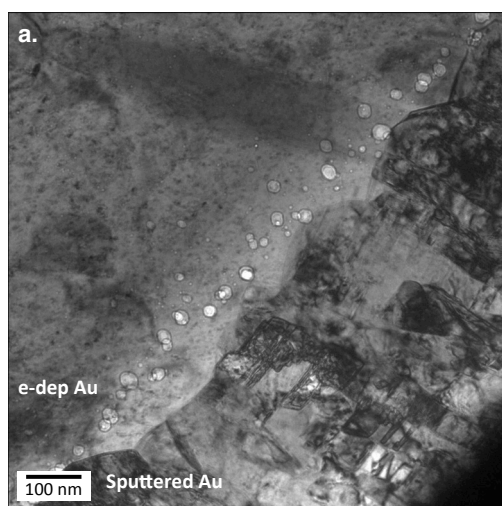
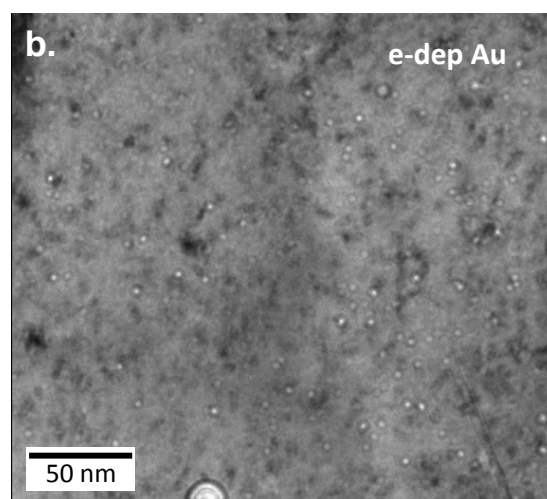
Figure 5

A similar pattern of large bubbles at the interface and smaller bubbles in the bulk is seen at the interface between the outer layer of sputtered Au and the electrodeposited Au (Figure 5a). Here, large bubbles (20 – 30 nm) are concentrated in the electrodeposited Au near, but not at, the interface. In the bulk of the electrodeposited Au, small ( $\sim 2$  nm) bubbles are uniformly distributed through the thickness (Figure 5b). These bubbles likely contain hydrogen that was evolved from the hydrolysis of water in the aqueous deposition bath. The current used during the deposition is sufficiently high for this process to occur.

Figure 5: TEM images of bubbles in the electrodeposited Au layer. In a.), large bubbles near the interface between the electrodeposited gold and sputtered gold layers are evident. The black spots in the electrodeposited gold layer are FIB-induced damage. Image b.) shows bubbles (small white circles) distributed through the bulk of the electrodeposited gold layer.

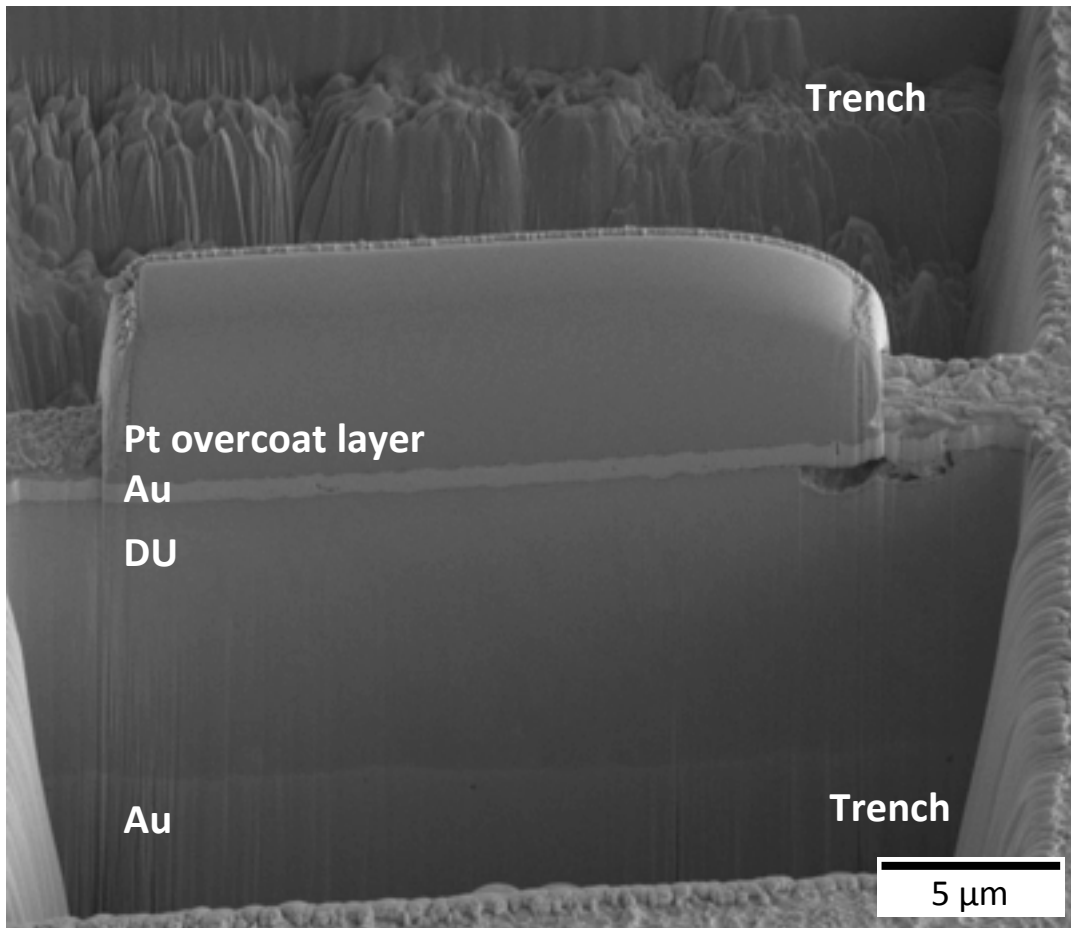
Figure 7

Figure 7: A sample extracted from a hohlraum using the FIB. At the Au liner surface (*i.e.*, the inner surface of the hohlraum), this sample appeared pristine. However, as this SEM image shows, there is pitting below the surface at the Au liner/DU interface. (Note: the Pt overcoat layer is applied in the FIB to protect the sample's surface during ion milling.)

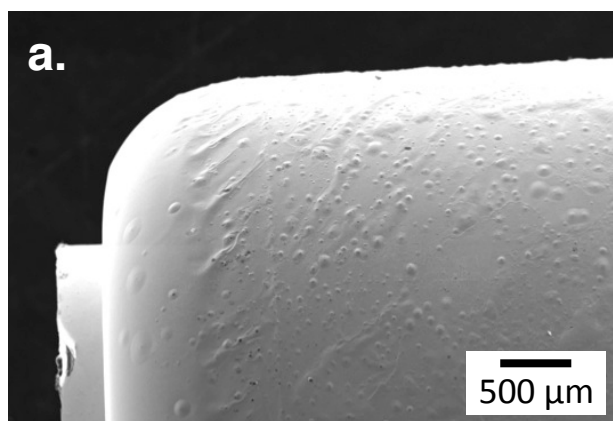
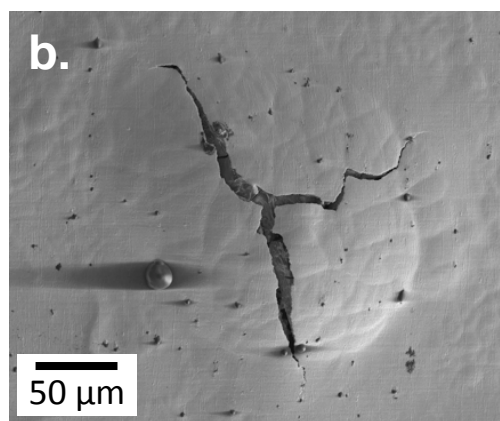
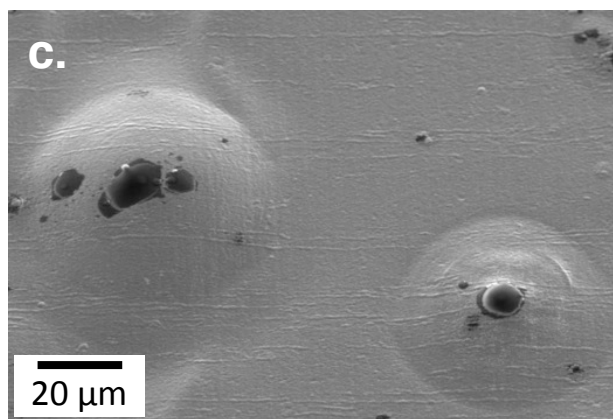
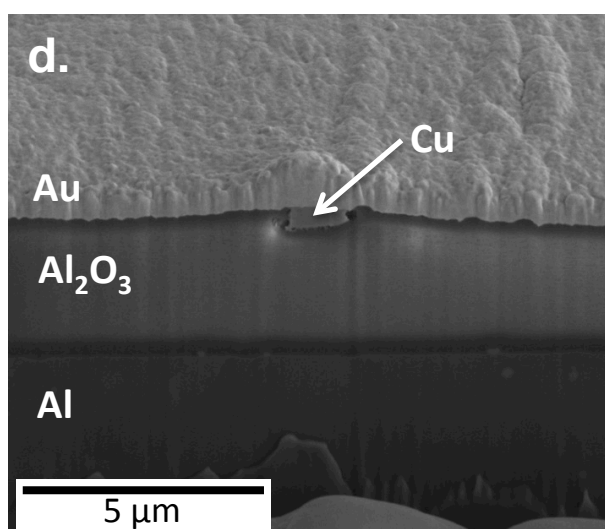
Figure 8

effectiveness of these two layers, a sample containing only the Cu and Au liner layers sputtered on an Al mandrel was subjected to a harsh nitric acid etch (more severe than the etching conditions used for hohlraum production). Nitric acid etches Cu, so if the Au liner layer is permeable, we would expect to see degradation of the Cu. After this etch, the surface of the sample was peppered with  $\sim 50\text{ }\mu\text{m}$  diameter blisters (Figure 8a). Some of these blisters were cracked (Figure 8b), and others had  $\text{Al}_2\text{O}_3$  at their apogees (Figure 8c). FIB cross-sections through blisters showed that much of the Cu layer had dissolved and was replaced by a layer of  $\text{Al}_2\text{O}_3$  that had grown from the Al mandrel (Figure 8d). The Cu layer had been reduced from a continuous layer to randomly spaced hillocks surrounded by  $\text{Al}_2\text{O}_3$ .

Figure 8: SEM images of blisters in a gold layer that was sputter-deposited onto a Cu-coated Al mandrel. The Au/Cu/Al assembly was etched in nitric acid. (a.) Radius area of the gold surface showing severe blistering. (b.) A cracked blister on the gold surface. (c.) Two Al<sub>2</sub>O<sub>3</sub>-topped blisters on the gold surface. (d.) Cross-sectional image of the mandrel. The Cu layer, previously covering the Al mandrel, has been almost entirely dissolved and replaced by Al<sub>2</sub>O<sub>3</sub>.

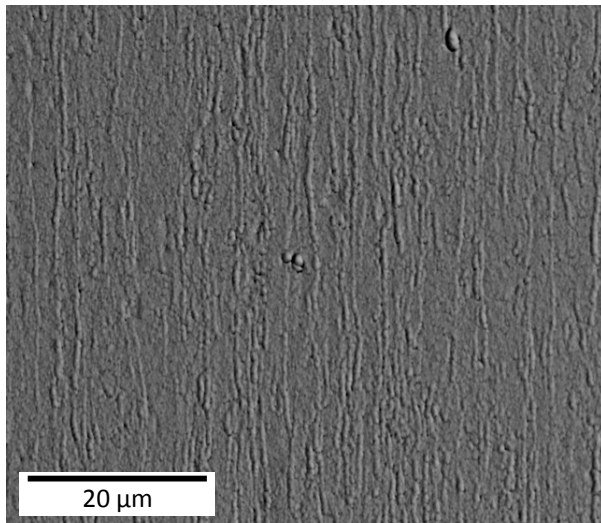
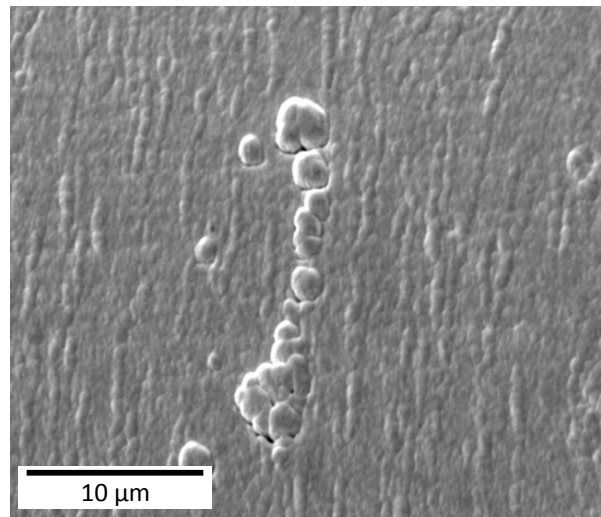
Figure 9

SEM images of the Au liner microstructure in plan view are shown in Figure 9. The microstructure is columnar, with strings of asperities that run parallel to the long axis of the hohlraum. The Cu layer shows a similar microstructure, with asperity strings and faceted islands (Figure 10). The surface of the Cu appears porous; the columnar grains have not fully grown together, leaving voids between the grains (Figure 11). Images of the machined Al mandrel also show a rough microstructure, with strings of impurities running along the length of the mandrel, which is the extrusion direction for the Al rod used as the starting

Figure 9: SEM images of the as-deposited Au liner. The microstructure has strings of asperities running along the long axis of the cylinder.

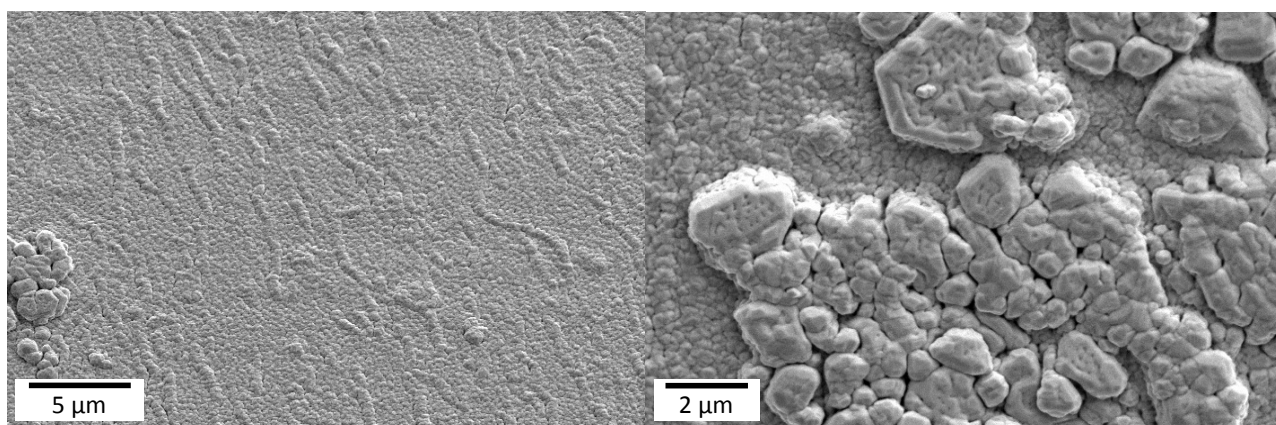
Figure 10

Figure 10: SEM images of the as-deposited Cu layer, which is sputtered on the Al mandrel. Similar to the gold liner, the surface shows strings of asperities. Some of the islands are faceted.

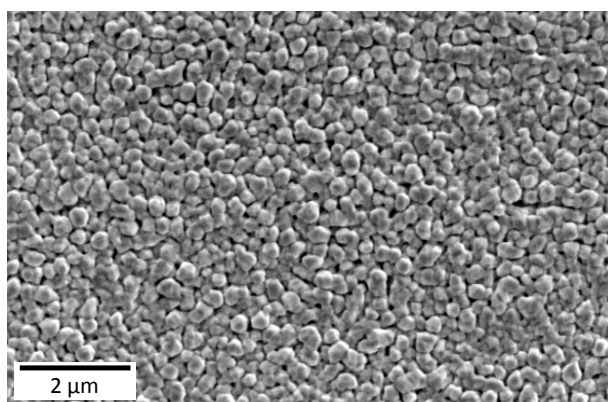
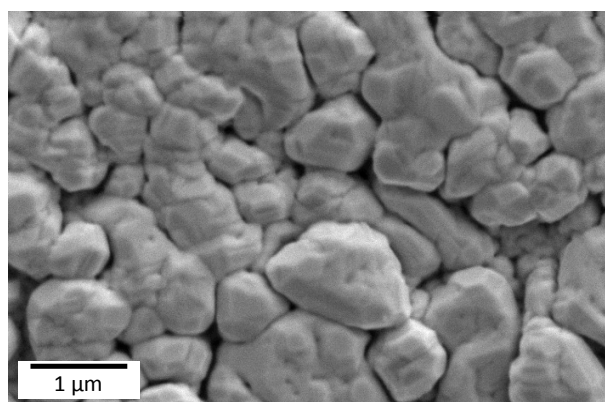
Figure 11

Figure 11: High-resolution SEM images of the sputter-deposited copper surface. The grains are columnar, and have not fully grown together, likely leading to paths for chemical etchants to leach through this layer.

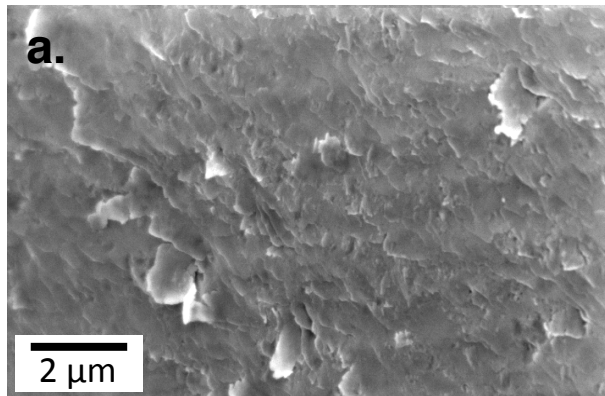
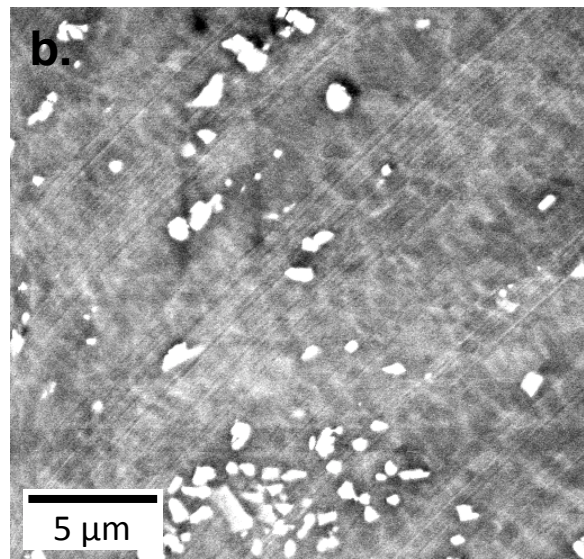
Figure 12

material. The 1100 Al alloy used here contains hard Si and Fe inclusions that can dull machining tools, resulting in the flaked surface shown in Figure 12a. After ion milling of the Al mandrel, the impurities are even more evident. The ion milling preferentially etches the Al, leaving behind strings of Fe and Si asperities (Figure 12b). These features are then replicated in all subsequent deposited layers, which can result in voids and paths for chemical etchants to permeate the layers.

Figure 12: SEM images of a machined Al 1100 mandrel surface. (a.) The flaked surface finish of the as-machined mandrel is caused by hard Si and Fe inclusions in the alloy, which dull the diamond tool. (b.) After ion etching, the hard inclusions (light contrast) are more prominent because the etch preferentially attacks the Al, leaving behind the impurities. These asperities are replicated in all subsequently deposited layers.

Because asperities in the Cu and Au liner layers appear to originate on the Al mandrel, improving this surface may improve the yield. One way to improve the surface is the use a cleaner Al substrate, rather than an alloy with known inclusions. SEM images of Al mandrels machined from 99.99% Al are shown in Figure 13. The parallel lines on these images are the tool marks; the asperities and flaking of the surface that are seen in the Al 1100 alloy mandrels are not present here. Additionally, a shorter ion etch time may improve the Al surface because the inclusions will not become as pronounced when the Al is preferentially removed. However, decreasing the ion etch time may result in poor Cu adhesion. Recent limited-quantity trials with Al mandrels that were etched for half the time normally used produced excellent quality hohlraums. More trials are needed to verify that shorter ion etch times increase the yield on a production-quantity scale.

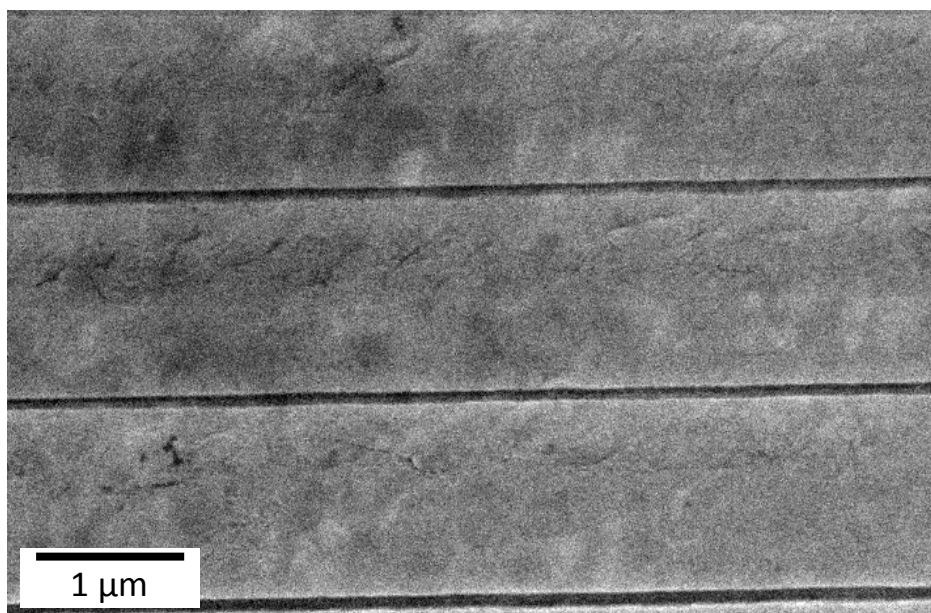
Figure 13

Figure 13: SEM image of the machined surface of a 99.99% Al mandrel. The parallel lines are tool cutting marks. The inclusions and flaking observed on mandrels machined from an Al 1100 alloy are not seen in this high-purity material.
