Fukushima Forensics: Combustible Gas Effects

April 28-29, Washington, DC

Nathan Andrews (SNL) and Wilson Laungdilok (Fauske
and Associates)

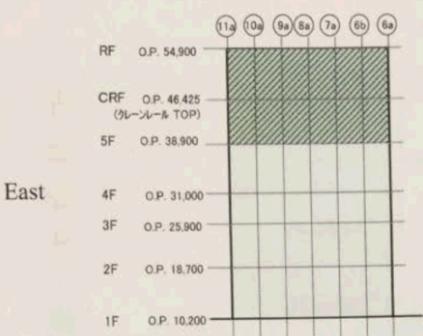
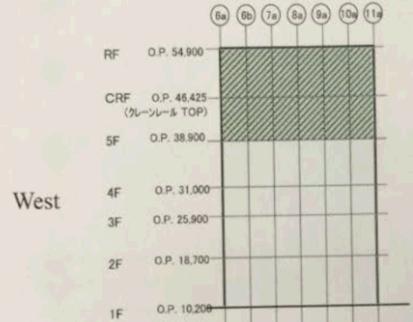
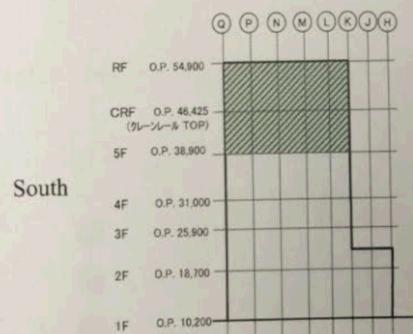
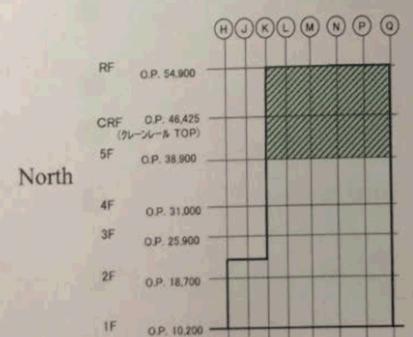
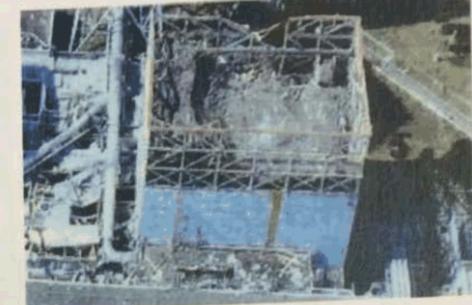
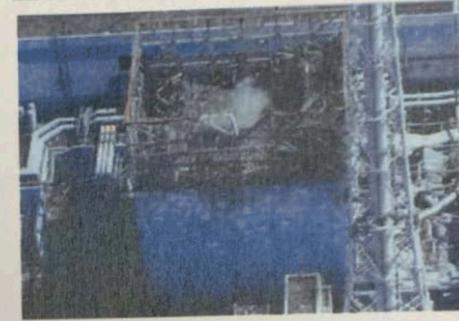
1F1 End State

- Damage following explosion
- Shows all four sides of the building

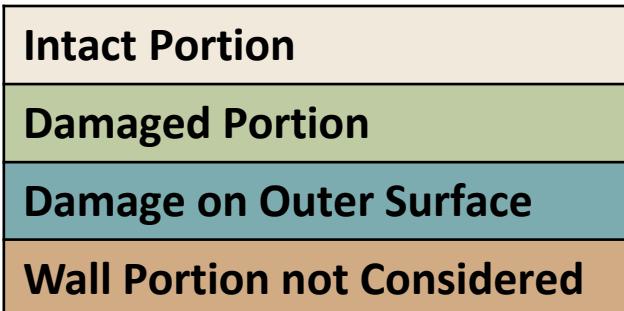
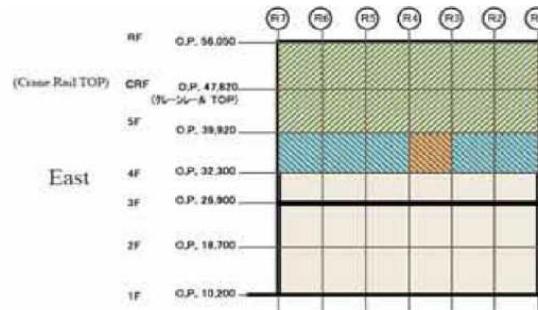
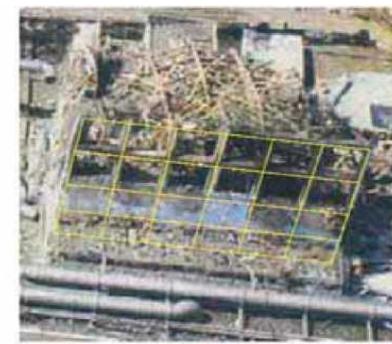
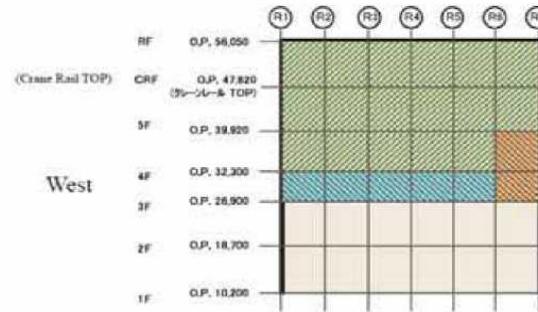
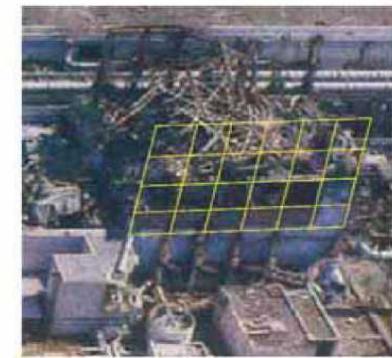
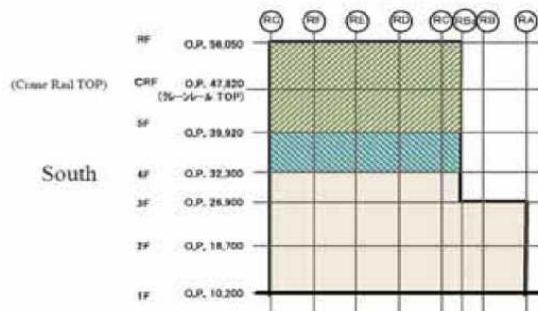
1F3 End State

- Damage following explosion
- Shows all four sides of the building

- **The damage to the 1F3 building was more extensive compared to damage incurred at 1F1 and 1F4.**
 - To what extent was the damage caused by the energetic explosion as a consequence of drywell head seal failure at high PCV pressure and temperature is a question to be answered.

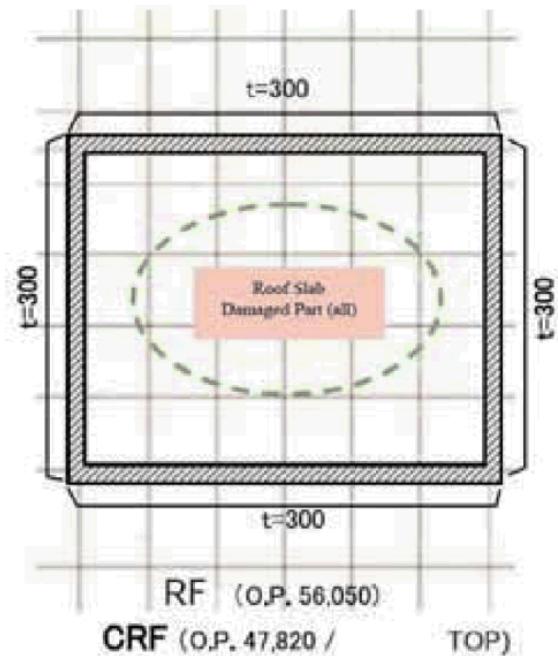
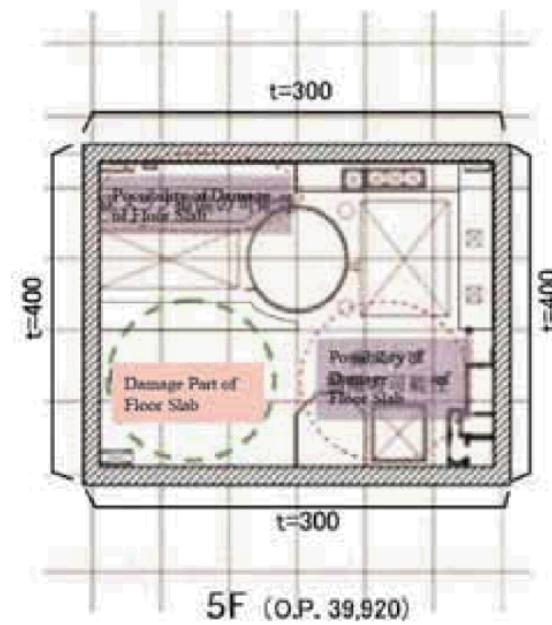
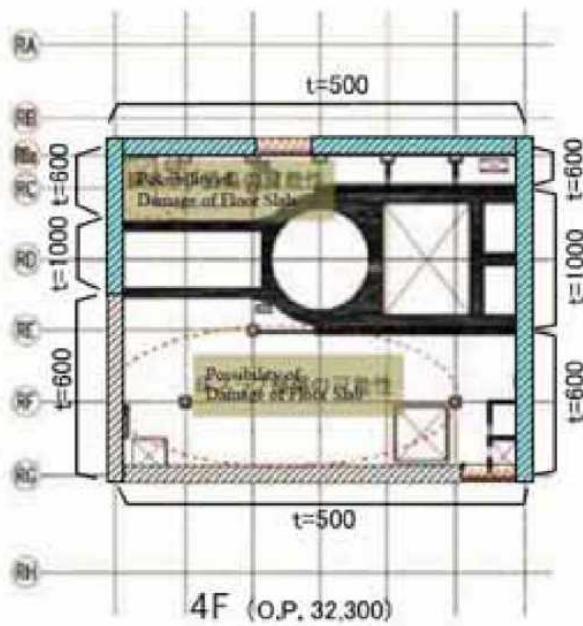
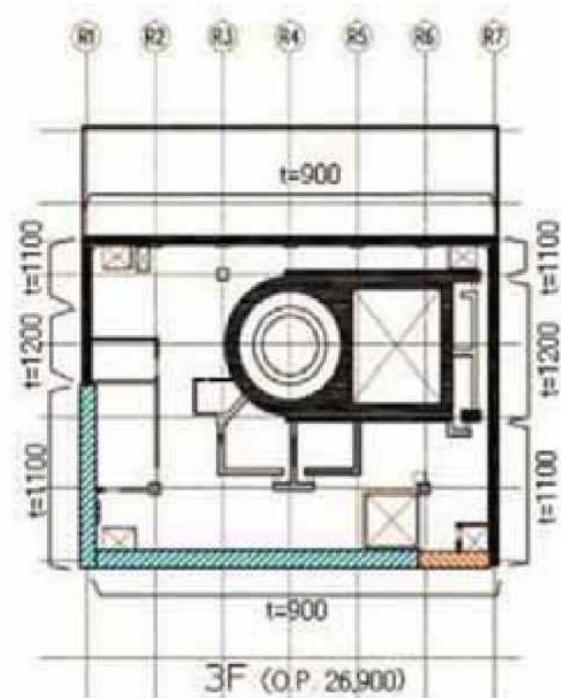
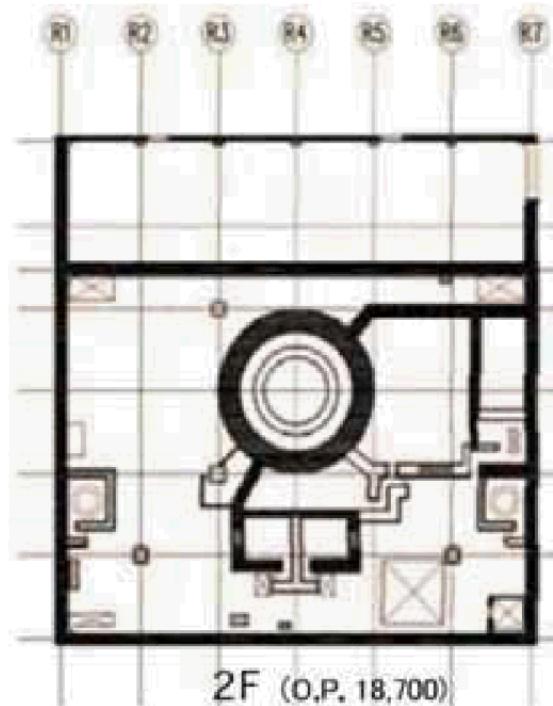
1F3 End State

- Floor plan

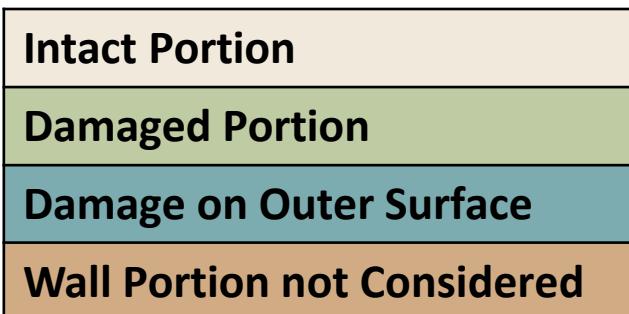
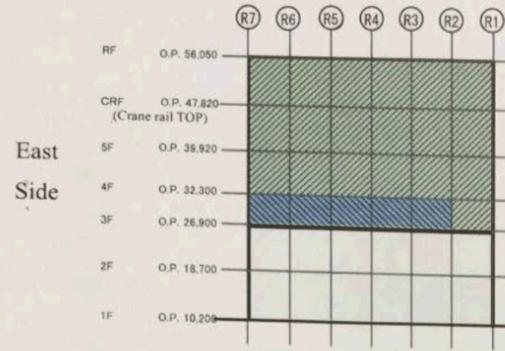
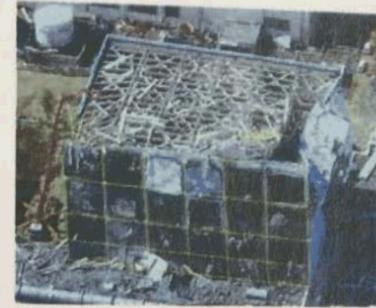
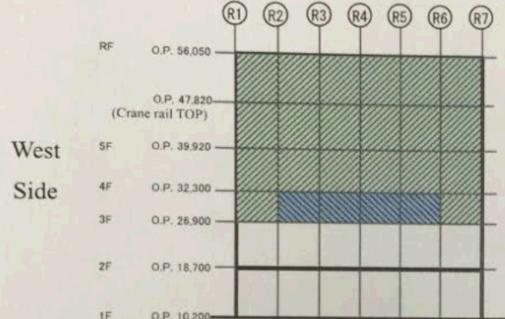
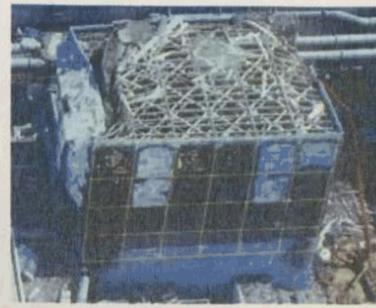
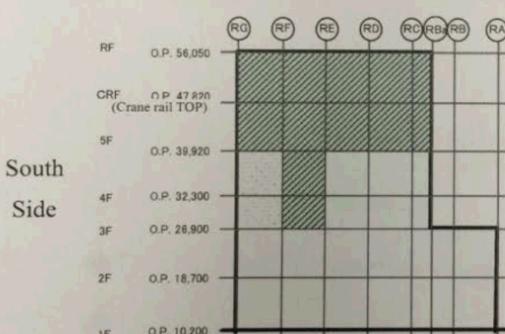
1F4 End State

- Damage following explosion
- Shows all four sides of the building

- **The shared vent stack between 1F3 and 1F4 allowed hydrogen that was vented from 1F3 to enter the 1F4 reactor building.**
 - Radionuclide surveys and examination information confirm that the shared vent stack was the reason for the explosion in the 1F4 reactor building.

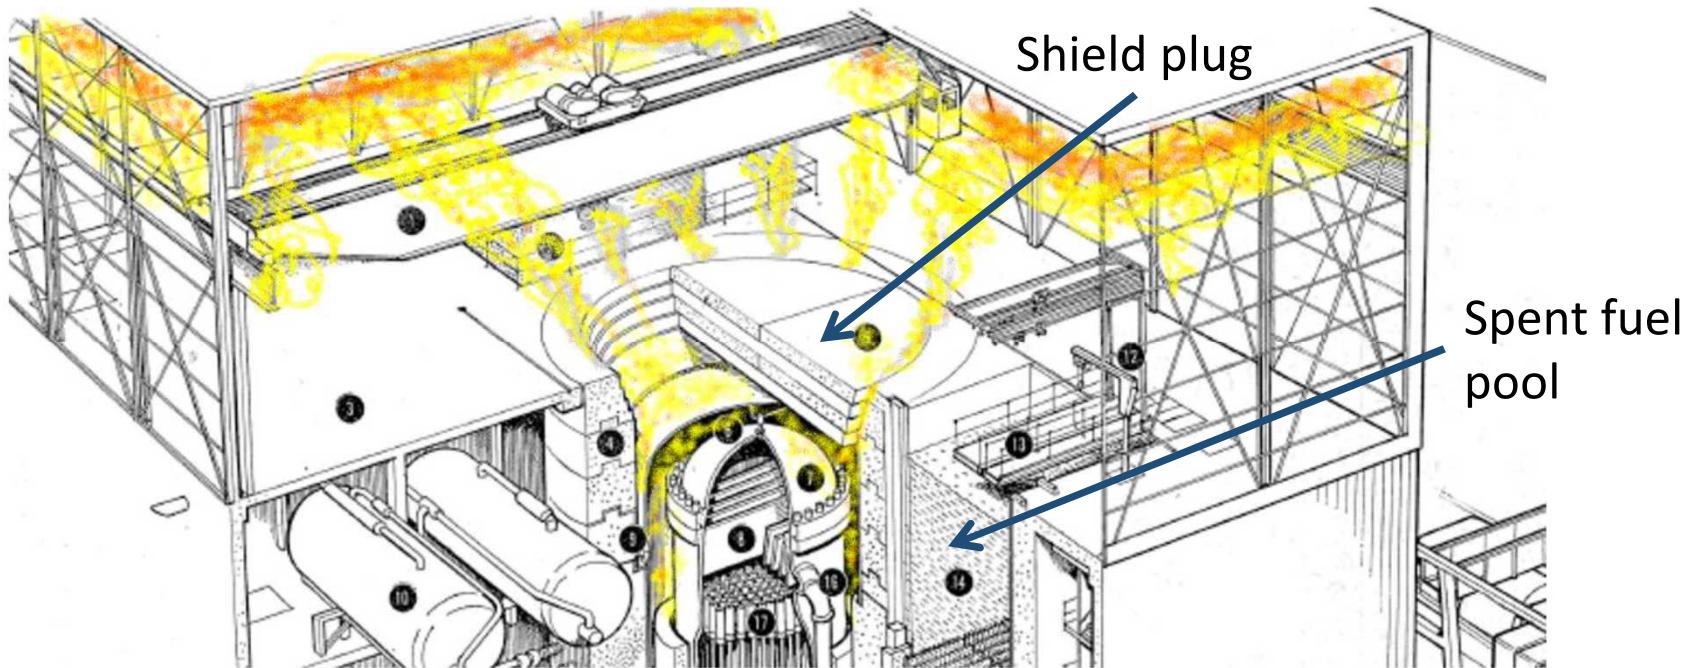
Hydrogen Accumulation in 1F1 – Alternative

- Between ~12 hours and ~23 hours, steam and hydrogen leaks from drywell head flange and enters RB via shield plug seams
- Hydrogen, CO and steam rises to roof and spreads laterally
- Steam produced in MCCI and from emergency water injection
- Condensation in refueling bay depletes steam in hot layer and enriches hydrogen
- Mixture displaces air from building
- Steam mole fraction exceeds 50% - inert conditions prevent combustion

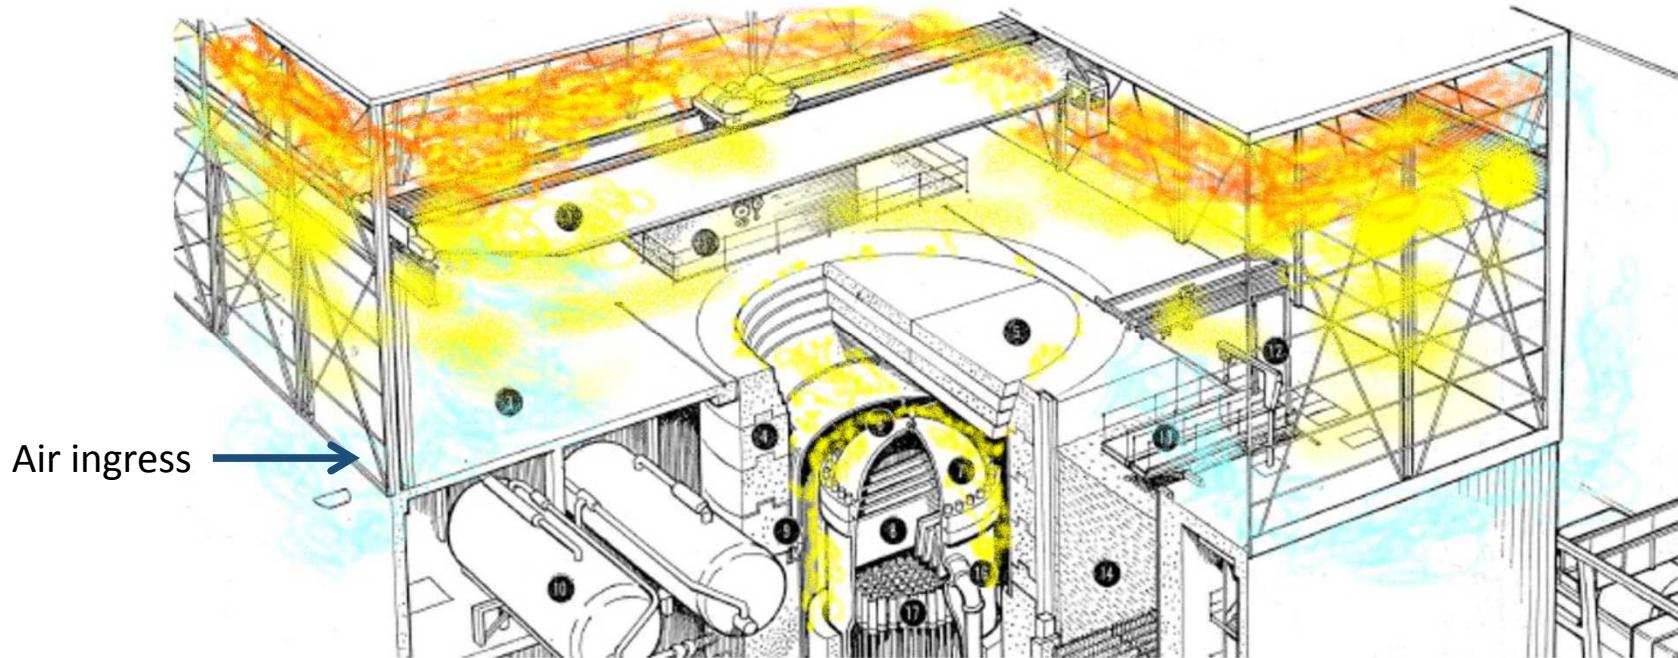
Combustible Conditions Follow PCV Venting in 1F1 - Alternative

- At around ~23 hours, steam and hydrogen leakage from PCV greatly reduced
 - Water injection was stopped
 - PCV was depressurized by operator venting action
- Continuing condensation without steam source....
 - Reduces steam molar fraction to below 50% in refueling bay, and
 - Produces partial vacuum that draws in outside air
- Air ingress and steam condensation leads to conditions favoring combustion
- Hydrogen stratification produces flammable or detonable concentrations of H_2/O_2

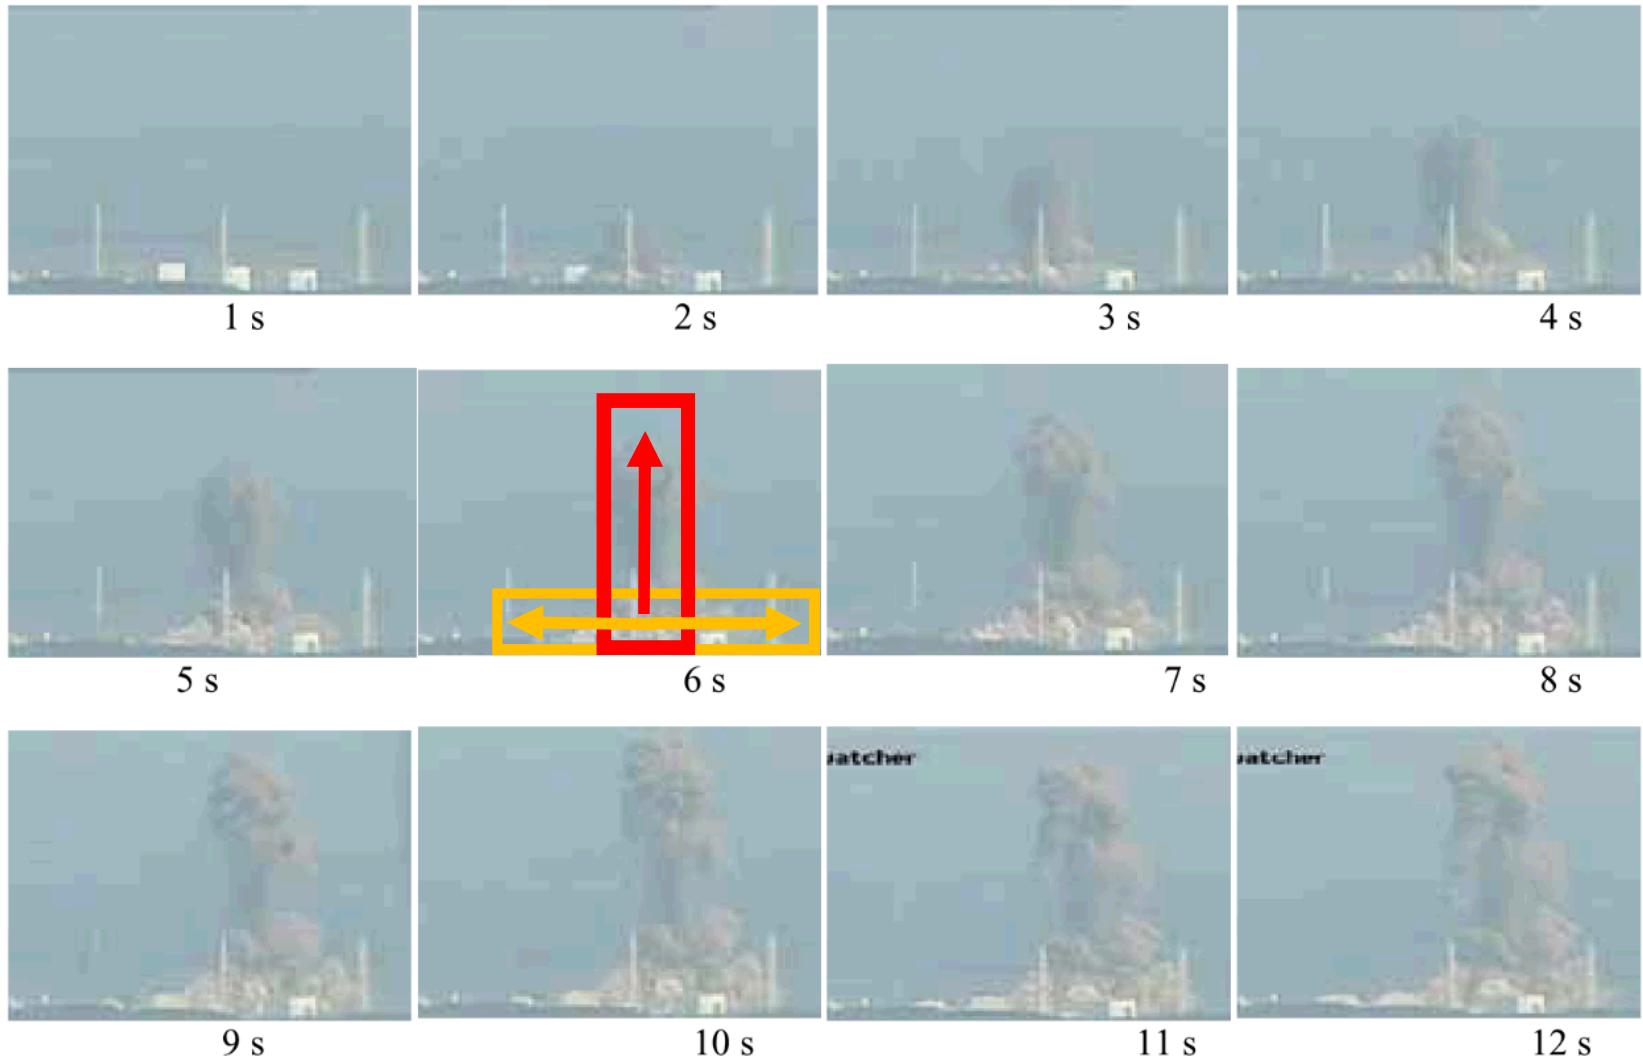
Two Separate Explosions at Unit 3

- There appeared to be at least two explosions
- First:
 - less energetic and directed horizontally (similar to that of 1F1)
 - The color of the explosion “smoke” appears white and orange
- Second:
 - Directed vertically with an almost perfect spherical fireball appearing above the building
 - Shooting up very high into the sky (about 3 times the vent stack height)
 - Large chunks of materials appeared to be carried with the fireball.
- 1F3 images indicate that concrete pillars on the building top floor were highly damaged
- Product gas of the explosion appears to be a darker color, raising questions:
 - Reactor building concrete dust was generated from the explosion?
 - If dust was generated within the drywell due to MCCI?

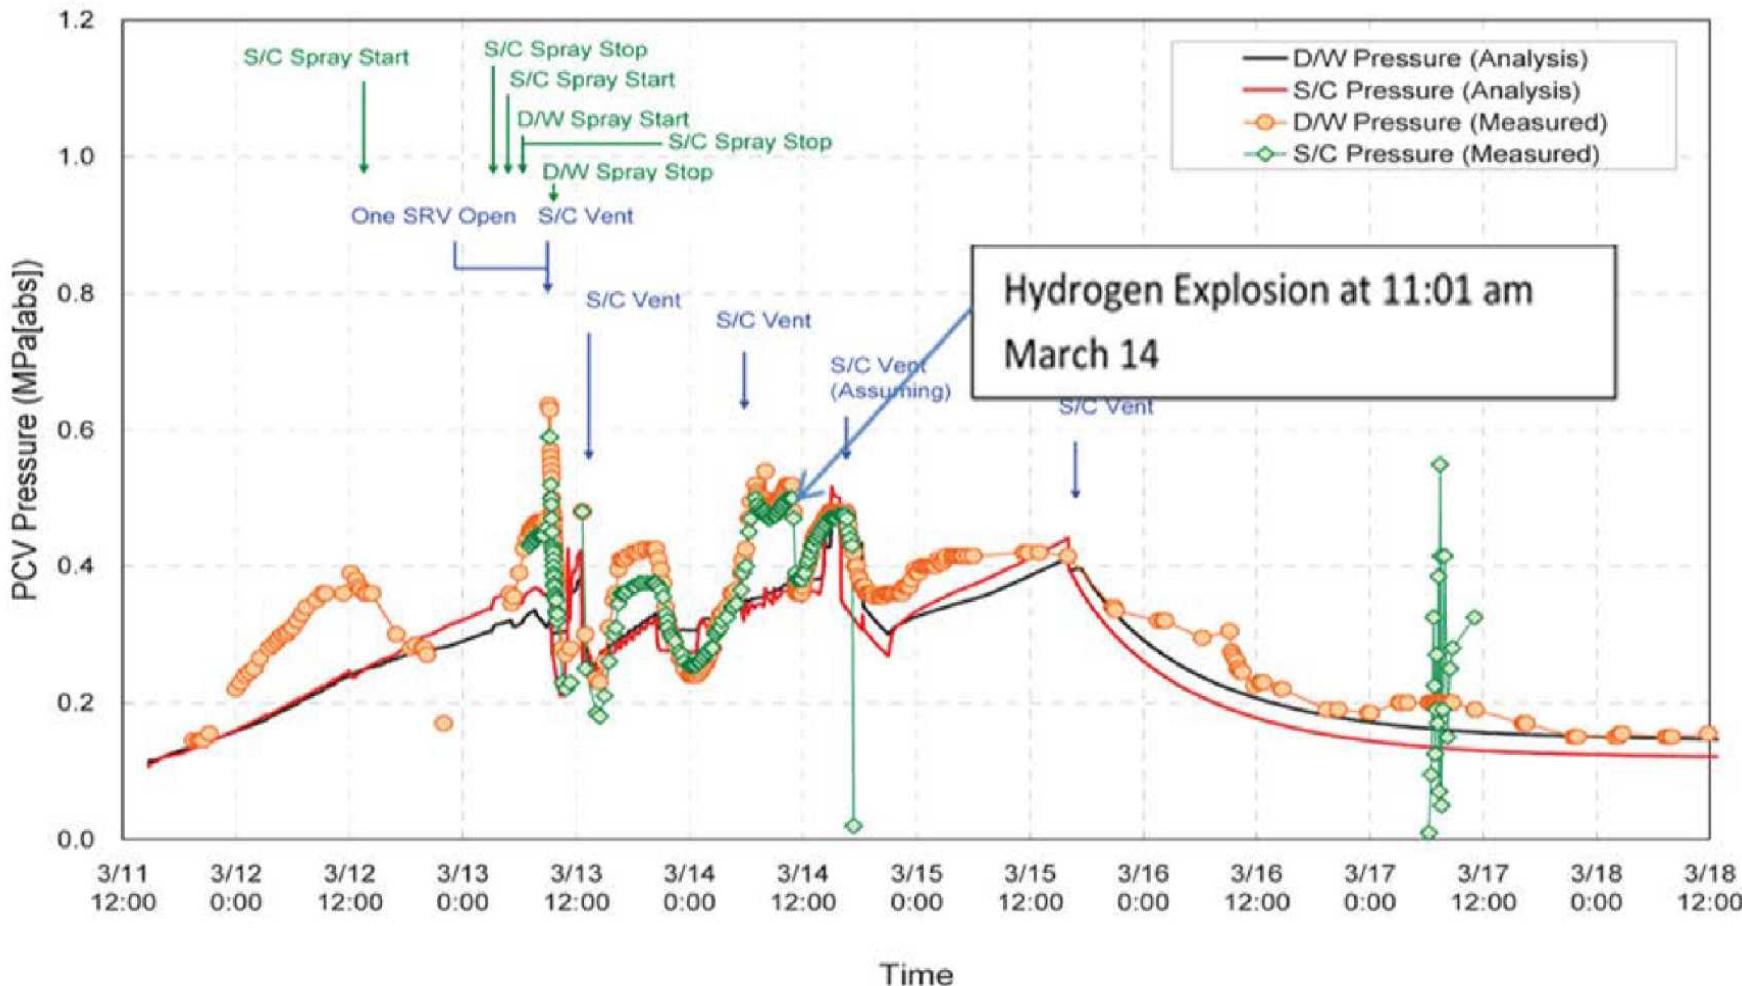
1F3 Plant Data

Primary containment failure before explosion

- DW head failure
- Bellows failure

- **The 1F3 explosion was not a stand-alone randomly occurring event.**
 - The 1F3 explosion was most likely initiated by failure of the drywell upper head seal when it was at high PCV pressure of 0.53 MPa.
