Analysis of a Radioactive Release in a Nuclear Waste Disposal Facility

James Poppiti, CHP, Roger Nelson, Walter J. MacMillan, CHP, and Scott Cunningham

The Waste Isolation Pilot Plant (WIPP) is a 655-meter deep mine near Carlsbad, New Mexico, used to dispose the nation's defense transuranic waste. Limited airborne radioactivity was released from a container of radioactive waste in WIPP on 14 February, 2014. As designed, a mine ventilation filtration system prevented the large scale release of contamination from the underground. However, isolation dampers leaked, which allowed the release of low levels of contaminants after the event until they were sealed. None of the exposed individuals received any recordable dose. While surface contamination was limited, contamination in the ventilation system and portions of the underground was substantial. High efficiency particulate air (HEPA) filters in the operating ventilation system ensure continued containment during recovery and resumption of disposal operations. However, ventilation flow is restricted since the incident, with all exhaust air directed through the filters. Decontamination and natural fixation by the hygroscopic nature

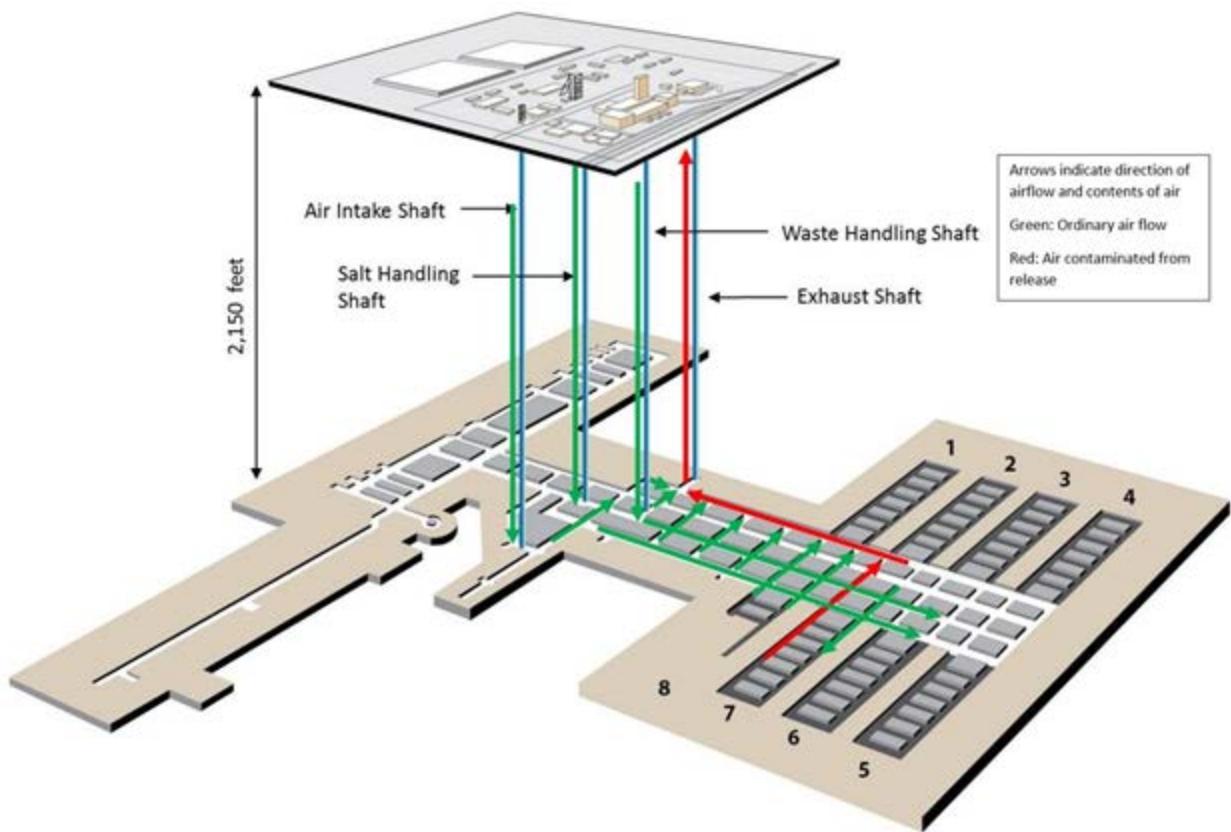
Figure 1

WIPP is a deep geologic repository mined out of a thick evaporite bed of Permian salt approximately 655 meters below the surface. TRU waste typically consists of debris, solids and soils resulting from the research and production of nuclear weapons and post-cold war environmental restoration. Both the above ground and sub-surface facilities are shown in Figure 1. There are four shafts from the surface to the waste repository level. There are four ventilation circuits in the mine; air comes in from the air intake, salt hoist, and waste handling shafts. There is, by design, a direct path from waste handling to the exhaust shaft. The north, mining, and disposal circuits are separate until they combine at the exhaust shaft. [Poppiti, 2016]

There are seven existing waste disposal areas in WIPP called panels. Construction of planned Panel 8 is not yet complete. Each complete panel is comprised of 7 rooms and each room is approximately 1390 square meters by 4.2 meters high. The southernmost point of the waste disposal area is about 1 kilometer away from the exhaust shaft.

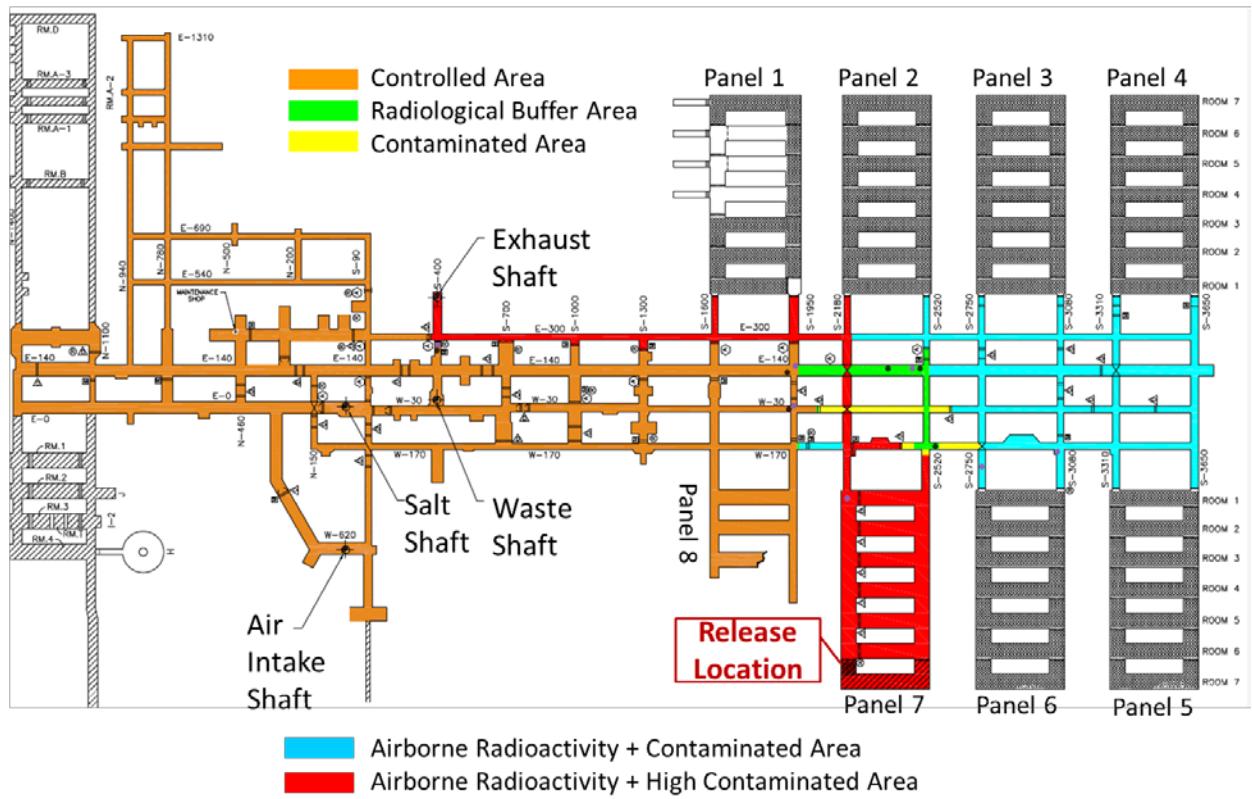
A radiological survey was conducted during the mine reentry process. Figure 2 shows surface alpha activity and provides the nomenclature for labeling the underground drifts (i.e. tunnels). The release took place in Panel 7, Room 7, along drift S-2180. As indicated in the survey map, Panel 7, drift S-2180, and portions of drifts E-300 and S-400 were highly contaminated, along with the exhaust shaft and the above ground ventilation system. A high contamination area has greater than 33 Bq/100 cm² removable contamination and a contaminated area has greater than .33 Bq/100 cm² removable.

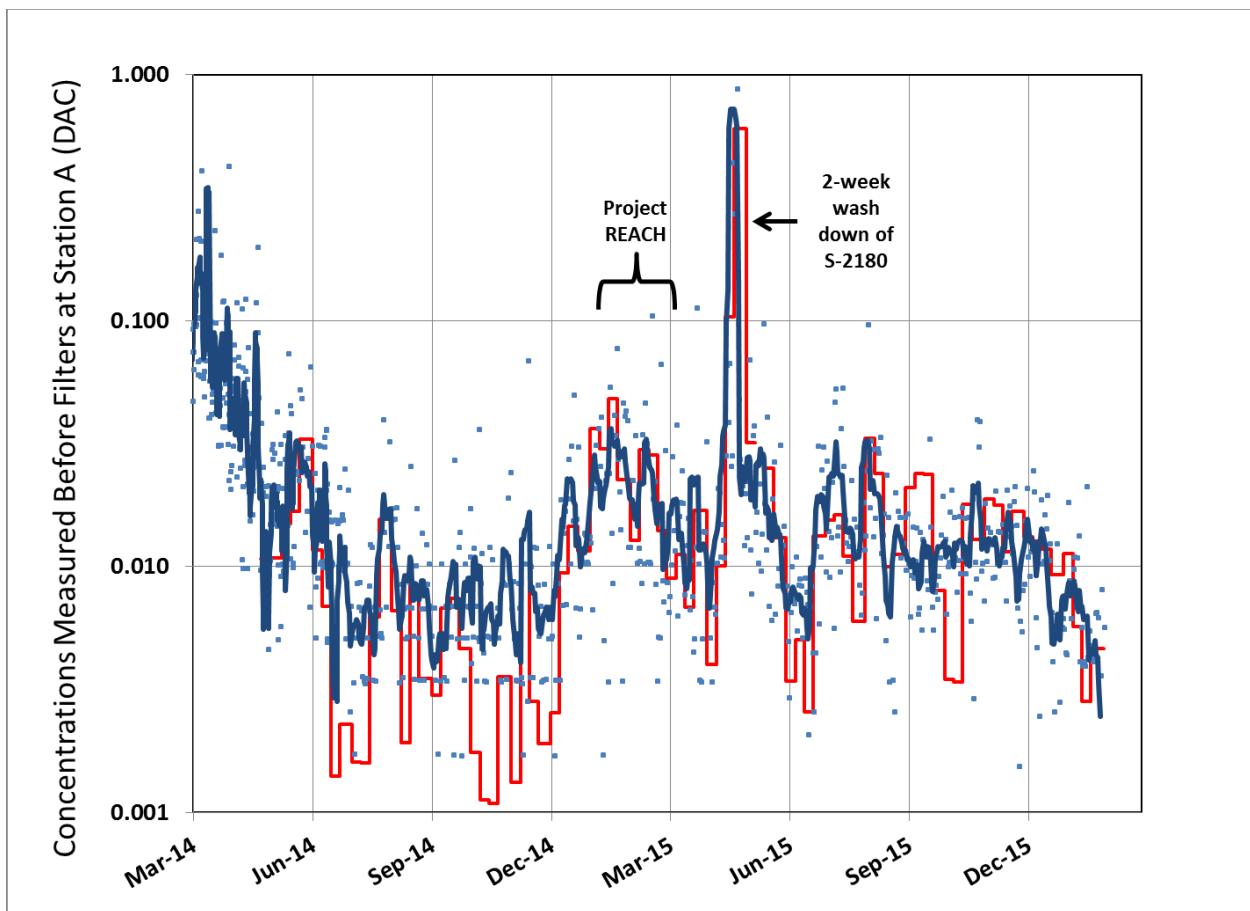
Figure 3

Airborne contamination data taken over 18 months for the exhaust filters are shown in Figure 3. These data were collected at Station A at the surface upstream of the exhaust HEPA filters. These data show that the concentration of airborne alpha in the exhaust air is low, with a nominal concentration less than 0.002Bq/m³ (0.02 DAC). The Derived Air Concentration (DAC) used is a weighted average of ²⁴¹Am and ²³⁹Pu. DAC values are based on either a stochastic (committed effective dose) dose limit of 0.05 Sv or a deterministic (organ or tissue) dose limit of 0.5 Sv per year, whichever is more limiting. In the case of ²³⁹Pu and ²⁴¹Am the DAC is based on the 0.5 Sv limit to bone surface (i.e., the non-stochastic limit).

Two periods worth noting are annotated on Figure 3. The first is in January 2015 (labeled Project REACH in Figure 3). These approximately month long elevated levels were a result of a significant effort to photograph and physically inspect every container in Room 7 of Panel 7 to ensure no other waste containers were involved in the release event. A crew of workers wearing powered air-purifying respirators used a mechanical boom stretched over 30 meters out over the stacked containers in Room 7. While efforts were made to minimize disturbing surfaces of the waste stack, there were inevitable scrapes and brushes of the boom and camera equipment across contaminated surfaces. Any radioactive particulate that had loosely settled on the containers and emplacement materials would not have been trapped like

The second period of note is a two week spike that occurred in April 2015. This coincided with a dedicated effort to wash down the walls and floor of the exhaust drift from Panel 7 (S-2180). This drift represents the most contaminated area in the underground. A powered cart with a large water tank (2000 liters) and orchard sprayer was used to apply about 12 liters of fresh water per linear meter along the drift. The drift was first hand sprayed to wet the surface and then the water was sprayed behind the cart as it advanced into the contamination. This method attempted to minimize the amount of material mechanically disturbed during the water application.

This drift was the most highly contaminated area outside of Room 7, and accounts for the elevated airborne levels measured at Station A. That is, decontamination of the most contaminated area resulted in the highest concentration on the Station A filters. While airborne levels were significantly higher during this period, it is notable that they did not exceed an average of about $0.08\text{Bq}/\text{m}^3$ (0.45 DACs). While this level is above the posting limit for airborne contamination (0.1 DAC) [10 CFR 835], the airborne levels quickly fell below $0.004\text{Bq}/\text{m}^3$ after decontamination was complete.
