**ART End User Applications**  
**Task 2.04.19.06**  
**Supercritical Transformational Electric Power (STEP)**

**Milestone Report**

***Resolving Turbine Degradation***

S-CO<sub>2</sub> Materials Development  
Work Package: AT-17SN190602 (STEP – 2)  
Level 3 Milestone Report: M3AT-17SN1906024

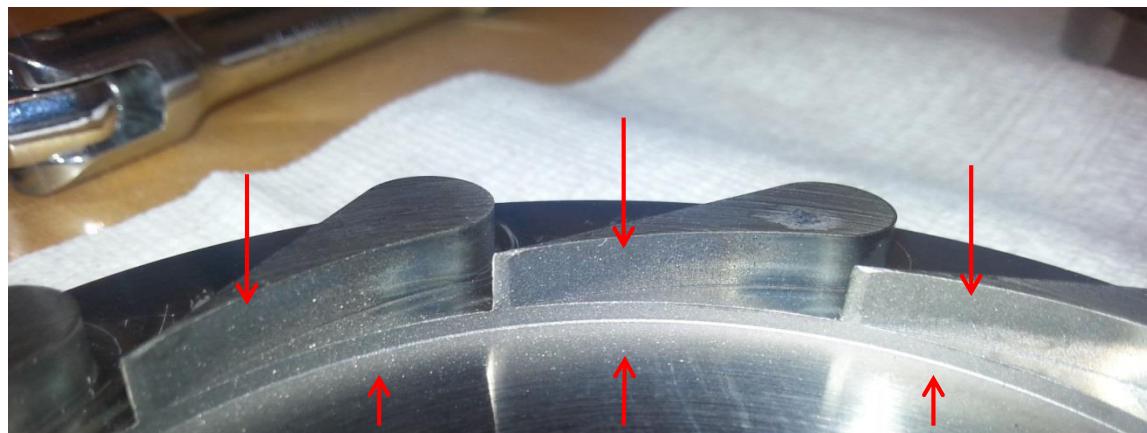
Focusing on the turbine nozzle, two forms of degradation have been observed. One form, shown in Figure 2, is the pitting of nozzle surfaces resulting in a matte surface finish that resembles that of a grit-blasted surface. The other form, shown in Figure 3, involves the thinning and eventual deformation of the thinnest sections of the nozzle.

Figure 2: Turbine nozzle showing areas of metal pitting/wear (indicated by arrows).

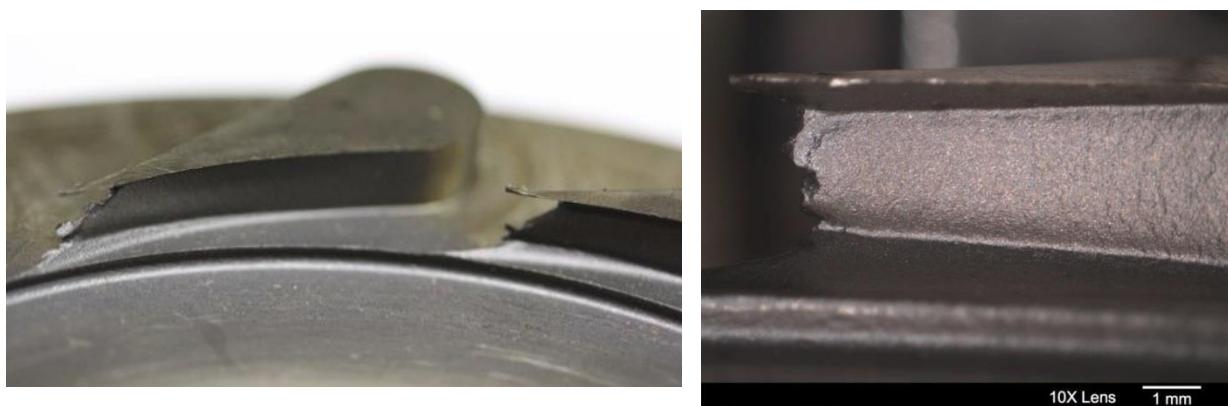
Figure 3: Excessive pitting and wear observed for flow directing portion of a turbine nozzle.

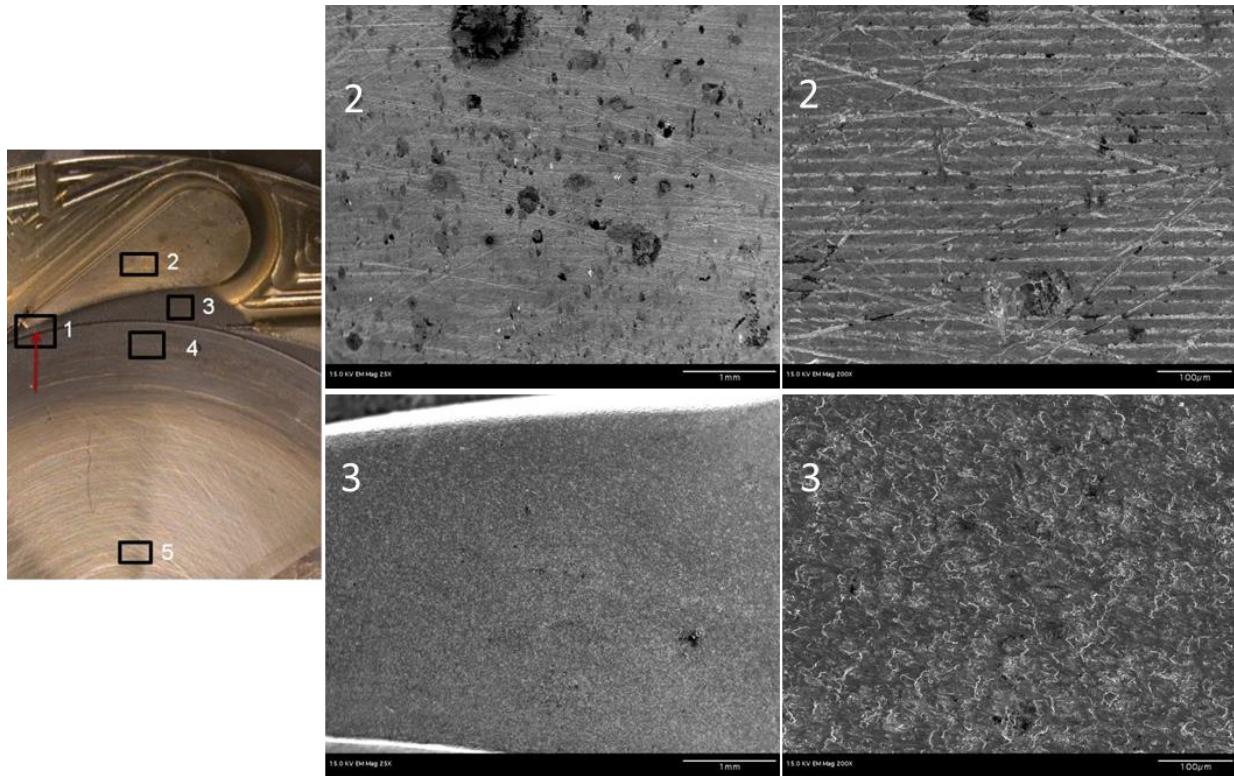
Microscopic characterization of worn vs. non-worn surfaces indicated significant differences both in terms of appearance and chemistry. In Figure 4, scanning electron microscopy (SEM) images of two separate surfaces are shown at two magnifications. In the case of Surface 2, this is a non-flow surface and one that did not show visible wear. Microscopically, this surface appears rather smooth and unchanged during operation in the test loop; machining marks from when the part was made are evident. Chemical analyses of this surface using Energy Dispersive Spectroscopy (EDS) revealed little change to the surface chemistry compared to that of the original alloy. Conversely, Surface 3 is the path of flow and one that had visible wear evident by its characteristic matte finish. Now, no machining artifacts were present on the surface; instead, the surface showed increased roughness resembling wear damage. Also, the surface chemistry showed significant iron enrichment as compared to the original alloy.

Based on this information, the cause for the observed wear was believed to be due to impingement of iron-rich particles with surfaces in the gas flow path. Furthermore, a hypothesis was developed that the source of these particles was the spallation of iron oxide from the interior walls of carbon steel gas inventory tanks; prior to use in the test loop, hydro pressure testing may have caused internal oxidation within the tanks. Testing was never conducted to prove this hypothesis. As a result, the specific cause of observed turbine degradation was unclear.

**Figure 4: Comparison of a non-flow surface with no wear (2) to a surface in the flow path with evident wear (3).**

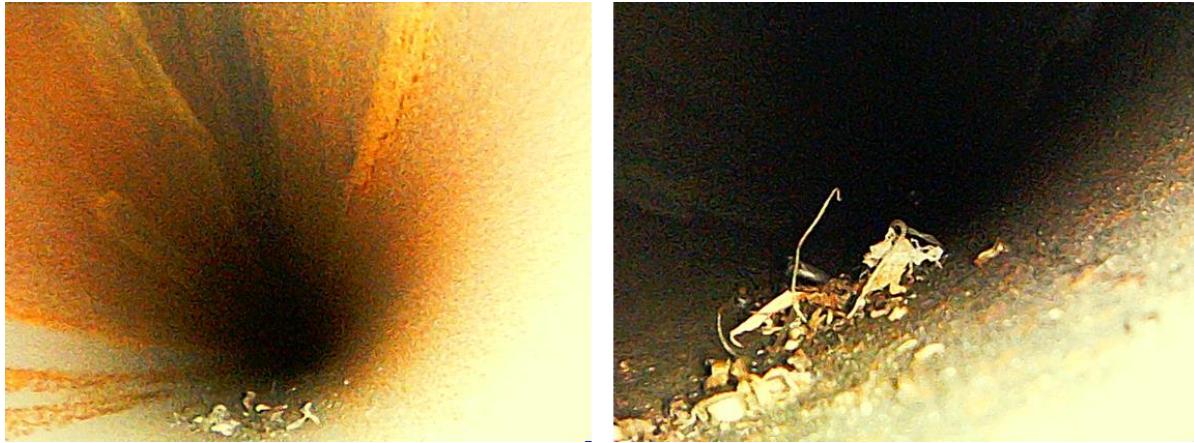
The borescope inspection of the tank interiors revealed a significant quantity of foreign material. A few images of the debris are shown in Figure 13. Visually, it resembled a mixture of metal shavings, glass fibers (likely fiber glass insulation), and metal oxidation product that had spalled from the interior cylinder walls. Samples of foreign material were extracted from each of the tanks, providing for a full characterization of its constituents. An SEM image of this foreign material is shown in Figure 14. EDS of this material revealed that it had a predominantly Fe-O chemistry, indicating that the debris was likely a combination of carbon steel shavings (Fe) and oxidation product ( $Fe_2O_3$ ).

Leading up to this inspection, it was hypothesized that these tanks contained metal oxidation product debris that was flowing into the loop and causing turbine degradation. This was thought to result from prior hydro-testing that was done in these tanks. Following the inspection, it was evident that this hypothesis may indeed be true, as foreign material in support of it was found within the tanks. However, for this hypothesis to be confirmed the presence of  $Fe_2O_3$ , without chromium, needed to be present in the main part of the  $sCO_2$  system (to be discussed later).

Figure 13: Figure 40. Images of debris within the expansion tanks, as captured by borescope.

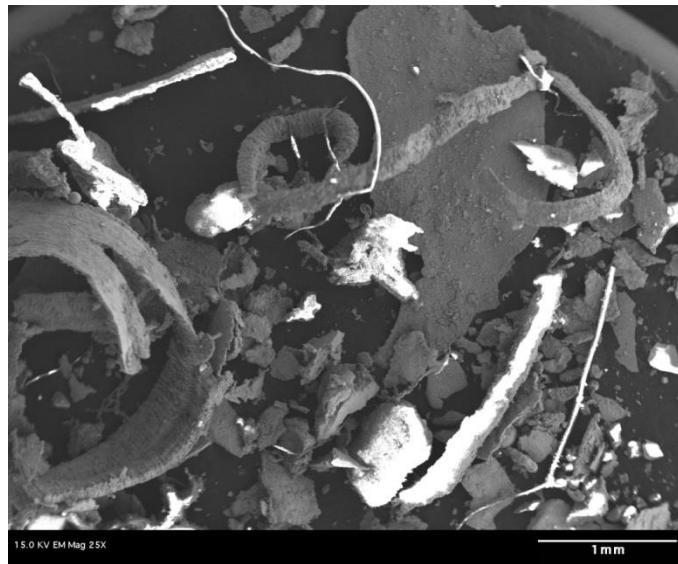
Figure 14: SEM image of foreign material from the expansion tanks.

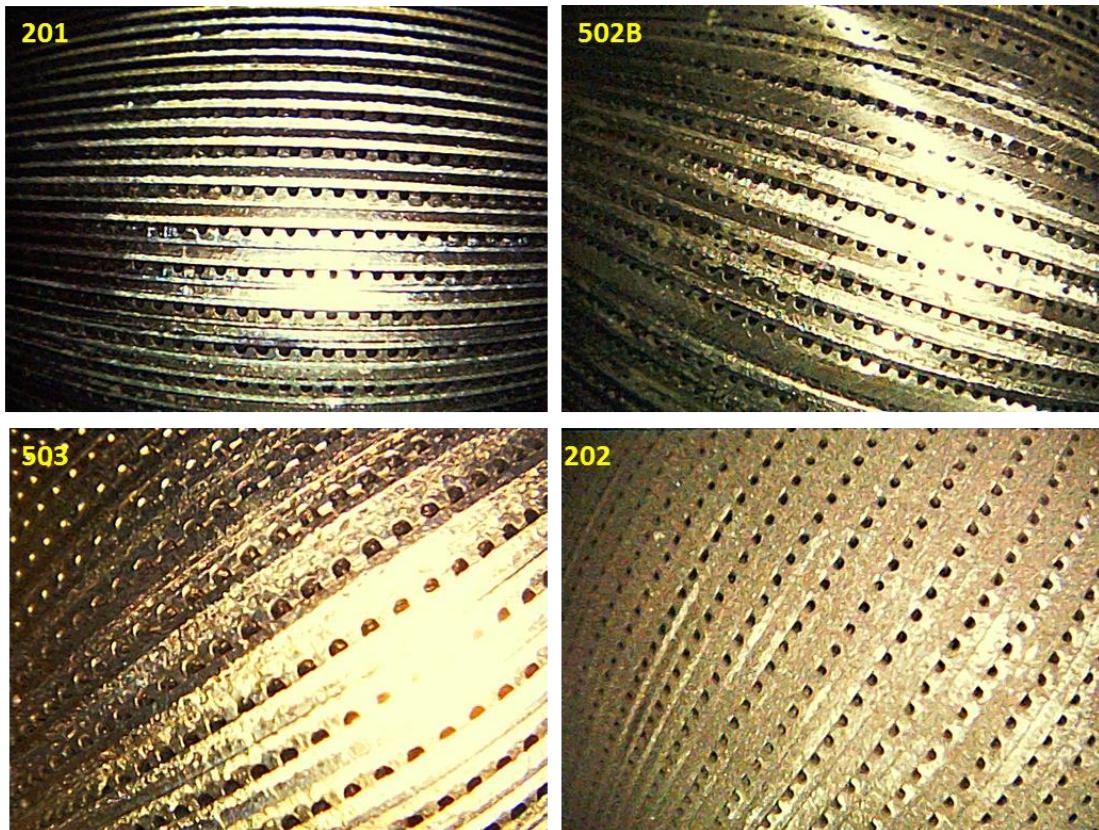
The HT Recup has four separate manifolds directing CO<sub>2</sub> flow across its channels. An image of the HT Recup is shown in Figure 15. After exiting the turbine, hot CO<sub>2</sub> enters the HT Recup at manifold 201, and exits at manifold 202. Flowing in the opposite direction, cool CO<sub>2</sub> enters at manifold 502B and exits at manifold 503. Each manifold was inspected using the borescope. Images of the fluid flow channels within each manifold are shown in Figure 16. Fluid flow channels at manifolds 201, 502B, and 503 appeared clean, and free from surface contamination or corrosion product. In the case of manifold 202, there was a surface film (contamination or corrosion product) covering the fluid flow channel surface. Foreign material was collected from within manifolds at 502B and 202, while none was found in the other two manifolds. It is unclear why just the one surface was contaminated while the others were clean, or why two of the manifolds contained debris while the others did not.

Figure 16: Fluid flow channel surfaces for the four manifolds of the HT Recup.

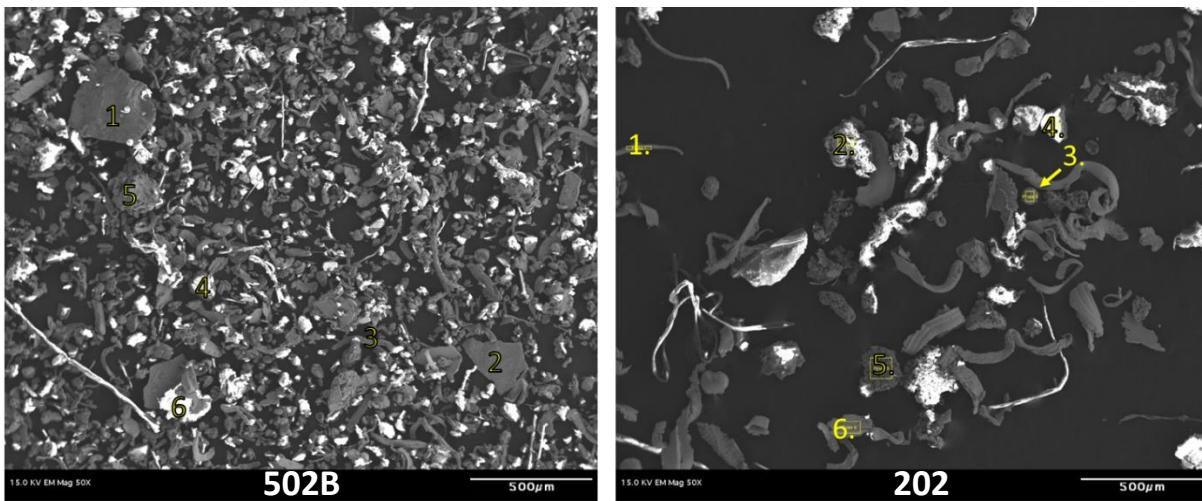
SEM images of the debris collected from the manifolds at 502B and 202 are shown in Figure 17. In both instance, there are predominantly particles which show up dark, along with fewer light particles. The darker particles appear to be stainless steel having a chemistry of primarily Fe-Cr-Ni. In some instances these particles have the appearance of metal shavings. The lighter particles appear to be oxides having a chemistry that contains Si-Al-O, among others.

1. Fe, Cr, Ni, Mo, Cu, Si
2. Fe, Cr, Mn
3. Fe, Cr, Ni, Mo
4. Si, O, Cl
5. Fe, Cr, Ni, Al, O
6. Fe, Cr, Ni, Si, O, Cl

1. Fe, Cr, Ni, Si, O
2. Si, Ti, O, Fe
3. Fe, Cr, Ni, O
4. Si, O, Al, Na, Ca, Cl, Mo
5. Si, O, Al, Ca, Cl, K, Fe
6. Fe, Cr, Ni, Al

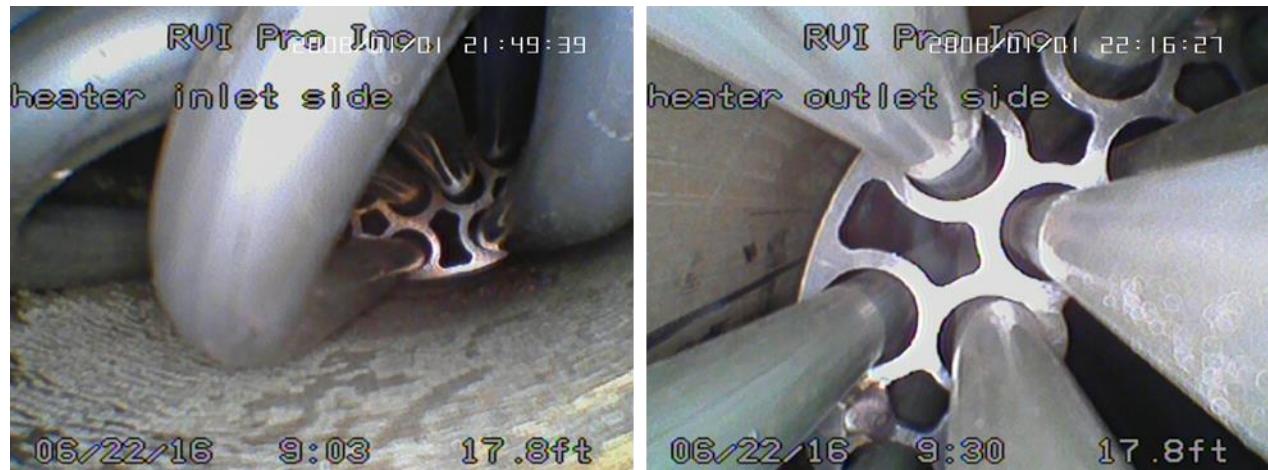
Referring back to the loop diagram in Figure 11, the inlet is shown as 504, while the outlet from the heater is shown as 600. Images of these two locations are shown in Figure 18. Interior photos of each are shown in Figure 19. The areas of the heaters that could be inspected using the borescope appeared to have some oxidation, but overall were relatively clean. The exception to this was an area near the entrance to the heaters that had a rather large pile of debris. An image of this debris is shown in Figure 20. A sample was extracted from the heater for analysis. An SEM image of this material is shown in Figure 21. Similarly to the material from the HT Recup, the material appears to be predominantly stainless steel shavings along with a few oxide particles, an indication that carbon steel inventory tanks may not be the source of particulate contamination.

Figure 19: Interior photos of the inlet and outlet areas of the heaters.

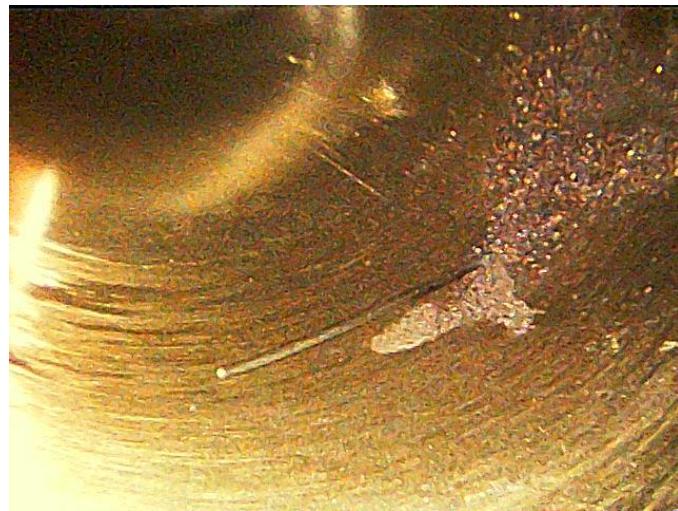
**Figure 20: Image of foreign material debris within the heater inlet at 504.**

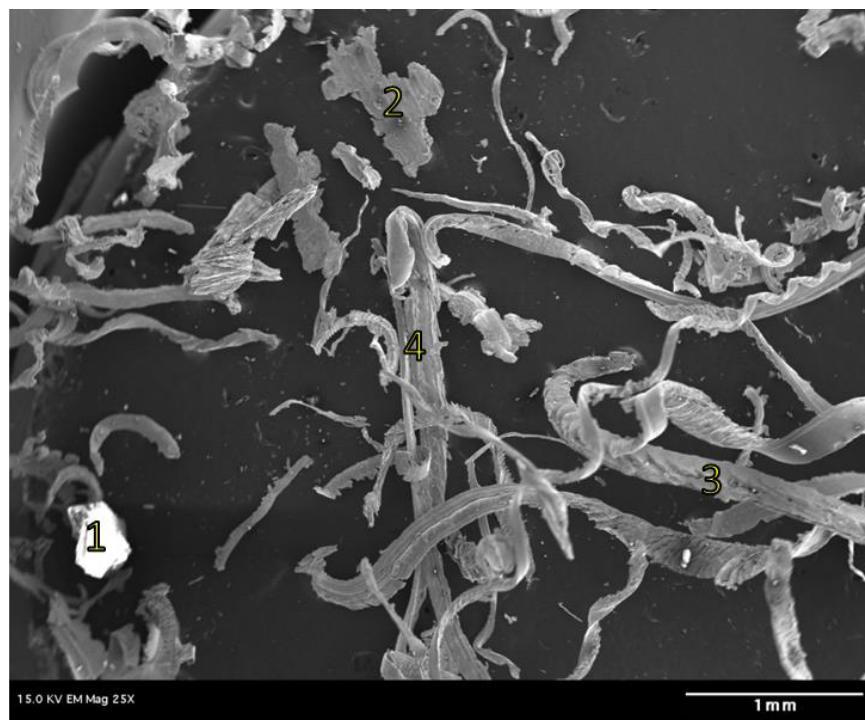
1. Al, O, Na, Si
2. Fe, Cr, Ni
3. Fe, Cr, Ni
4. Fe, Cr, Ni

**Figure 21: SEM image and EDS chemistry of debris collected from the heater inlet.**

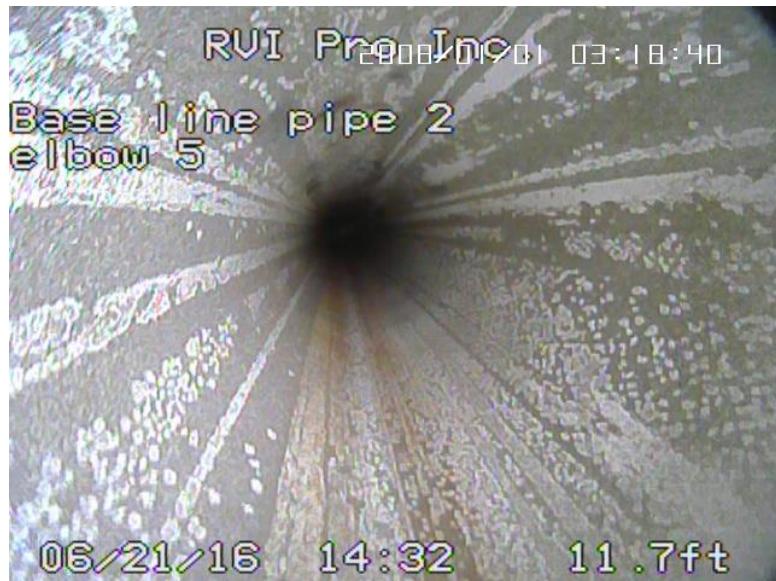
Although the entire length of pipe for the test loop system was inspected using the borescope, the areas of most interest associated to turbine degradation were sections of pipe running between Motor/Gen B and both the heaters and HT Recup. An image of the pipe interior for the section between the HT Recup and the heater inlet is shown in Figure 22. Foreign material in these sections of pipe was not visually evident using the borescope, but a small quantity was collected using the vacuum method. An SEM image of this material is shown in Figure 23. As was the case with both the HT Recup and the heater inlet, the material is predominantly stainless steel having a chemistry of Fe, Cr, and Ni. Again, oxides of Al and Si were also present.

Figure 22: Image inside pipe section between HT Recup (503) and heater inlet (504).

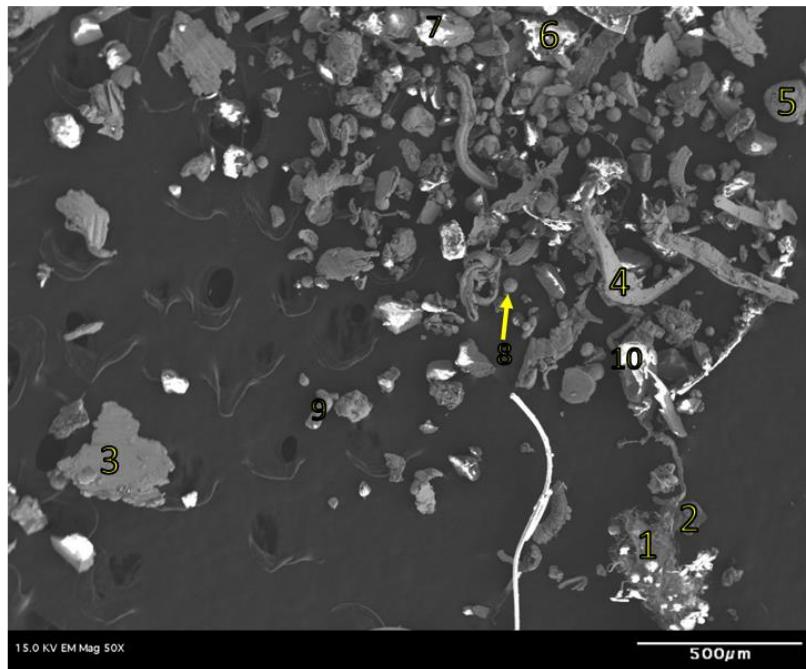
1. O, Fe, Si, Cu, Cr, Cl
2. Si, O, Al, Mg, Fe, K
3. Fe, Cr, Ni
4. Fe, Cr, Ni
5. Fe, Cr, Ni, O
6. Si, O
7. Si, O
8. Fe, Cr, Ni
9. Fe, Cr, Ni, Cu
10. Al, O

**Figure 23: SEM image and EDS chemistry of debris collected from the pipe section between HT Recup (503) and heater inlet (504).**

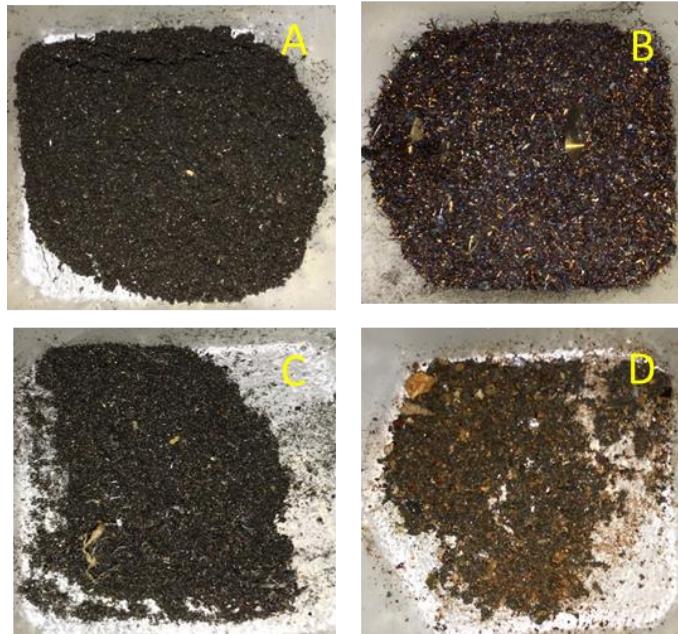
Having a more complete understanding of the foreign material chemistry is useful in comparing the material chemistry between the various locations. As such, four materials were selected for XRD analysis. These included material from the HT Recup at 502B and 202, the heater inlet at 504, and the expansion tanks. Photos of these four materials are shown in Figure 24. Visually, the material from the expansion tanks appeared different than the other three, while the others appeared more similar to each other. The expansion tank material had a reddish-orange color, likely indicating the presence of hematite ( $Fe_2O_3$ ), which forms during oxidation of carbon steel in  $CO_2$  but not of stainless steel. For stainless steel, oxidation in  $CO_2$  typically results in the formation of both  $Cr_2O_3$  and  $Fe_3O_4$ . Neither of these has the reddish-orange color of hematite.

**Figure 24: Foreign material collected for chemical analysis from the HT Recup at 502B (A) and 202 (C), heater inlet at 504 (B), and the expansion tanks (D).**

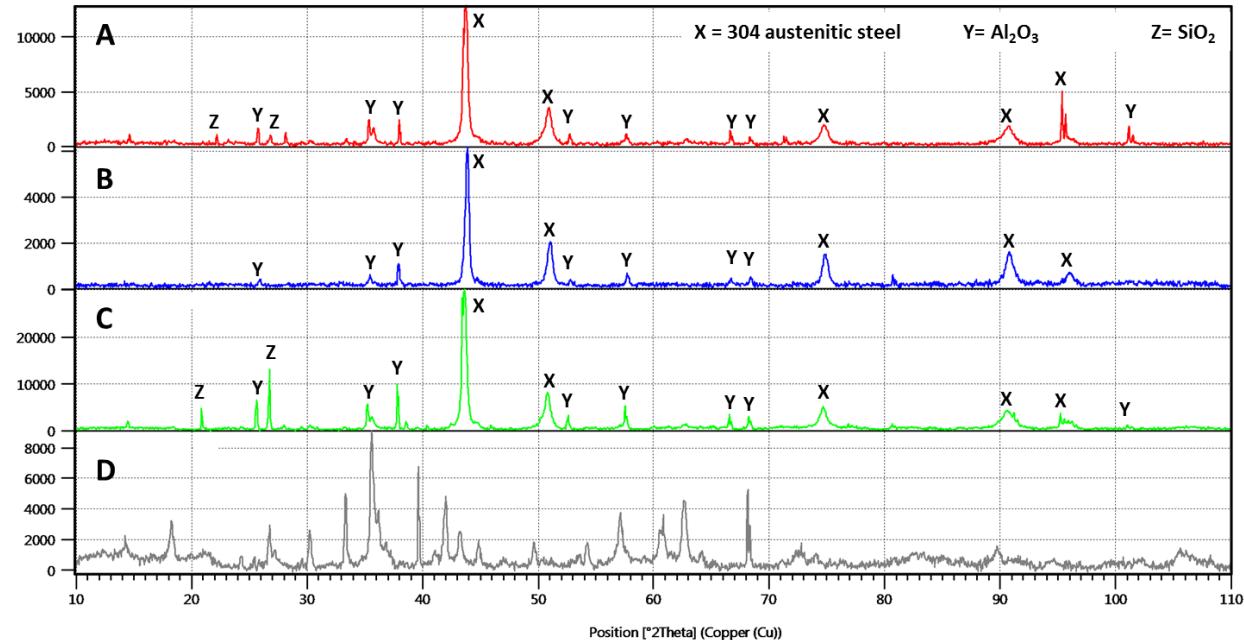
The XRD patterns collected for these four materials are shown in Figure 25. Here, peak indexing indicates a matching chemistry for all of the materials except for that of the expansion tank. The materials from the HT Recup and heater inlet indicate the presence of predominantly stainless steel along with oxides of aluminum and silicon. The chemistry for the material in the expansion tanks is quite different, with no noticeable correlated peaks between them. This provides a strong indication that the material within the expansion tanks is not flowing out into the test loop. The converse, material flowing from the loop into the expansion tanks, is also not occurring. This information eliminates the hypothesis of foreign material from the expansion tanks being the cause of turbine degradation, as it does not appear that this material ever leaves the tanks.

**Figure 25: XRD patterns for foreign material from the HT Recup at 502B (A) and 202 (C), heater inlet at 504 (B), and the expansion tanks (D).**

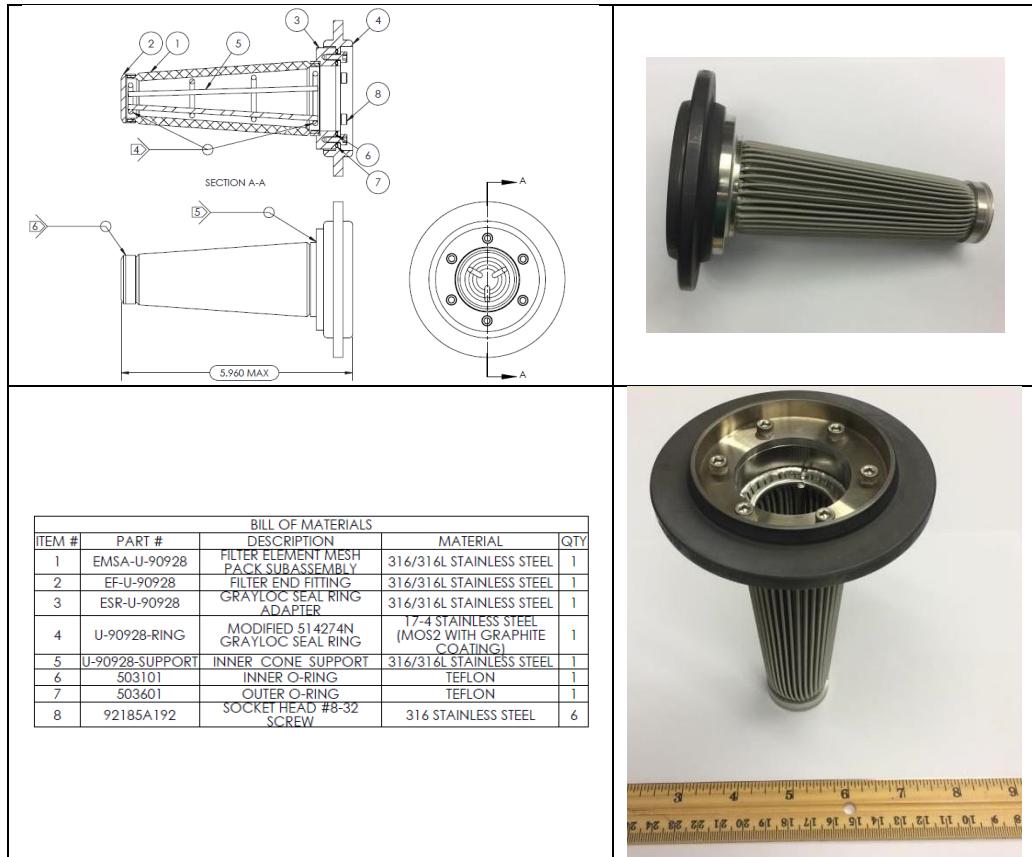
Figure 28: Design dimensions (in inches) and materials used for filter.

Based upon analysis performed above, the leading hypothesis is that small stainless steel particles are still present in the system – likely from the piping, which is 316L. Mitigation is the inclusion of a filter to remove particles, as the reason for why particles are present is still unknown.

Figure 28 shows both the drawing and some photos of the filter, which was fabricated from 316L with Norman's minimum filter screen of  $10\mu\text{m}$ . The filter was bolted to a Graylok ring to provide flexibility in moving among various locations within the RCBC. Detailed drawing supplied from Norman Filters is located in Appendix I: Materials Engineering Support Update, Quarter 2, Fiscal Year 2017 along with other design information.
