An Evaluation of Prototype Circuit Boards  
Assembled with a Sn-Ag-Bi Solder<sup>1</sup>

P.T. Vianco  
J.A. Rejent

Sandia National Laboratories  
Albuquerque, NM

### Abstract

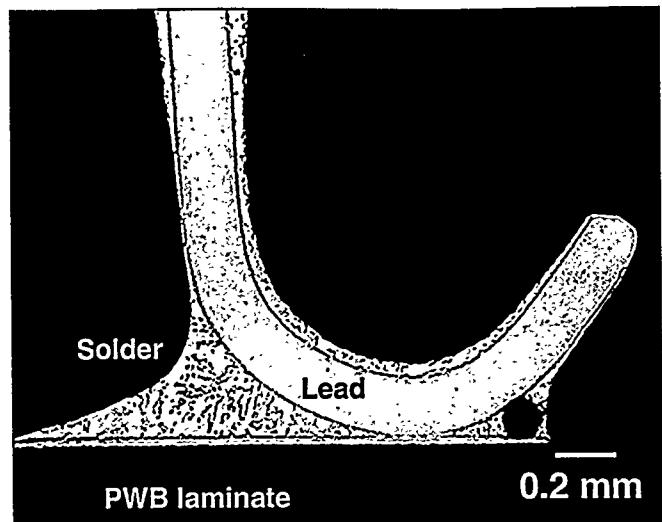
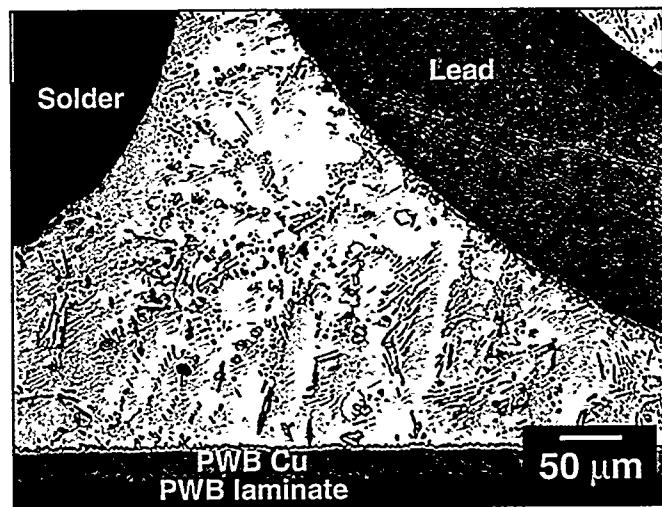
Exposure of the test vehicle to 1000 thermal cycles did not have a significant effect on the solder joints. Shown in Fig. 7 are low and high magnification optical micrographs of a J-lead solder joint from the PLCC package. It is also representative of the quality of the SOIC (gull wing) and chip capacitor solder joints, in that the latter showed no evidence of deformation within the solder. There was no loss of electrical continuity in any of the joints.

Fig. 7 Optical micrographs of a J-lead joint from a PLCC package after 1000 thermal cycles: (a) low magnification view of the whole joint and (b) high magnification view of the heel fillet.

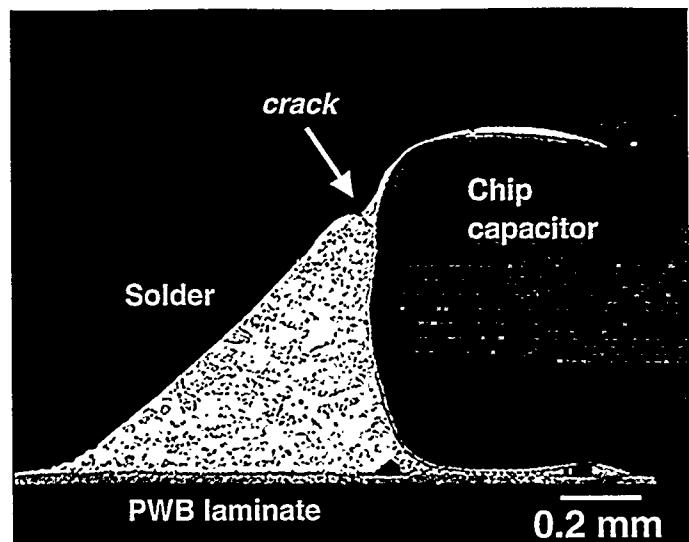
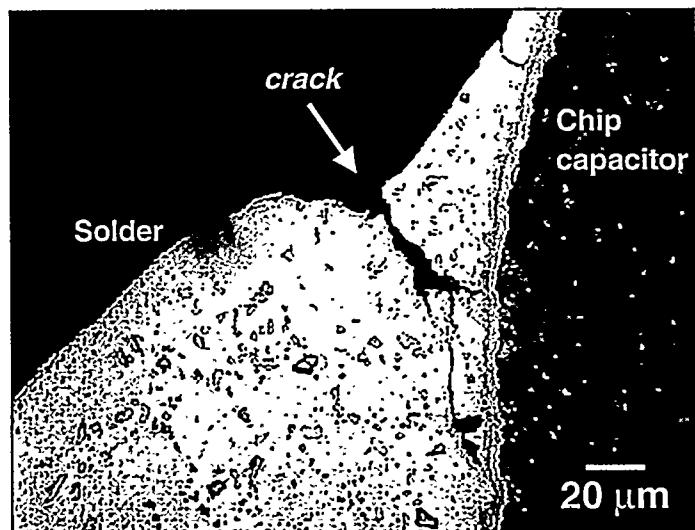
Next, the integrity of the solder joints following 2500 thermal cycles are discussed. Shown in Figs. 8, 9, and 10 are optical micrographs of solder joint cross sections representing the chip capacitor, the SOIC package, and the PLCC package, respectively. The cross sectional view of the solder joint from the chip capacitor (Fig. 8a) shows excellent integrity. Two small voids were observed in the fillet and gap. The only deformation observed is that of a crack that has formed at the top of the termination fillet. This damage scenario is also observed with Sn-Pb solder joints following thermal

cycling and, therefore, was not unexpected. The extent of cracking did not jeopardize the electrical function of joint nor would significantly degrade its mechanical strength. The SOIC and PLCC solder joints shown in Figs. 9 and 10, respectively, exhibited no indication of damage within the solder microstructure. Of particular interest is the solder within the gap formed between the lead and the bonding pad. It is here that thermal expansion mismatch strains in the Sn-Ag-Bi solder (global and local) will be very high. Views of the gap regions in the gull wing solder joint (Fig. 9b) and J-lead solder joint (Fig. 10b) confirmed the absence of significant deformation there. There was no loss of electrical continuity recorded in any of the joints.

Fig. 8 (a) Chip capacitor solder joint after 2500 thermal cycles. (b) High magnification image of the crack formed at the top of the fillet.

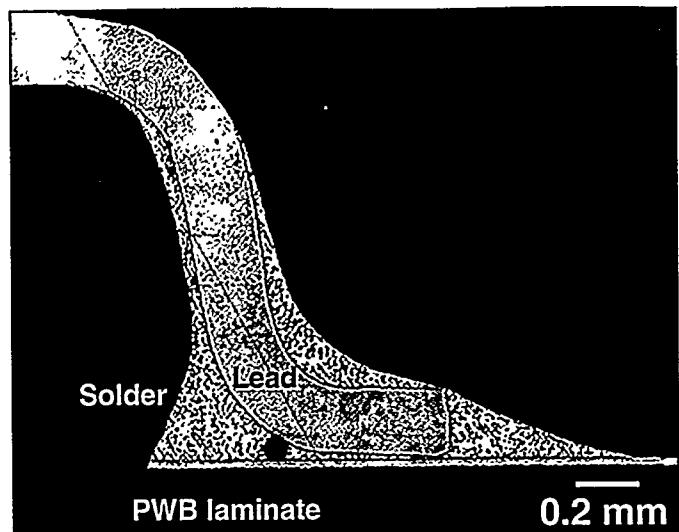
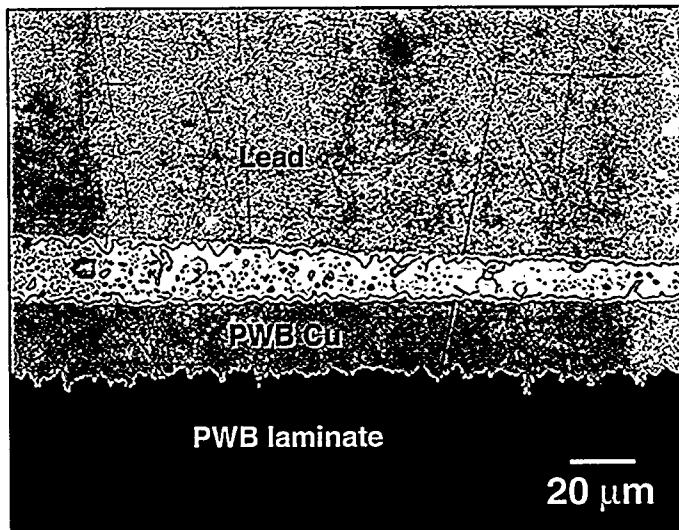
Fig.9 (a) SOIC solder joint after 2500 thermal cycles. (b) High magnification image of the gap region between the gull-wing lead and circuit board pad.

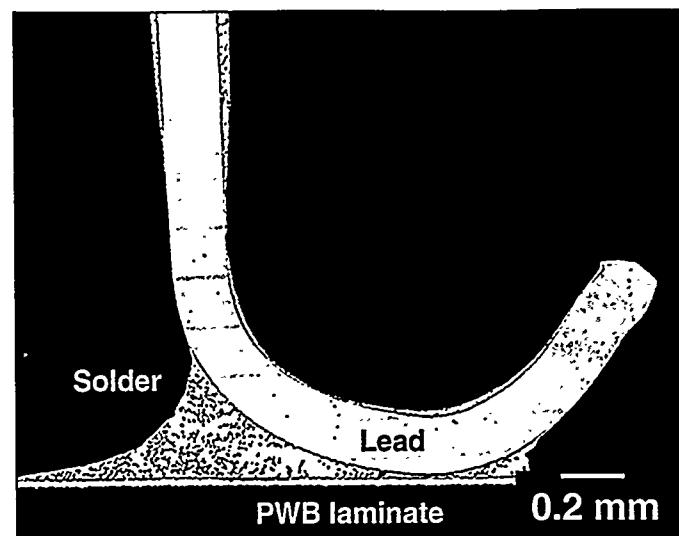
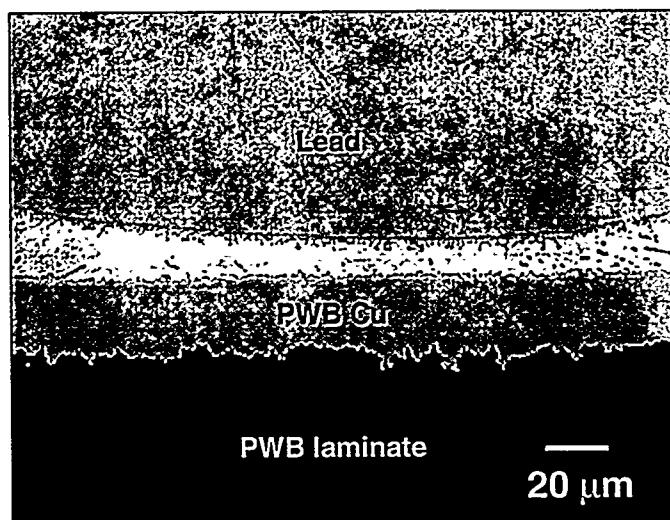
Fig. 10 (a) PLCC solder joint after 2500 thermal cycles. (b) High magnification image of the gap region between the J-lead and circuit board pad.

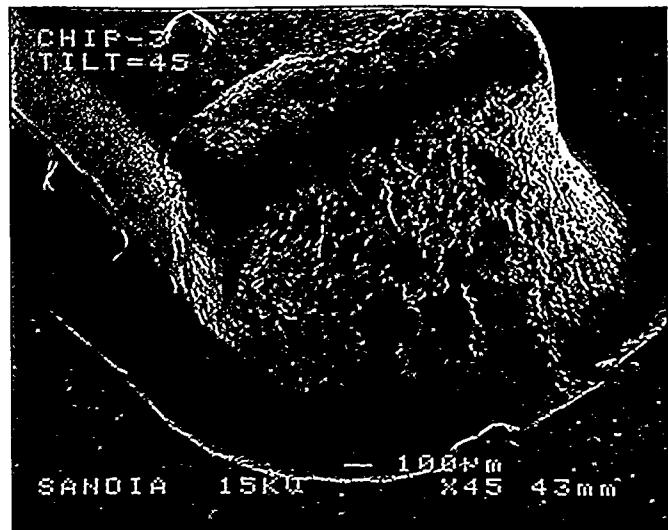
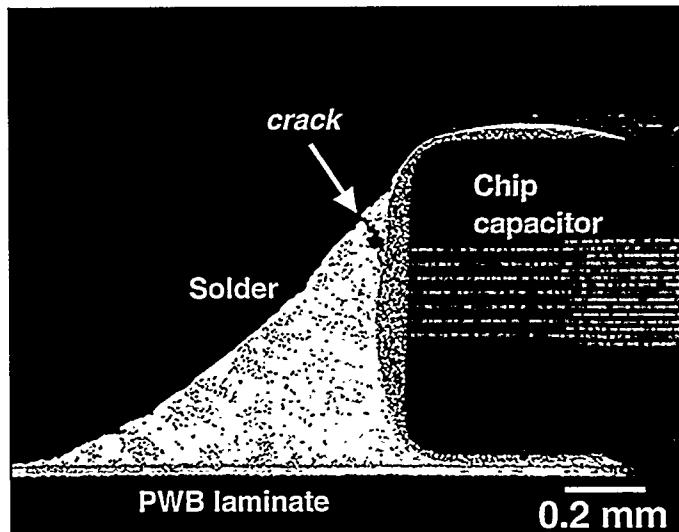
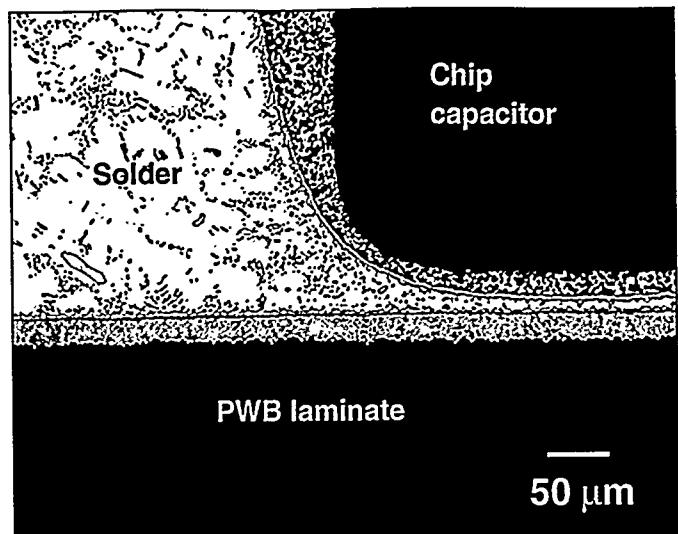
The test vehicles exposed to 5000 thermal cycles were examined by both SEM and optical microscopic techniques. The chip capacitor solder joints are shown in Fig. 11. The SEM photograph in Fig. 11a shows the chip capacitor solder fillet. The dark area showing "mud cracks" at the base of the fillet is the flux residue that had hardened and then fractured under the variable temperature environment. Cracking is observed near the top of the fillet. This crack formation is observed in cross section by Fig. 11b. This cracking is similar to that referred by Fig. 8a for the fillet exposed to 2500 thermal cycles, except that it was more prevalent and extensive in travel after 5000 cycles. On the other hand, the micrograph in Fig. 11c of the gap region clearly shows that no deformation or damage had developed in the solder under the chip structure.

Fig. 11 Chip capacitor solder joint after 5000 thermal cycles: (a) SEM image of the solder fillet, (b) optical micrograph showing the cross section of chip capacitor joint, and (c) high magnification, optical micrograph of the gap region of the solder joint. (*con't*)

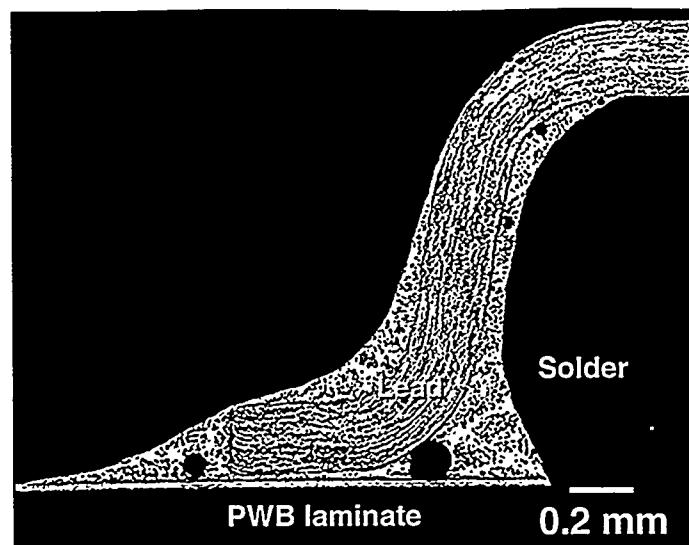
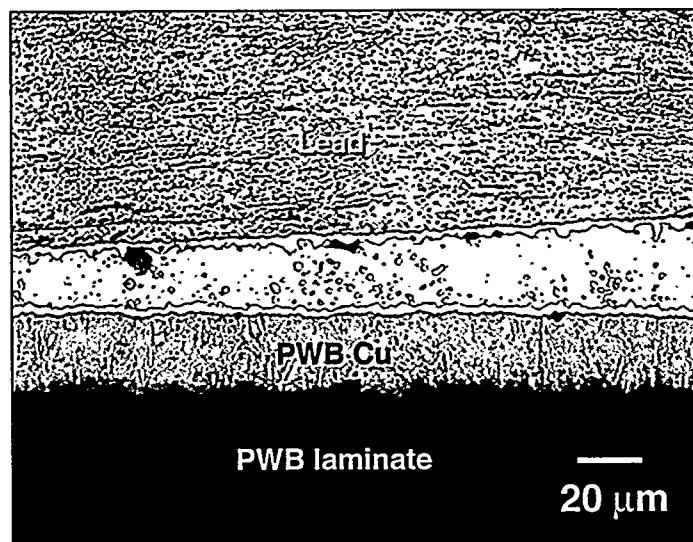
The appearance of the SOIC solder joints is documented in Fig. 12. Figure 12a is an SEM photograph of a gull-wing joint. A small degree of cracking was observed in the solder located on the surfaces of the lead as shown in Fig. 12b. In some instances, the cracks were discernable in cross sectional views. In those latter cases, the fractures did not appear to be associated with any particular phase or feature of the microstructure. Rather, the cracks may have been a result of localized thermal expansion mismatch between the lead material and the Sn-Ag-Bi. The high strength of the solder limited its ability to deform, resulting in the localized fracture. However, as is evidenced by the optical micrographs in Figs. 12c and 12d, cracks were not observed in the critical fillet or under-lead gap regions which provide a large extent of the mechanical attachment function. The micrographs also illustrate the important point that the presence of voids did not aggravate fatigue damage in the joints.

Fig. 12 SOIC solder joint after 5000 thermal cycles: (a, b) SEM images of the solder fillet, (c) optical micrograph showing the cross section of gull-wing lead joint, and (d) high magnification, optical micrograph showing the gap region of the solder joint. (*con't*)

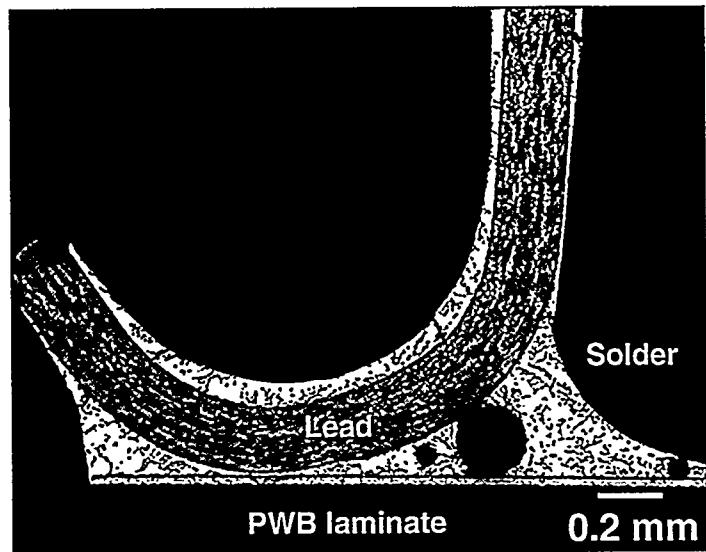
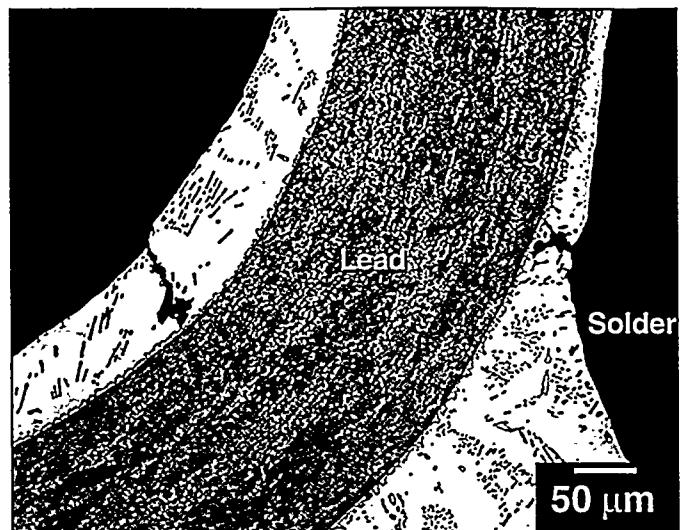
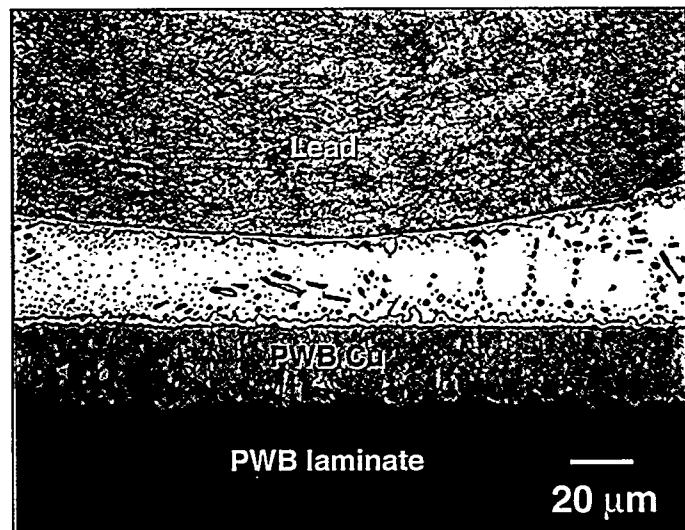
Shown in Fig. 13 is (a) an SEM image and (b, c, d) optical micrographs of a PLCC solder joint after 5000 cycles. The SEM photographs show that there was no large-scale deformation or cracking in the solder. However, viewing other joints did reveal some surface cracks similar to those observed with the SOIC solder joints. Those cracks are more clearly delineated in the optical micrographs of solder joint cross sections shown in Figs. 13b and 13c; a high magnification view of the cracks at the top of

the heel fillet are shown in Fig. 13c. There were no cracks apparent in the solder joint fillet nor in the gap region under the lead (Fig. 13d) that would jeopardize mechanical integrity or electrical continuity.

Fig. 13 PLCC solder joint after 5000 thermal cycles: (a) SEM image of the solder fillet, (b) optical micrograph showing the cross section of J-lead joint, (c) high magnification, optical micrograph showing cracks in the solder film on the lead surface, and (d) optical micrograph of solder in the gap region of the joint beneath the lead.  
(con't)

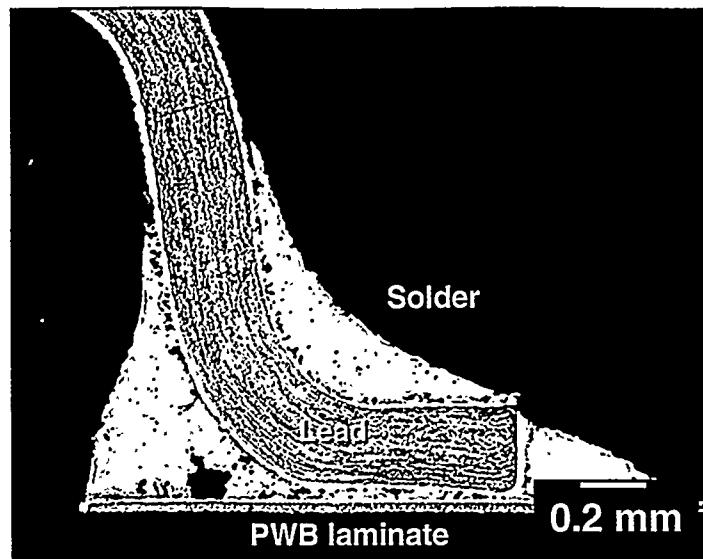
A comparison was made between the above observations and those developed from similar test vehicles that were assembled with 96.5Sn-3.5Ag or 58Bi-42Sn solders[8]. Those prototypes were subjected to the same thermal cycling environments. The Sn-Ag solder joints appeared very similar to those of the Sn-Ag-Bi interconnects after 5000 cycles. On the other hand, the Bi-Sn solder joints rapidly degraded with thermal cycling. This point is exemplified by the optical micrograph in Fig. 14 showing an SOIC solder joint after 5000 thermal cycles. The mechanism by which the Bi-Sn joint degraded is a result of the accelerated intermetallic compound layer growth at solder/Cu interfaces[9]. In this case, that interface is that between the SOIC gull wing lead and the Bi-Sn solder. Specifically, the Bi component of the solder does not participate in the layer development. As a result, it is rejected ahead of the growing intermetallic compound layer, forming a brittle, continuous layer ahead of the latter. Consequently, the Bi layer readily fractures, producing voids as a result of the sample fabrication process but more importantly, causing a significant drop in the strength of the interface.

Fig. 14 Optical micrograph of the a 58Bi-42Sn, SOIC solder joint after 5000 cycles. Severe deterioration has taken place.

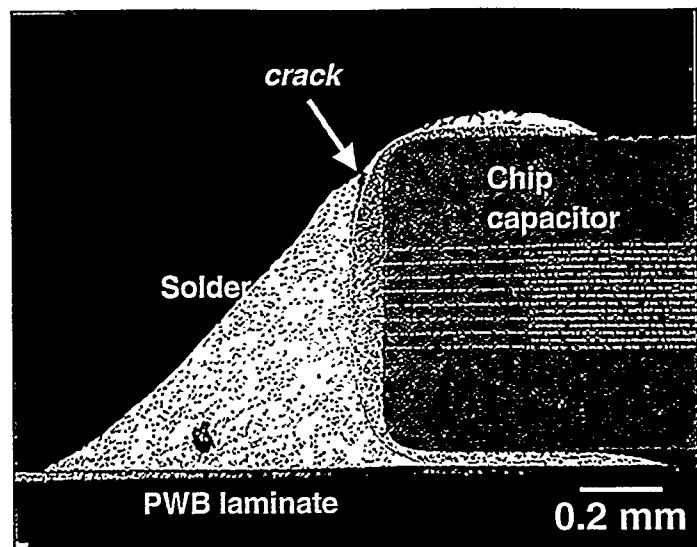
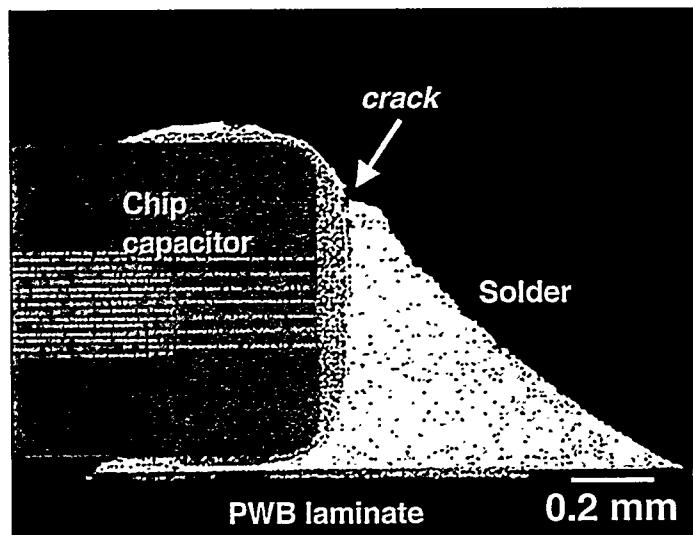
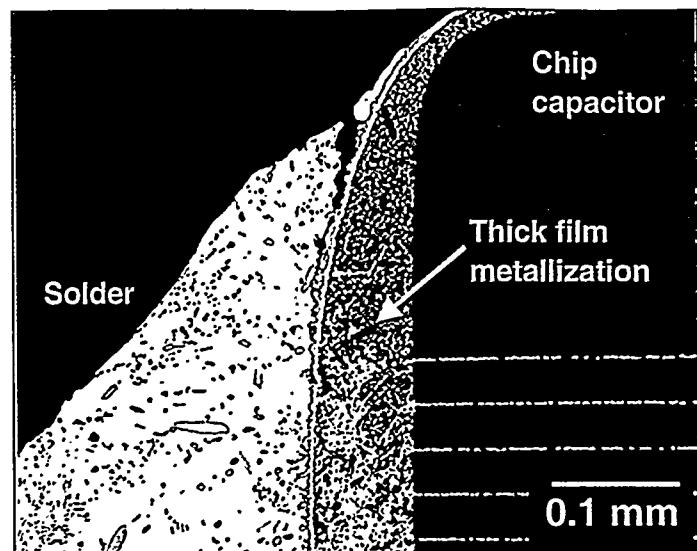
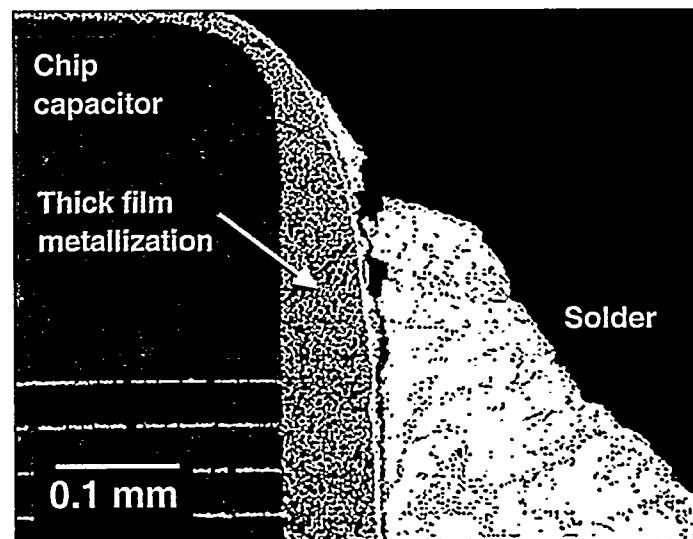
The chip capacitor Sn-Ag-Bi solder joints retained excellent integrity after 10,000 thermal cycles (Figs. 15a, 15b). The most persistent failure mode was that of crack formation at the top of the solder fillet. The extent of the crack development was greater than that observed after 5000 thermal cycles; a worse case is shown in Figs. 15c and 15d. The surface profile of the fillets showed a slightly rougher appearance. In one case, a crack had initiated at the rough, fillet surface and propagated about 75% of the distance *towards* the termination. There was no appearance of deformation or cracking of the solder in the gap between the capacitor and the bond pad. Also, there was no discernable evolution by the microstructure when the images in Fig. 15 were compared with those of chip capacitor solder joints in the as-fabricated condition.

The shear strength (Fig. 18) and fracture morphology information (Fig. 19) can be correlated as follows. As noted above, the fracture path propagated in both the solder and the chip capacitor structure over the range of thermal cycle conditions. The shear strength exhibited a decline at 5000 and 10,000 cycles. Assuming that the adhesion strength between the metallization and the capacitor was not affected by the thermal cycling conditions, then the drop in strength was due to a decrease in load-bearing area at the solder/termination interface (top of region "A"). Further growth of the fillet tip cracks shown in Figs. 11 (5000 thermal cycles) and 15 (10,000 thermal cycles) was the likely cause for the drop in shear strength of the solder joints.

Fig. 15 Optical micrographs of Sn-Ag-Bi solder joints on the chip capacitors that were exposed to 10,000 thermal cycles: (a, b) low magnification views and (c, d) high magnification views of the tops of the solder fillets. (*con't*)

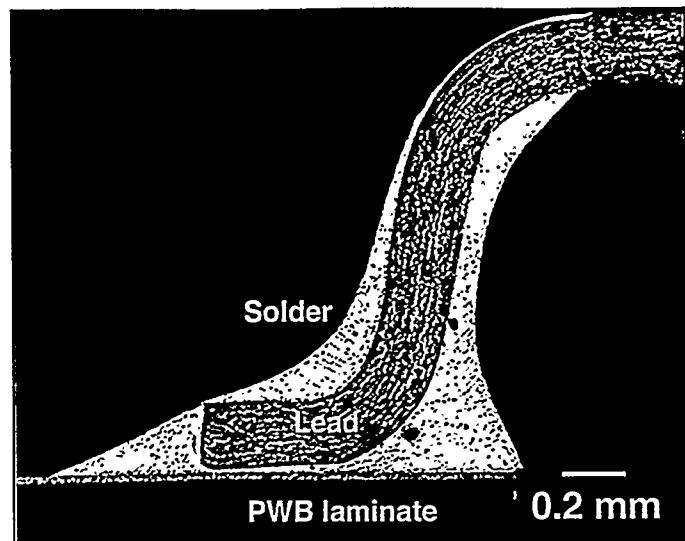
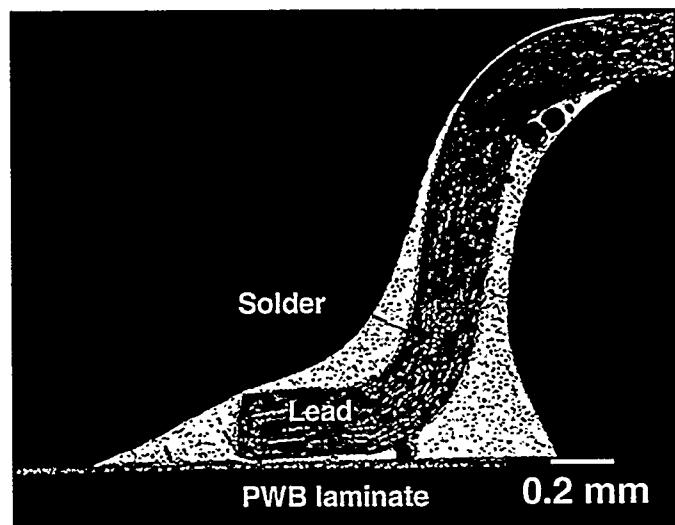
Damage to the SOIC solder joints was largely absent in the cases that were examined (Fig. 16a). Some roughening of the fillet surfaces was observed. In the joint shown in Fig. 16b, small cracks formed in the top surface solder film as well as on the lower reaches of the fillet surface. However, those cracks did not extend to a degree that would pose a significant threat to the functionality of the interconnect. There was no indication of damage to the solder in the gap found between the lead and the bonding pad. The general microstructure of the solder throughout the joint was not significantly changed by the thermal cycling environment.

Fig. 16 Optical micrographs of the SOIC gull-wing solder joints after 10,000 thermal cycles. The case in (a) was typical with an absence of damage while that in (b) shows the formation of some surface cracks.

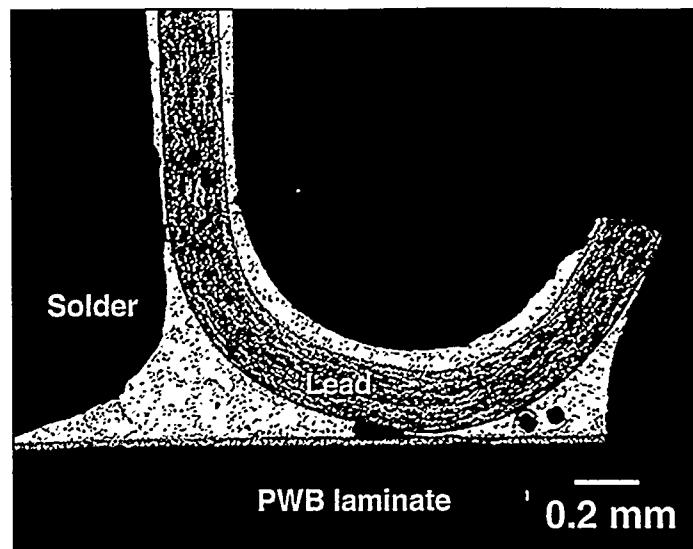
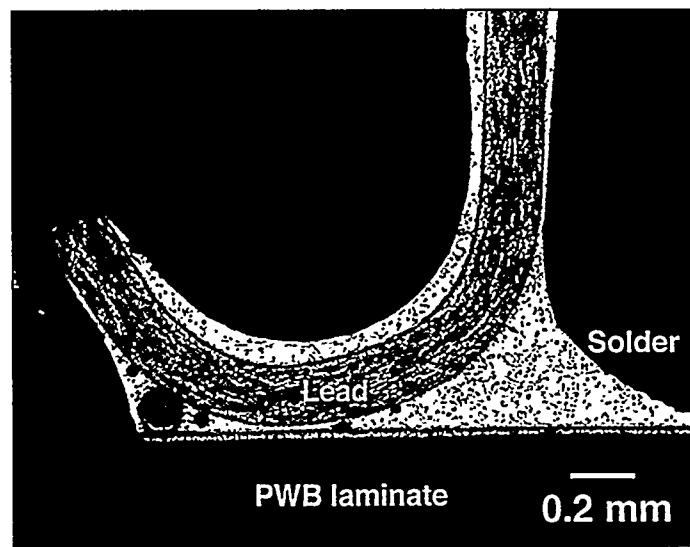
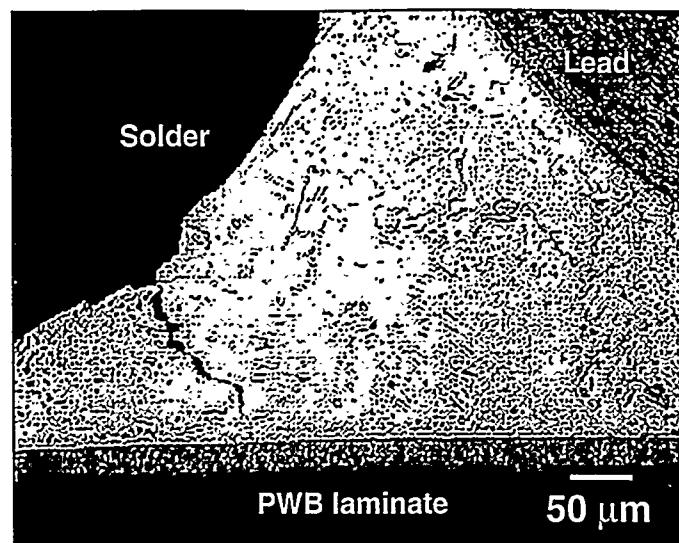
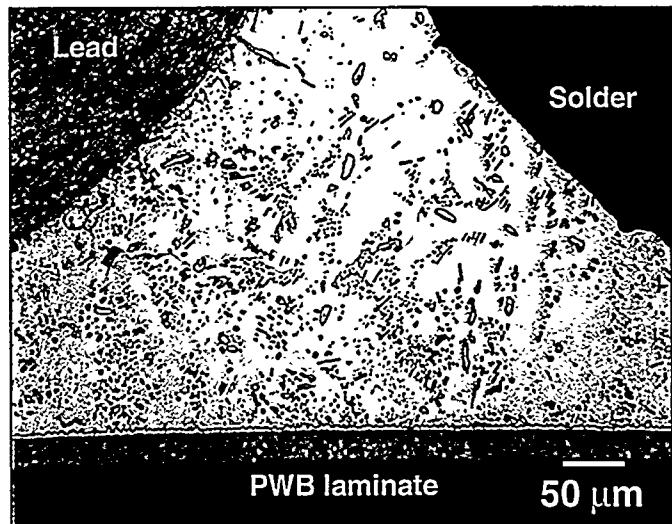
The PLCC solder joints exhibited some damage. Shown in Figs. 17a and 17b are low magnification micrographs of the solder joint cross sections. The solder fillet surfaces have roughened with the cycling exposure. Cracks were observed on the thin solder film coating the top of the leads. A crack was also noted in the heel fillet of the joint shown in Fig. 17a. An improved view of the crack is shown in Fig. 17c which, along with Fig. 17d, provide high magnification images of the heel fillets. The crack does not appear to be associated with any microstructural inhomogeneity of the solder. The location of the crack suggests that its source was global thermal expansion mismatch between the package and laminate that resulted in bending (tensile) loads by the J-lead and subsequent cracking in the fillet. Shear fatigue loads caused by both global and local residual stresses had no observable effect on the Sn-Ag-Bi solder because in the gap region at which such stresses were of maximum magnitude, no damage was observed in the solder microstructure. Only isolated areas of grain boundary slip within the Sn-rich matrix were noted.

Fig. 17 Optical micrographs of the PLCC J-lead solder joints after 10,000 thermal cycles: (a, b) low magnification images and (c, d) high magnification images of the solder joint fillets. (*con't*)
