**North Slope of Alaska ARM Facilities**  
**Monthly Status Update**  
**Sandia National Labs**

**June 2017**

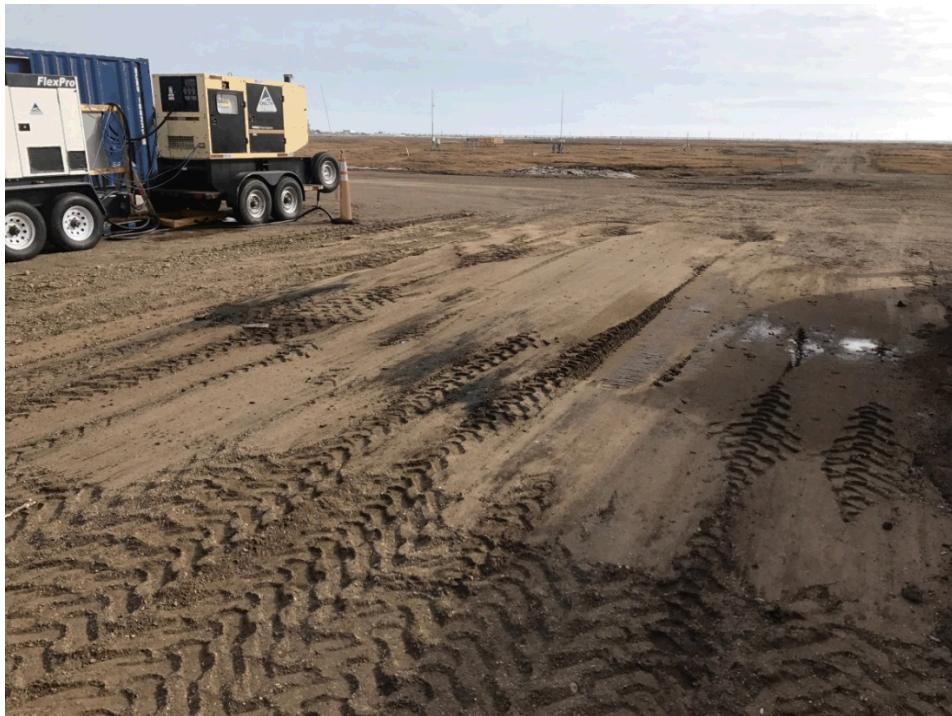
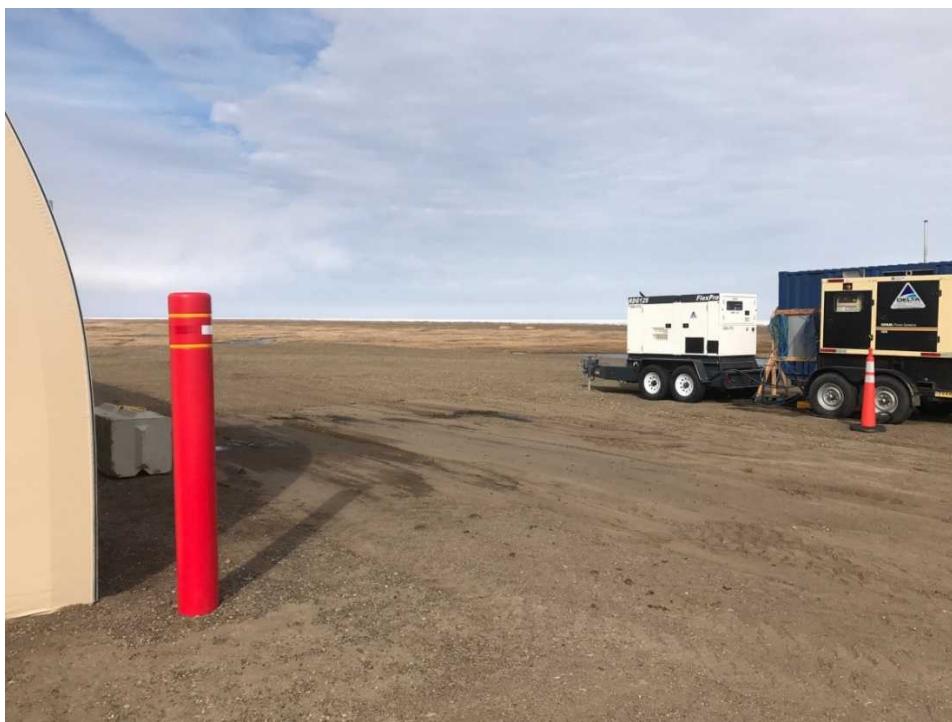
Site cleaned up after fire.

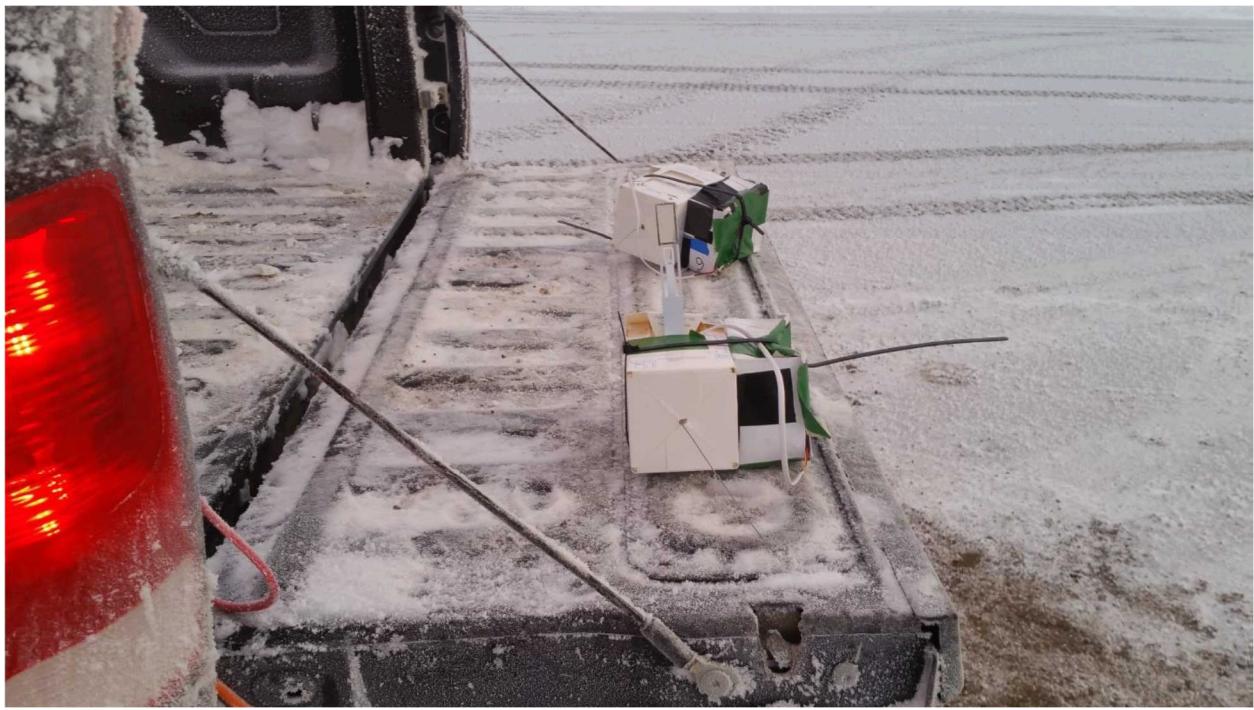
Figure 1: Previously used cardboard iMet radiosonde and SLWC housings

Supercooled liquid water sonde analysis from May 2017 is ongoing. Quicklooks for the SLWC are in progress. New housings have been 3D printed for the iMet radiosondes and supercooled liquid water sondes at SNL. These housings will be lined with RF-reducing foam in order to try to prevent some of the EMI problems encountered at Oliktok. The housings will be a great improvement over the previous cardboard housings, which fell apart after operating in clouds and were time consuming to prepare for flight.
