WINCO-1153

## **CORROSION IN ICPP FUEL STORAGE BASINS**

**W. J. Dirk**

**September 1993**

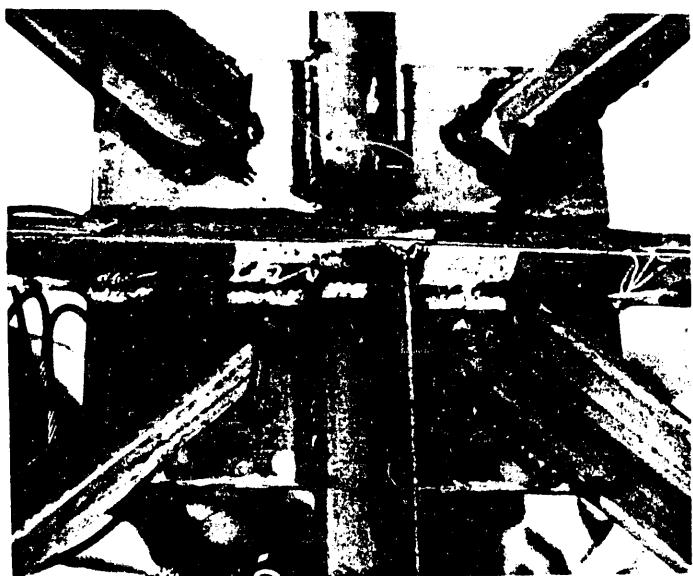
Stainless steel and aluminum corrosion coupons have been installed in the south basin. A welded stainless steel tie plate, representing the "Tie-Plate" for the stainless steel fuel storage racks, has been inspected on a semi-annual basis for 13 years (Figure 5). During each inspection period the coupon has been evaluated for stress corrosion cracking using a fluorescent dye penetrant examination. In addition, ultrasonic thickness measurements have been made periodically. Results are shown in Table II.

Figure 5 - Stainless Steel "Tie-Plate"  
13 Years Exposure

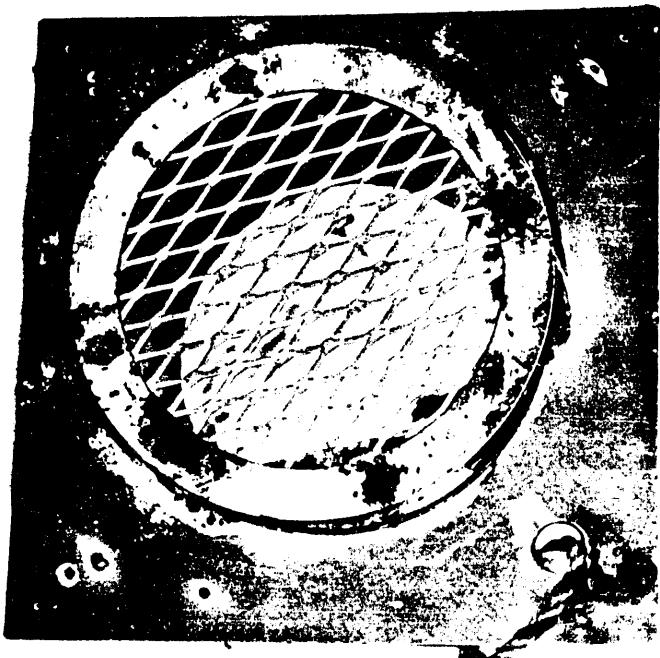
Two types of aluminum corrosion coupons have been installed in the south basin. The first type uses an expanded metal mesh to duplicate the screens on the aluminum racks. The second type of coupon uses a woven wire mesh to duplicate the screens on previous aluminum racks. These coupons were designed with plate material, pipe material, and crevices. Figures 6 through 11 show the chronological progression of corrosion of these coupons. These coupons have been inspected every 6 months and have seen an exposure of 10.6 years. Aluminum has shown a general attack of 1.5 mpy with preferential attack in the form of pitting and crevice attack. Ultrasonic thickness measurements are shown in Table III and Table IV for the expanded aluminum mesh and wire mesh aluminum corrosion coupons.

Figure 8- Aluminum 6 Years Exposure

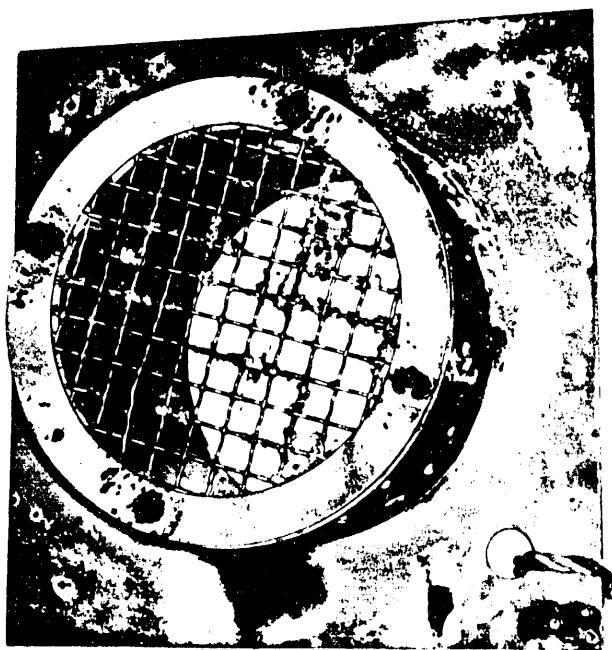
Figure 9 - Aluminum 6 Years Exposure

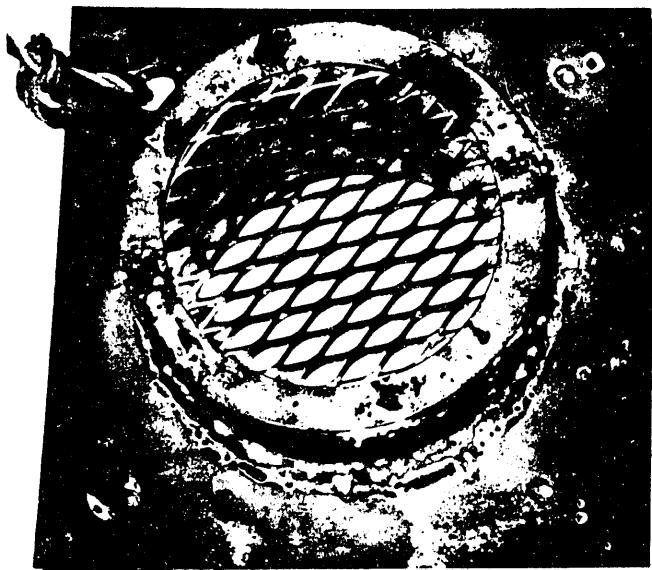
Figure 10 - Aluminum 10 Years Exposure

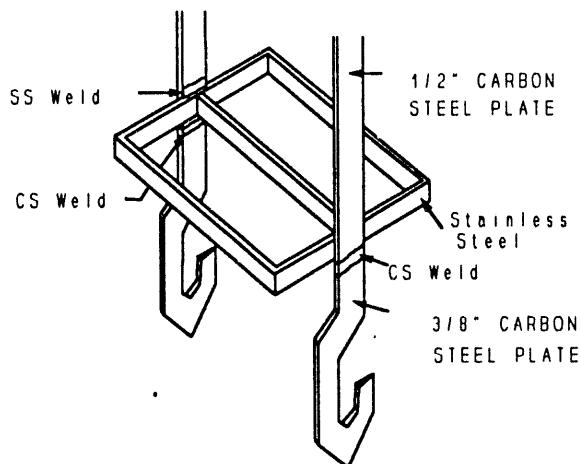
Figure 12 - Double Trunion Hook

Failure of one of the hooks on a double trunion hanger (Figure 12) in 1992 led to increased inspection of existing hangers supported by the monorail system. There are three types of hangers used in the North and Middle basin. The first is a welded Type 304 stainless steel hanger with a single hook. One of these hangers was tested to failure and a section of the welded 5/8 inch hook and hanger assembly was metallurgically evaluated. There was no indication of significant attack of the stainless steel at any point. Ultrasonic thickness measurements showed no indications of general attack after 17 years of exposure when the immersed section was compared to the section above the water line.

The third type of hanger examined was the double trunion hook type (Figure 12). Two hangers were examined. The first in a routine inspection showed that both hooks had fallen off in service under a no-load condition near the junction of a stainless steel to carbon steel weld. Drawings indicated that there was a step down at this point where a separate section of the 3/8 inch thick hook which was welded with a 1/8 inch fillet weld on one side to the 1/2 inch thick carbon steel hanger. The question to be resolved was whether the hook failed by galvanic attack or attack of the small fillet weld. In actuality, the joint was an open butt weld, not a fillet weld (Figure 20). A second hanger was removed from the basin and a section involving the stainless steel to carbon steel weld and the open butt weld was cut out (Figure 21). The results indicated that the failure occurred because of general corrosion of the carbon steel weld. Galvanic attack of the carbon steel caused by the bi-metallic couple with the stainless steel was not a factor.

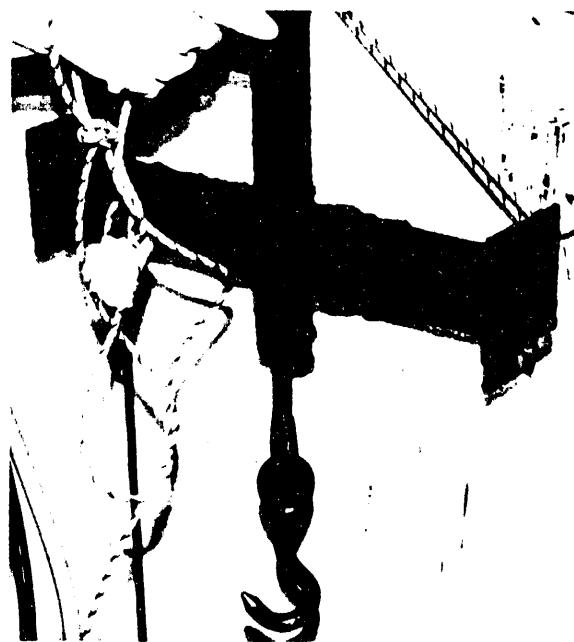
Figure 13- Single Carbon Steel Hanger Stainless Steel Hook

The second type of hanger was constructed of a 1/2-inch thick by 2-inch-wide carbon steel bar with a 5/8 inch Type 304 stainless steel eye piece welded in a notch cut into the end of the bar (Figure 13). The carbon steel had been previously galvanized to increase the service life, however, there was very little zinc galvanizing left. Ultrasonic thickness measurements made on the carbon steel bar showed a general thickness loss of 0.106 inches after 24 years exposure to the basin water. The area where the stainless steel rod was welded into the carbon steel bar showed evidence of attack in the heat affected zone parallel to the weld. This is indicative of galvanic attack. This hanger was sectioned and metallographically examined. Figure 14 shows a description of where the hanger was sectioned and Figure 15 shows a representation of the sectioned piece. The cross section of the hanger (Figure 14-B) shows incomplete penetration of the weld resulting in a crevice on both sides of the stainless steel rod. This crevice was filled with corrosion product and allowed chloride ions from the basin water to concentrate. Figure 16 shows an example of chloride stress corrosion

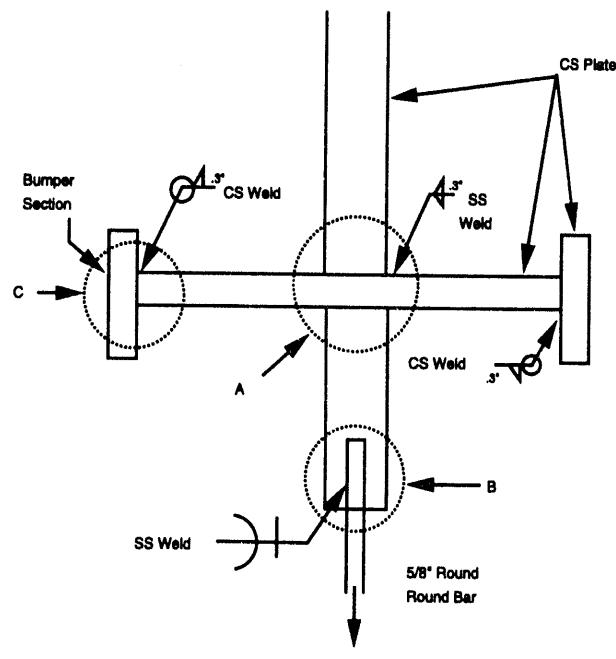
Figure 14 - Single Hanger Assembly

A, B, C - Areas of Prime Corrosion Concern

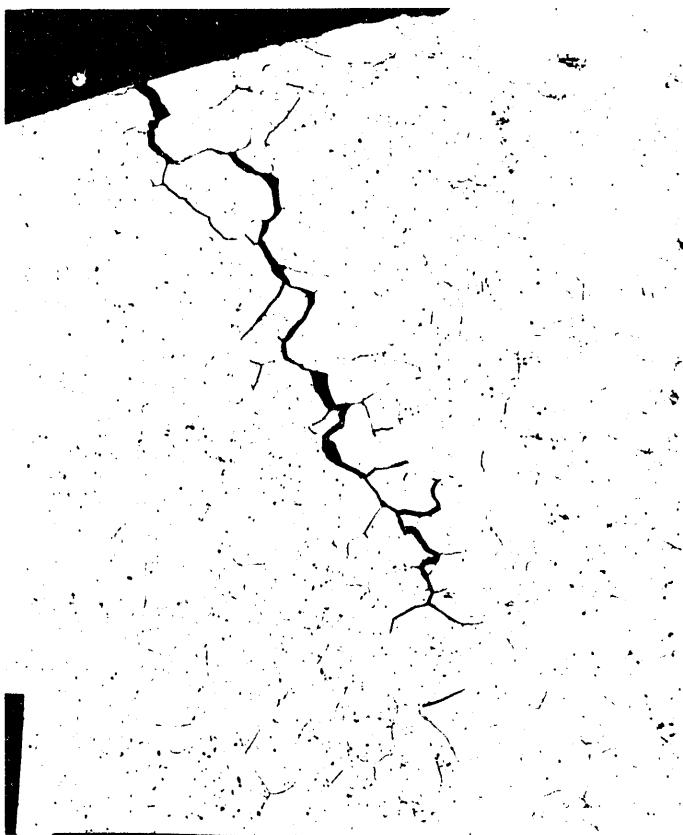
cracking of the Type 304 stainless steel bar which initiated near the heat affected zone. Other types of cracks were noted, but have been attributed to hot cracking during fabrication. An example of these type of cracks are shown in Figure 17. A second sample was cut from the bumper section of the carbon steel hanger (Figure 14-C). The bumper is important in keeping nuclear fuel separated for nuclear criticality safety. Since the carbon steel had been heavily attacked, it was necessary to evaluate the carbon steel welds to determine their structural strength. The metallographically mounted cross section of the welds showed some corrosion product, the remaining weld showed sufficient weld integrity to prevent loss of the bumper section due to a normal impact (Figure 18). A third section was cut from the bumper cross piece where it was welded to the main carbon steel bar (Figure 14-A). This section showed that the carbon steel was welded with a stainless steel weld rod. Hot cracking of the stainless steel weld occurred in this section (Figure 19)

Figure 16 - Intergranular Crack of the Type 304 SS 5/8 inch Single Hook Welded Bar-100X

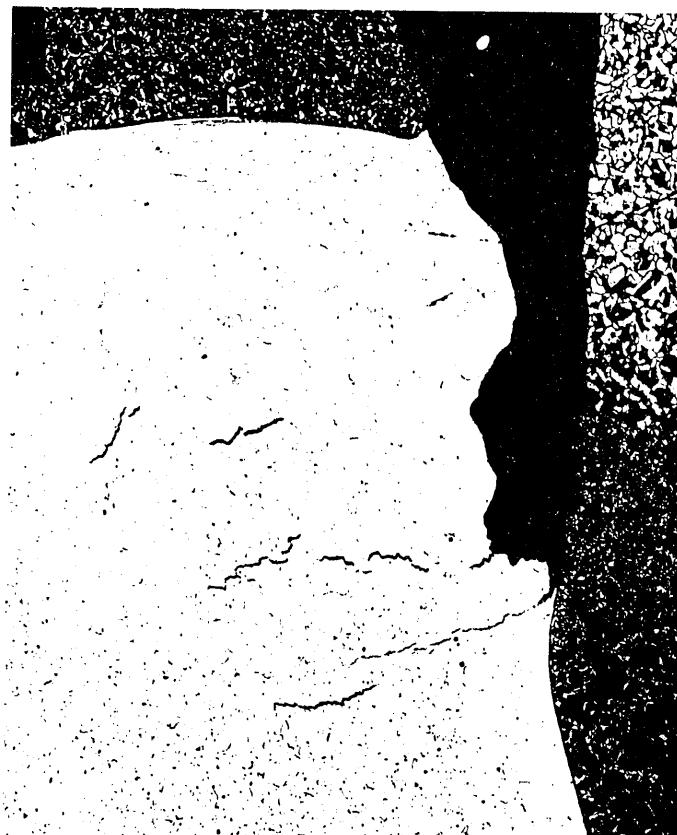
Figure 17 - Solidification cracks of the Stainless Steel Bumper Weld - 50X

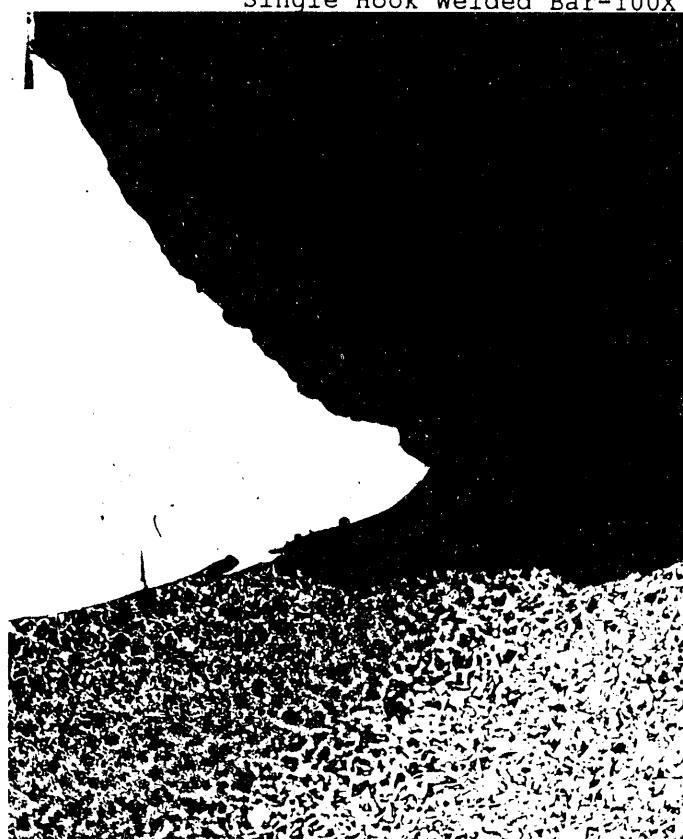
Figure 18 - Galvanic Attack of the Type 304/Carbon Steel Weld

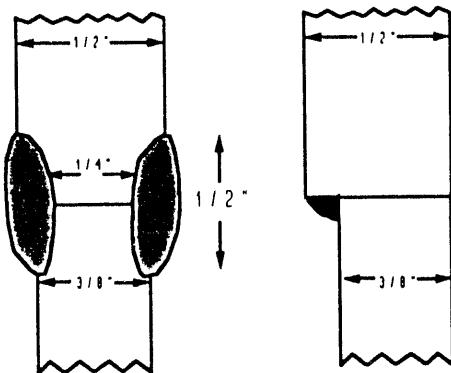
Figure 20 - Double Yoke  
Open Butt Weld
