SAND93-2453 • UC-235
Unlimited Release
Printed January 1994

Operational Experience and Evaluation of a Dual-Element Stretched-Membrane Heliostat

John W. Strachan and Jake Van Der Geest

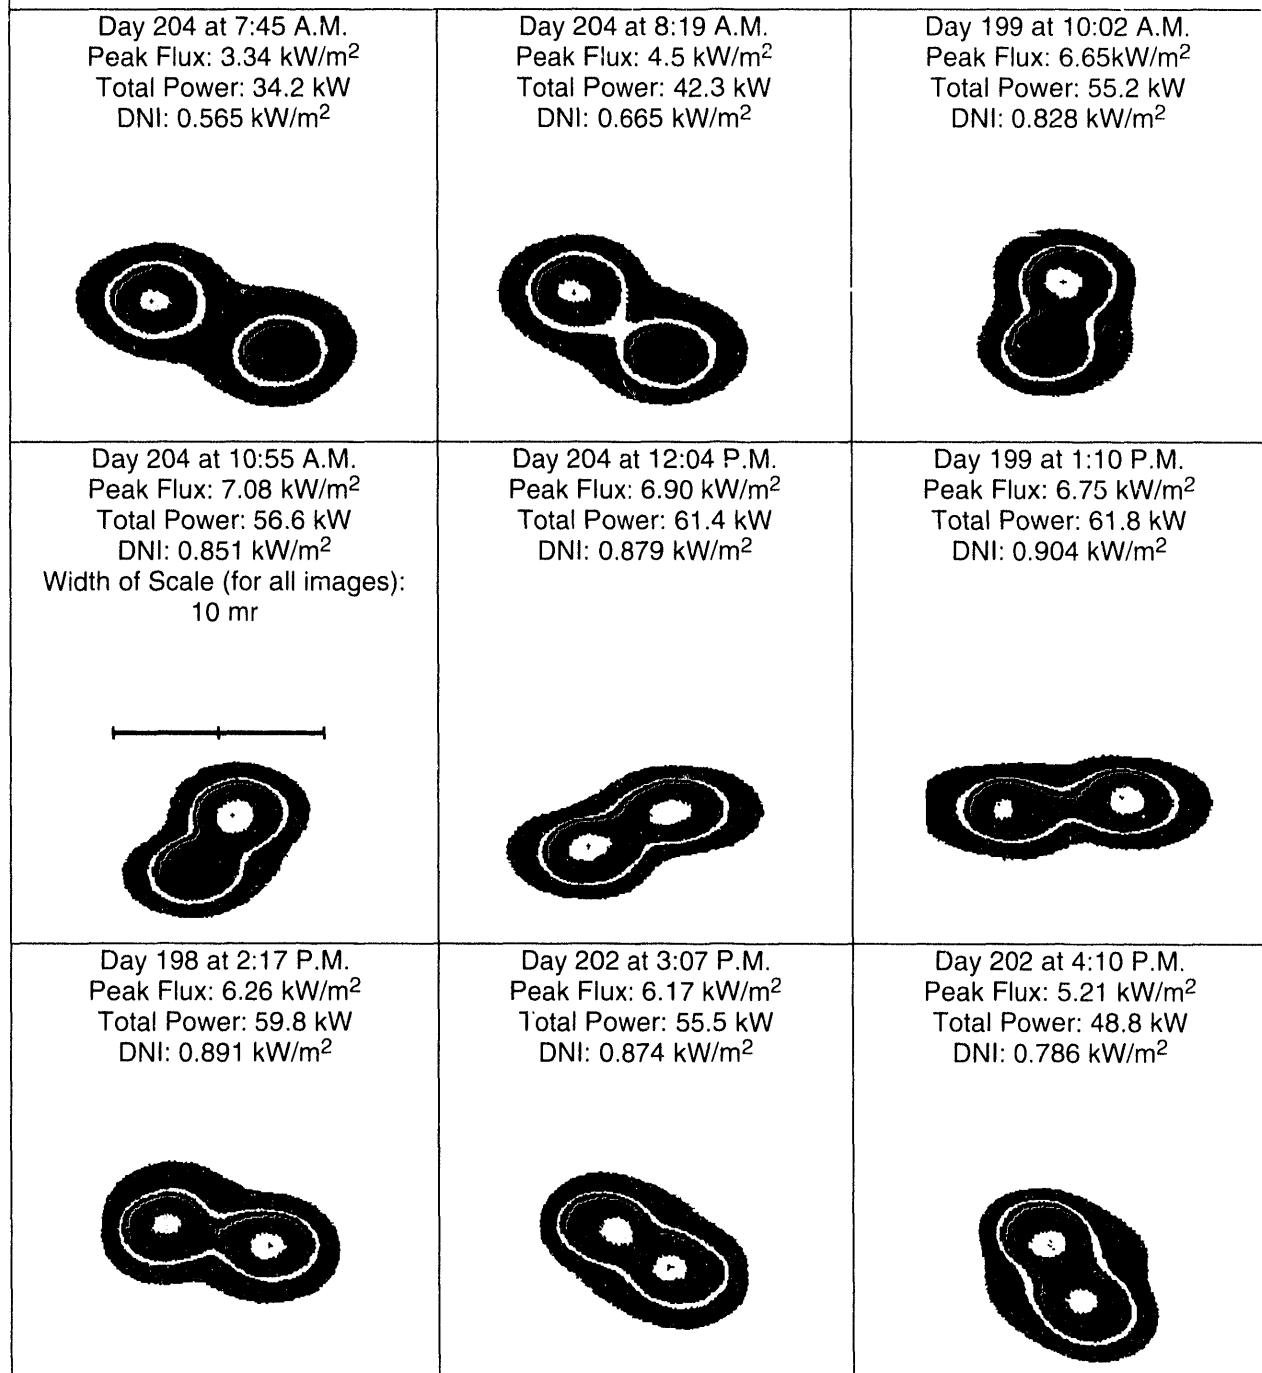
Figure 4: All-Day Optical Performance
(note scale in 4th image)

solar noon in mid-January of 1991. The consequences of this non-optimal canting were evident when the all-day beam quality test was performed in mid-July 1992. The module beams did not overlap one another (Figure 4) and the peak flux levels observed (Figure 5) corresponded to the flux produced by a single module.

Attention will have to be given to the canting strategy for dual-element stretched-membrane heliostats in order to minimize the pointing error due to a fixed canting. An analysis of this issue is recommended and could be performed using a heliostat modeling tool such as HELIOS. If that analysis should indicate the need, a means (manual or motor-driven) of

adjusting the module aim points could be incorporated into the heliostat's design.

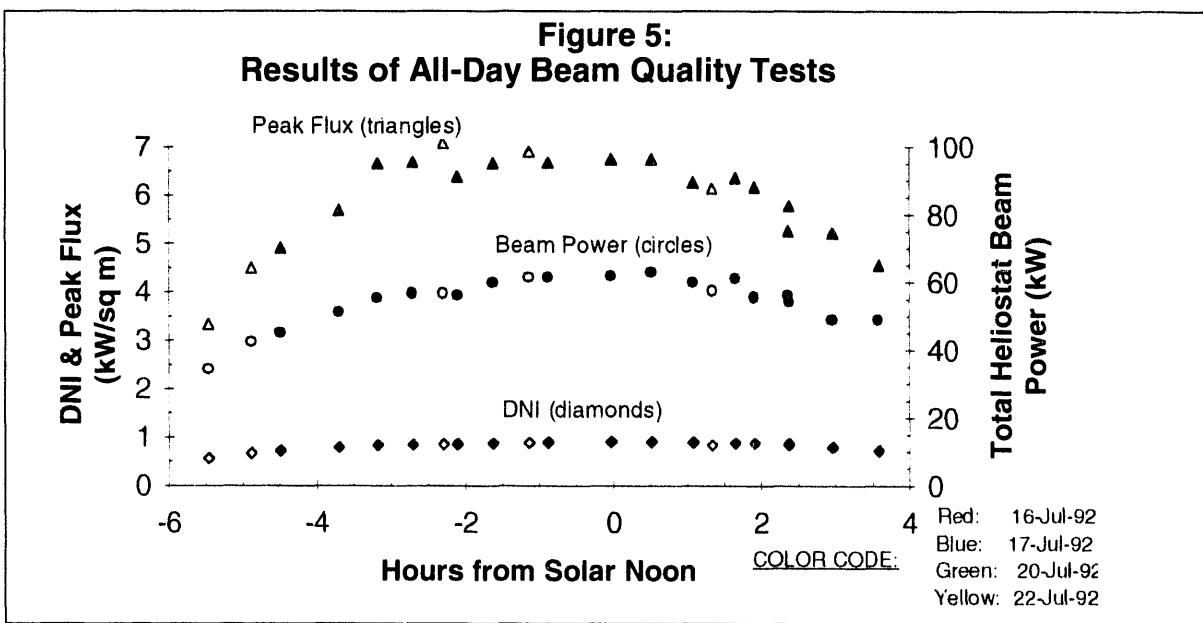
In the four hour-period centered around solar noon the average total power produced by the heliostat was 60 ± 6 kW with an average insolation level of 0.88 ± 0.04 kW/m². When normalized to "one sun" (1.0 kW/m²) this yields an average noontime performance of 68.2 kW of total power or 0.70 kW per square meter of heliostat collector area. The average peak flux during the same four-hour period was 6.5 ± 0.6 kW/m². (We did not normalize this performance figure with respect to the heliostat's cosine losses, but in this evaluation the point on the elevation axis half-way between the heliostat's two mirror modules was located 50.3 m west, 249 m north, and 18.6 m below the beam tracking aimpoint.)

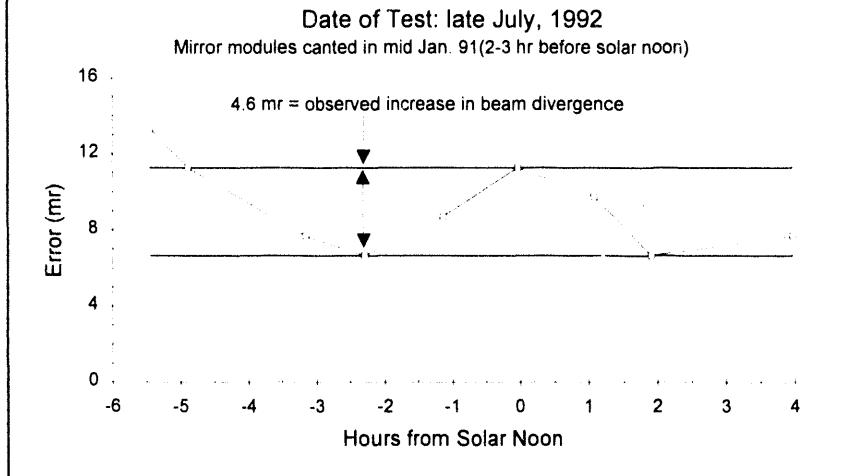
Figure 6: Canting-Related Mirror Pointing Error Over the Course of a Day

If a heliostat's mirror modules subtend a large angle, relative to the angular size of the solar receiver for which they are intended, then the canting or aiming of the modules is a design consideration with added significance. If the canting of the mirrors is performed only once (when the heliostat is first erected), then the modules' geometry is fixed. The receiver-to-heliostat-to-sun geometry, however, is not fixed, but varies with the sun azimuth and elevation angle over the course of the day and with the earth's declination angle over the course of the year. Consequently, the relative position of the module beams on the receiver will vary and the beams will generally **not** coincide. This constitutes a form of mirror pointing error. In the case of a heliostat with two circular, 8 m diameter modules, the year-long average angular separation of the beams will be considerable and is likely to be a much larger contributor to overall collector beam slope error than are the surface slope errors.
