Predicting the Reliability of Package-on-Package-Package (PoPoP) Interconnections Based on Accelerated Aging Experiments and Computational Modeling

P. Vianco, J. Rejent, M. Grazier, B. McKenzie, A. Kilgo, and M. Neilsen,

Sandia National Laboratories*
Albuquerque, NM 87185

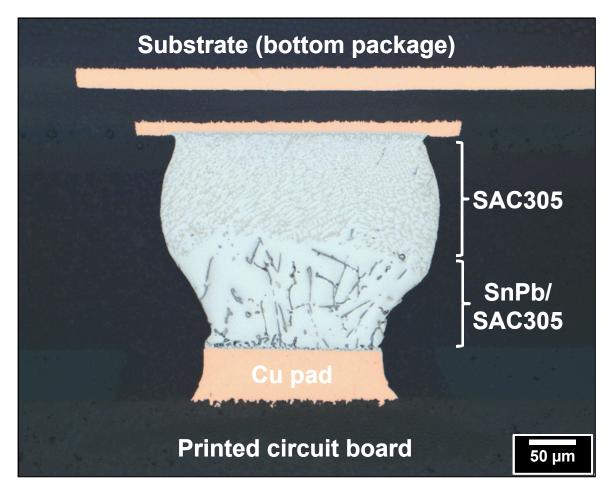
S/N05: as-fabricated; underfill, middle and bottom gaps

The dual microstructure is illustrated by this optical micrograph:

Excessive voids and cracks were not observed in any joints.

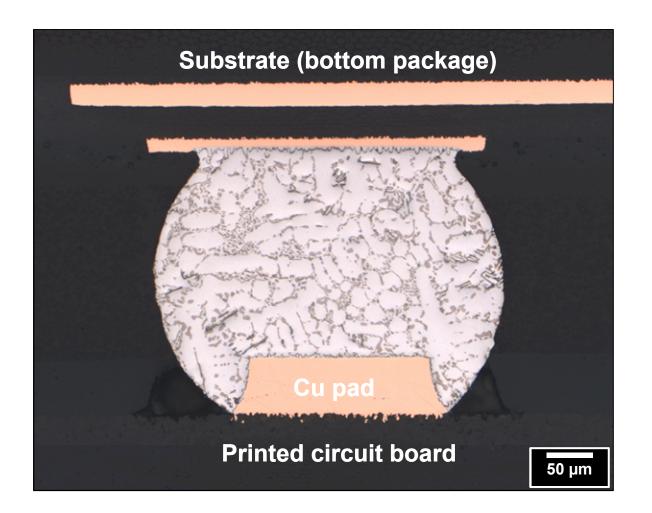
This optical micrograph shows the homogeneous microstructure.

Although the Ag₃Sn particles were not uniformly distributed across the entire joint, this trend did not affect TMF performance.

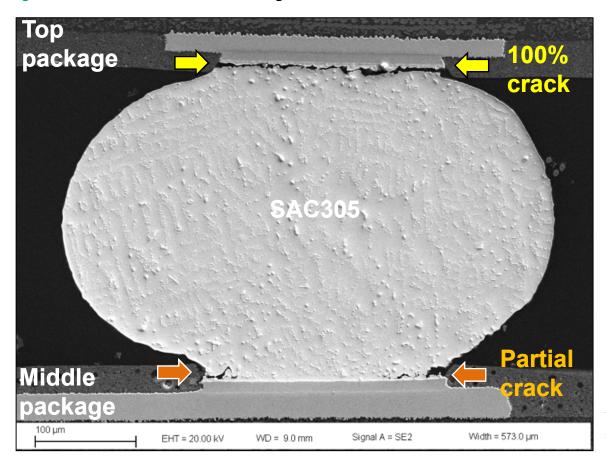
S/N22, U10A, top; No underfill; Failed: 3068 cycles

Mixed SnPb/SAC305 bottom joints; no underfill: Failure of the top solder joints was caused by the "100% crack" at the top pad.

Partial cracks were observed at the bottom pad (middle package).

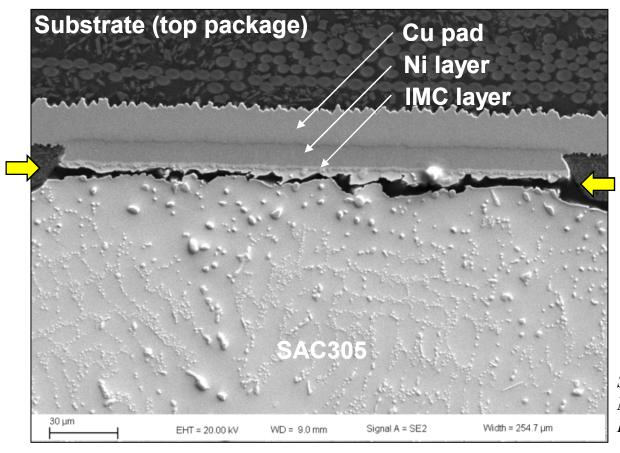
S/N22, U10A, top; No underfill; Failed: 3068 cycles

Mixed SnPb/SAC305 bottom joints; no underfill: The "100% crack" exhibited the expected TMF morphology of having developed in the SAC305 solder near to, but not at, the solder/pad interface.

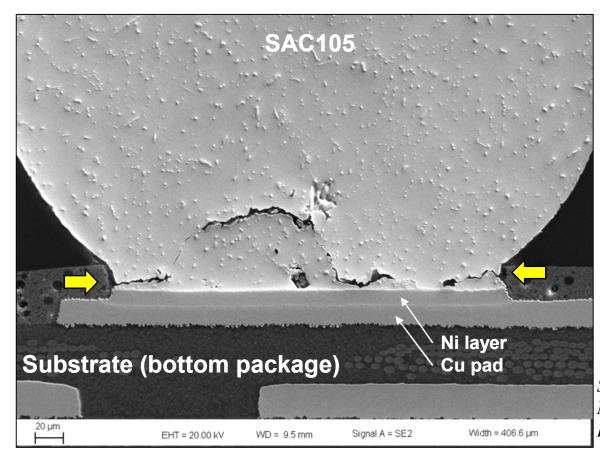
S/N22, U10A, top; No underfill; Failed: > 3068 cycles

Mixed SnPb/SAC305 bottom joints; no underfill: The "100% crack" of the middle solder joints was near the bottom pad.

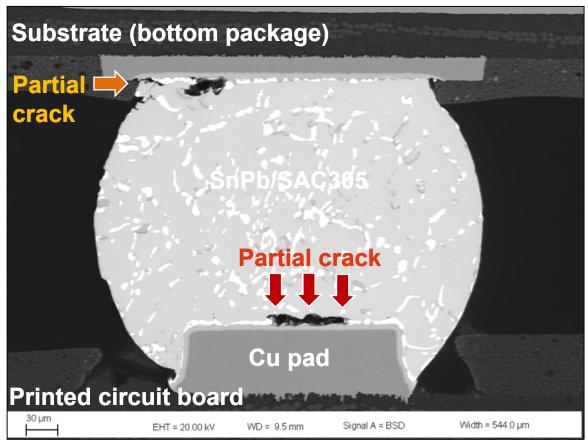
S/N22, U10A, top; No underfill; Failed: > 3068 cycles

Mixed SnPb/SAC305 bottom joints; no underfill: An example of the "100% crack" was not captured for the bottom solder joints in this particular cross section; the partial TMF crack is evident.

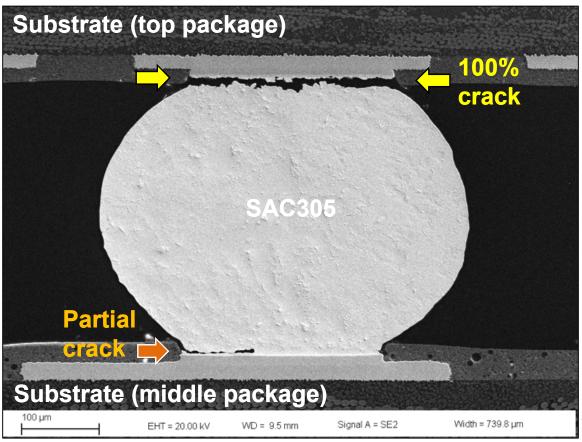
S/N10, U10A, top; Underfill, bottom; Failed: ≥ 4506cycles

Mixed SnPb/SAC305 bottom joints; Underfill, bottom gap, only:
 The top solder joints failed by a "100% crack" at the top pad.

A partial crack was observed at the bottom pad (middle package).

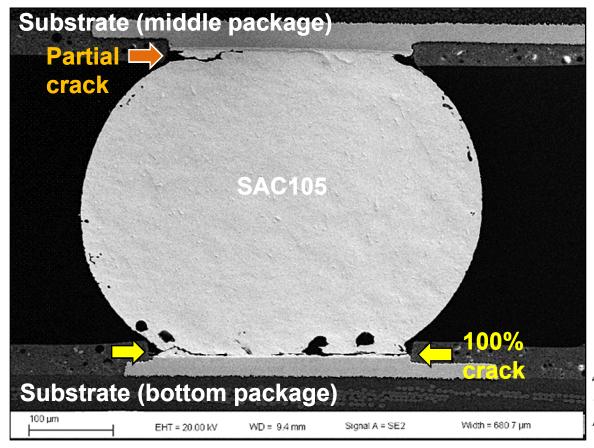
S/N10, U10A, top; Underfill, bottom; Failed: ≥ 4506cycles

Mixed SnPb/SAC305 bottom joints; Underfill, bottom gap, only: The middle joints failed by a "100% crack" at the bottom pad.

A partial crack was observed at the top pad (top package).

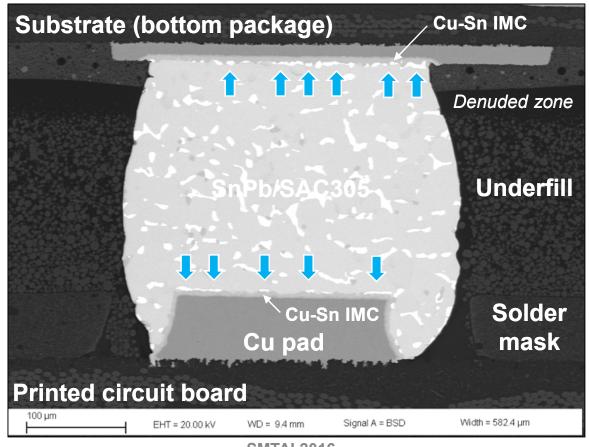
- Mixed SnPb/SAC305 bottom joints; Underfill, bottom gap, only:
- The bottom solder joints had not failed; but, they did exhibited the development of the Pb-rich layer ahead of IMC growth (blue arrows.)

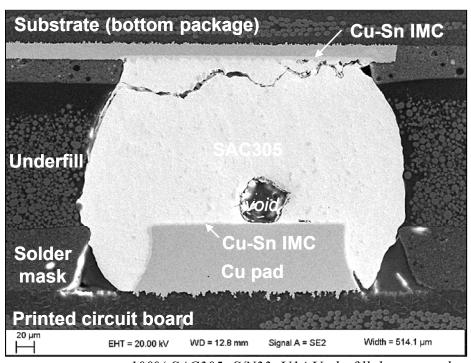
100% SAC305; S/N33, U14 Underfill, bottom, only

- 100% SAC305 bottom joints; Underfill, bottom gap, only:
- The microstructures were examined, which belonged to both "high-η" and "low-η" mechanisms.

"Low-n" mechanism

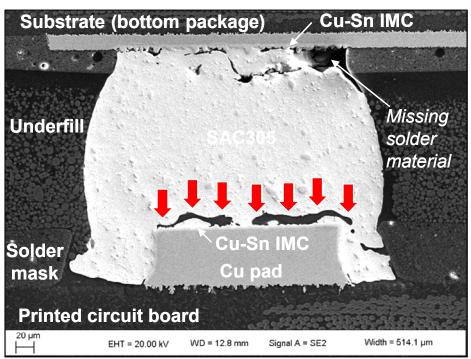
100% SAC305; S/N33, U01 Underfill, bottom, only

"High-η" mechanism

The "high-η"mechanism included cracks at the Cu pad (red arrows).
