DOE/NV--1594

**Post-Closure Report for Closed  
Resource Conservation and Recovery  
Act Corrective Action Units, Nevada  
National Security Site, Nevada**

**For Calendar Year 2017**

May 2018

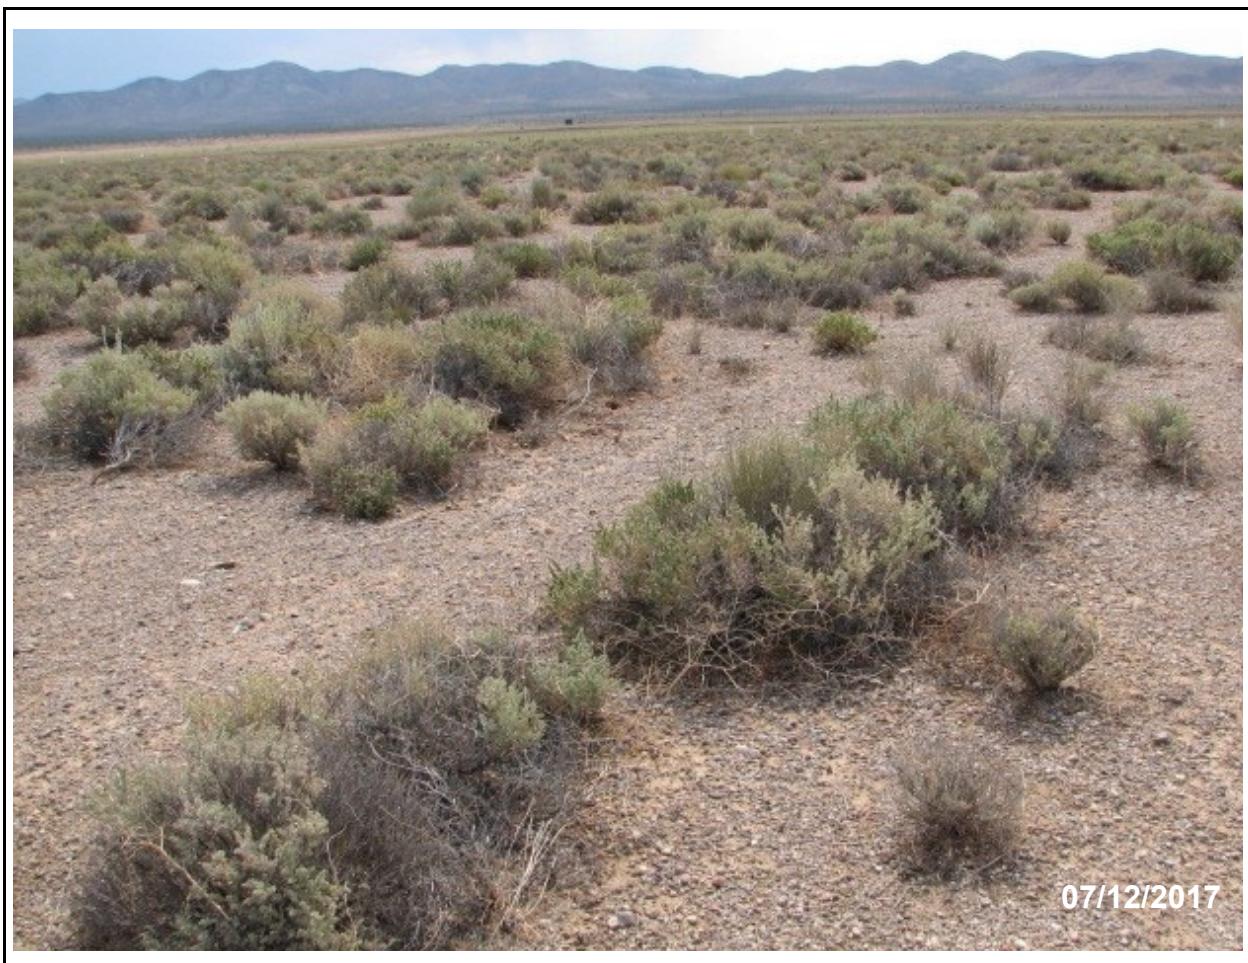
**Figure 4-7**  
**Overview of Plant Community That Has Established on CAU 110**  
**over the Last 17 Years**

Shadscale (*Atriplex confertifolia*) continues to be the most abundant shrub species on the closure cover (Figure 4-7). None of the plants observed showed signs of stress; however, several dead shadscale saltbush plants were noted. Flowering plants were uncommon because of the time of sampling. Current annual growth, evidenced by new leaves and stems, was good. Nevada jointfir (*Ephedra nevadensis*), the second most common perennial species, was also not in flower but showed good growth. The other shrubs occasionally encountered on the closure cover were winterfat (*Krascheninnikovia lanata*) and fourwing saltbush (*Atriplex canescens*), which like the other two shrubs did show signs of significant annual growth and were not flowering. No perennial plant seedlings were seen.

Note: Shadscale saltbush and Nevada jointfir are the two most dominant plants found on the closure cover.

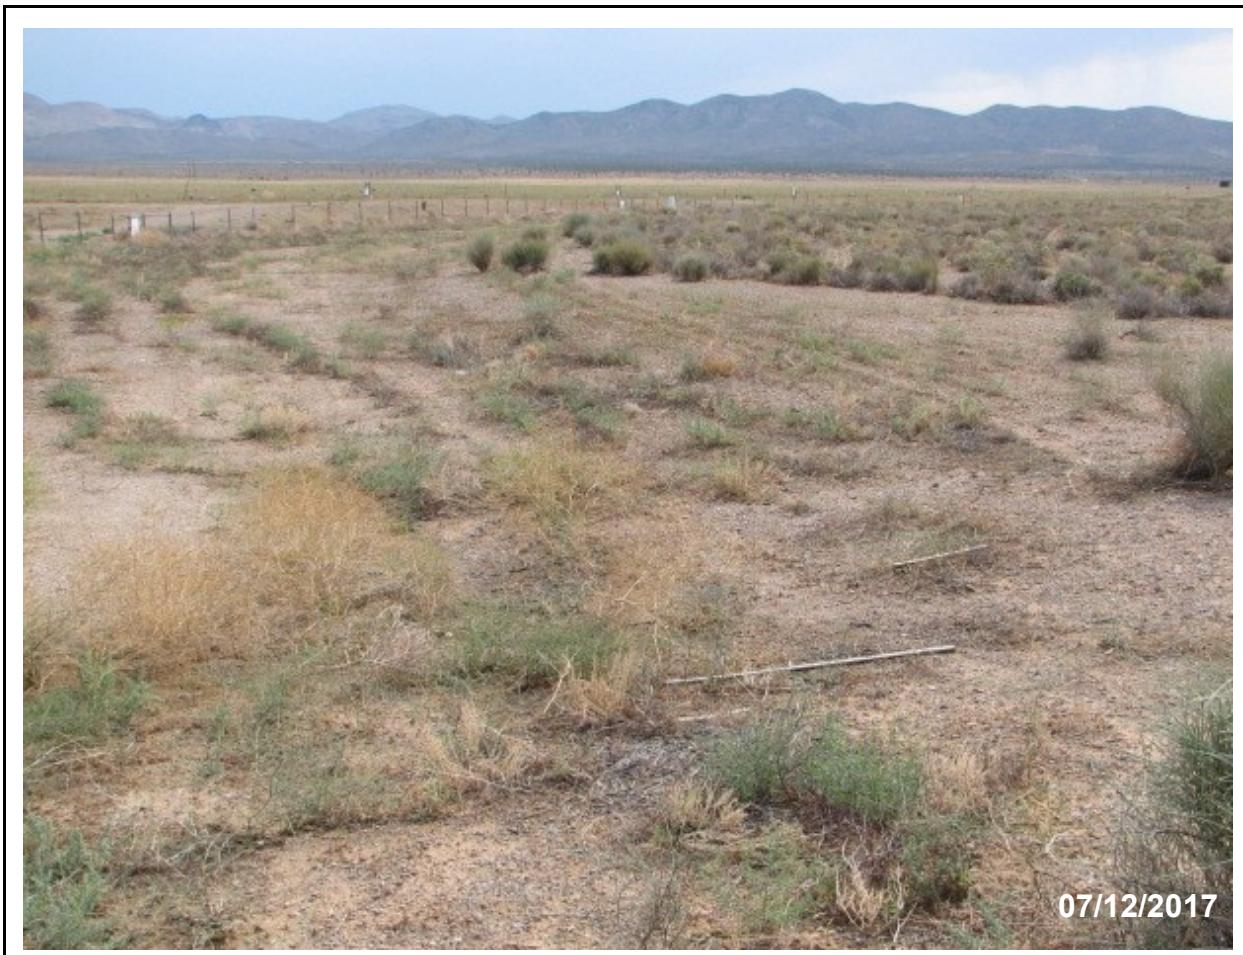
**Figure 4-8**  
**Unseeded Area That Is Occupied by Noxious Weeds (foreground)**

surrounding the cover that was not seeded continues to be covered with noxious weeds (Figure 4-8), which highlights the importance of seeding to establish a perennial plant community.

Note: Cover cap is in the upper right of photo.

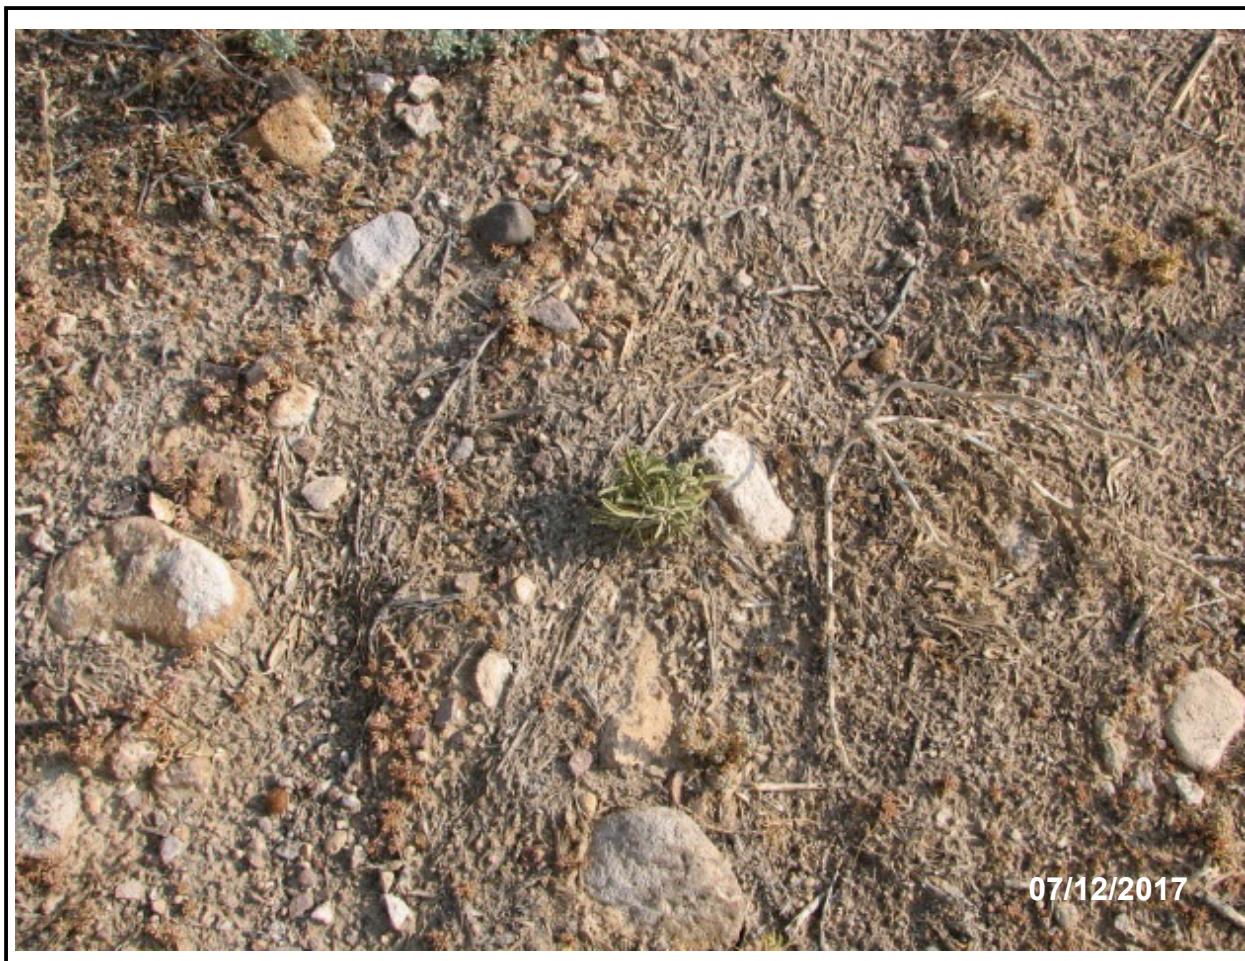
**Figure 5-17**  
**CAU 111 South Cover - Fourwing Saltbush**

Overall, the integrity of the cover caps is very good. Given the abundant precipitation received last fall and winter, it is surprising that weedy plant cover is not higher than it is. No rabbits were

observed, but some rabbit droppings were found on some of the covers. Perennial plant cover is still lacking, and efforts should be made to establish perennial vegetation on the cover caps.

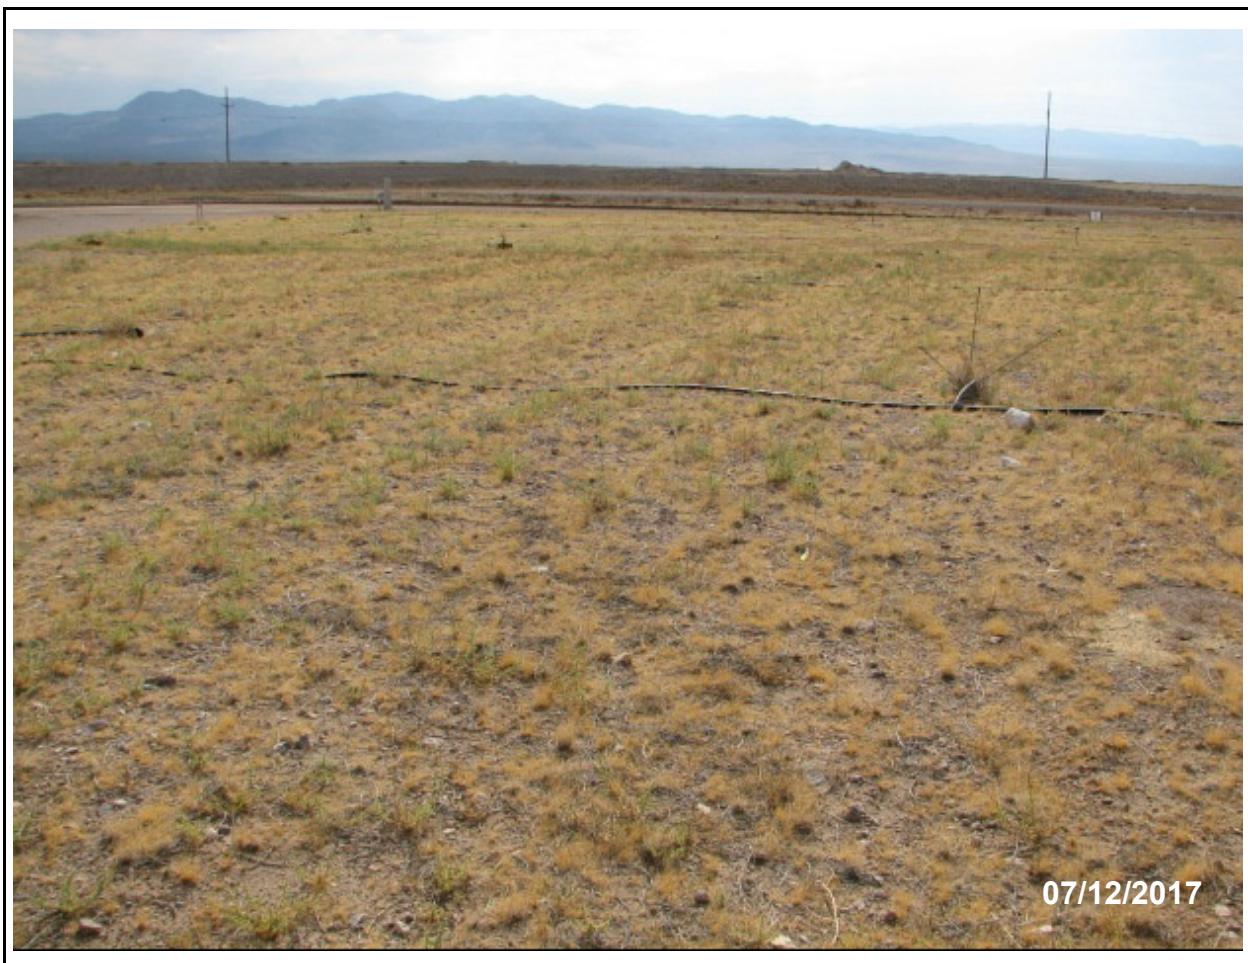
**Figure 5-18**  
**CAU 111 North-North Cover - Weed Species Dominate**

- **North–South Cover**—Weedy species dominate the site predominantly saltlover, Russian thistle, and Arabian schismus. Around 20 mature fourwing saltbush plants were found on the eastern part. A few rodent holes were seen but not a concern. A zebra-tailed lizard (*Callisaurus draconoides*) was observed on site.
- **North–North Cover**—Weedy species dominate the site predominantly saltlover, Russian thistle, and Arabian schismus, with schismus dominating the eastern portion of the cover (Figure 5-18). Rodent holes were found on the site but are not enough of a concern to trap the rodents.
- **West Cover**—Weedy species dominate the site, predominantly saltlover, Russian thistle, and Arabian schismus. A few rodent holes were seen but not a concern.

The revegetation test plot effort of the south–north cover was started on December 4, 2017, and is ongoing. The purpose of the effort is to eventually revegetate the 92-Acre Landfill area with a diversity of healthy native plants that will be sustainable. Field practices follow processes outlined in the *Tribal Revegetation Project, Fieldwork Plan, 92-Acre Area, Area 5 Radioactive Waste Management Complex, Nevada National Security Site, Nevada* (December 2017).
