Center of Wafer Gate Leakage Resulting in Product Yield Loss: A Failure Analysis Perspective

SAND2017-4202D

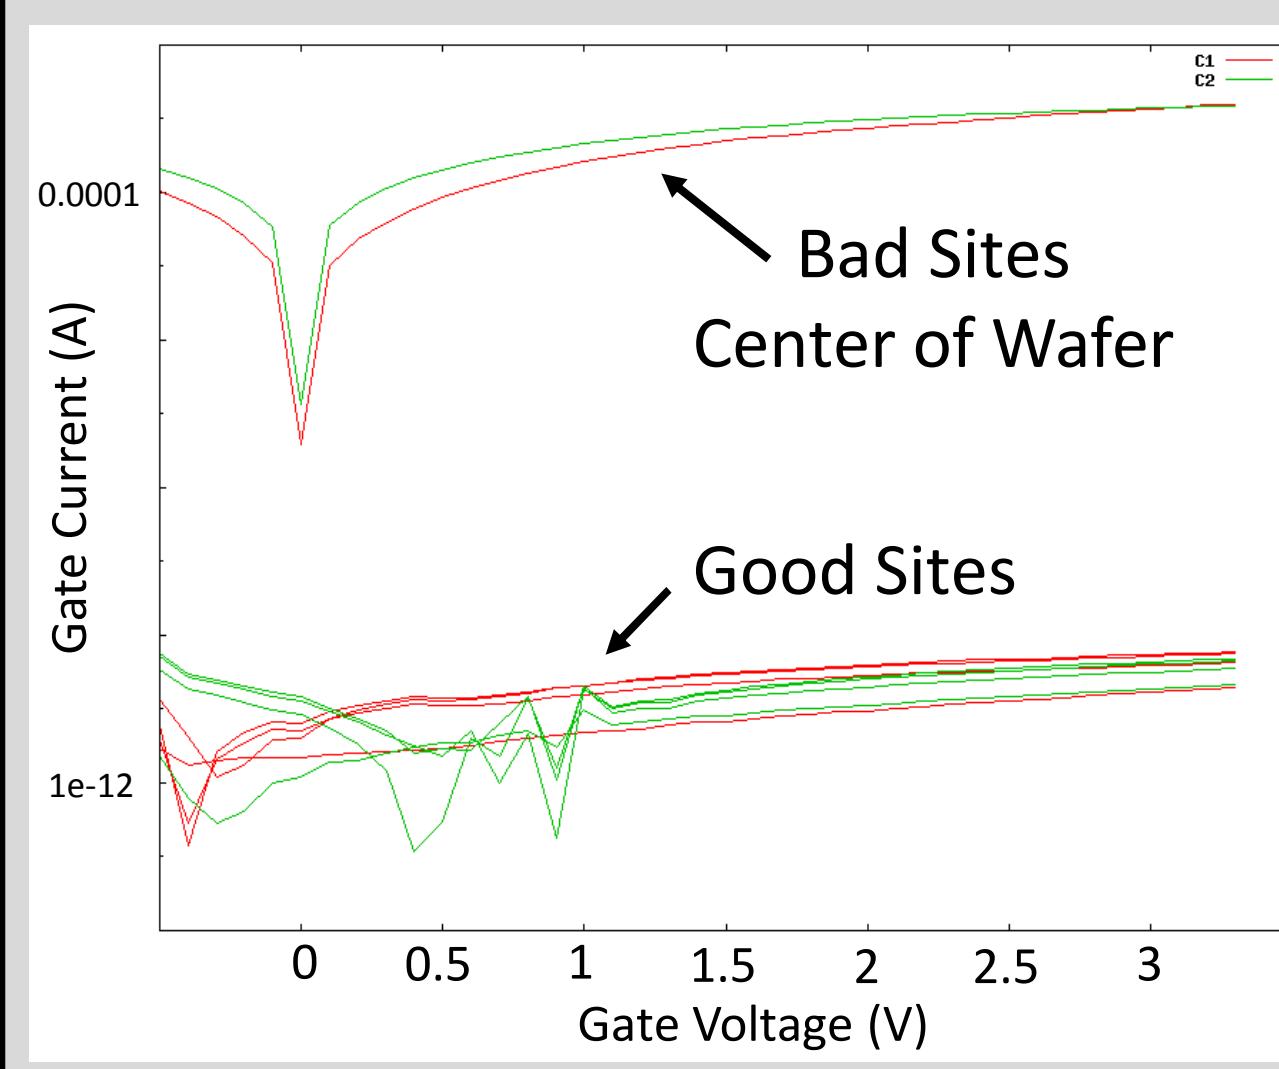
Wafer-level: Discrete Transistor

Data indicates high current at center site ($\sim 10^{-4}$ A at 3V) and at good die sites ($\sim 10^{-10}$ A at 3V).

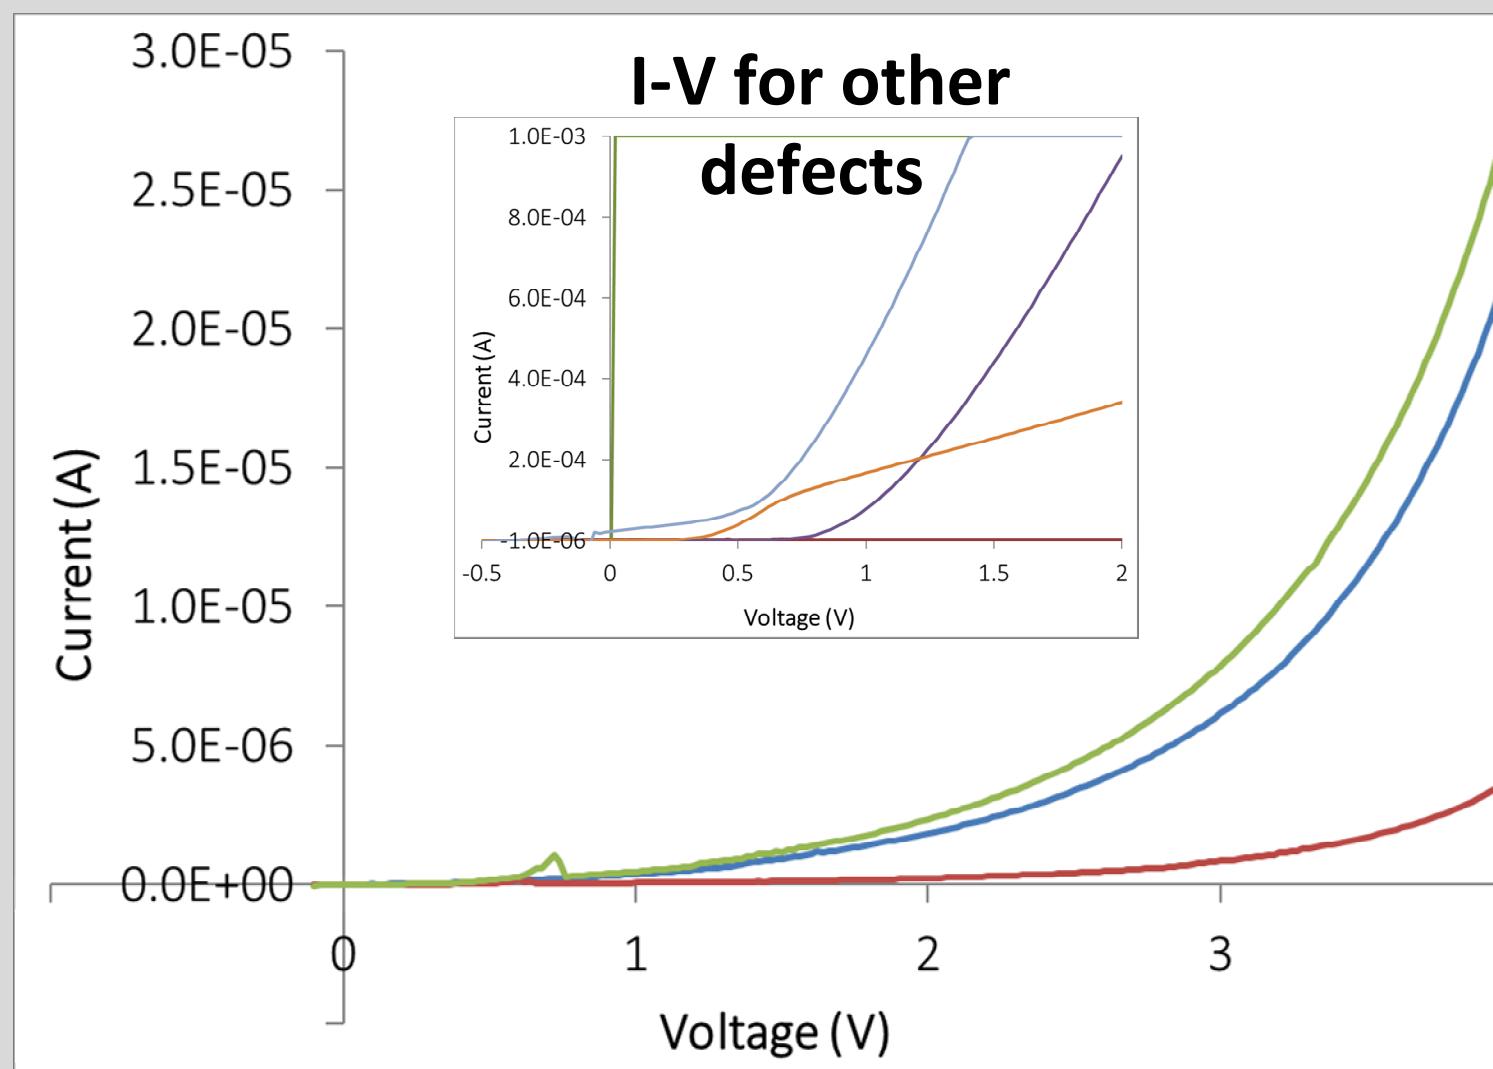
Packaged Eiger Device

Determined characteristic shape of current-voltage sweep: Bad site ($> 10^{-6}$ A @ 3V). Good site ($\sim 10^{-7}$ A @ 3V).

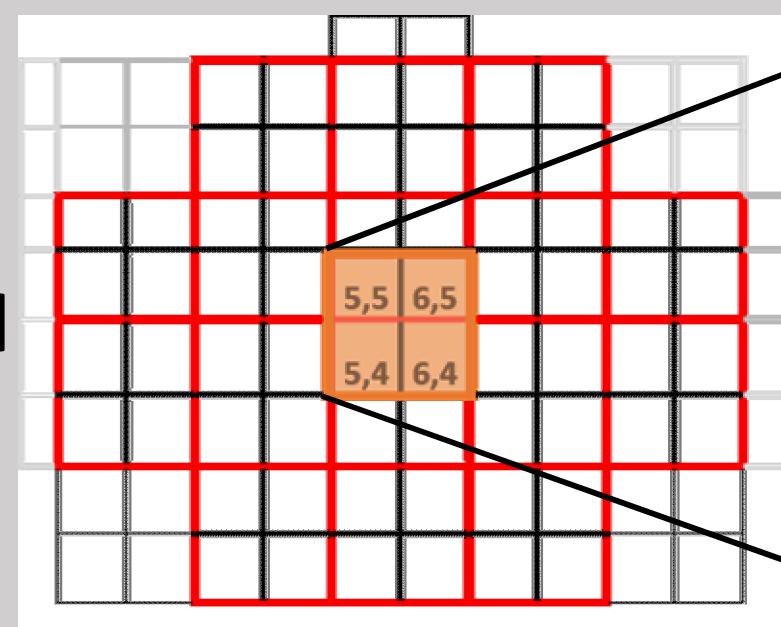
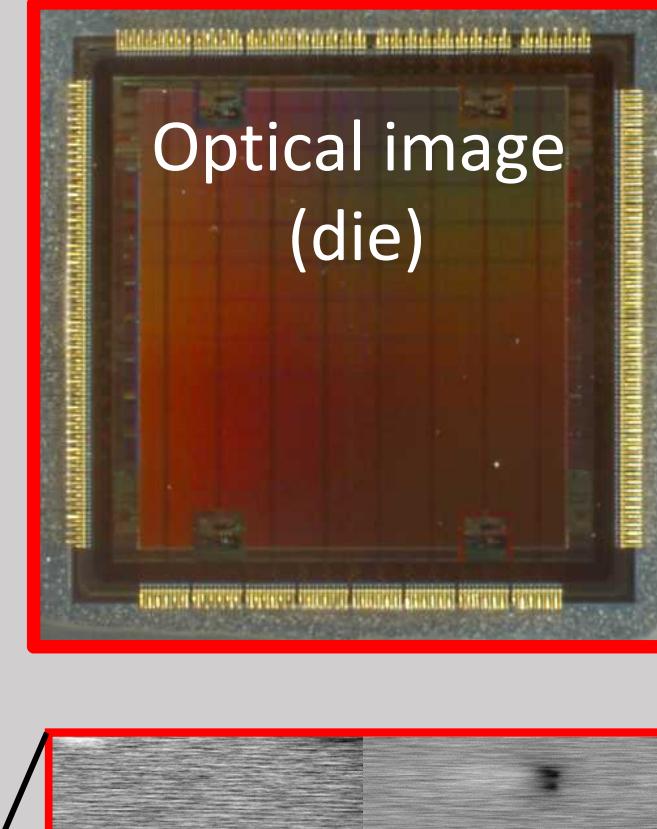
- Laser technique used to localize failure sites (thermally-induced voltage alteration, TIVA)
 - In packaged parts, we determined a characteristic pattern for this failure mode
 - Directional with respect to the center of the wafer
 - Diffuse dark signals

Die layout, kill zone in orange

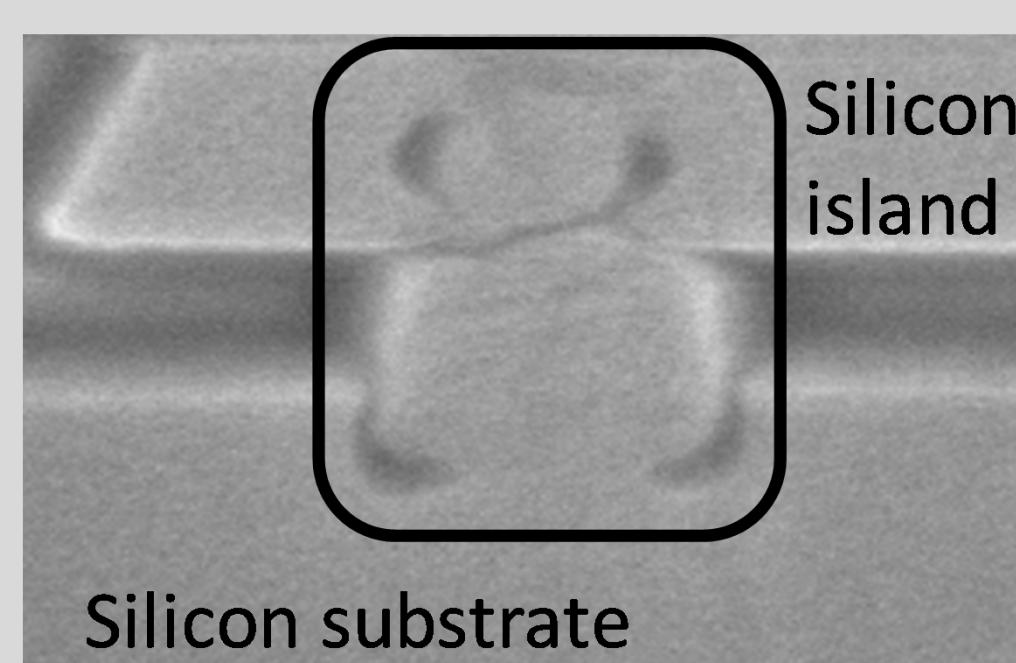
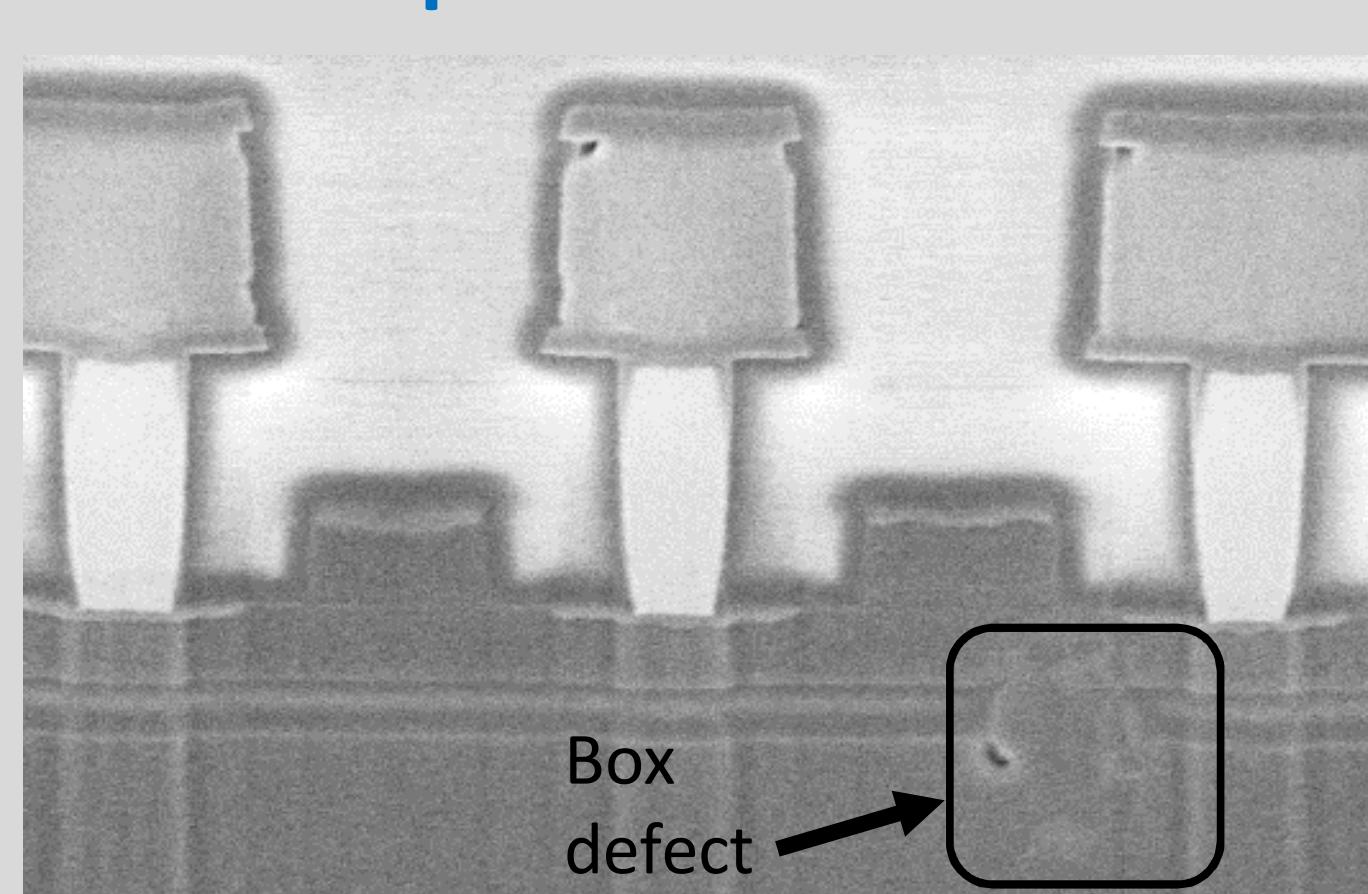
- Ability to cross-section, image and provide chemical analysis at defect location
- Typically utilized after other localization FA techniques
- At wafer level, the leaky transistors had leakage paths to the substrate (Box defects)
 - Transistors without gate leakage also exhibited Box defects
- At package level, we never found macroscopic physical defects

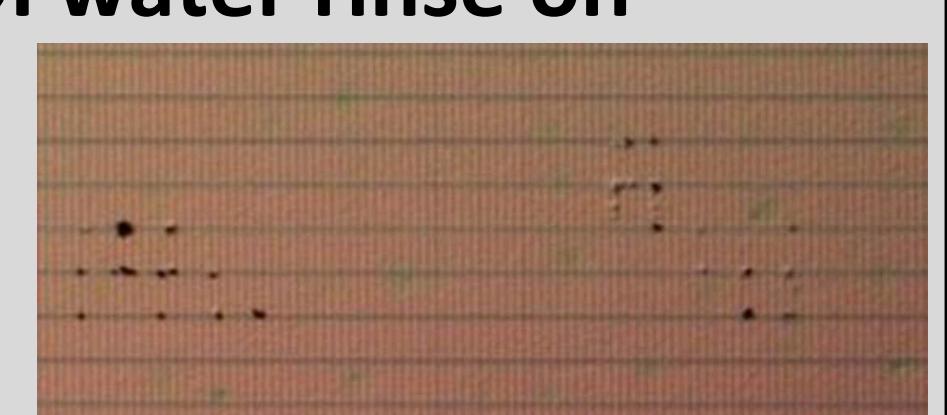
Optical image of 'tetris-like' defects observed on test structure dummies at the center of wafer

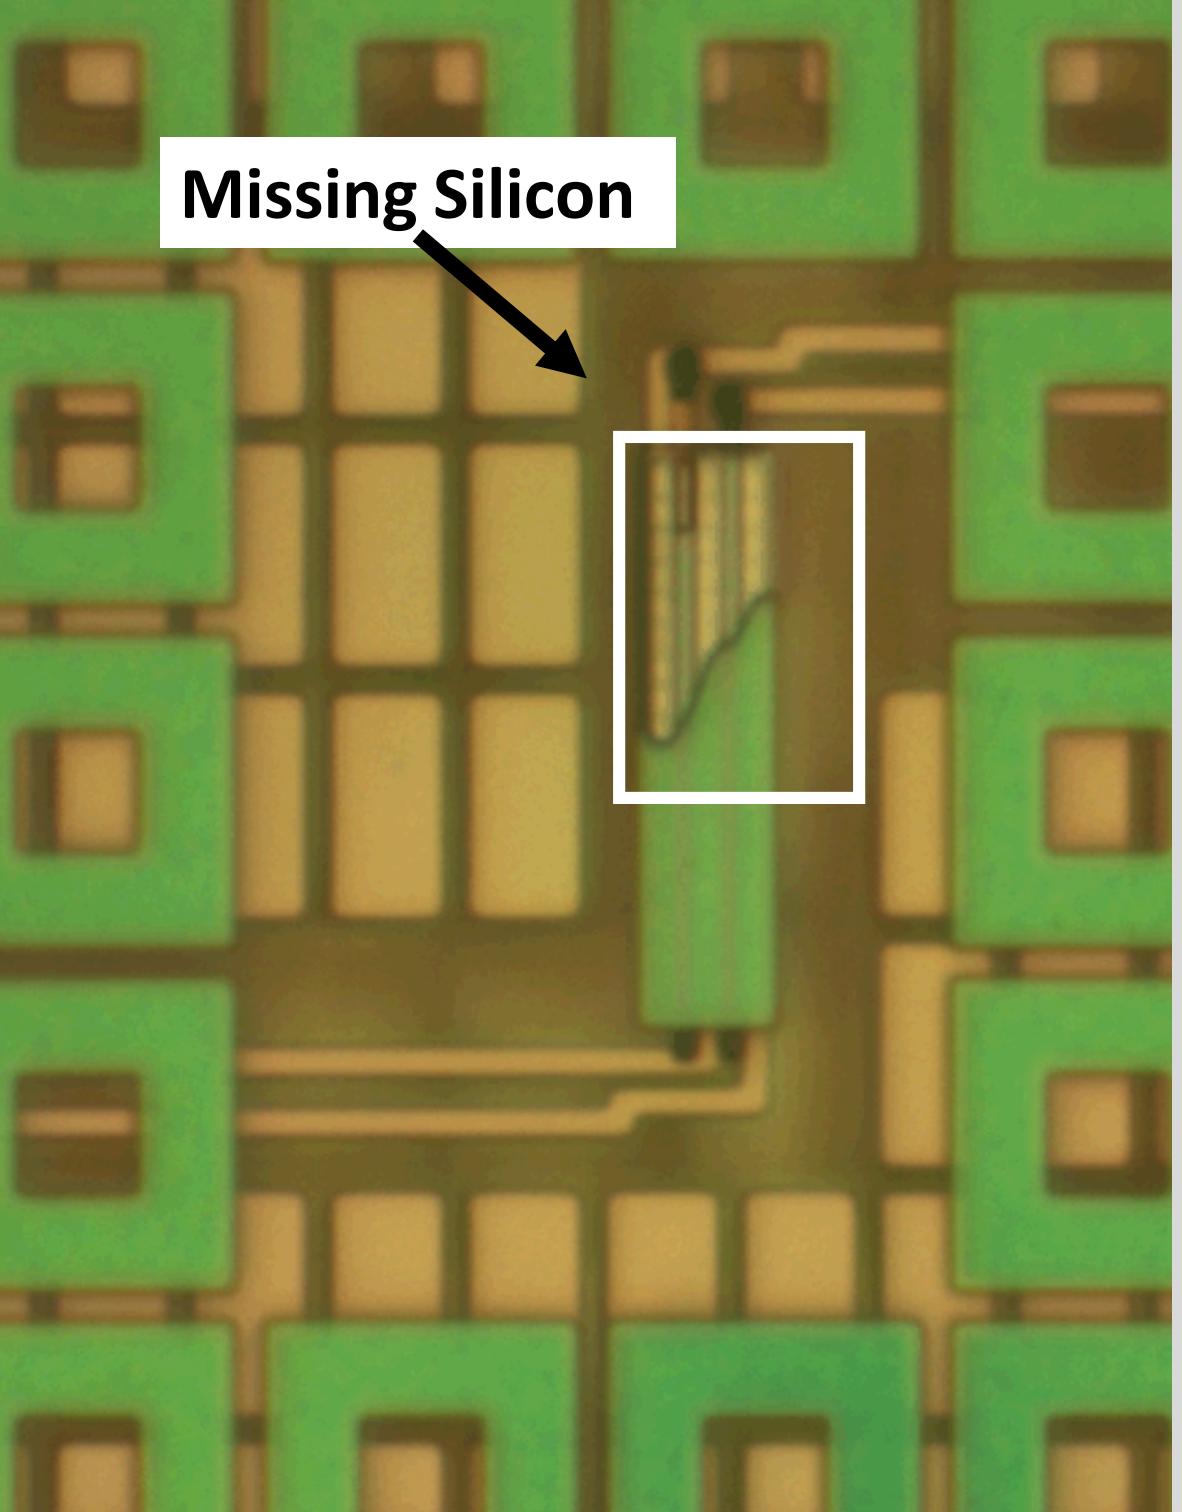
Optical image of a cleaved section from a wafer post thinning

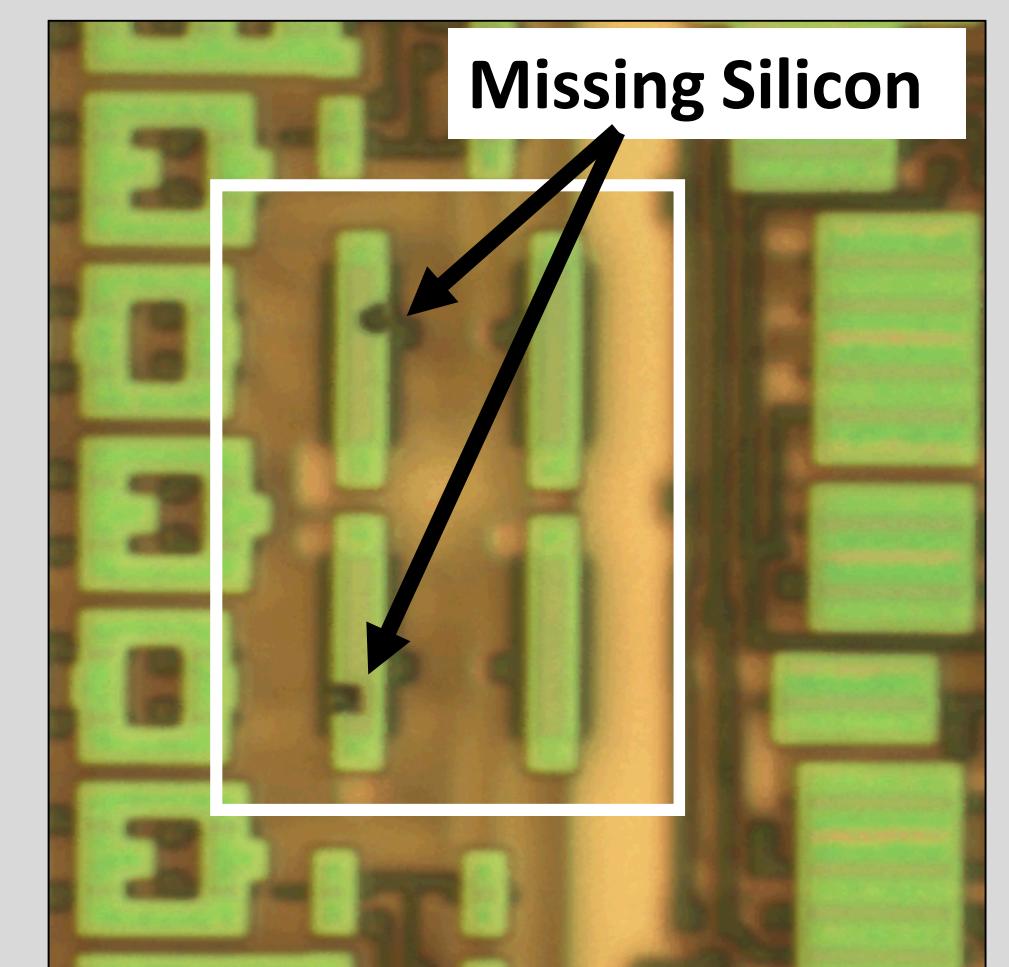
Backside optical image of a single transistor where part of the Si island has been etched away indicating the presence of a Box defect.

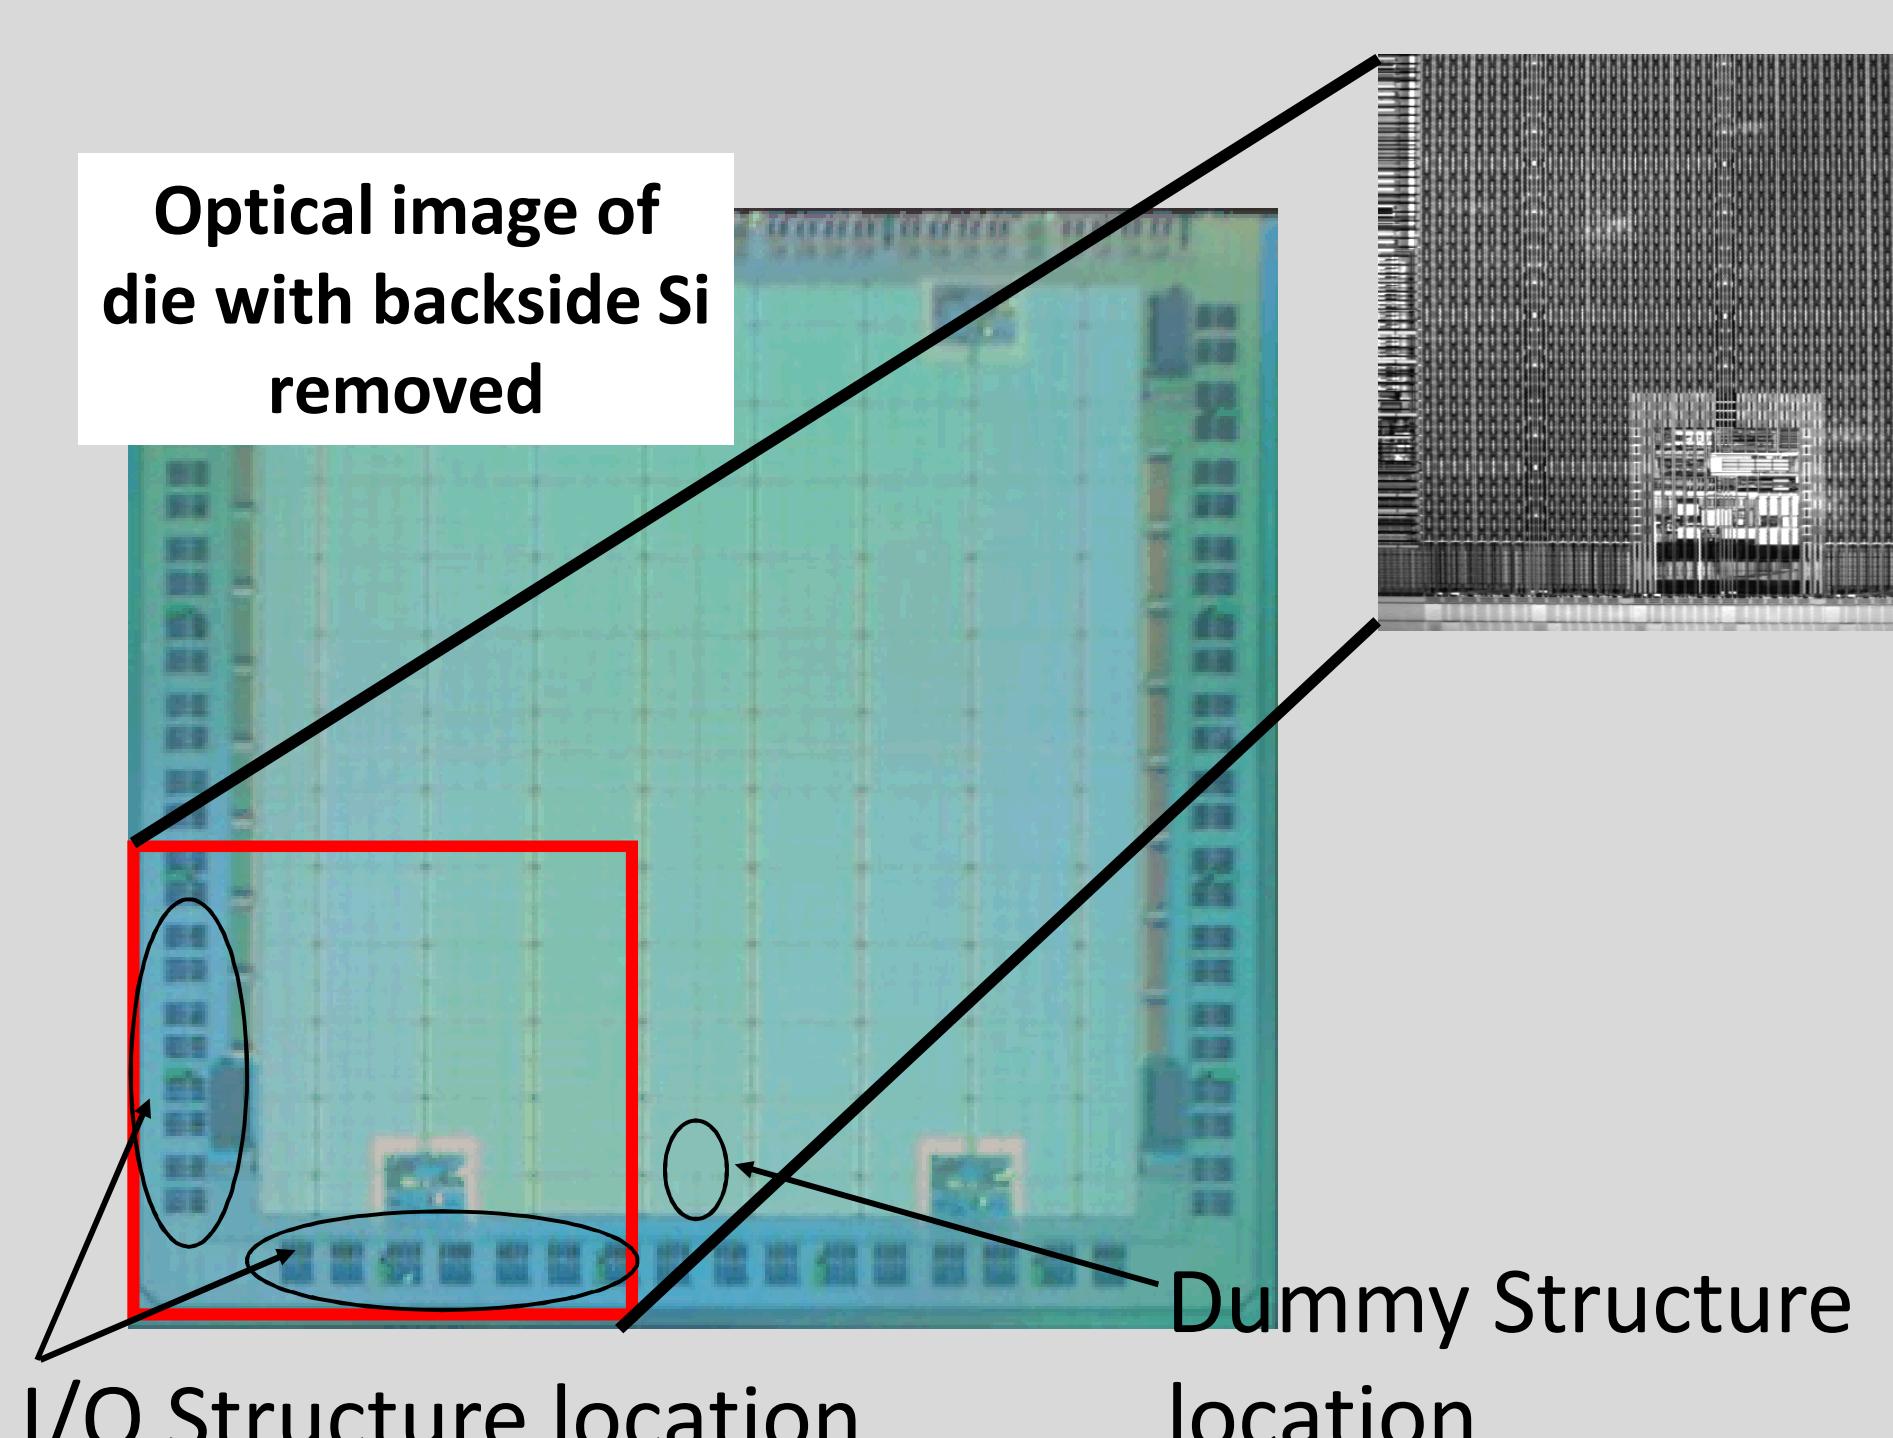
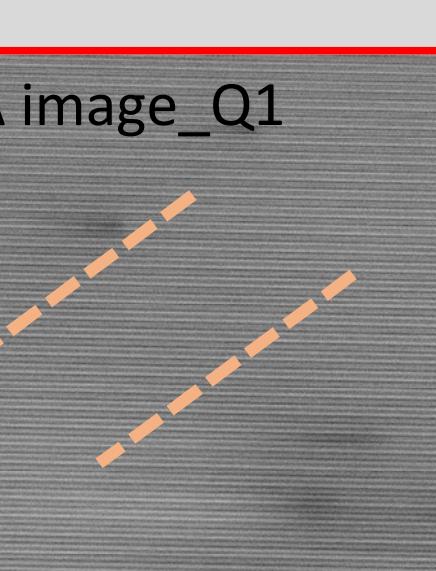
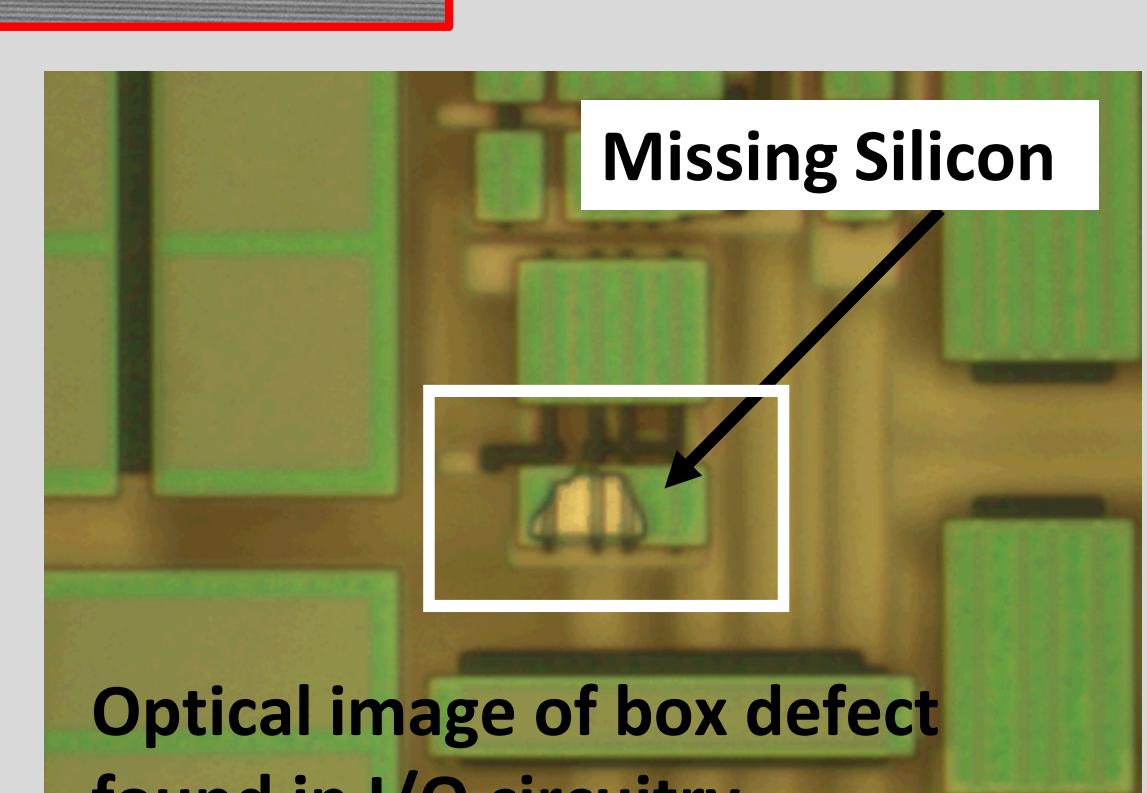
Optical image of Box defects found in dummy structures

- Areas outside of the four center die
- Passing discrete transistors (confirm FIB results)
- Die I/O circuitry that does not influence device leakage
- Dummy structures

Box Defects were not found at the TIVA signal sites (confirmed FIB results) but were found in close by I/O structures and dummy structures.
