Charge-Induced Damage on SOI Wafers: A Case SAND2017-4485C

Mary A. Miller and Darlene M. Udoni
Sandia National Laboratories, Albuquerque, New Mexico, USA
e-mail address: mamill@sandia.gov

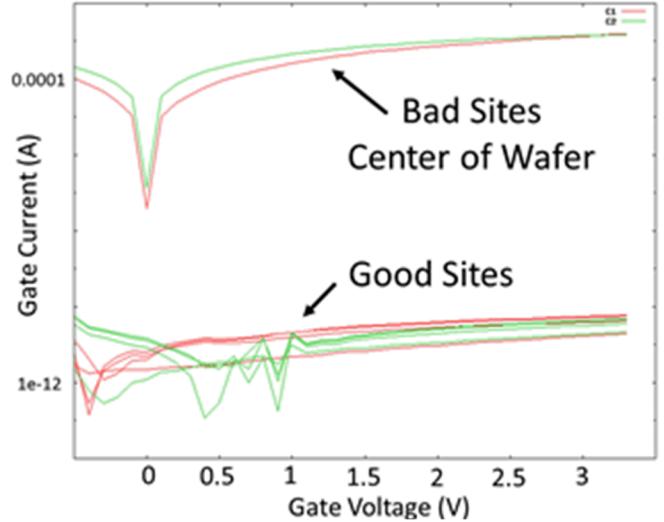
The electrical failure described in this work first manifested as transistor gate leakage evident only in the center of the wafer. The structures would consistently fail at this parametric test site over multiple lots. Die yield did not indicate spatial yield loss at wafer probe, but began to indicate failures once the center dice were packaged. Both wafer-level discrete transistors and packaged ICs were delivered for failure analysis. Transistors which typically measured less than nAs of current measured greater than 1mA at 3.3V. Figure 1 shows current-voltage (I-V) sweeps typical of good and bad sites. For packaged parts, values were dependent on the type of packaged IC but all exhibited leakage-type failures.

Figure 1: Comparison of level of gate current on both good and bad discrete transistors. Both bad sites shown are located at the wafer center.

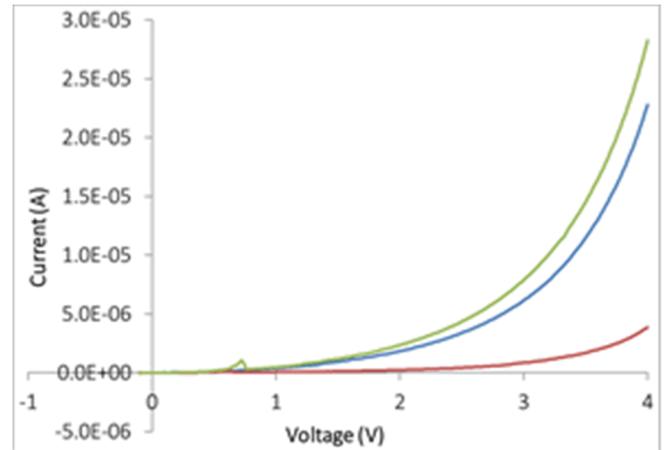
A significant number of packaged failures originating from die that surround the center of wafer were examined. Although optically they indicated no obvious visible damage, a trend emerged in the electrical behavior of the I-V sweep. Figure 2 shows a sampling of a few of the packaged parts. The shape of the curve was very consistent for this type of failure. When compared to other leakage-type failures from the same IC-type, running IV sweeps became an easy screening method to filter out this failure mechanism prior to more destructive analysis of packaged parts (e.g. jet-etch).

Figure 2: Characteristic I-V shape of packaged ICs that failed due to charge-induced damage

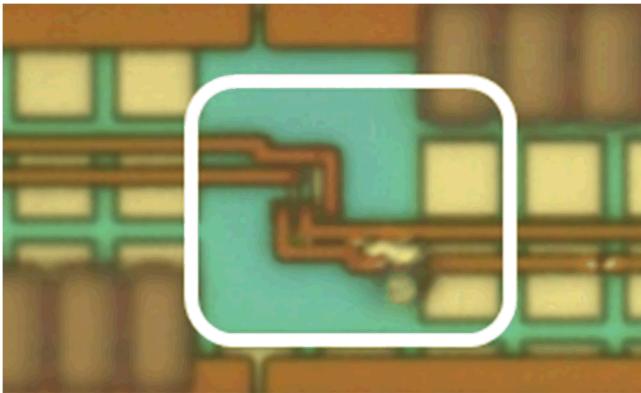
Optical inspection was also carried out on the discrete transistors where damage was observed in some structures. An example is shown in Figure 3. Although the visible damage occurred within the transistor wiring, focused ion beam (FIB) cross-sectional analysis found macroscopic damage also in the transistor itself. At the optical damage site, catastrophic melting of the metal line and cracking was observed but nothing indicating cause of failure. Within the transistor, however, a silicon filament electrically shorting the island through the buried oxide layer to the Si substrate was observed. For this work, this type of defect is referred to as a Box defect and an example is shown in Figure 4.

Figure 3: Optical image of cracking and melting around one of the wires leading to the discrete transistor

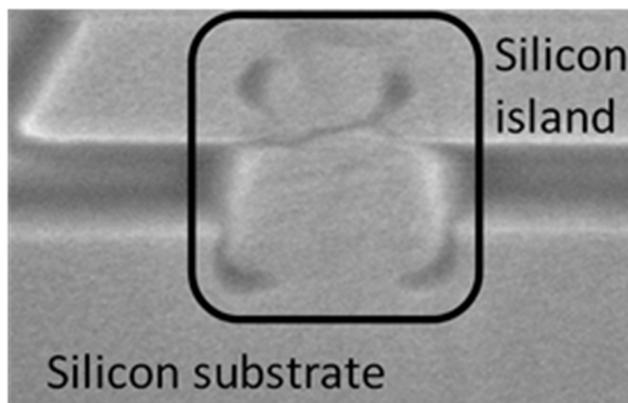
Figure 4: FIB / scanning electron microscopy (SEM) image showing a Si filament extending from the island to the silicon substrate

Although it was not yet determined whether the Box defect was causal or symptomatic of catastrophic charge-induced damage, it was necessary to determine spatial extent of damage. Individual FIB cross-sections were time consuming and only provide information on a small area of the wafer. It was understood that the center dice were not yielding and the center test structures were failing, but the step size of the die and the test structures were such that that affected area could not be accurately determined. To better understand scope of the affected area, the Si substrate was lapped and chemically etched (XeF_2) away. Optical analysis could then be performed from the backside over a large area of a wafer. The Box defects provided a Si pathway through the Box layer such that the chemical etch attacked the islands where Box defects were present. Subsequently the images shown in Figure 5 are not the Box defects themselves but rather chemically-highlighted islands where the Box defects once were. The large-scale affected zone of the wafer could be mapped out in this way.

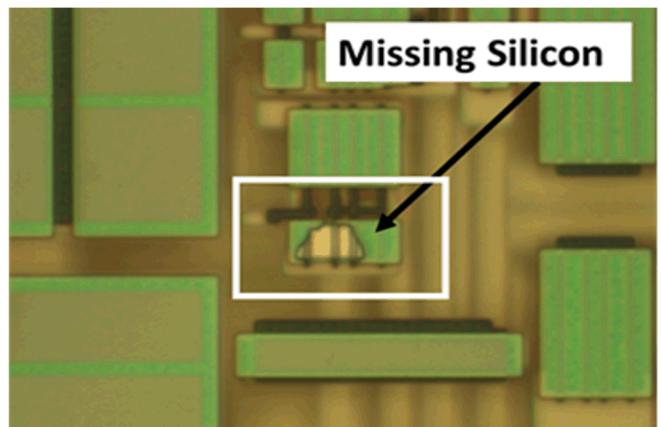
Figure 5: Optical image through the backside of the wafer with the substrate silicon chemically removed. The missing silicon within the island indicates that this structure had a Box defect that provided a physical pathway through which the XeF_2 penetrated the Box layer and attacked the island silicon.

This process was applied to both the wafers to understand affected area as well as the packaged parts to understand whether the Box defects themselves proved to be the cause of the electrical leakage. However, in the packaged parts, the Box defects showed up primarily in no connect circuitry, dummies and in areas that wouldn't necessarily lead to leakage of the device. They were not present in the array of the device. It was determined that the Box defects were symptomatic of this type of failure mechanism but not causal.

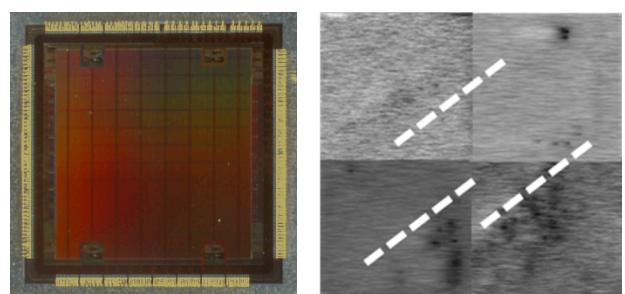
Packaged parts were also examined extensively with thermally-induced voltage alteration (TIVA) to pinpoint cause of leakage. Multiple dark diffuse defect signals were apparent in the TIVA images. Figure 6 shows an optical image of the IC and four stitched images that make up the TIVA mapping of the part. Under high magnification, the TIVA signals maintained a soft, diffuse edge, not necessarily indicating a particular transistor or similar structure. The signals also had a directionality to them. In Figure 6, white dashed guide lines indicate the directionality of the signals. This direction was consistent for the die location. Figure 7 shows how the direction of the defect signals changes with die location. The die shown in Figure 6 was positioned in the bottom right corner of the graphic. This type of TIVA signal, both in pattern and direction, proved to be very characteristic of IC charge-induced damage on the SOI wafers.

Figure 6: Characteristic TIVA map (1340nm) of packaged IC indicating a dark, diffuse, directional pattern to the TIVA signals.

More than one FIB cross section of the diffuse dark TIVA signals did not reveal any macroscopic physical defects at any of the sites. It is suspected that gate oxide failures were the cause of the signals. Gate oxide failures are not easily imaged with FIB/SEM resolution.

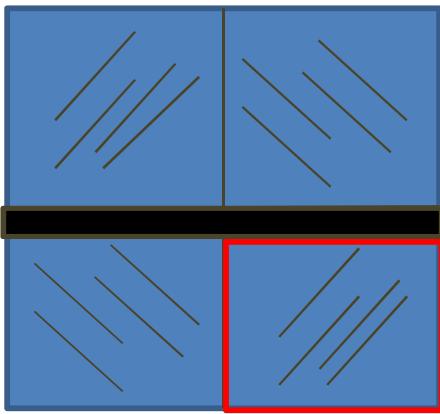
Figure 7: Schematic showing the direction of the dark, diffuse TIVA signals with respect to die location around the center of the wafer. The die shown in Fig. 6 is indicated by the red box.
