Radiation Effects on Teflon Wires

LeRoy Whinnery, Alexis Abelow, Wei-Yang Lu, Karla Reyes, Donald Ward, Dustin Murtagh, Zachary Meinelt, Nathalie Le Galloudec, Al Ver Berkmoes, Raymond Friddle

Problem

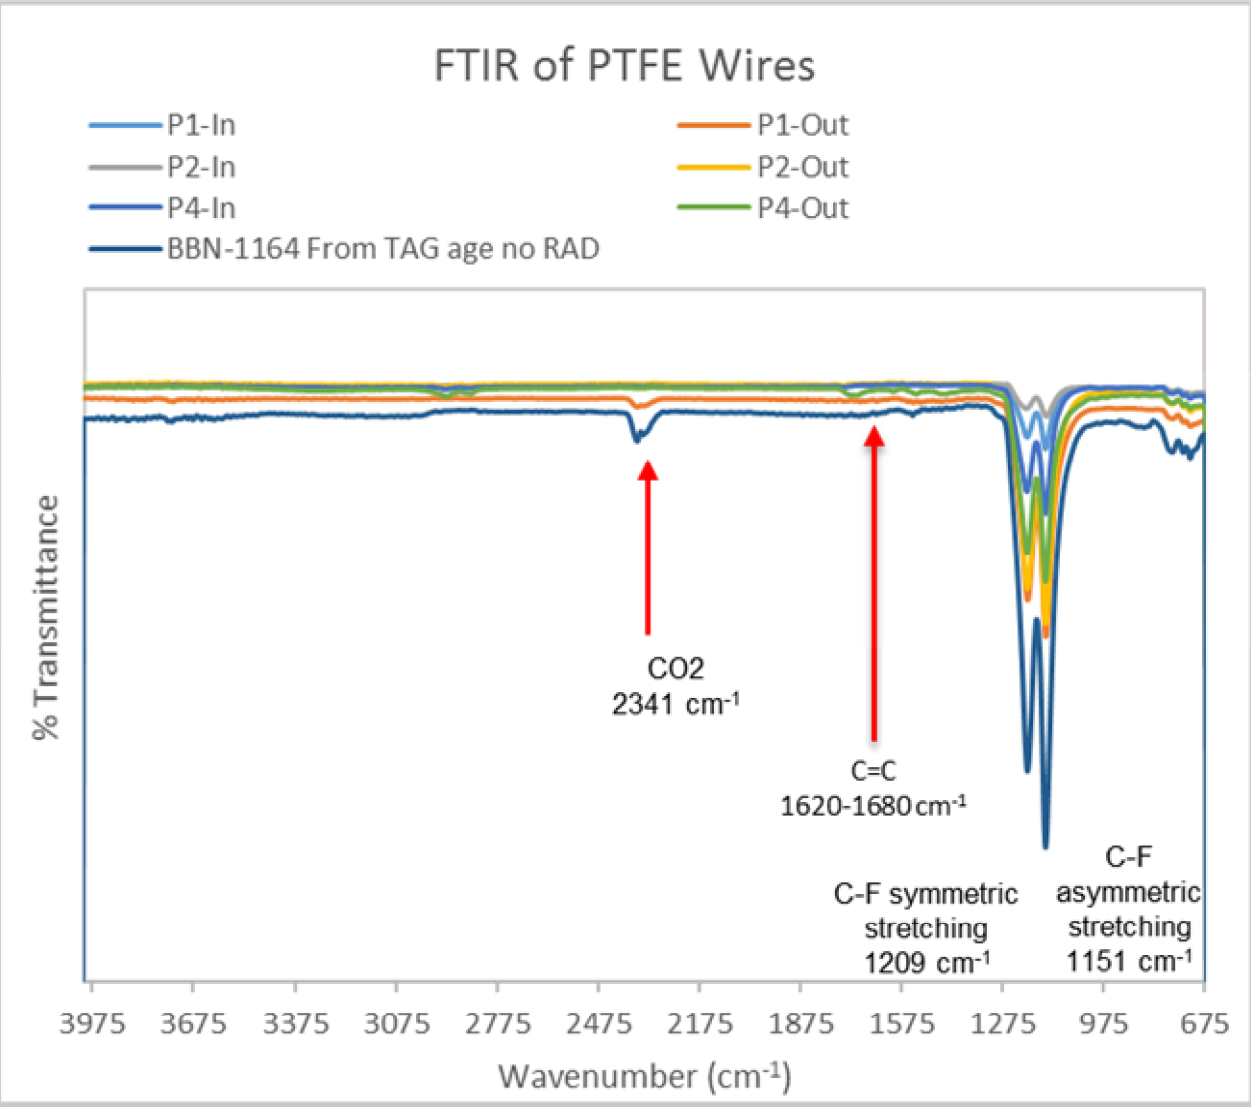
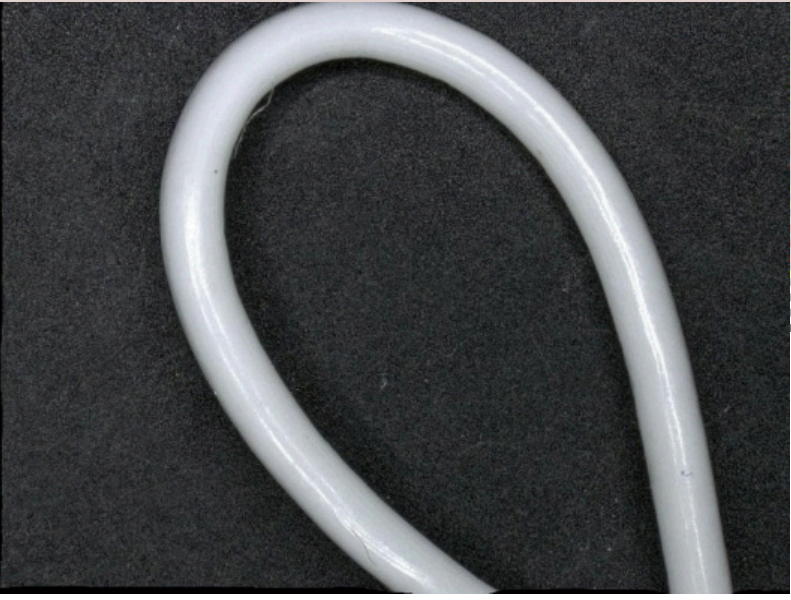
Radiation Damage Mechanism

The mechanism of Teflon degradation by radiation has been well studied. No C=C peaks observed in FTIR

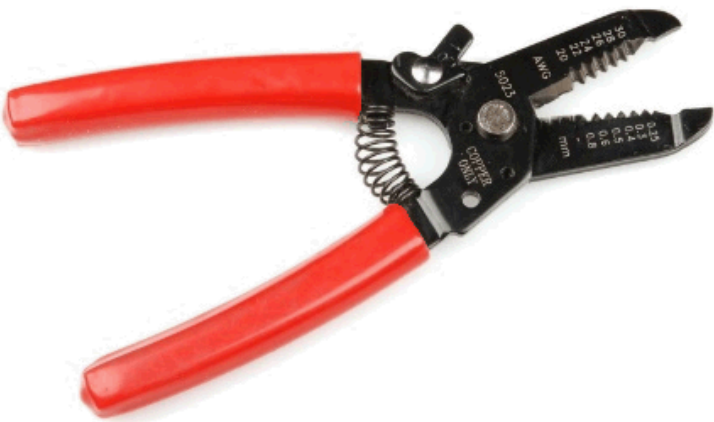
Conductor removal for tensile testing -a possible source of variability (flaws)

- Wire strippers were used to remove a small amount of insulation.
- Pliers were then used to grab the copper conductors.
- Sliding my grip down the wire many times allowed it to slowly release from the insulation and be removed.
- Gloves helped with gripping the Teflon.
- Care was taken to not pull too hard or too fast.
