Failure Analysis and Process Verification of High Density Copper ICs Used in Multi-Chip Modules (MCM)

Sandia National Laboratories, Albuquerque, NM, USA

Abstract

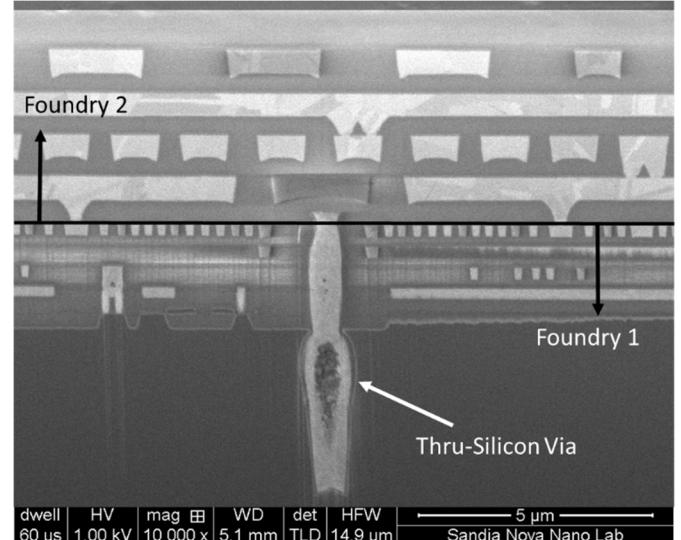
Fig. 1. FIB cross-section showing the boundary between the two foundries' processing.

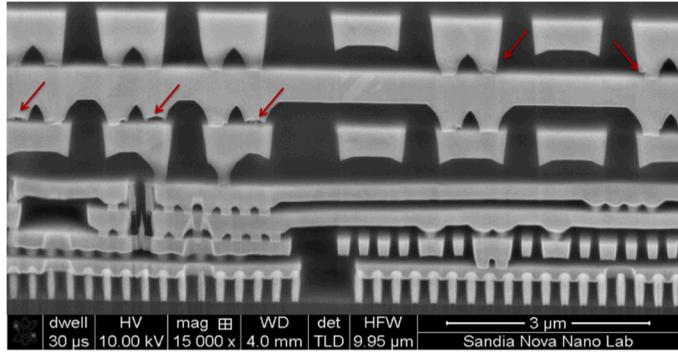
Each die contains several common V_{dd} , Gnd, and signal pads. These functions are interconnected within a tile and between tiles. In the center of the wafer, common power and ground pins failed open. Time Domain Reflectometry (TDR) was used to determine the relative distance of the open failure from the test point. In this test, TDR contacts were placed on a calibration standard to establish a continuity baseline. The TDR probes were raised off the calibration standard to obtain an open state at the probes. Six test pads with known open failures were tested. A fast rise time was observed on these six test pads indicating an open circuit failure. Using a velocity factor of 0.4 [8], the distance from the test pad to the open failure measured approximately 1.5 mm. These results were presented to the design engineers where circuits of interest matching that distance from the test pads were identified and selected for guided FIB cross-sectional analysis. As shown in Fig. 4, numerous metal-via issues were observed in M5/M6 and M6/M7 interconnect sites. These vias were identified as being partially or completely open. EDS analysis of M5/M6 and M6/M7 vias shown in Fig. 5 revealed a tantalum liner conforming to the partial and incomplete via profile. This indicates the partial and incomplete via issues occurred prior to tantalum liner deposition. Identification of partial and completely open vias from guided FIB cross-sectioning showed the via/metal defects are present in significant quantity. These findings were sufficient for the manufacturer to move forward with corrective actions and did not warrant further investigation. Possible causes for this failure include; residual and/or marginal resist fill during trench patterning, damage to the SiN or top of the previous copper layer, or SiN punch-thru causing copper oxidation.

Fig. 4. FIB cross-sectional analysis revealed partial and incomplete vias between M5/M6, and M6/M7.

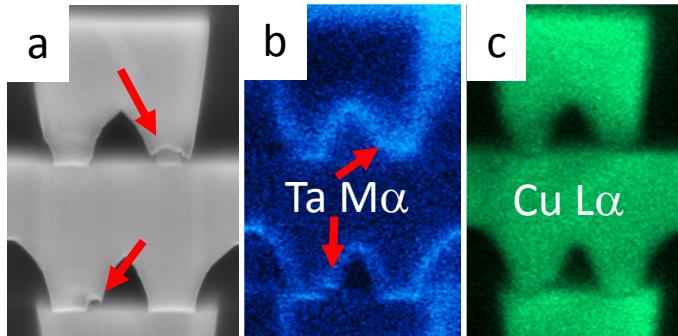
Fig. 5. a) SEM image of M5/M6 and M6/M7 vias. b) EDS map of Tantalum liner $M\alpha$ x-ray and, c) Copper La x-ray.

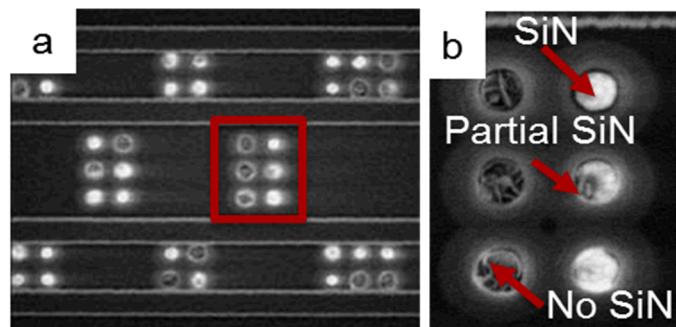
M7/M8 via/metal interfaces. Results from these short loop experiments showed SiN was fully and partially removed after a post-etch high temperature ash process. As shown in Fig. 6, bright contrast spots at the bottom of the vias indicate the SiN etch-stop layer is intact. Vias with bright and dark contrast show partially intact SiN. Vias with dark contrast show SiN has been completely removed. In vias missing SiN, crystalline features are observed at the bottom of every. These results are shown in Fig. 6b. Cross-sectional analysis of an open via verified the SEM results and is shown in Fig. 7. The crystalline features were identified as copper oxide occurring at the via/metal interface. SiN punch-thru exposed the underlying copper layer to a high temperature ash process resulting in oxidation of the copper at the damage site. This copper oxide prevented the tantalum liner from contacting the underlying copper layer.

Fig. 6. Plan-view SEM images of vias with SiN, partially missing SiN and no SiN a) low mag., and b) high mag after high temperature ash processing.

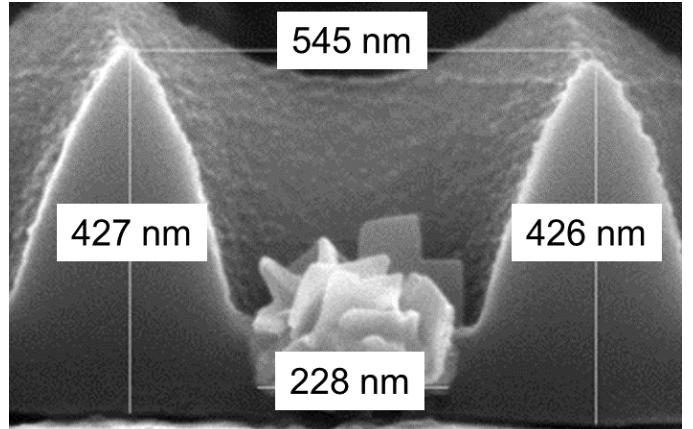
Fig. 7. FIB cross-section showing recrystallized copper oxide (CuO) at the bottom of a via.

Based on initial FA results and short loop findings, corrective actions were developed and implemented to prevent open failures. By increasing the thickness of the SiN layer, damage and/or punch-thru failures resulting in copper oxidation were eliminated. These results are shown in Fig. 8. In addition to the SiN layer corrective action, the via-metal dual damascene stack and etch processes were modified to improve sidewall conformity. A two-stage oxide etch process was implemented to selectively land on the SiN. This corrective action enables better, high-temperature ash processes for photoresist removal to be used. A mid-layer SiN etch stop was also implemented to prevent the vias from flaring. Newly fabricated vias have much less side wall tapering and no CuO build-up indicating the corrective actions resolved the root cause of open via failures.

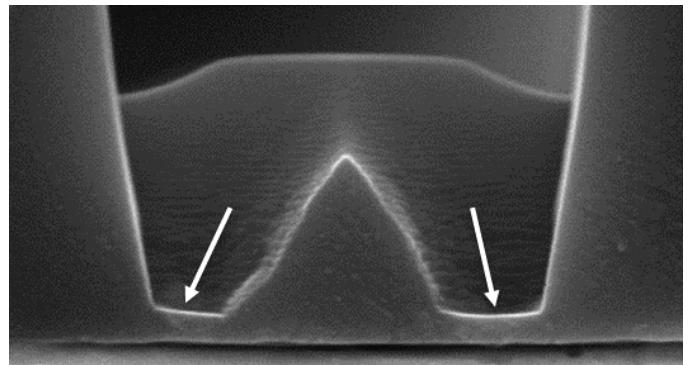
Fig. 8. FIB cross-section of a via post thicker SiN deposition. No copper oxidation is observed.

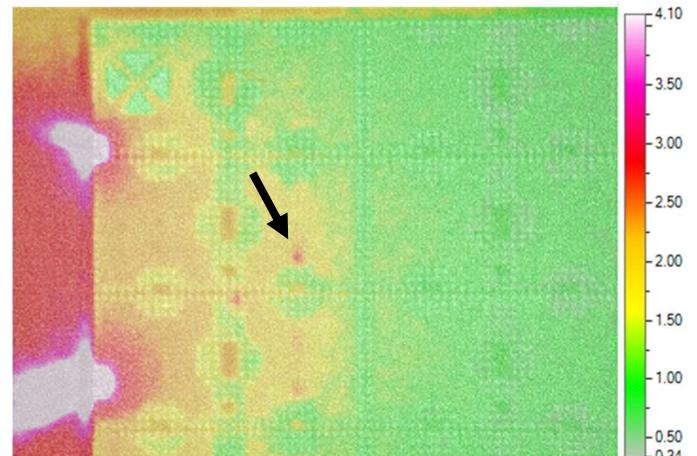
The high copper density of this die effectively acted as a heat sink, dispersing much of the thermal signature during lock-in thermography. Initial lock-in thermal analyses taken at 100 mV and 30 mA showed significant heating across a very large area in the die. This sample was probed between power and ground on two separate tiles. A large thermal bloom spanning 3 tiles (6 mm) is shown in Fig. 9. The hottest spot (noted by the arrow in Fig. 9) was selected for cross-sectional analysis. Results (not shown) did not reveal any defects or shorted lines. Thermal images were taken on several failed dice using the same probe configuration. In each instance, the thermal signatures varied die to die with hot spots in different locations.

Fig. 9. Lock-in thermal image of a power/ground short taken at 100 mV and 30 mA.

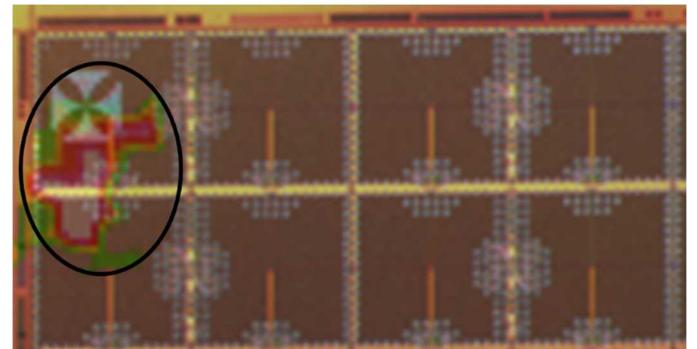
Efforts to perform backside lock-in thermography at wafer level produced similar results. Thermal blooms like those from the front side were observed. Backside thermal images helped narrow the location of the defect but did not contain any fiducials for alignment. Manual alignment of a back-side thermal image with a top side image revealed an area $\sim 2 \text{ mm}^2$ spanning two tiles (Fig. 10).

Fig. 10. Back-side lock-in thermal image aligned to a front side optical image shows a region of interest spanning 2 tiles.

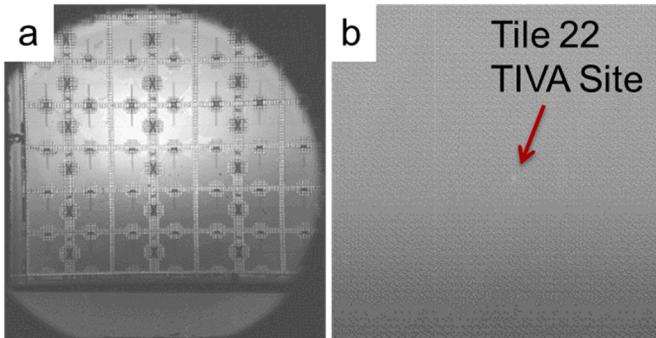
were probed in 3 separate tiles. Each time, the TIVA signal from each test occurred in the same location. This TIVA site is observed in tile 9 is shown in Fig. 11. Multiple signals were shorted to power and ground. Probing revealed TIVA sites in tile 9, same location. This failure has compromised multiple copper lines. High magnification of the power to ground short using elevated laser power and device stimulus revealed a TIVA signal near a bank of test pads (Fig. 12).

Fig. 11. a) reflected light image of a failed device, b) a TIVA site located in tile 22, ~ 6 mm from the stimulus site.

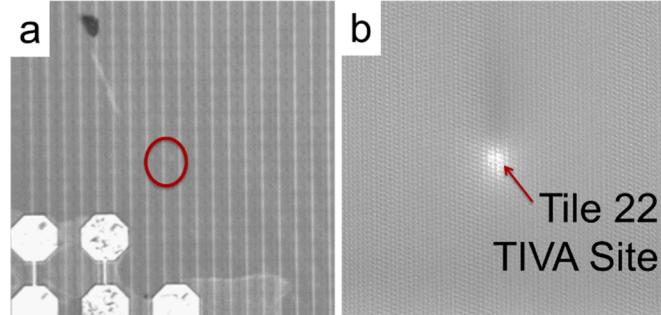
Fig. 12. a) reflected light image of the suspect site in tile 22, b) TIVA image located ~ 240 μ m north of a test pad.

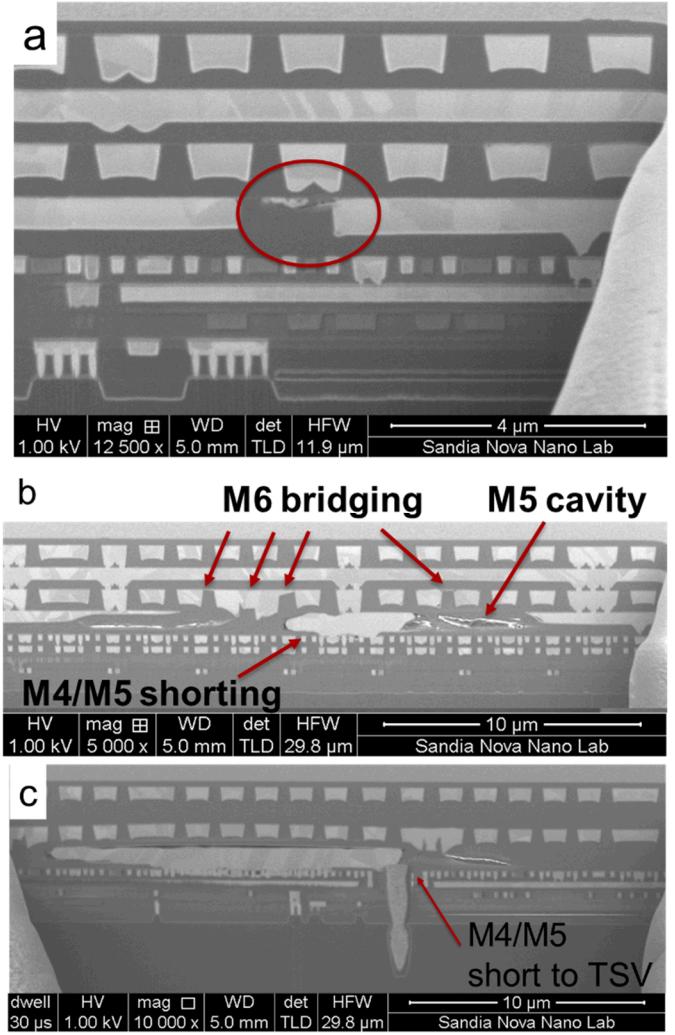
FIB cross-sectional analysis performed at the TIVA site is shown in Fig. 12. Initial findings revealed thickness variations in M5, dielectric cracking, and cavities in the inter level dielectric (ILD). Fig. 13a shows thinning at M5 (circle) at the beginning of the TIVA signal. Comparing this region to the design reveals M5 should have extended to the end of the metal line with the fabricated M5 thickness of $\sim 600 \text{ nm}$. In addition, the FIB cross-section shows M5 thickness variation of 90 nm or 15% of the nominal M5 thickness. In Fig. 13b, a cross-section taken 3 μm further into the sample (from 13a) shows a copper globule forming at M5. In addition to the copper globule, the dielectric above M4 appears to be missing allowing this defect to bridges multiple M4 lines. Other defects include lateral M5 bridging, copper pooling causing M6 bridging and in one instance, shorting to a TSV. These findings explain why under multiple shorts across multiple signal lines were observed in the same area.

In addition to the dense metallization, the large copper globule (10 μ m – 20 μ m) acted as another heat sink requiring more laser power and drive current to stimulate the defect. The root cause of this failure was attributed to a backside wafer roughening step. Two issues contributing to this failure are: a) back-side roughening process adding particles to the device surface, and b) damage to the capping layer introduced by particles or use of a vacuum chuck. After foundry 1 completes M4 processing, a 35 nm SiN protective cap is blanket deposited on the wafer prior to shipping. Upon receipt at foundry 2, the wafers were cleaned and placed device side down on a vacuum chuck for backside roughening. The placement of wafers device side down damaged the SiN film resulting in exposure of M4. Particle contamination introduced from back side roughening further exasperated this problem. To address this issue, foundry 1 modified their protective stack (35nm SiN) to 70nm SiN/300nm SiO₂/100nm SiN. Foundry 2 removed the vacuum chuck in favor of a perimeter contact holder for backside roughening. Implementing these corrective actions reduced the number of particles and defects.

Fig. 13. FIB cross-sections a) near the beginning of the TIVA signal reveals thickness variations and damage in M5, b) 3 μ m further into the sample shows an M5 copper globule bridging M4, M5 and M6 traces, and c) M4/M5 short to a TSV.

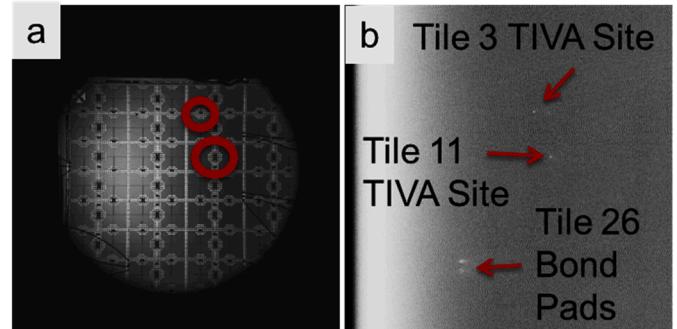
TIVA analysis of another die using elevated drive current and laser power revealed two TIVA signals located in tiles 3 and 11. These two TIVA signals shown in Fig. 14 were observed when power and ground were probed in tiles 15 and 26 respectively. Other signal pads probed to ground produced one TIVA signal at the same location as the power/ground signal produced in tile 11. These individual TIVA signals are shown in Fig. 15. The TIVA signal in 15b only occurs during power/ground probing. The TIVA signal in tile 11 (15b) appears stronger in the upper left portion of the test pad. FIB cross-sectional analysis of the TIVA site in tile 11 (15d) revealed a similar copper globule as

Fig. 14. a) reflected light image with circles indicating tiles where TIVA signals were observed, b) TIVA signals in tiles 3 and 11 after testing power/ground in tile 26.

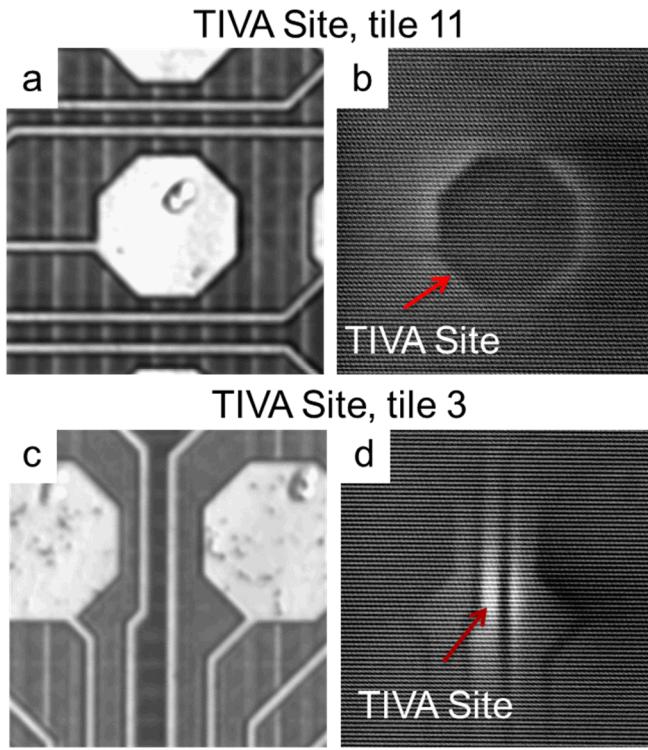
Fig. 15. TIVA signals observed during power to ground probing in tile 26 show a) reflected light image and b) TIVA image directly underneath a test pad in tile 11 and c) reflected light image and d) TIVA image between 2 pads in tile 3.

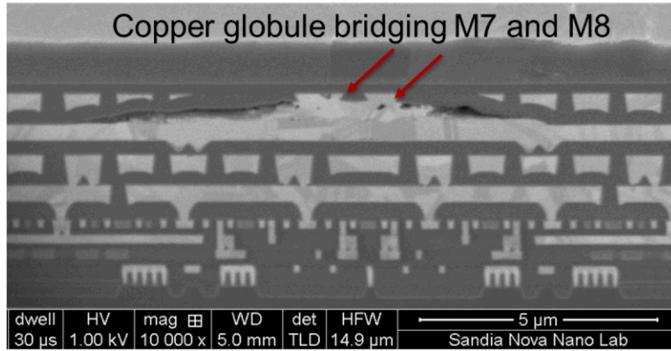
the failure mechanism. Here, the copper globule occurred in M7 and extended upwards bridging multiple M7 and M8 lines. In addition, the copper globule caused several M8 lines to fail open. These features are shown in Fig. 16.

Fig. 16. FIB cross-section of a copper globule bridging adjacent M7 and M8 lines.

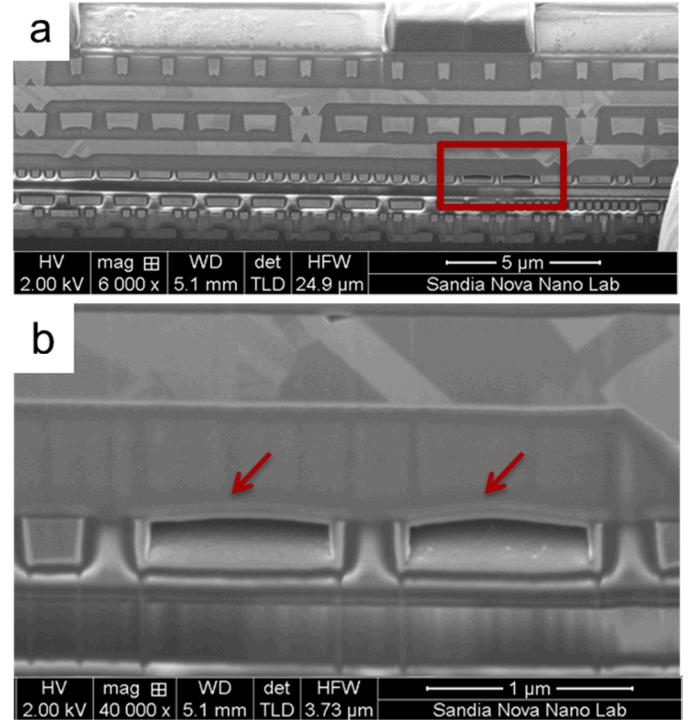
The TIVA signal observed in tile 3 (15d) was FIB cross-sectioned. Initial analysis revealed two hollow M4 lines but no shorting defect as shown in Fig. 17. Chemical analysis of the interior of these lines revealed the tantalum liner is intact but the line completely lacking copper. As the cross-section progressed closer to the TIVA site, one hollow trace ended while the shape of the other hollow trace changed. Fig. 18 shows a collapsed trace resulting in deformation of the upper level ILD. This deformation caused a dip in the ILD creating an uneven surface. Subsequent copper deposition resulted in a low point causing a thickness variation of ~ 200 nm in M5 above the collapsed M4 line. During CMP processing, the excess copper was not cleared resulting in a pool of copper bridging two M5 lines. This defect is shown in Fig. 19 where three cross-sections taken at the end of one M5 line (a), in the ILD (b) and

Fig. 17. FIB cross-section revealed a) two hollow M4 traces, b) higher magnification showing a convex structure.

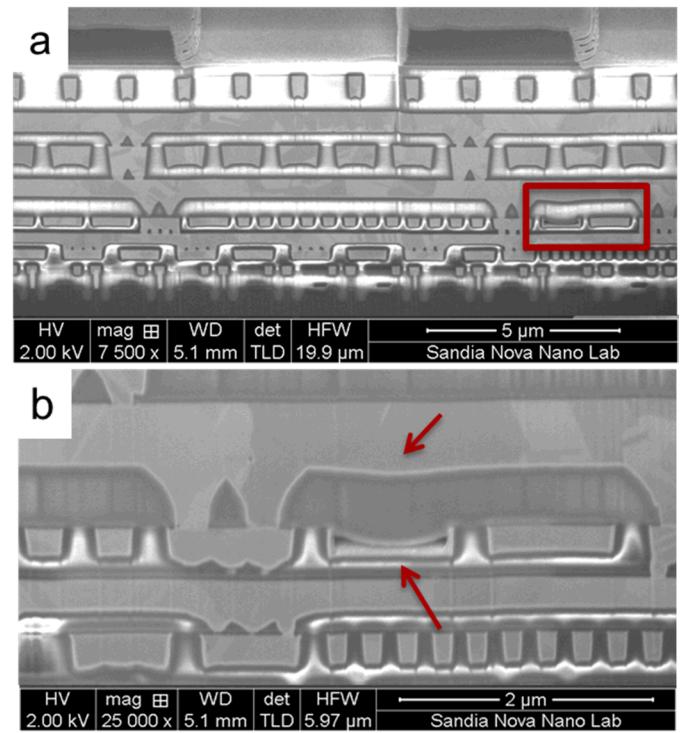
Fig. 18. FIB cross-section further showed a) hollow M4 trace with concave structure, b) higher magnification showed concave structure and the effect on the upper level ILD.

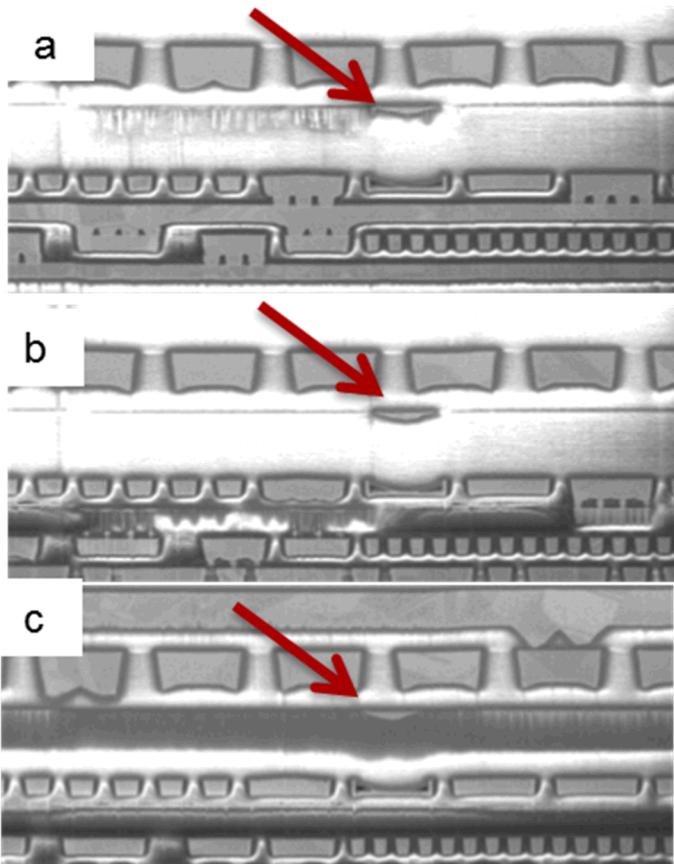
at the beginning of the next M5 line show the copper above the collapsed M4 trace bridging both M5 lines resulting in a small, localized power/ground short.

We believe the copper in M4 was removed due to pin holes and damage in the SiN. Aggressive cleans attacked M4 and etched the copper. Subsequent rinse and cleaning processes removed the copper leaving the tantalum liner intact. When the hollow trace collapsed creating an undulation in the ILD, copper was pooled creating a thicker region above the hollow M4 line. This copper was not removed during CMP resulting in a puddle bridging adjacent M5 lines. Similar corrective actions were taken to address the SiN film and protect the underlying copper layers.

Fig. 19. FIB cross-sections showed a) concave M4 trace with M5 ending, b) ILD with a small copper film present after CMP, c) the small copper film contacting an adjacent M5 trace resulting in a power/ground short.
