URTeC: 2902624

Hydraulic Fractures in Core From Stimulated Reservoirs: Core Fracture Description of HFTS Slant Core, Midland Basin, West Texas

Julia F.W. Gale*, Sara J. Elliott, Stephen E. Laubach

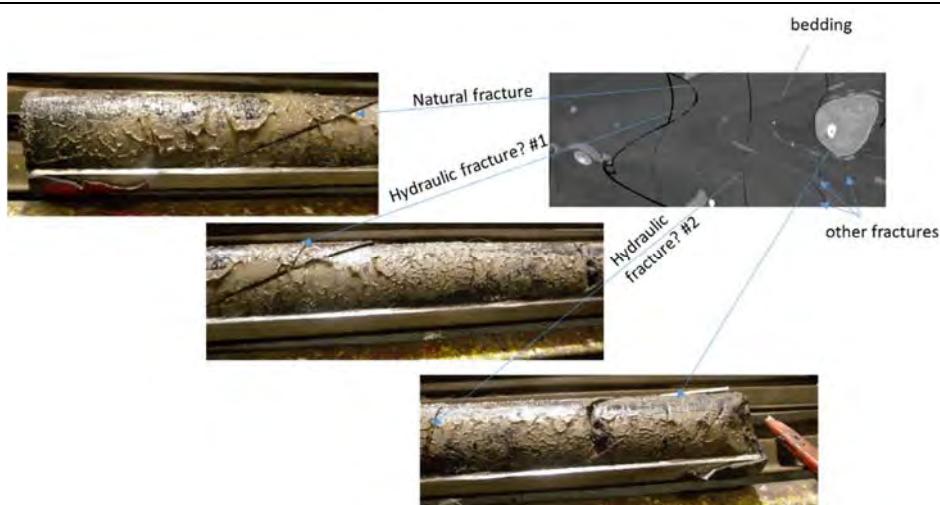
Method 1: the aluminum tube only was cut in a “clam shell,” with a 50:50 cut subparallel to bedding (Fig. 1). Fractures were easily examined after the drilling mud had been scraped off. Core pieces could be taken out and replaced, and the aluminum tube could be replaced once examination was complete. Damage to core was minimized using this method. Once the analysis was done, the whole assembly (core and tube) was put back together and secured with shrink wrap for storage. This method was found to be superior.

Figure 1. Core left whole while aluminum tube is bisected and opened to reveal core (“clam-shell” method). Example test on section, where core has several fractures. Top right = CT scan for this 3-ft section.

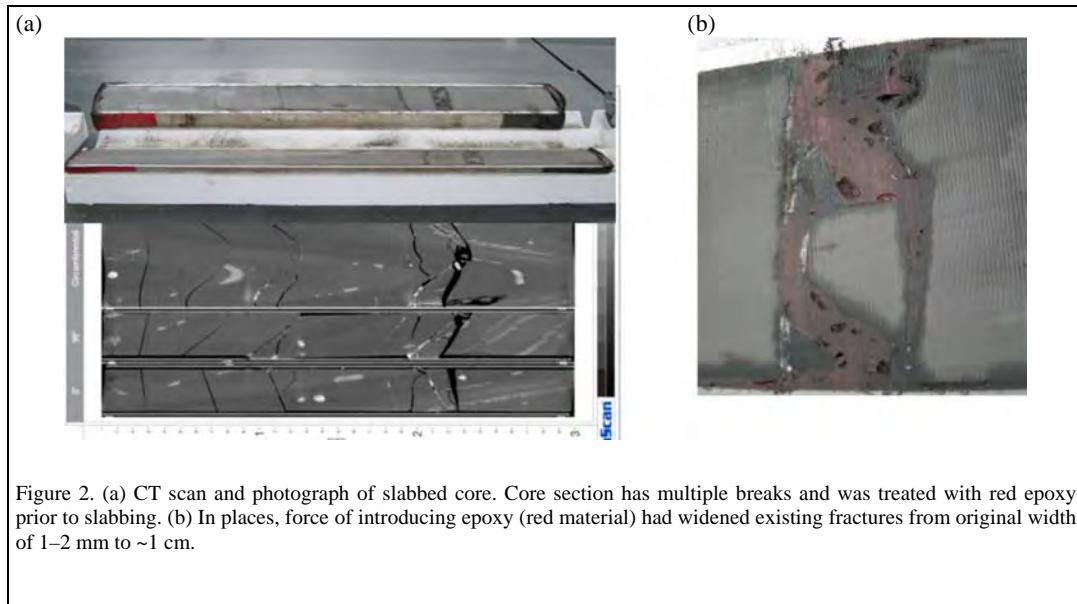
Method 2: two 2-ft sections were stabilized with red-stained epoxy prior to slabbing (Fig. 2). Sections that were epoxied and then slabbed subparallel to bedding were stabilized successfully, although the fracture surfaces are no longer visible (Fig. 2a). Whereas this technique prevents further breakup of core, it is the least-desirable option because inspection of fracture surfaces is essential for determining fracture origin. Also, because introduction of epoxy widened some of the fractures considerably (up to 1 cm), the geometry now observed is not the true, original, fracture geometry (Fig. 2b). No further sections were epoxied. Method 3: core was slabbed in the sleeve with no stabilization (Fig. 3a). The CT scan (Fig. 3b) showed that this short section had several fractures in it. The pieces of core, however, could not easily be taken out of the halved tube and had to be turned out on the bench for observation

Figure 2. (a) CT scan and photograph of slabbed core. Core section has multiple breaks and was treated with red epoxy prior to slabbing. (b) In places, force of introducing epoxy (red material) had widened existing fractures from original width of 1–2 mm to ~1 cm.

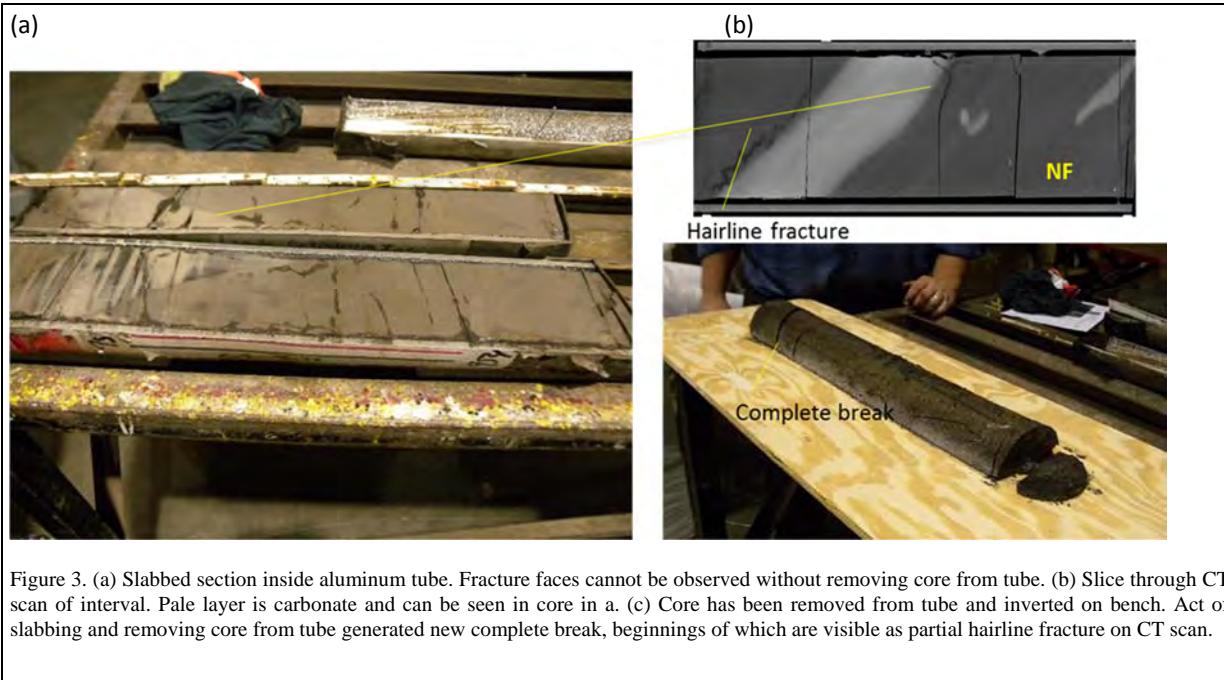
of fracture faces. This activity resulted in new breaks being created in the core (Fig. 3c), and it was decided that slabbing, even with the core in the tube, was too damaging and should not be done prior to fracture description.

Figure 3. (a) Slabbed section inside aluminum tube. Fracture faces cannot be observed without removing core from tube. (b) Slice through CT scan of interval. Pale layer is carbonate and can be seen in core in a. (c) Core has been removed from tube and inverted on bench. Act of slabbing and removing core from tube generated new complete break, beginnings of which are visible as partial hairline fracture on CT scan.

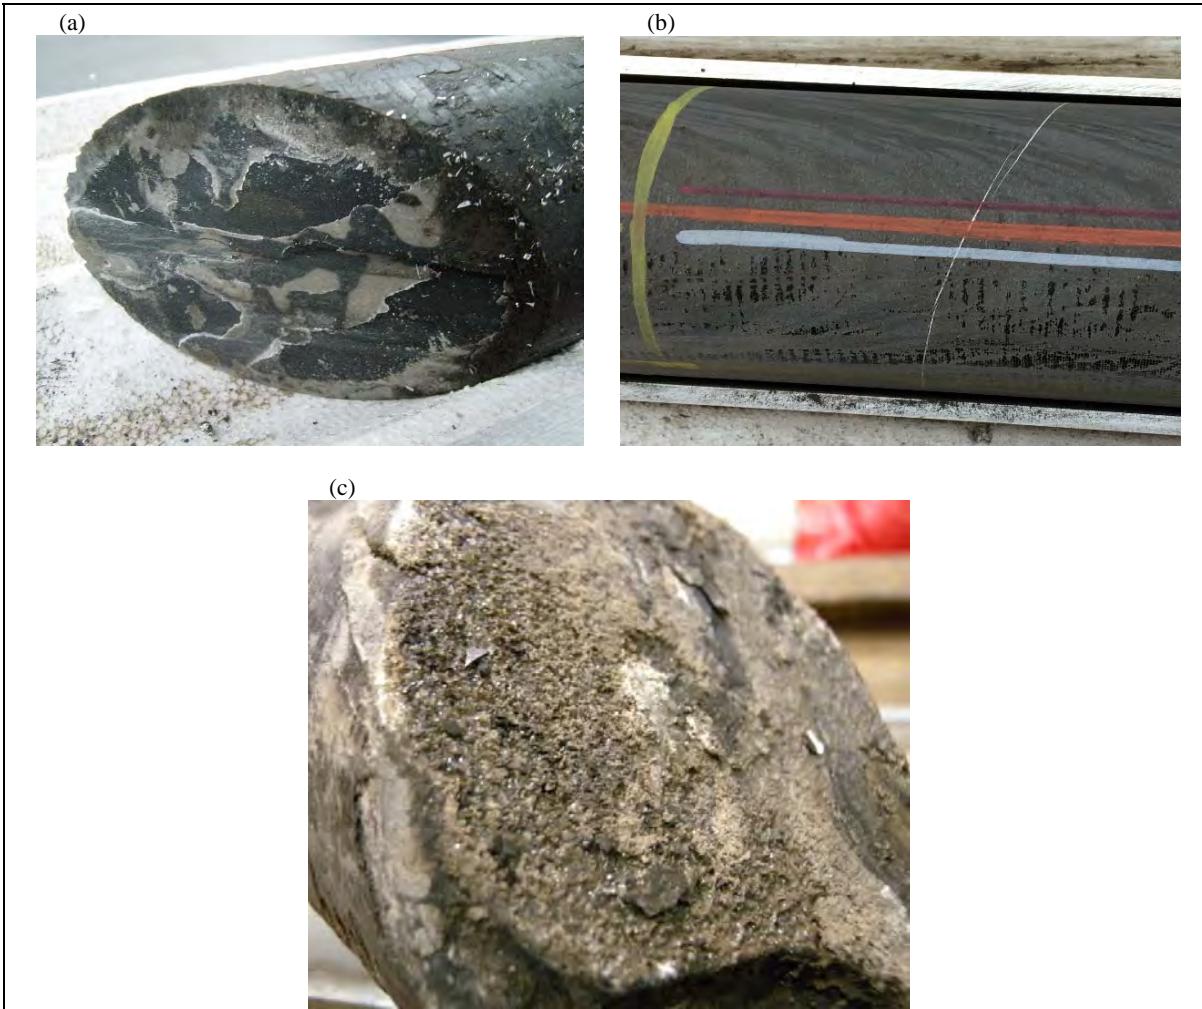
Two main sets of natural opening-mode fractures filled with calcite cement are present: Set 1 trends broadly NE–SW (Figs. 4a, 5a), and Set 2 trends WNW–ESE (Figs. 4b, 5b), both with steep dips. These natural fractures are identified primarily on the basis of calcite mineral fill. Fractures may be fully sealed and intact, partly sealed and intact (with original fracture porosity), or parted (Fig. 4a). In the latter case, cement can be seen on the fracture wall(s). This cement can be subtle and present as a patchy veneer on one or both surfaces. In some fractures, positive cement identification is challenging—dried drilling mud can also resemble a pale cement veneer. The mud reacts with dilute HCl (owing to carbonate entrained in the mud) so that an acid-drop test cannot be used to identify cement. A small chip from such a fracture surface at the end of one core was imaged and examined using SEM-based EDS. The material on the surface proved to be dried drilling mud. When positive identification of cement is not possible, orientation is a useful indicator of fracture origin, although it is not definitive by itself. In two locations Set 1 natural fractures have euhedral calcite cement on their surfaces, indicating they were open in the subsurface (Fig. 4c). We did not measure the kinematic aperture because these fractures are now parted, but we estimated them to have been more than 1 mm wide.

Figure 4. Natural fractures in the slant core. (a) Parted, Set 1 fracture with patchy calcite on fracture face. (b) Intact, Set 2 composite fracture; of the three segments, the middle segment is offset uphole from the other two by a few millimeters. Slight deviation of fracture path at tips indicates stresses ahead of tips were modified by presence of approaching neighbor. (c) Euhedral calcite crystals on Set 1 fracture face indicating fracture was open in subsurface.

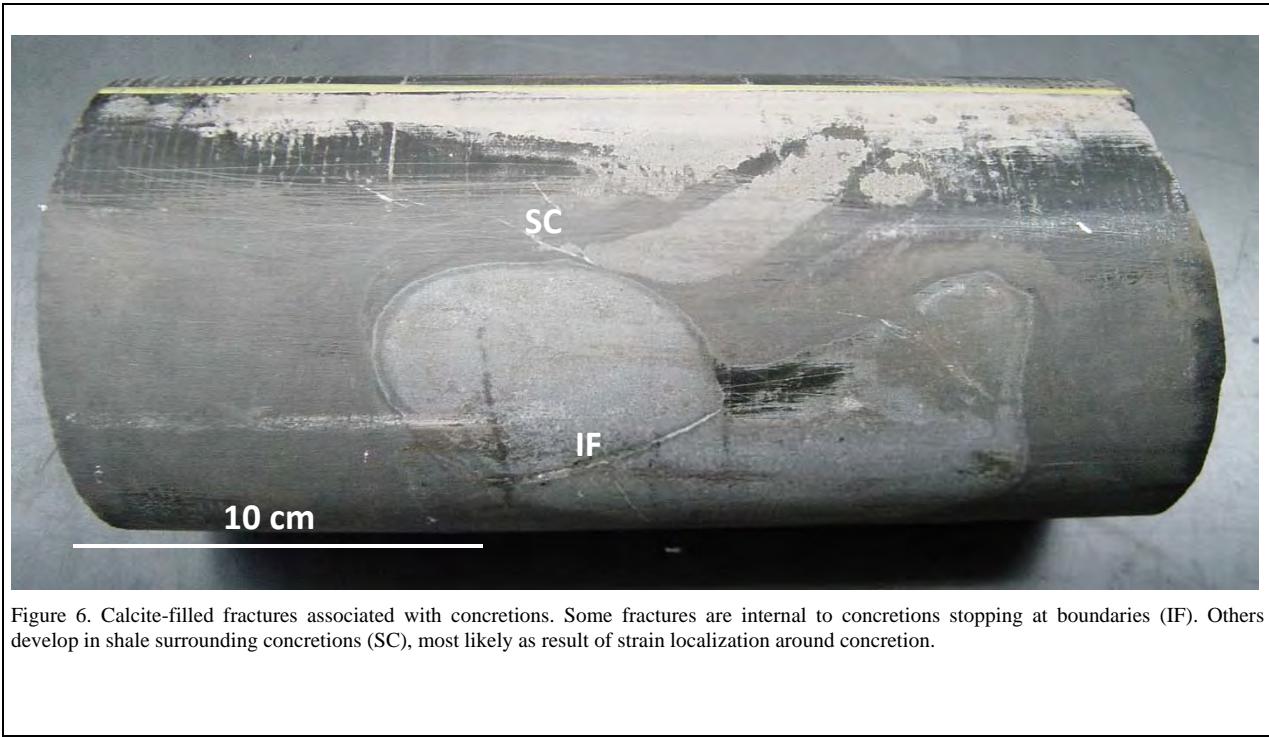
The natural, calcite-filled fractures in this well are typical of fractures in shale, occurring as narrow, composite groups typically less than 1 mm wide (c.f. those described by Gale et al., 2014, and references therein). The smallest are only a few centimeters in length and height, and the largest are perhaps 1 m or so long and high (but continue out of the core). Some are bed bound. Occurrences of other natural-fracture types are minor, including those internal to concretions and those related to deformation around concretions (Fig. 6).

Figure 6. Calcite-filled fractures associated with concretions. Some fractures are internal to concretions stopping at boundaries (IF). Others develop in shale surrounding concretions (SC), most likely as result of strain localization around concretion.

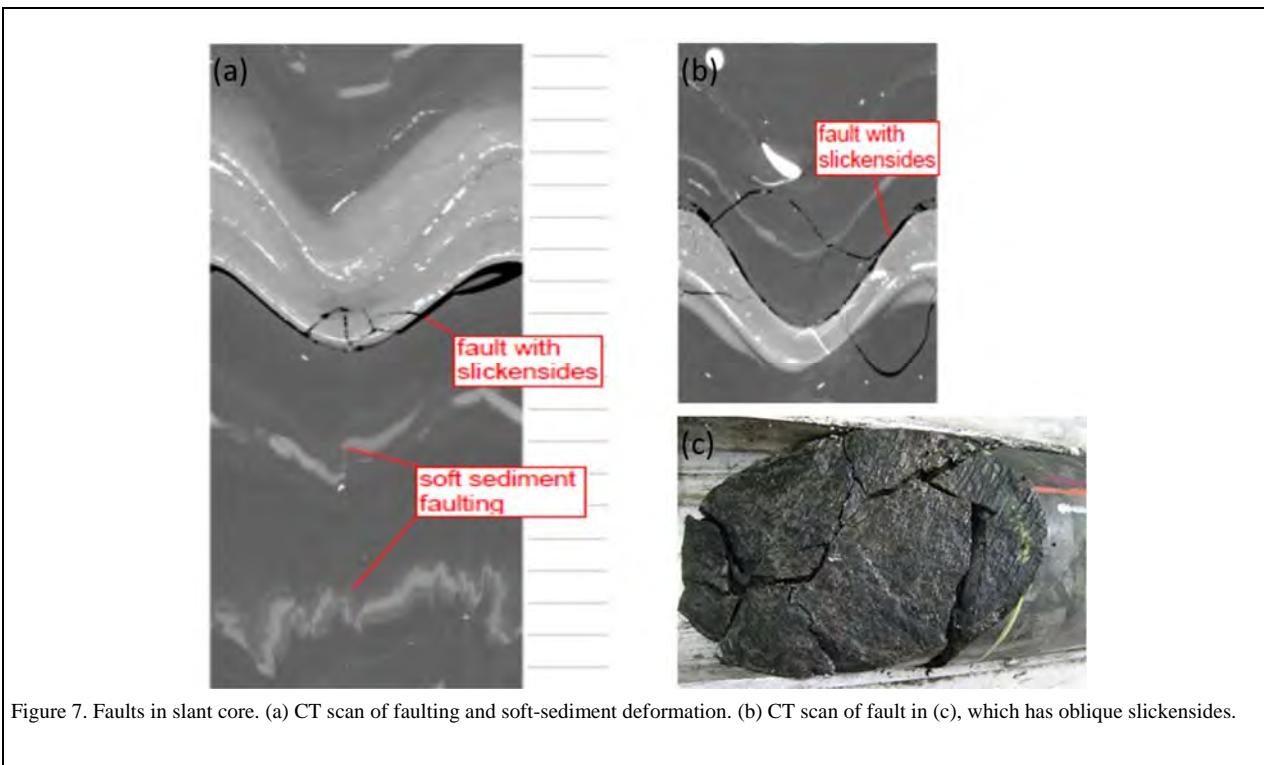
Two types of fault occur: early, soft-sediment deformation faults (Fig. 7a) and later, moderately dipping faults with oblique slip, indicated by slickensides on the fault planes (Fig. 7a–c). In one fault oriented $292.5^\circ/57.4^\circ$ NE, slickensides suggest normal and dextral components of oblique slip. Some have a small amount of calcite cement.

Figure 7. Faults in slant core. (a) CT scan of faulting and soft-sediment deformation. (b) CT scan of fault in (c), which has oblique slickensides.

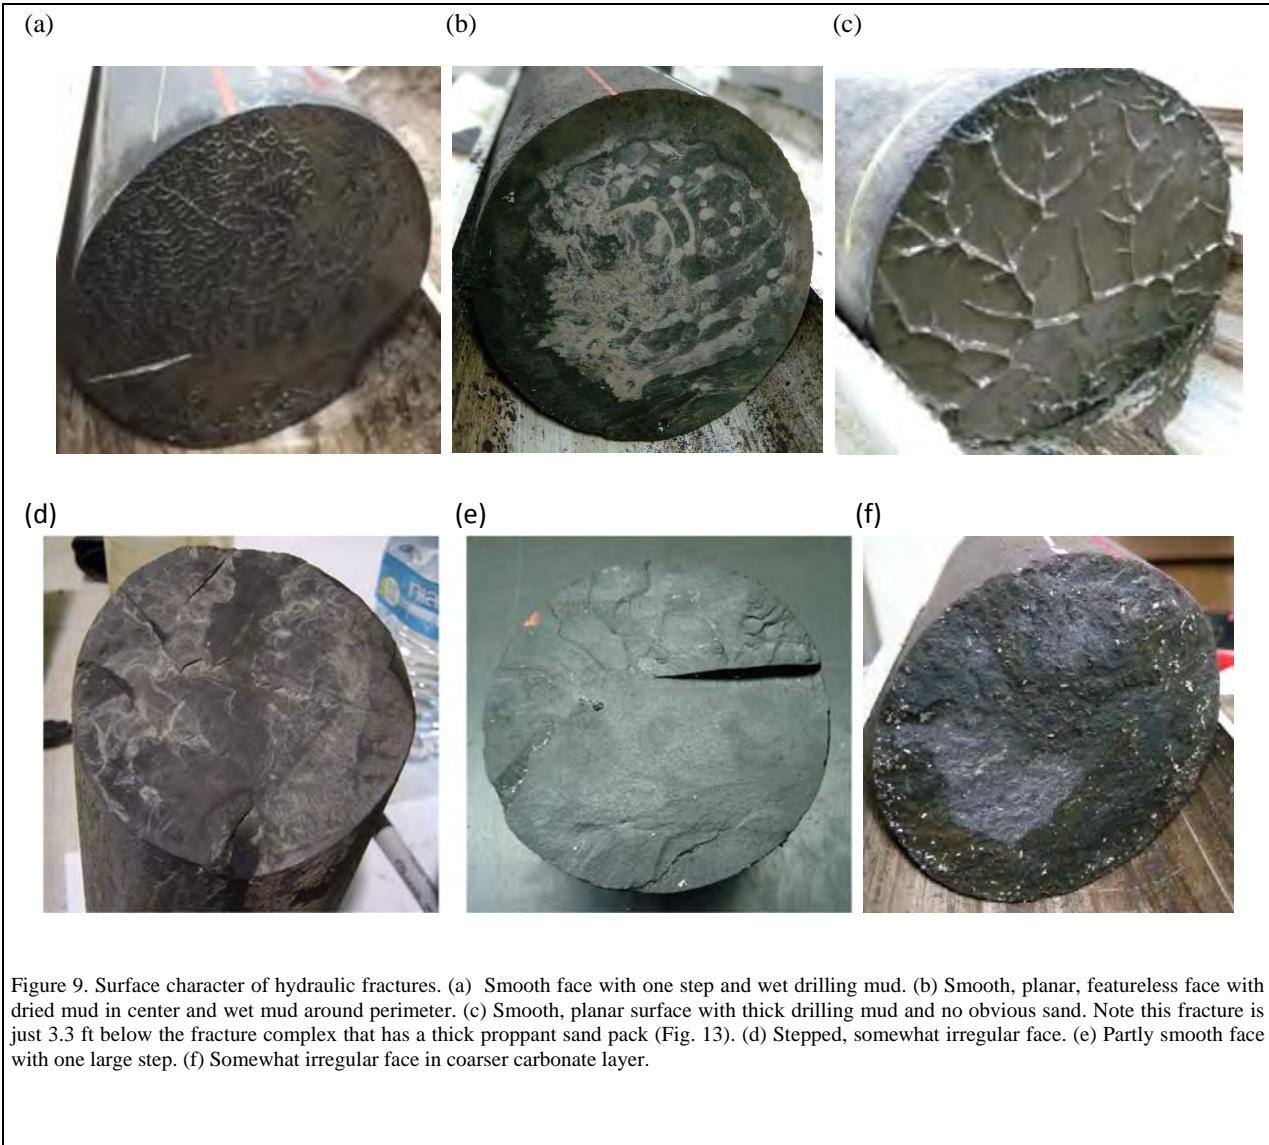
Occurrence of hydraulic fractures in the cores is heterogeneous, with both clusters and interval with no fractures. Many are single planar breaks with smooth surfaces, and some have a stepped geometry (Fig. 9). In other cases, two or more breaks are closely spaced, suggesting bifurcation. Clusters of two to four core-normal fractures in the space of a few centimeters are common and may be multiple hydraulic-fracture strands (Fig. 10). In rare cases, bifurcation is captured in the core and can be used to infer the direction of hydraulic-fracture growth.

Figure 9. Surface character of hydraulic fractures. (a) Smooth face with one step and wet drilling mud. (b) Smooth, planar, featureless face with dried mud in center and wet mud around perimeter. (c) Smooth, planar surface with thick drilling mud and no obvious sand. Note this fracture is just 3.3 ft below the fracture complex that has a thick proppant sand pack (Fig. 13). (d) Stepped, somewhat irregular face. (e) Partly smooth face with one large step. (f) Somewhat irregular face in coarser carbonate layer.

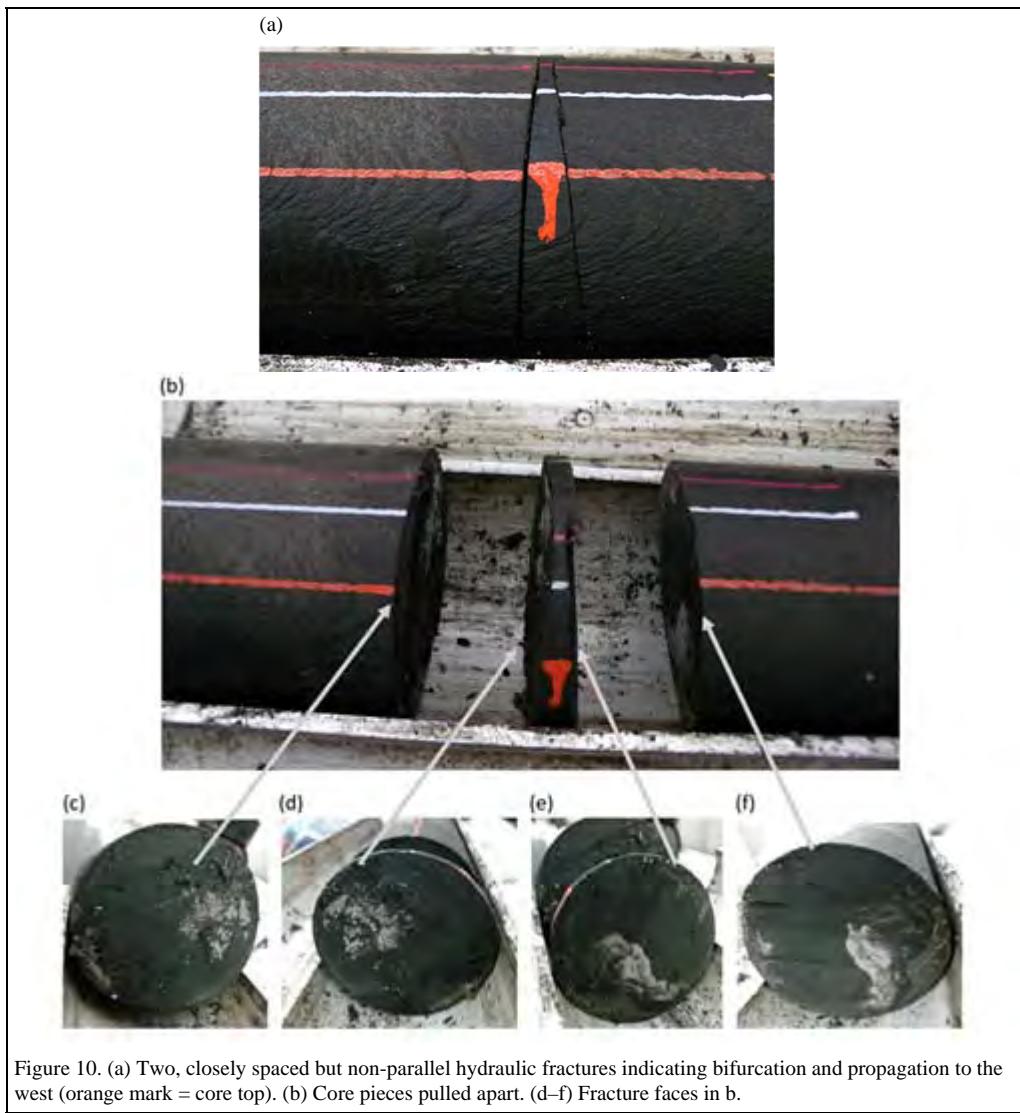
Figure 10. (a) Two, closely spaced but non-parallel hydraulic fractures indicating bifurcation and propagation to the west (orange mark = core top). (b) Core pieces pulled apart. (d–f) Fracture faces in b.

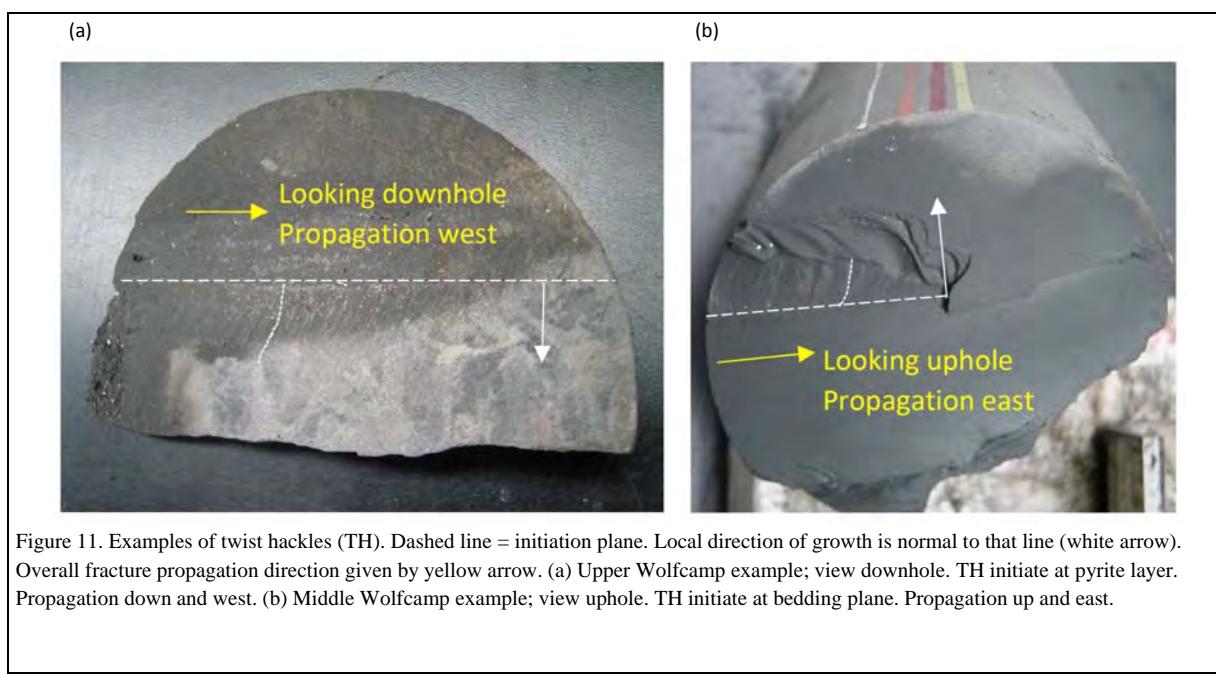
In addition to bifurcation, surface markings such as twist hackles may be used to determine local propagation direction of the fracture (Fig. 11). Twist hackles initiating at mechanical-layer changes are orthogonal to the layer and gradually taper out away from the point of initiation. These may be used to indicate the local direction of hydraulic-fracture propagation. In some cases, determining wider-scale lateral propagation on the basis of asymmetry of twist-hackle steps may be possible. Multiple examples of twist hackles occur in the slant core—some suggesting local upward propagation, others downward, some large-scale eastward propagation, and some westward.

Figure 11. Examples of twist hackles (TH). Dashed line = initiation plane. Local direction of growth is normal to that line (white arrow). Overall fracture propagation direction given by yellow arrow. (a) Upper Wolfcamp example; view downhole. TH initiate at pyrite layer. Propagation down and west. (b) Middle Wolfcamp example; view uphole. TH initiate at bedding plane. Propagation up and east.

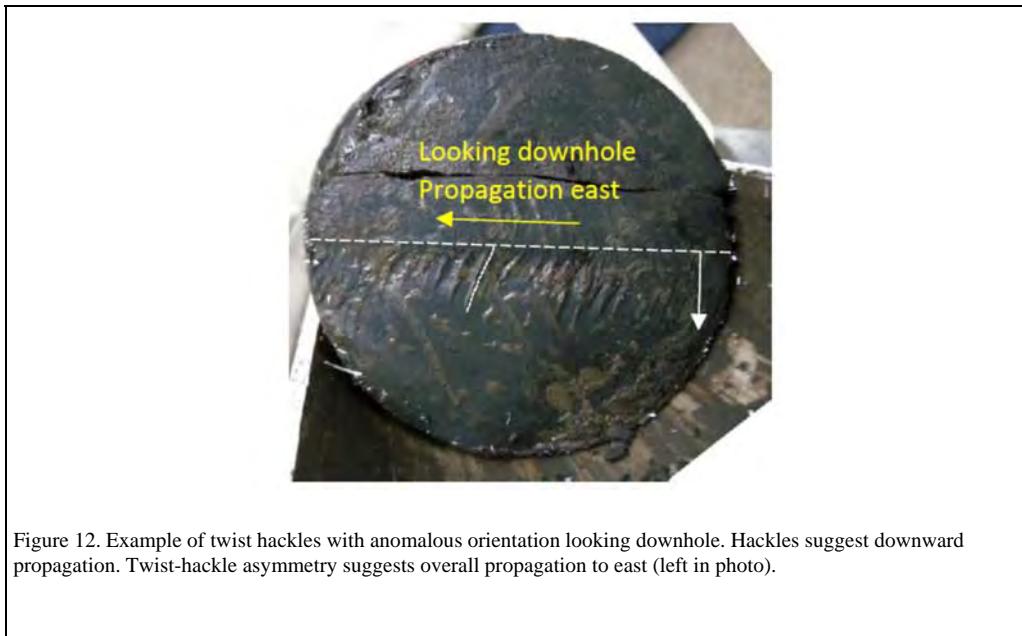
Some twist hackles have apparently anomalous geometries, however, in that the inferred propagation direction is not consistent with the relative positions of the nearest stimulation well and the slant well. In one example (Fig. 12), twist hackles initiate off bedding and suggest local downward propagation. Twist-hackle asymmetry suggests that overall propagation is to the east, but the 6U well is below and to the east of the slant core at this location, and hydraulic fractures would therefore be expected to grow up and to the west.

Figure 12. Example of twist hackles with anomalous orientation looking downhole. Hackles suggest downward propagation. Twist-hackle asymmetry suggests overall propagation to east (left in photo).

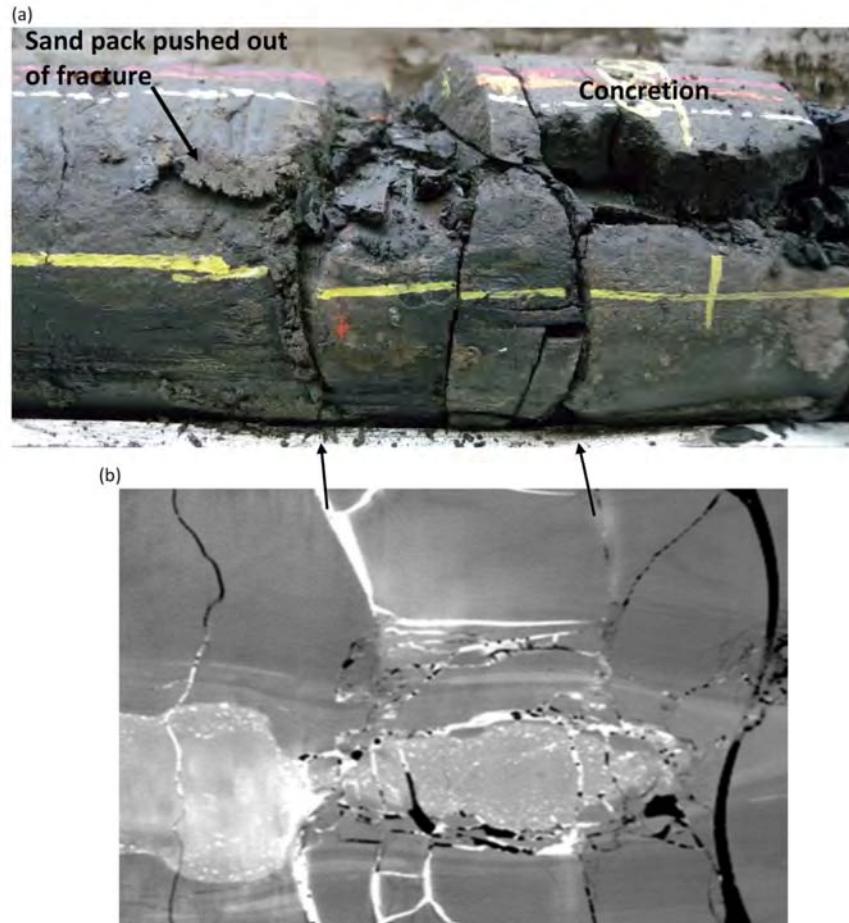
Hydraulic fractures contain a sand (proppant) pack in three locations, all of which lie within a more intensely fractured interval in the Upper Wolfcamp (Figs. 13–15). In one example sand occurs as patches on a fracture face that is part of a HF doublet (Fig. 13). Notably no drilling mud is present, indicating that the sand was in place prior to drilling. The thickest sand pack occurs at a location where the HF is branched and the pack is present in each strand (Fig. 14). The total complex is approximately 1 cm thick. The third sand pack location is at a concretion (Fig. 15). Where HFs encounter concretions, fractures become complex, and the concretions are shattered. The sand is visible in the fracture at the uphole end but can also be seen in some of the other breaks. A piece of the sand pack appears to have been pushed out of the fracture (Fig. 15a)—it was sampled and the remainder left intact. The CT scan shows a bright signal in the fractures and in the concretion, which is likely pyrite (Fig. 15b). The dark-gray signal of proppant noted in Figure 14a is not apparent, possibly being obscured by the pyrite.

Figure 15. Sand pack in complex hydraulic fracture adjacent to a concretion. (a) Sand on outer surface of core with multiple breaks visible. (b) CT circumferential scan.

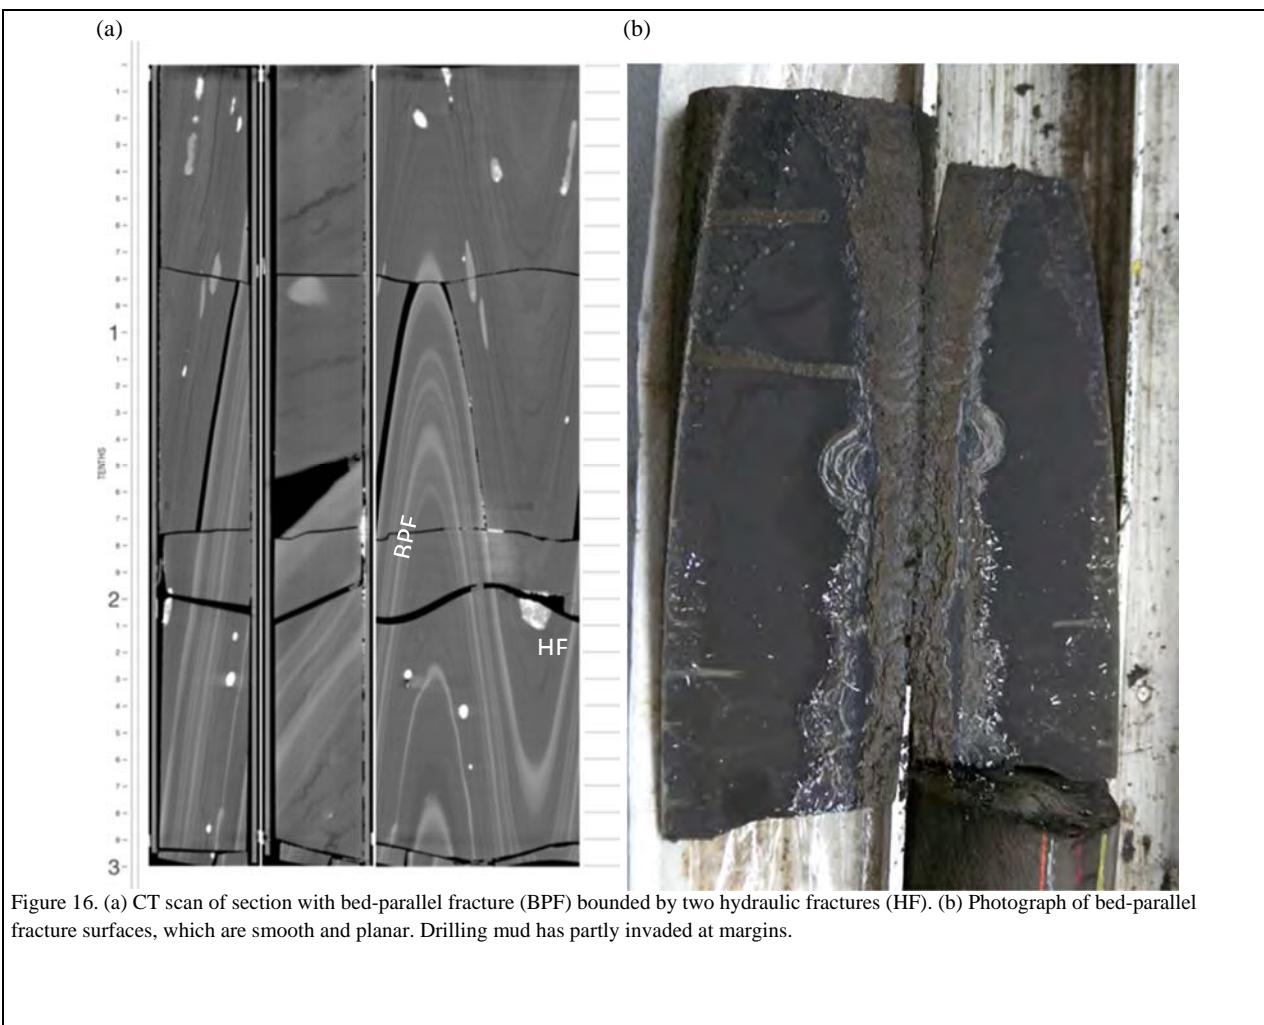
- (1) Bedding-plane breaks connected to a hydraulic fracture (hard linked) (Fig. 16). These are smooth and planar when compared with other bed-parallel breaks, which are stepped and rough. Nonconnected, bed-parallel fractures could open as a result of a pressure front associated with hydraulic fracturing, and in this case would not be hard linked.
- (2) Hard-linked, reactivated breaks should have some proppant in them.

Figure 16. (a) CT scan of section with bed-parallel fracture (BPF) bounded by two hydraulic fractures (HF). (b) Photograph of bed-parallel fracture surfaces, which are smooth and planar. Drilling mud has partly invaded at margins.

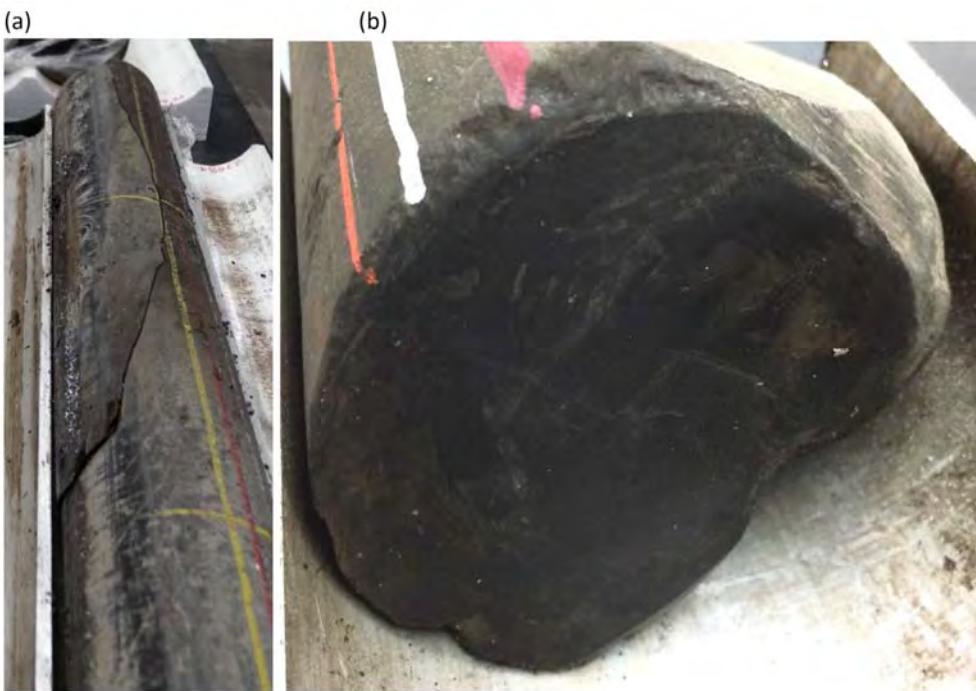
Drilling-induced fractures are mostly at a high angle to the well bore and parallel to $S_{H\max}$, as are hydraulic fractures. In horizontal or slant wells, drilling-induced fractures can be confined to the core top. In other cases in which the weight-on-bit has increased significantly, breaks can occur along the bedding, with petal shapes extending outward to the core margin (Fig. 17a). Induced fractures commonly have indications of breakage points within the core (e.g., core-rimming plumose markings, and sharp points at the core margin), and they tend to be approximately core symmetric, curviplanar (saddle shaped) (Fig. 17b), or irregular. Surface markings can form, no matter the mechanism. In natural and hydraulic fractures, the markings would have no relation to core margins, barring coincidence. In drilling-induced and core-handling fractures, plumose markings may emanate from a point source within the core. Some proppant grains may also be present, having been brought in with the drilling mud, but proppant will not be present as a sand pack. Drilling can also cause natural fractures or other weak surfaces to break. Differentiating these from reactivation caused by hydraulic fracturing is difficult.

Figure 17. Drilling-induced fractures. (a) Petal centerline shape, viewed looking downhole. (b) Irregular, saddle-shaped fracture.

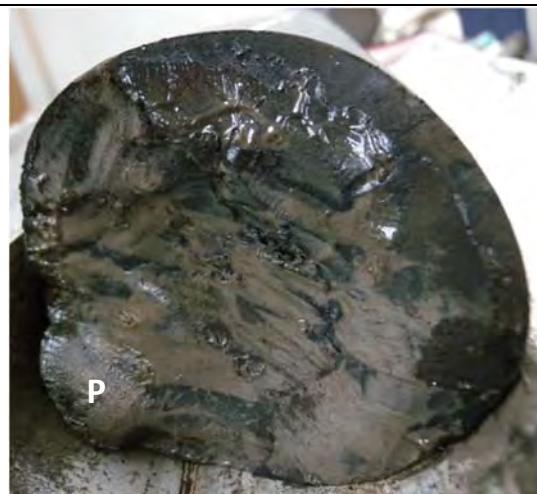
Core recovery causes vertical-stress release, commonly creating breaks parallel to bedding in vertical cores. In this slant well, few examples occur, and where they do occur, it is commonly at the core margin close to another break. Breaks can also occur during core recovery as the core is retrieved around the bend at the well heel, damage most likely mitigated by the aluminum tube. Sharp points on the fracture face are commonly produced in core during flexural breaking, and in rotary-drilled sidewall plugs they can be used to identify plug orientation (Laubach and Doherty, 1999). Here they are an indicator of breakage after the core has been acquired (Fig. 18).

Figure 18. Likely core recovery fracture with an irregular surface and sharp point (P) suggesting break initiated within core.

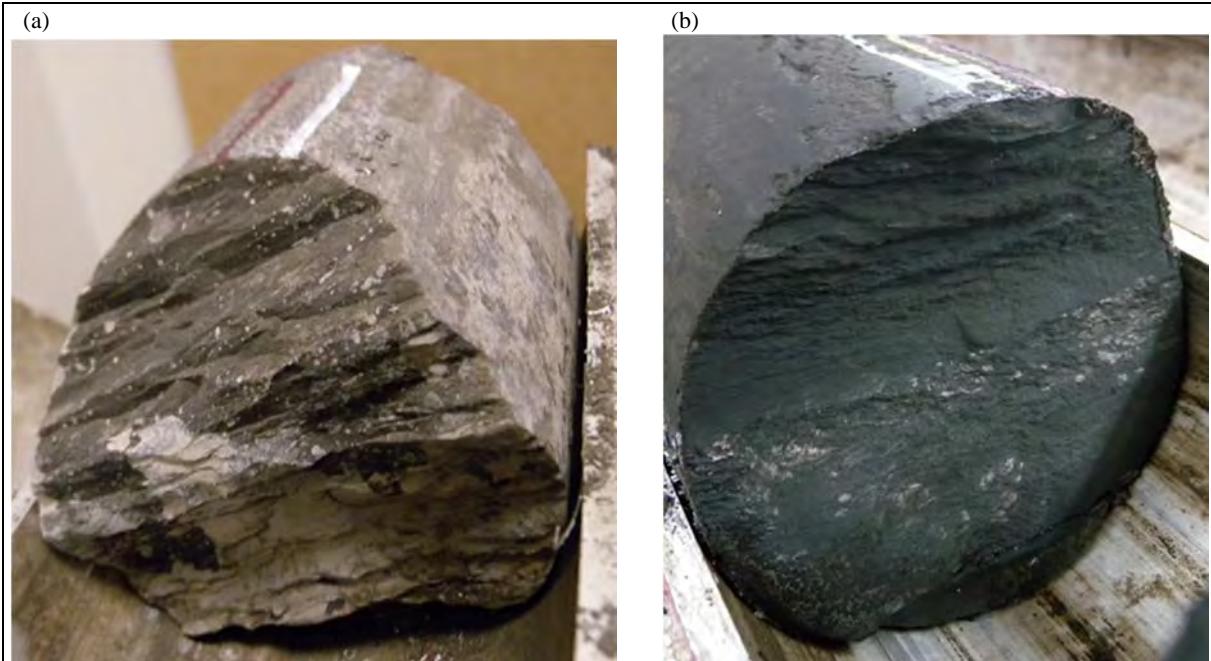
Damage can also occur during sawing into sections, transportation, and other handling up to the point of CT-scan acquisition. In these cases, surfaces are rough and fresh, although some drilling mud is generally present (Fig. 19a). These fractures are present in the CT scan; new fractures created as a result of handling/desiccation after CT-scan acquisition are not present in the CT scan. These surfaces are fresh breaks and have no drilling mud (Fig. 19b).

Figure 19. (a) Likely core-handling fracture. Irregular surface with some drilling-mud splatters. (b) Post-CT-scan break. Irregular with rough surface and no drilling mud inside.
