**North Slope of Alaska ARM Facilities**  
**Monthly Status Update**  
**Sandia National Labs**

**October 2018**

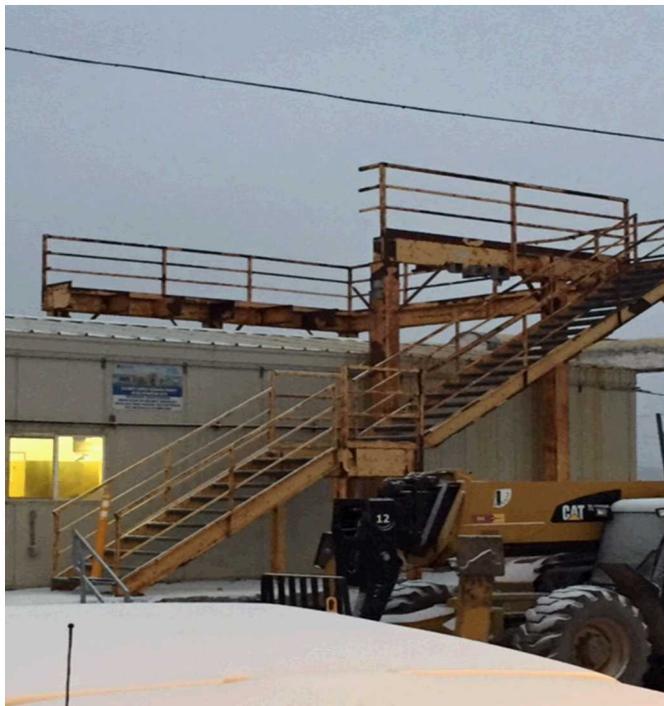
Maintenance building deck was removed. Rust was dripping from deck making rust stains on the maintenance building. It was felt that the deck was no longer safe to use.
