North Slope of Alaska ARM Facilities
Monthly Status Update
Sandia National Labs

January 2019

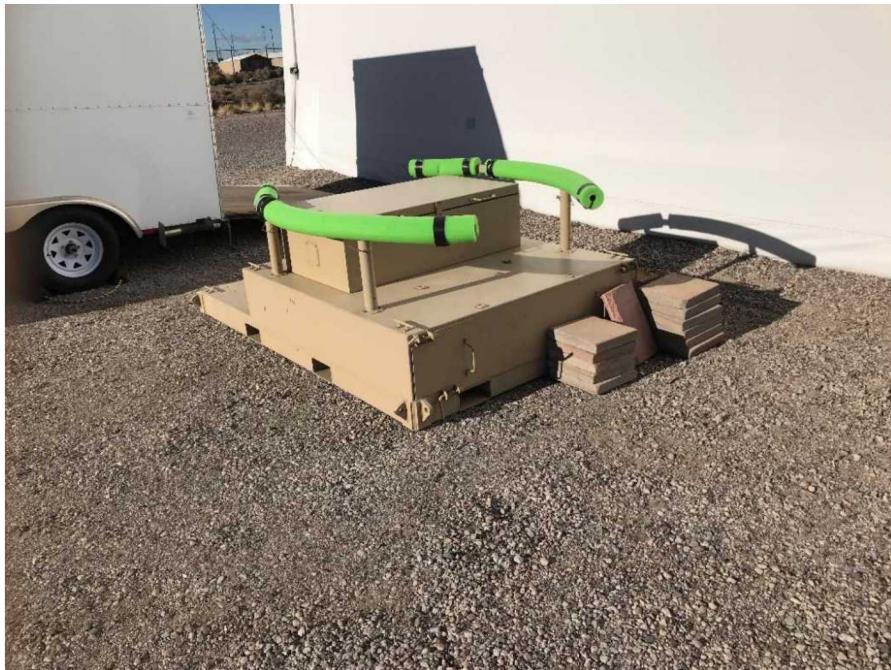
Removed existing winch trailer electronics control box and mounting frame to make the trailer more user friendly.

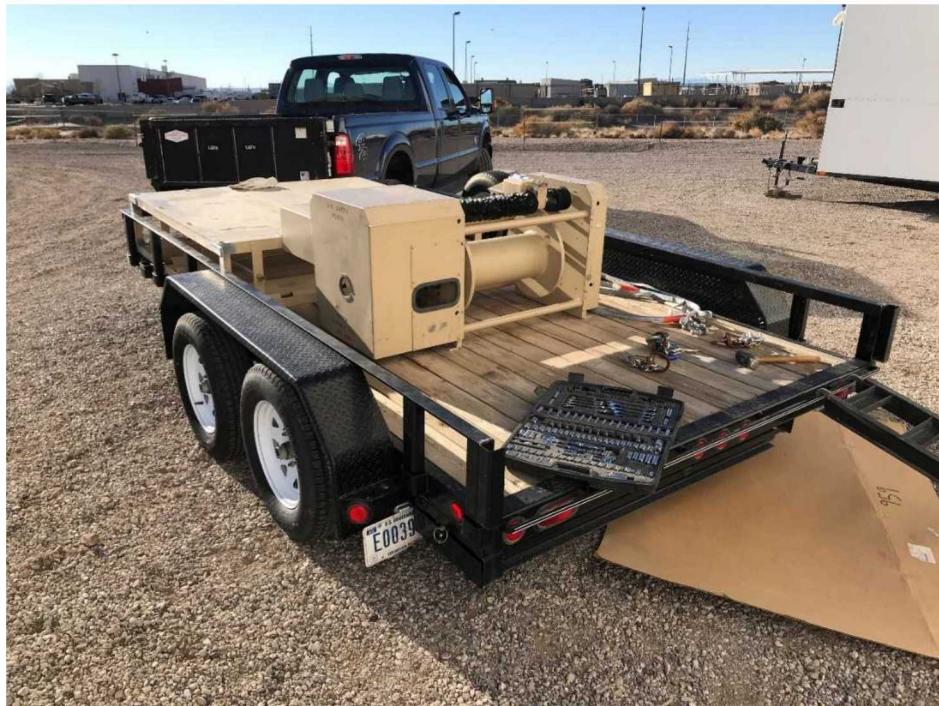
Trailer was reoutfitted with an old helium rack to add the capability of transporting helium cylinders. Winch was mounted to the frame of the trailer and 4" U-channel was added to further secure the winch to the frame.

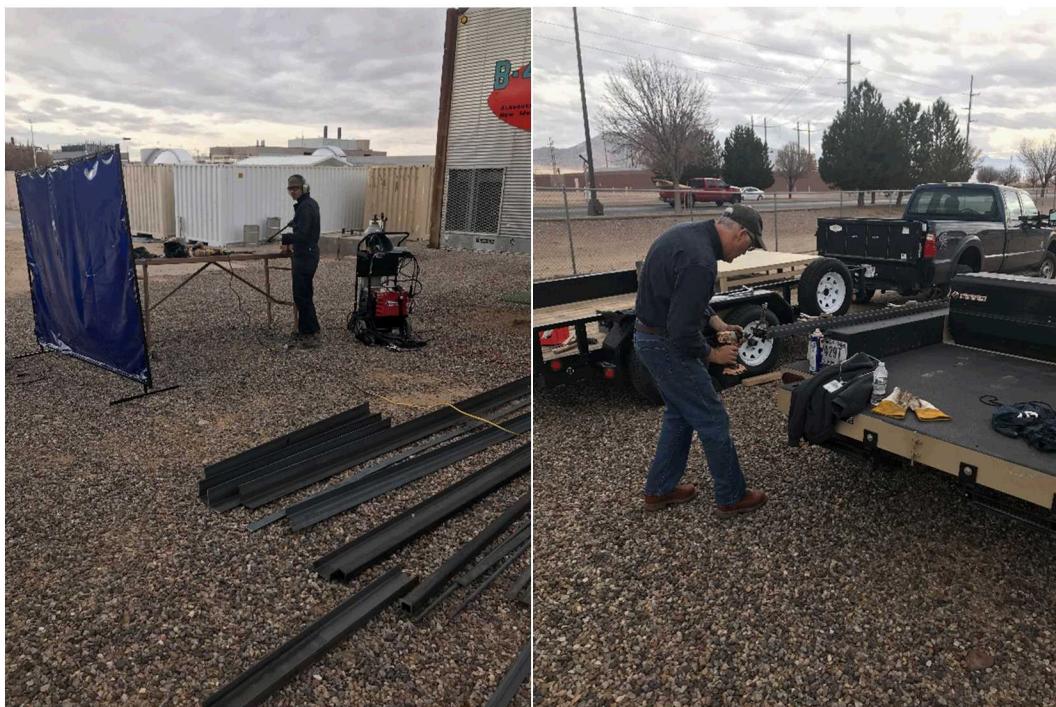
A new helium rack being fabricated, and U-channel crossmember being fabricated.

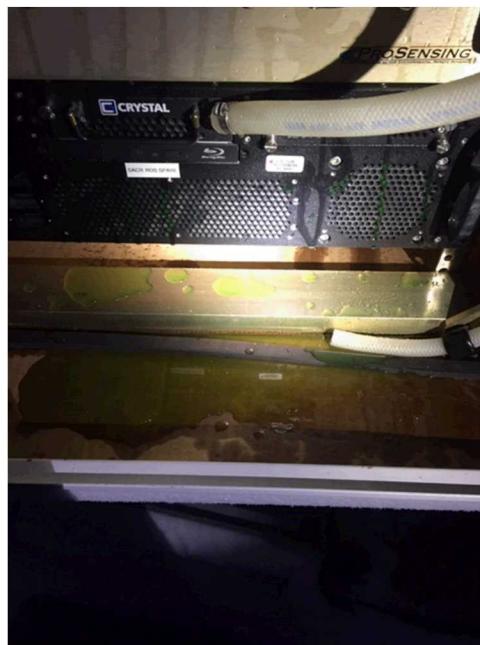
SACR has glycol leak on W Band side and has been shut down until repairs can be made.
