ORNL - TM - 1030

DYNAMIC CORROSION STUDIES FOR THE HIGH FLUX ISOTOPE REACTOR

J.L. English and J.C. Griess

SEPTEMBER 1966

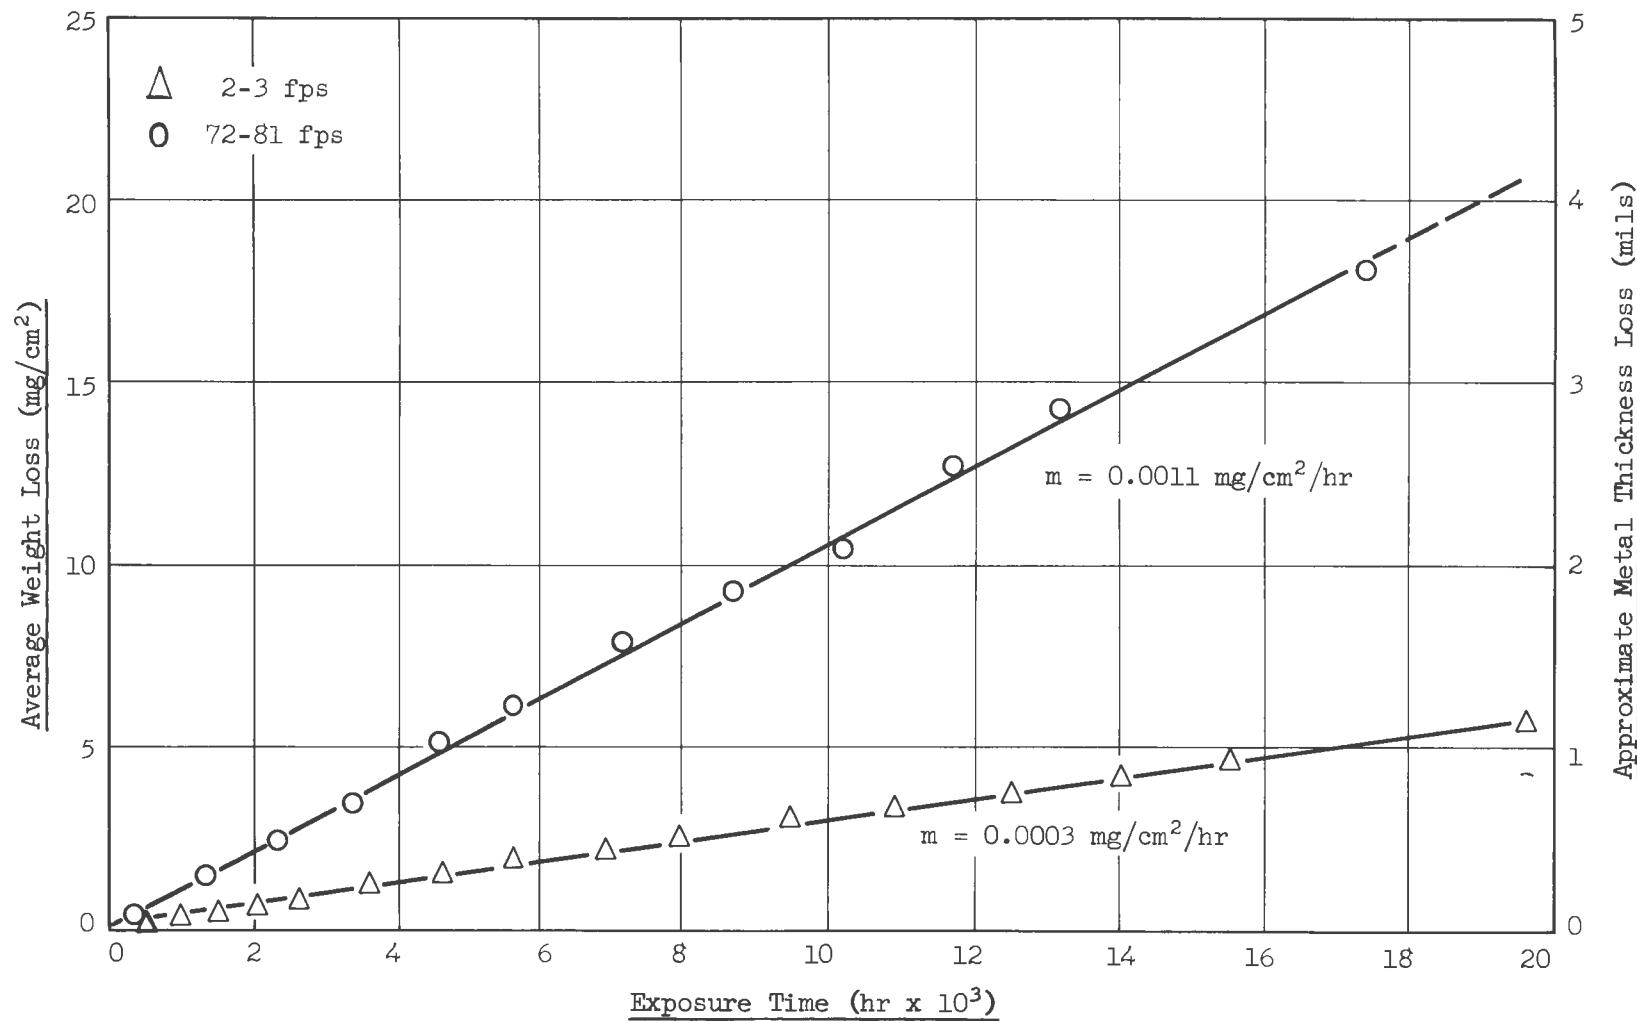
ORNL-DWG-66 7713

At least duplicate, and in some cases quadruplicate, specimens of reactor-grade, QMV beryllium were exposed at the following flow rates for the indicated times: 2 to 3 fps, 19,630 hr; 13 fps, 17,600 hr; 23 fps, 17,600 hr; 22 to 33 fps and 33 to 51 fps, 5,590 hr; 51 to 72 fps, 17,360 hr; and 72 to 81 fps, 17,360 hr. In all cases, the specimens developed only very thin, tarnish-like films which weighed only 0.1 to 0.2 mg/cm². All specimens were weighed several times during the exposures. At the lowest velocity (2 to 3 fps), the specimens corroded at a constant rate of 0.6 mpy. At all other velocities, the specimens corroded at the rate of 2.0 ± 0.1 mpy. Figure 1 shows a plot of weight loss versus time for specimens at the lowest and highest velocities tested. Very mild and infrequent pitting was first apparent on the specimens after 1000 to 3500 hours. With continued exposure, the pits deepened and the pitting frequency increased slightly. At the lowest velocity, the measured depths were about 8 mils after 17,600 hours. At the highest velocity after 17,360 hours, the maximum pit depth was essentially the same. Both the general corrosion rate of beryllium and its tendency to pit in water at a pH of 5 and at 100°C are such that the corrosion damage to the beryllium reflector in the HFIR should be inconsequential.

Fig. 1. Effect of Velocity on Corrosion of QMV Beryllium by pH 5.0 Water at 100°C.

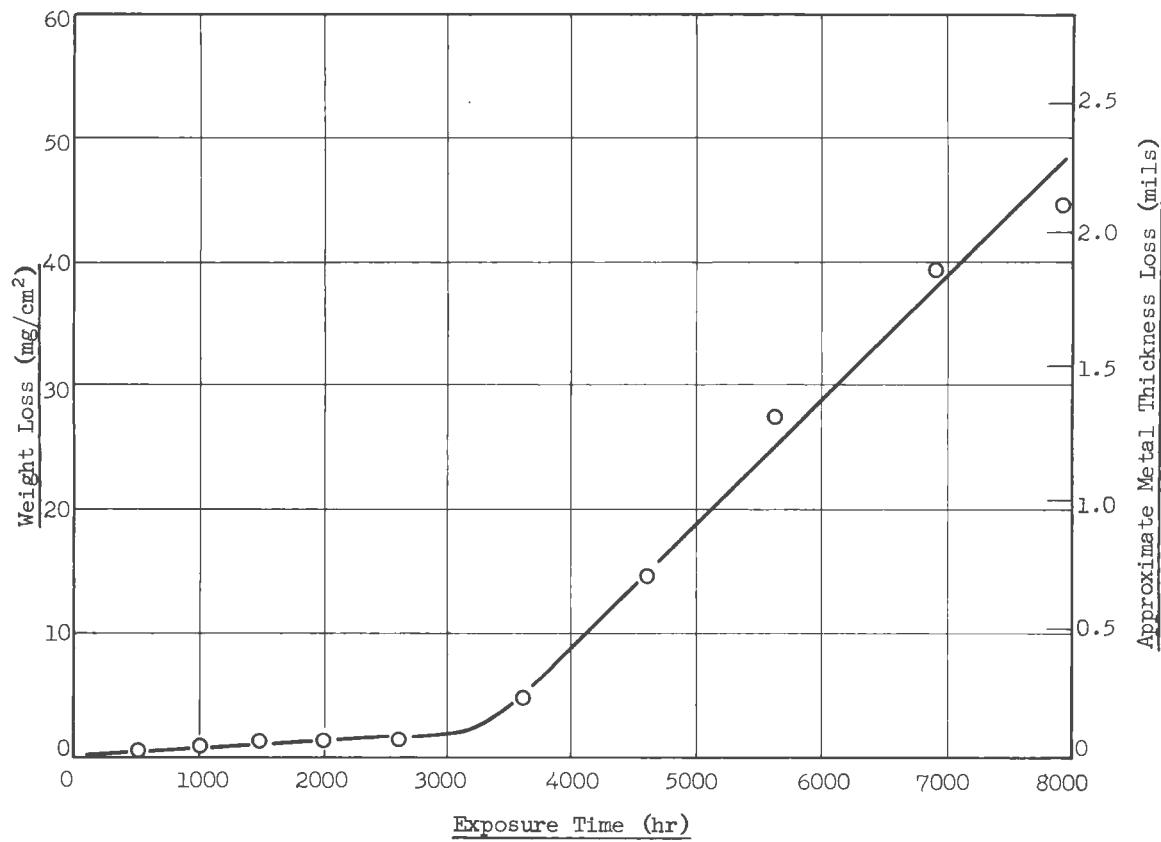
ORNL-DWG 66-7714

The behavior of commercial-purity nickel in pH 5.0 water at 100°C during a 7900-hr exposure period is shown in Fig. 2. For the first 2600-hr of the exposure the corrosion rate was 0.2 mpy. During the

Fig. 2. Corrosion of Commercial-Purity Nickel in pH 5.0 Water at 100°C and 2-3 fps.

period between 2600 and 3100 hours, the corrosion rate increased to nearly 4 mpy and remained constant for the rest of the test. The average rate for the entire test was slightly greater than 2 mpy. Prolific shallow pitting took place during the first 1000 hours. By the end of the test, the depth of the attack had increased only slightly to 2 mils, but the frequency increased to such magnitude that it was impossible to measure the pit population per unit area.

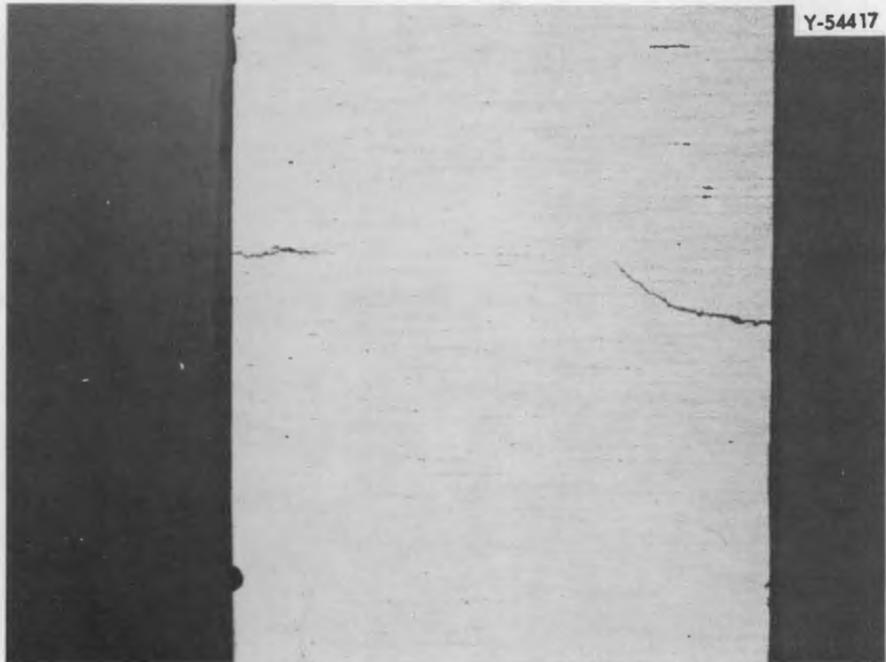
A second composite specimen, prepared by bolting a 6061-T4 aluminum specimen between plates of 304 and 420 stainless steel, was exposed for 12,475 hours (Test No. 10). The 420 stainless steel was hardened to 43 Rockwell C by heating fifteen minutes at 1010°C (1850°F), water quenching, and reheating for $2\frac{1}{4}$ hours at 538°C (1000°F) followed by air cooling to room temperature. The specimen was dismantled frequently during the test. The first indication of pitting on the aluminum appeared after 1000 hours at which time pits slightly over 3 mils deep were observed. With increased exposure time, these pits deepened - becoming as deep as 10 mils at the end of the test. After a 3600-hr exposure, pits up to 1 mil deep were observed on the type 420 stainless steel. Also the 420 stainless steel specimen showed substantial staining and accumulation of rust-colored corrosion products. The pits were confined to the surface contacted by the aluminum. At the end of the test the 420 stainless steel specimen showed scattered pitting slightly over 4 mils in maximum depth. No pitting was found on other faces but two cracks were detected on opposite surfaces as shown in Fig. 3. The larger crack (Fig. 4) extended approximately 90 mils into the metal; the smaller crack was about one half this depth. Metallographic examination showed the cracks to be predominately intergranular (Fig. 5). The average attack rate on the 420 stainless steel was 0.2 mpy.

Fig. 3. Transverse View Showing Cracks in Hardened Type 420
Stainless Steel Specimen After 12,475 Hours in Boiling pH 5.0 Water.
Etched in Glyceria. Magnification 9X.

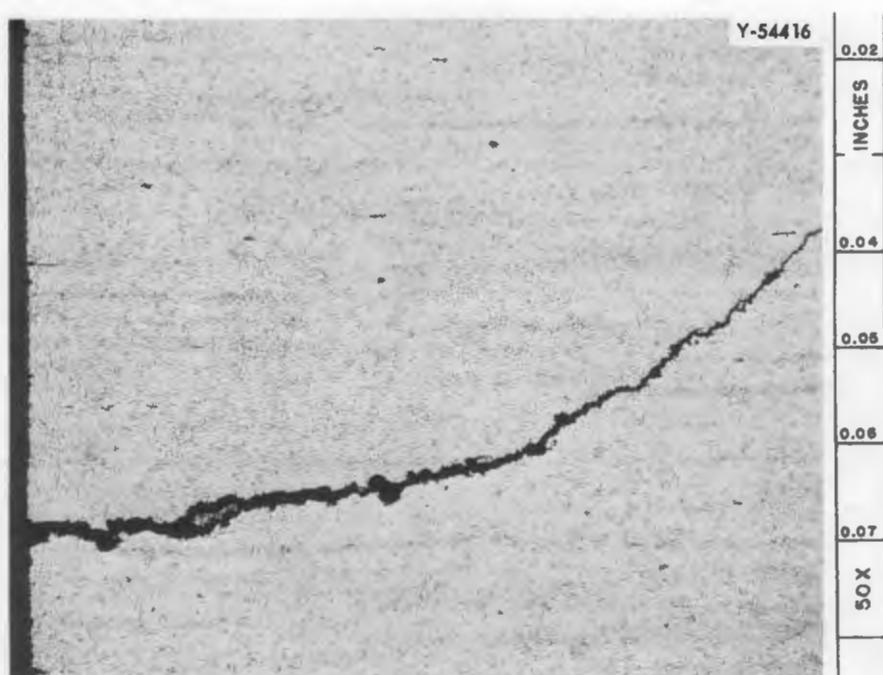
Fig. 4. Appearance of Larger Crack in Hardened Type 420
Stainless Steel Specimen. Etched in Glyceria. Magnification 50X.

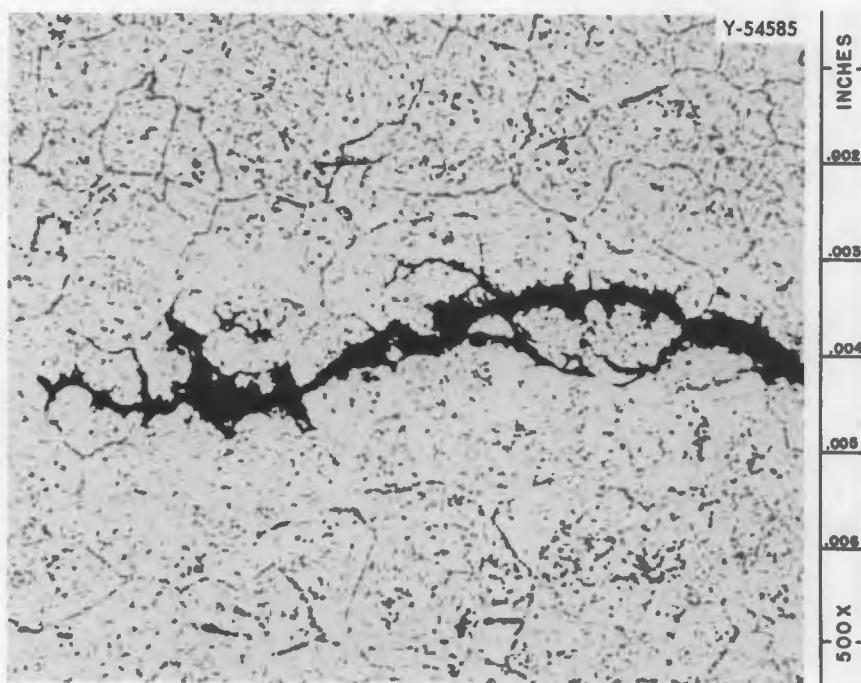
Fig. 5. Enlarged View Showing Predominant Intergranular Nature of Crack in Hardened Type 420 Stainless Steel Specimen. Electrolytic Oxalic Acid Etch. Magnification 500X.

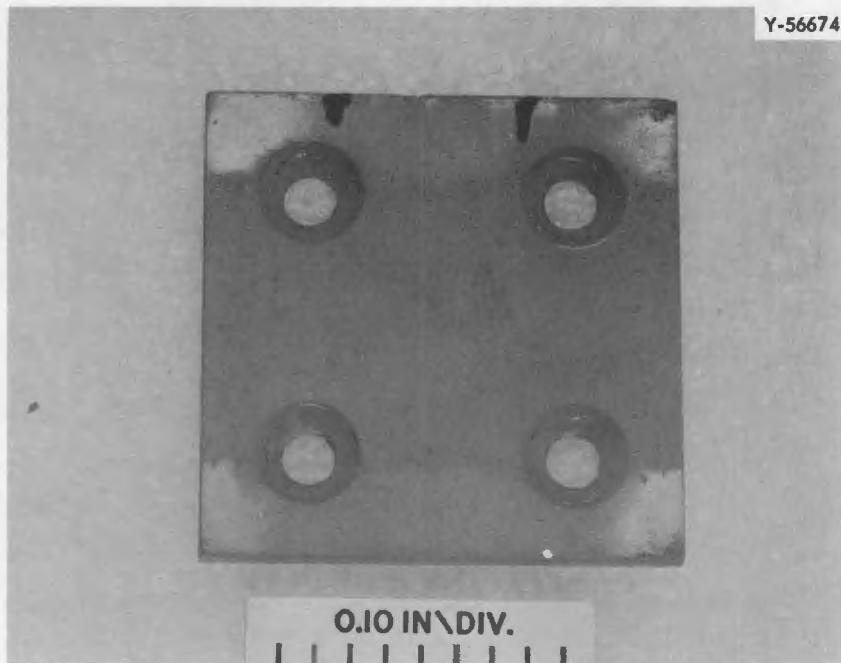
During periodic examination of the beryllium - stainless couples, two cracks were found on one of the beryllium specimens after 10,440 hours of test. Prior to the beginning of the test and frequently up to this time all specimens were examined microscopically at 90X without evidence of cracks. The cracks originated from the edge of the specimen where identification numbers had been stamped. Figure 6 shows the general location of the cracks after the specimen has been separated from the stainless steel upon completion of the test. The four holes are sites where flat-headed stainless steel screws were used to bolt the two specimens together. It appeared that little, if any, extension of the cracks occurred during the balance of the test. Figure 7 shows a macrograph of one of the cracks extending into the flat surface of the specimen. Figures 8 and 9 show magnified views of the two cracks. The deeper crack (Fig. 8) penetrated 7 mils into the metal and the smaller one, 5 mils. A polarized light view disclosed that the cracks were transgranular (Fig. 10).

Fig. 6. Black-Marked Areas on Top of Specimen Show Approximate Location of Cracks on QMV Beryllium Coupled to Type 304 Stainless Steel. Total Exposure: 11,980 Hours at 100°C in pH 5.0 Water.

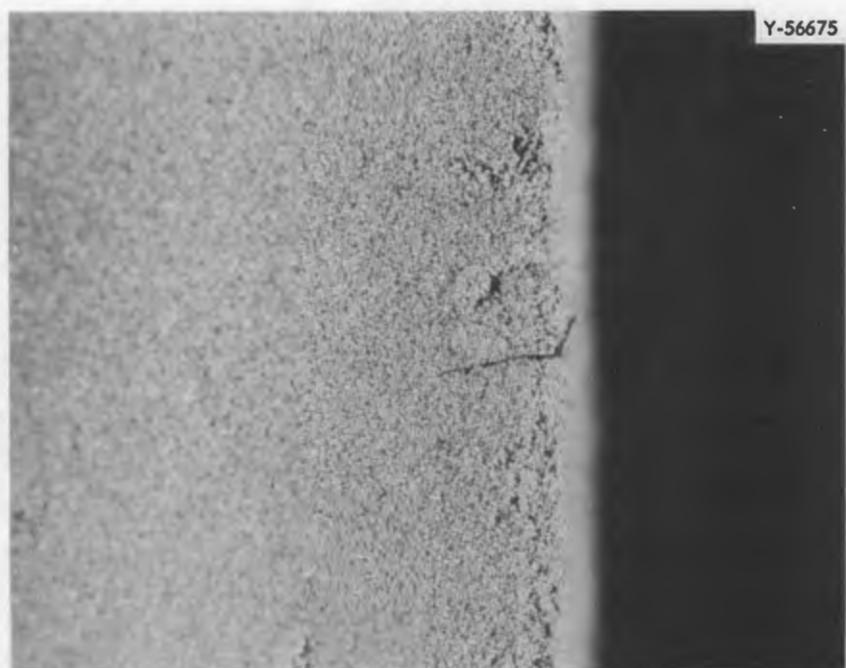
Fig. 7. View of One of Two Cracks in QMV Beryllium Specimen.
Crack Originated on Edge and Extended Across Flat Surface. Defilmed.
Magnification 10X.

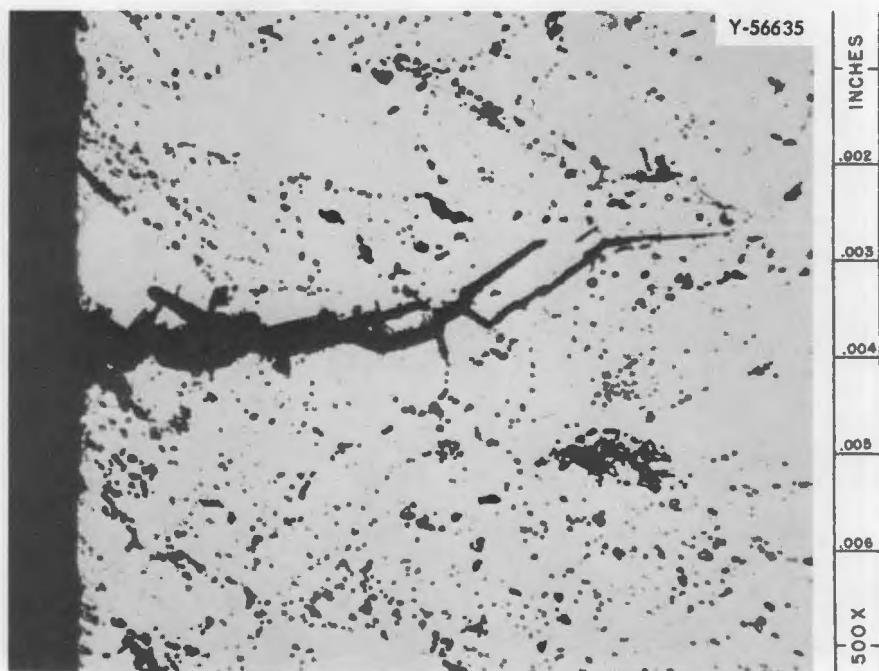
Fig. 8. One of Two Cracks Found in QMV Beryllium Specimen After Extended Exposure in pH 5.0 Water at 100°C. As-Polished. Magnification 500X.

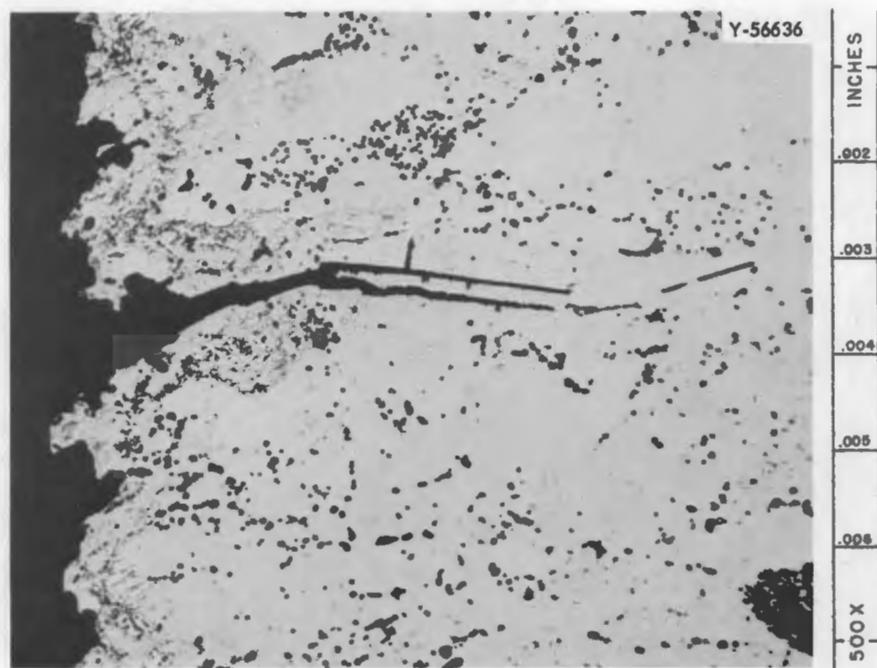
Fig. 9. Second of Two Cracks Found in QMV Beryllium Specimen After Extended Exposure in pH 5.0 Water at 100°C. As-Polished. Magnification 500X.

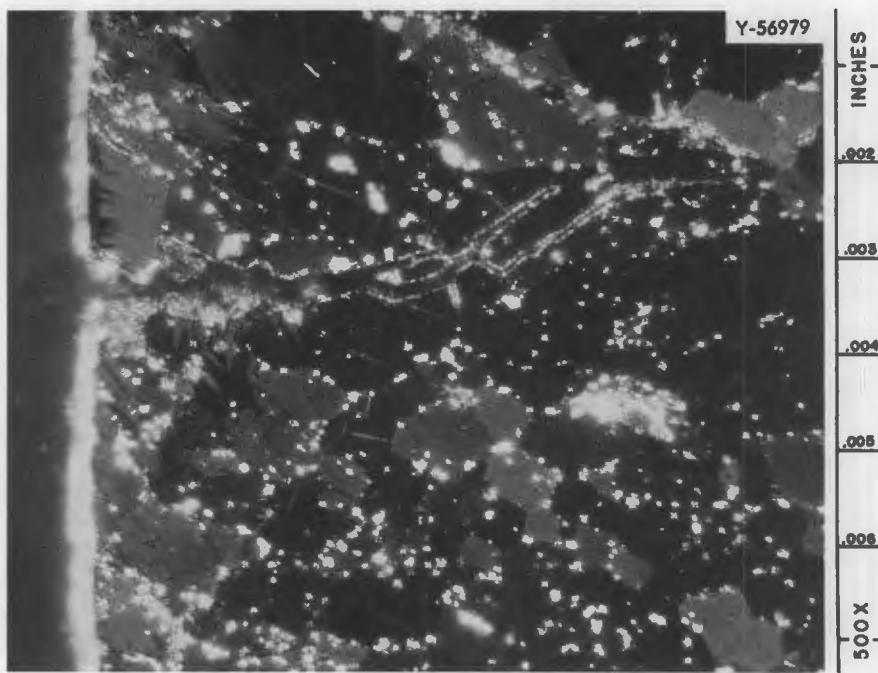
Fig. 10. Polarized Light View Showing Transgranular Nature of Crack in QMV Beryllium Specimen. As-Polished. Magnification 500X.

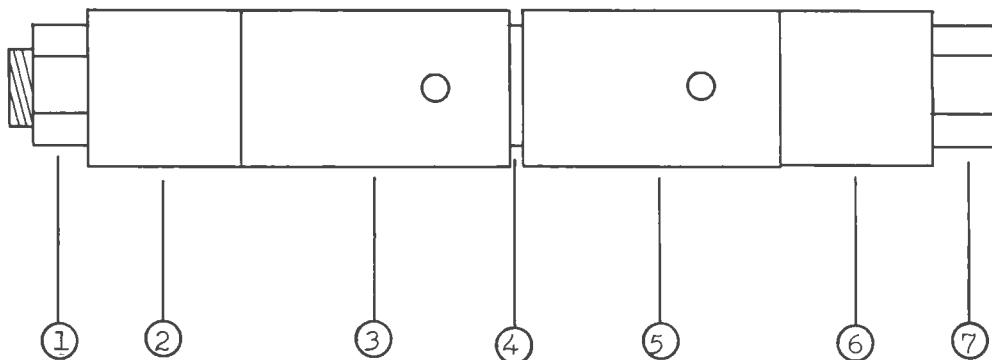
Fig. 11. Schematic Diagram of Galvanic Specimen No. 1.

Galvanic Specimen No. 1 - Figure 11 presents a schematic diagram of galvanic specimen No. 1. Most of the components in the specimen were exposed for a total of 6385 hours during which period the assembly was dismantled six times for evaluation of corrosion behavior of the components. The highest torque required to loosen the assembly was 15 ft-lb at the end of the first run of 265 hours. Thereafter, the torque varied between 6 and 8 ft-lb.

The 1100 aluminum gasket (No. 4 in Fig. 11) was removed after 1775 hours and replaced with a 304 stainless steel gasket. At the same time, an additional 304 stainless steel gasket was placed between the 6061-T6 aluminum and 304 stainless steel sleeves (No. 2 and 3). The total exposure time for the two added gaskets was 4610 hours. At the time of removal, the 1100 aluminum gasket showed pits between 2 and 3 mils deep on contact surfaces.

During the course of the test, scattered pitting developed on most of the aluminum contact surfaces regardless of whether the contacting material was aluminum or stainless steel. Maximum pit depths were 7 to 8 mils at the end of the test. The average corrosion rate for aluminum was 0.1 mpy. Attack on stainless steel components was negligible.

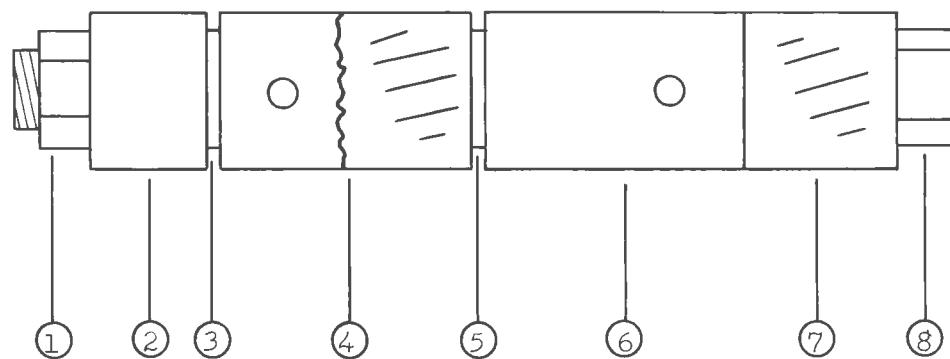
Fig. 12. Schematic Diagram of Galvanic Specimen No. 2.

After the initial 2000-hr exposure, the two 1100 aluminum gaskets (No. 3 and 5 in Fig. 12) were removed and replaced with 304 stainless steel gaskets. In addition, a stainless steel gasket of type 304 was placed between the aluminum-coated stainless steel and the 6061-T6 aluminum sleeves (No. 6 and 7).

The electroless nickel coating underwent severe attack during the initial 770 hours. The observed weight loss was 38 mg/cm^2 , equivalent to a corrosion rate of 19 mpy. At this time, the remaining nickel coating was stripped from the 6061-T6 aluminum sleeve by treatment with hot 15 v/o HNO_3 solution. The sleeve was then pickled in warm nitric-hydrofluoric acid mixture and exposed for the balance of the test in the pickled condition.

The 1100 aluminum gaskets that were removed after 2000 hours had pits up to 5 mils deep, independent of the material contacting them. At the end of the test the stainless steel gaskets showed no measurable corrosion other than some random staining on contact surfaces which were metallic and lustrous in appearance. The partially aluminum-coated stainless steel exhibited a weight loss of 0.7 mg/cm^2 (based on total surface) with scattered pits to 5 mils on the surface contacted by the 304 stainless steel gasket. The totally aluminum-coated stainless steel sleeve showed a weight loss of 1.8 mg/cm^2 with a few pits up to 8 mils

deep on contact surfaces. The most severe pitting occurred on the 6061-T6 aluminum bolt; several pits to 20 mils were found. The corrosion rate for both the bolt and the 6061-T6 aluminum nut was 0.1 mpy for the 13,775-hr exposure. The aluminum sleeve from which the electroless nickel plate was removed by acid stripping after the initial 2000 hours corroded at a rate of slightly less than 0.1 mpy. Several pits reaching a maximum depth of 7 mils were found on the surface contacted by the stainless steel gasket. No pitting was found other than on contact surfaces of the aluminum members of the multimetal assembly.

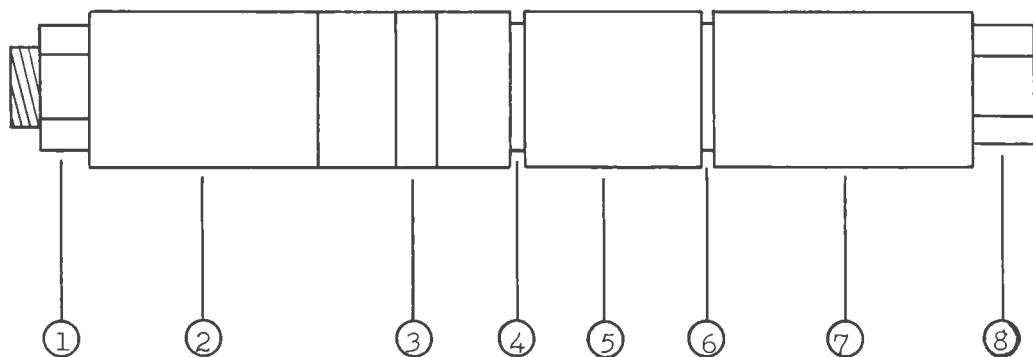
Fig. 13. Schematic Diagram of Galvanic Specimen No. 3.

Galvanic Specimen No. 3 - Figure 13 shows a schematic diagram of galvanic specimen No. 3. Included in the assembly were components of type 304 stainless steel and 6061-T6 aluminum that were "electrolyzed" by a proprietary process. The deposited coating contains approximately 97% Cr with the balance iron and silicon. The electrolyzed components included a 304 stainless steel nut (No. 1 in Fig. 13), threads only on the 304 stainless steel bolt (No. 8), a 6061-T6 aluminum sleeve (No. 5), and a second 6061-T6 aluminum sleeve with a groove 10 mils deep by $\frac{1}{8}$ in. wide machined through the electrolyzed layer.

After an initial run of 1000 hours, a torque of 5 ft-lb was sufficient to loosen the assembly, indicative of freedom from galling. The two 1100 aluminum gaskets showed a few scattered pits to 3 mils in depth on contact surfaces. One contact surface of one of the electrolyzed aluminum sleeves (No. 5) was badly flaked; the second electrolyzed sleeve (No. 3) showed less intense flaking on both contact surfaces. There was no evidence of flaking in the machined groove around the periphery of the latter sleeve. The electrolyzed layer on the stainless steel components was in excellent condition. Similarly, the bare 304 stainless steel sleeves showed no signs of corrosion damage.

Prior to the start of the second run, a $\frac{1}{8}$ -in.-thick Delrin plastic gasket was placed between components No. 7 and 8 in Fig. 13 and the assembly was torqued to 5.5 ft/lb. The second run lasted 1520 hours. During this period the Delrin gasket underwent nearly complete degradation thereby releasing the torque on the assembly. The contact surfaces on

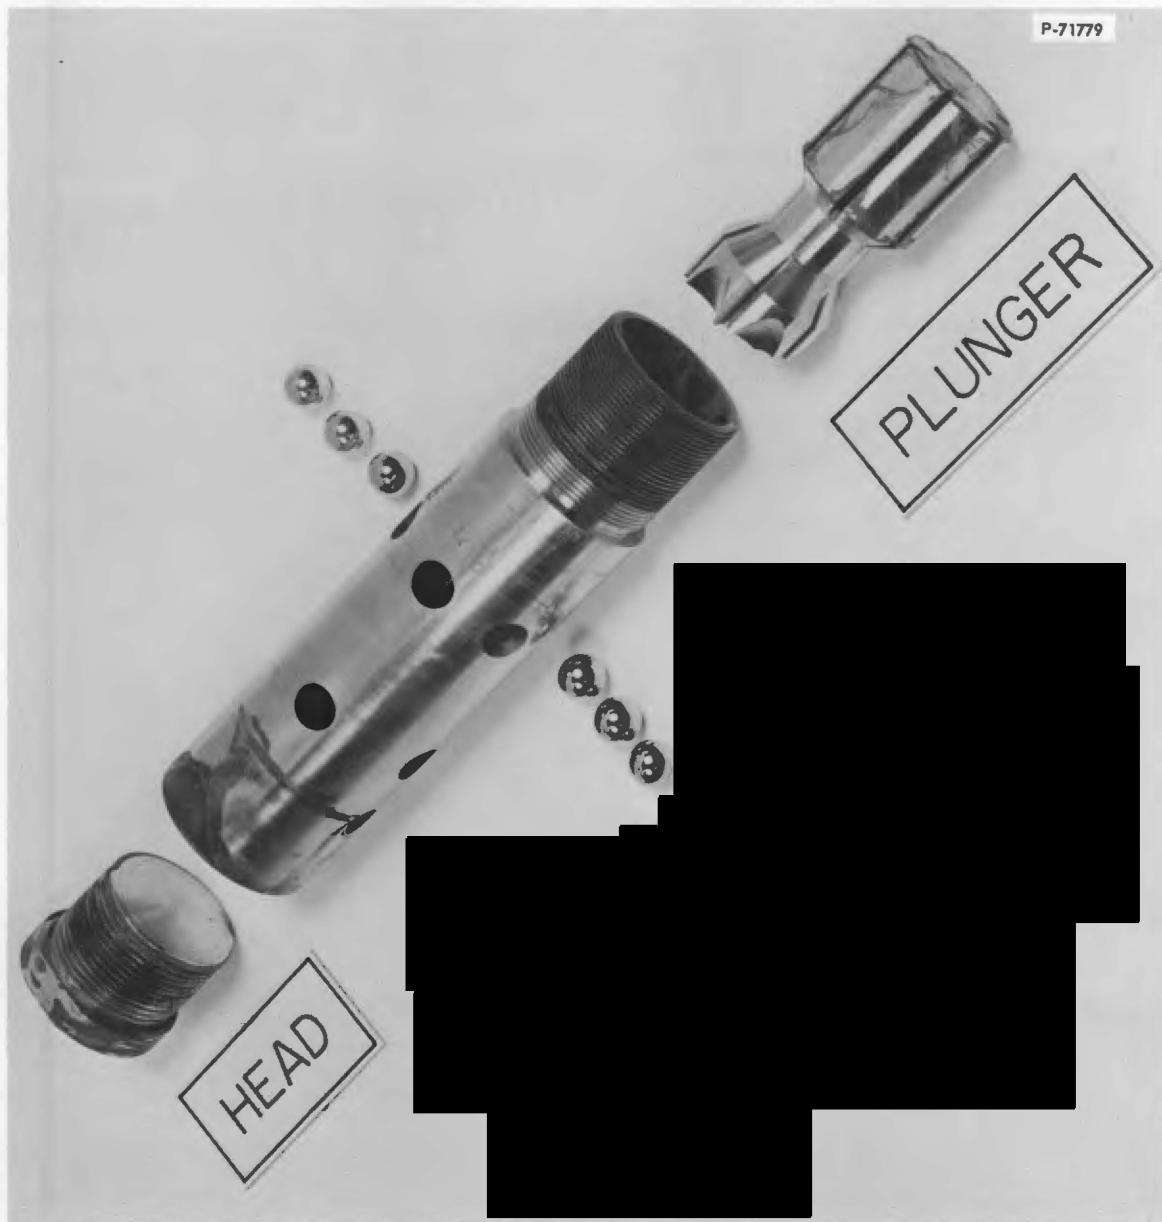
Fig. 16. Post-Test Condition of Ball-Latch Mechanism After 11,770 Hours in pH 5.0 Water at 100°C.
