Handling and Treatment of Sodium-Potassium Alloy (NaK) after the Loss of Key Personnel 19002

October 2018

Idaho National Laboratory

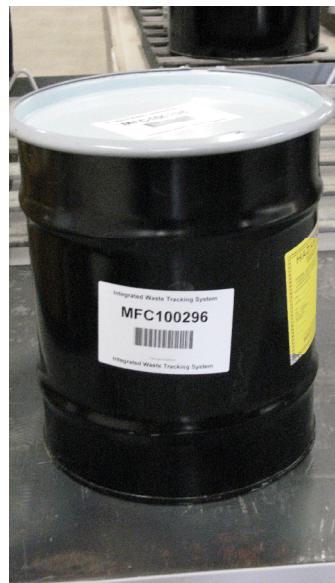
Complex (MFC) research building, located on the Idaho National Laboratory. Workers were transferring 2-3 ounces of NaK from a metal can to a poly bottle so that it could be sent off for characterization. During transfer to the poly container, a reaction of NaK with air was observed in the metal can and poly container. This was an anticipated event. As noted in a critique report the poly bottle also generated heat resulting in a silver dollar sized melted spot on the bottle². In response the two containers were flooded with argon, closed and placed in a safe condition. The workers immediately made notifications and the fire department was deployed as a precautionary measure. The containers were observed overnight with no additional reaction noted. The following day the containers were further packaged into a 10 gal drum and moved to a Resource Conservation and Recovery Act-permitted storage facility. The container was labeled and barcoded with container number MFC100296, see Figure 1. The container was transported to the storage location via a drum dolly on foot for approximately two blocks from where it was generated. According to one employee the trip took several hours because the drum heated up significantly at the slightest bump. Long cool down periods were required between short moves.

Figure 1. 10-gal container containing poly bottle with 2-3 ounces of NaK.

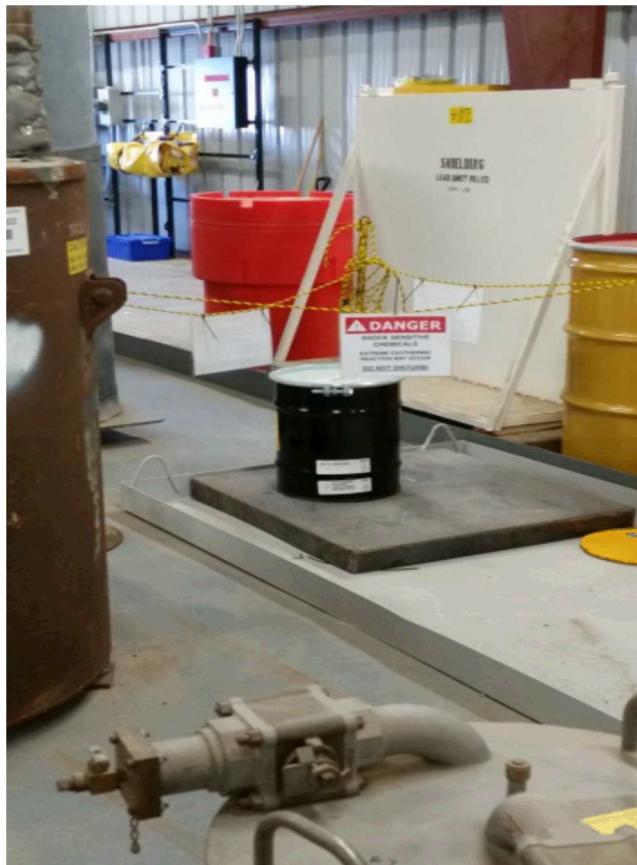
As a result of the assessment, an operability review by MFC Environmental, Safety, and Health to ensure adequacy and compliance with applicable requirements was performed. This review concluded that the container was acceptable for storage and that the container was properly labeled and inspected per the permit. Based on review by Industrial Safety and Health several controls were put in place which included, limiting access to the locked building, isolating the container by roping and posting as “shock sensitive”, see Figure 2, and suspending forklift operations pending further expert analysis.

Figure 2. 10-gal container containing poly bottle with 2-3 ounces of NaK

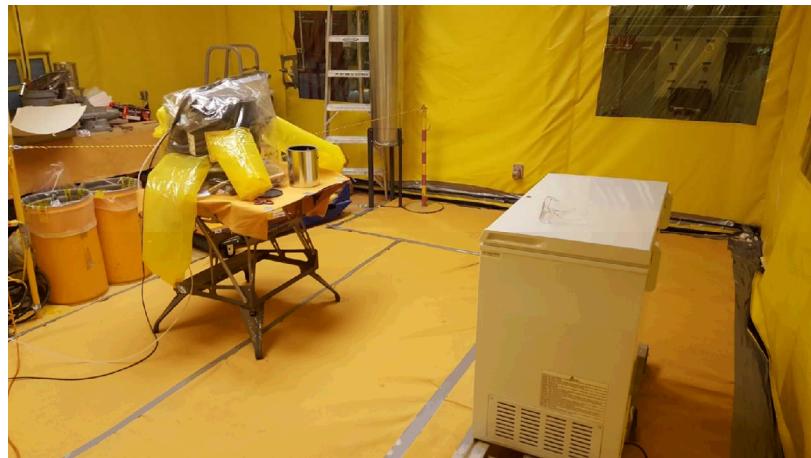
Figure 6. Showing freezer and glovebag with container

After completion of training MFC personnel developed a detailed inspection plan. The plan considered all associated risks in order to open and visually inspect the container. The inspection plan allowed for the container to be handled, transferred, opened, and inspected. The container was placed in a freezer at the storage location to ensure it would be maintained below its melting point in order to provide a more stable state for transferring the container to a separate inspection and treatment location elsewhere at MFC. After 24 hours the freezer was transferred via a forklift from the permitted storage facility to a facility where treatment of sodium and NaK is permitted. The freezer was brought into a large area enclosure tent where the container was removed from the freezer. The container was then placed into a glovebag that was sealed and inerted with argon, see Figure 6. The container was opened and the contents of the drum were inspected³. A small 60 ml poly bottle with a small amount of NaK was found which appeared to be approximately 2-3 ounces which coincides with what was indicated in the critique report. The poly bottle had signs of burns as noted in the critique report as well. Personnel also looked for oils or evidence of superoxides. No evidence of oils or superoxides were noted. The NaK container was then removed from the glovebag and transferred to a RCRA-permitted water wash vessel where the NaK was reacted. Due to the small amount of NaK, minimal reaction was noted.

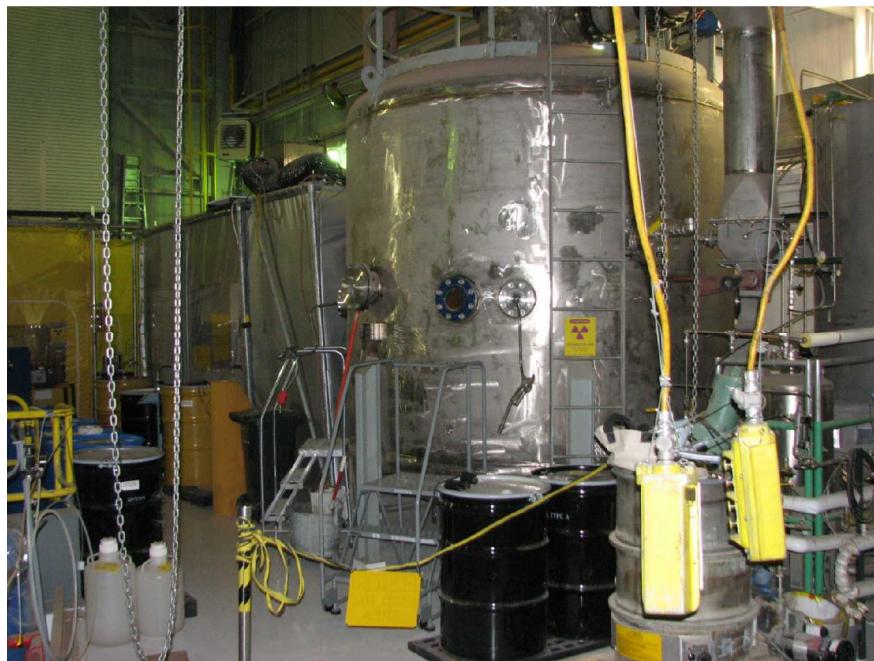
The water wash vessel is used to deactivate ignitable and reactive hazardous waste and has an operating limit of 5 pounds of NaK or sodium. The water wash vessel has been used since 1981 and is a vertical cylindrical tank. It is approximately 10 ft in diameter and 12 ft high. The water wash vessel has a personnel and equipment access door on one side to allow for the placement of materials and the removal of any reactants. Removable floor grating is installed near the bottom of the tank to provide a working platform for personnel and equipment. There are four penetrations for spray lances to discharge water in a controlled manner and three viewing windows to observe the deactivation operations. See Figure 7 showing a picture of the water wash vessel.
