SPIE Laser Damage Symposium 2014

# Repair of a Mirror Coating on a Large Optic for High Laser Damage Applications using Ion Milling and Over-Coating Methods

Ella Field, John Bellum, and Damon Kletecka  
Z-Backlighter Laser Facility, Sandia National Laboratories

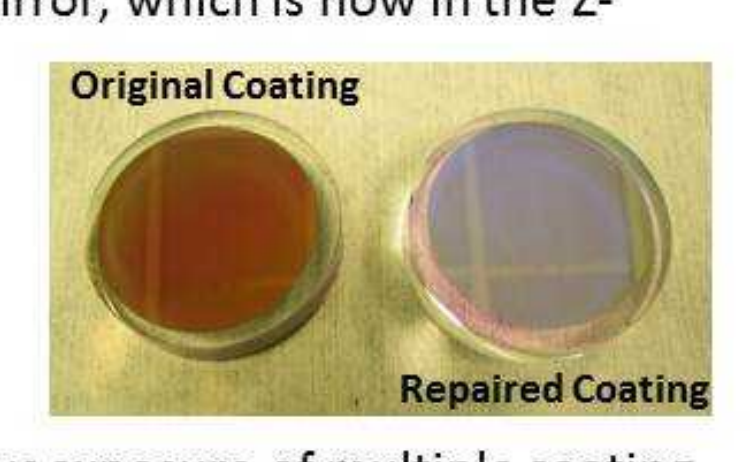
- Removing select layers (method 3)**
- LIDT compromised by poor spectral mismatch
  - Same etch non-uniformity leads to simultaneous exposure of multiple coating layers in bands across large optics

- We removed 10 layers from a 34-layer analogue of the original 42-layer coating. Layer 27 was intentionally an Hf metal layer. We etched through layer 25 and recoated 10 layers on top of it to form a repaired 34-layer coating free of Hf metal.

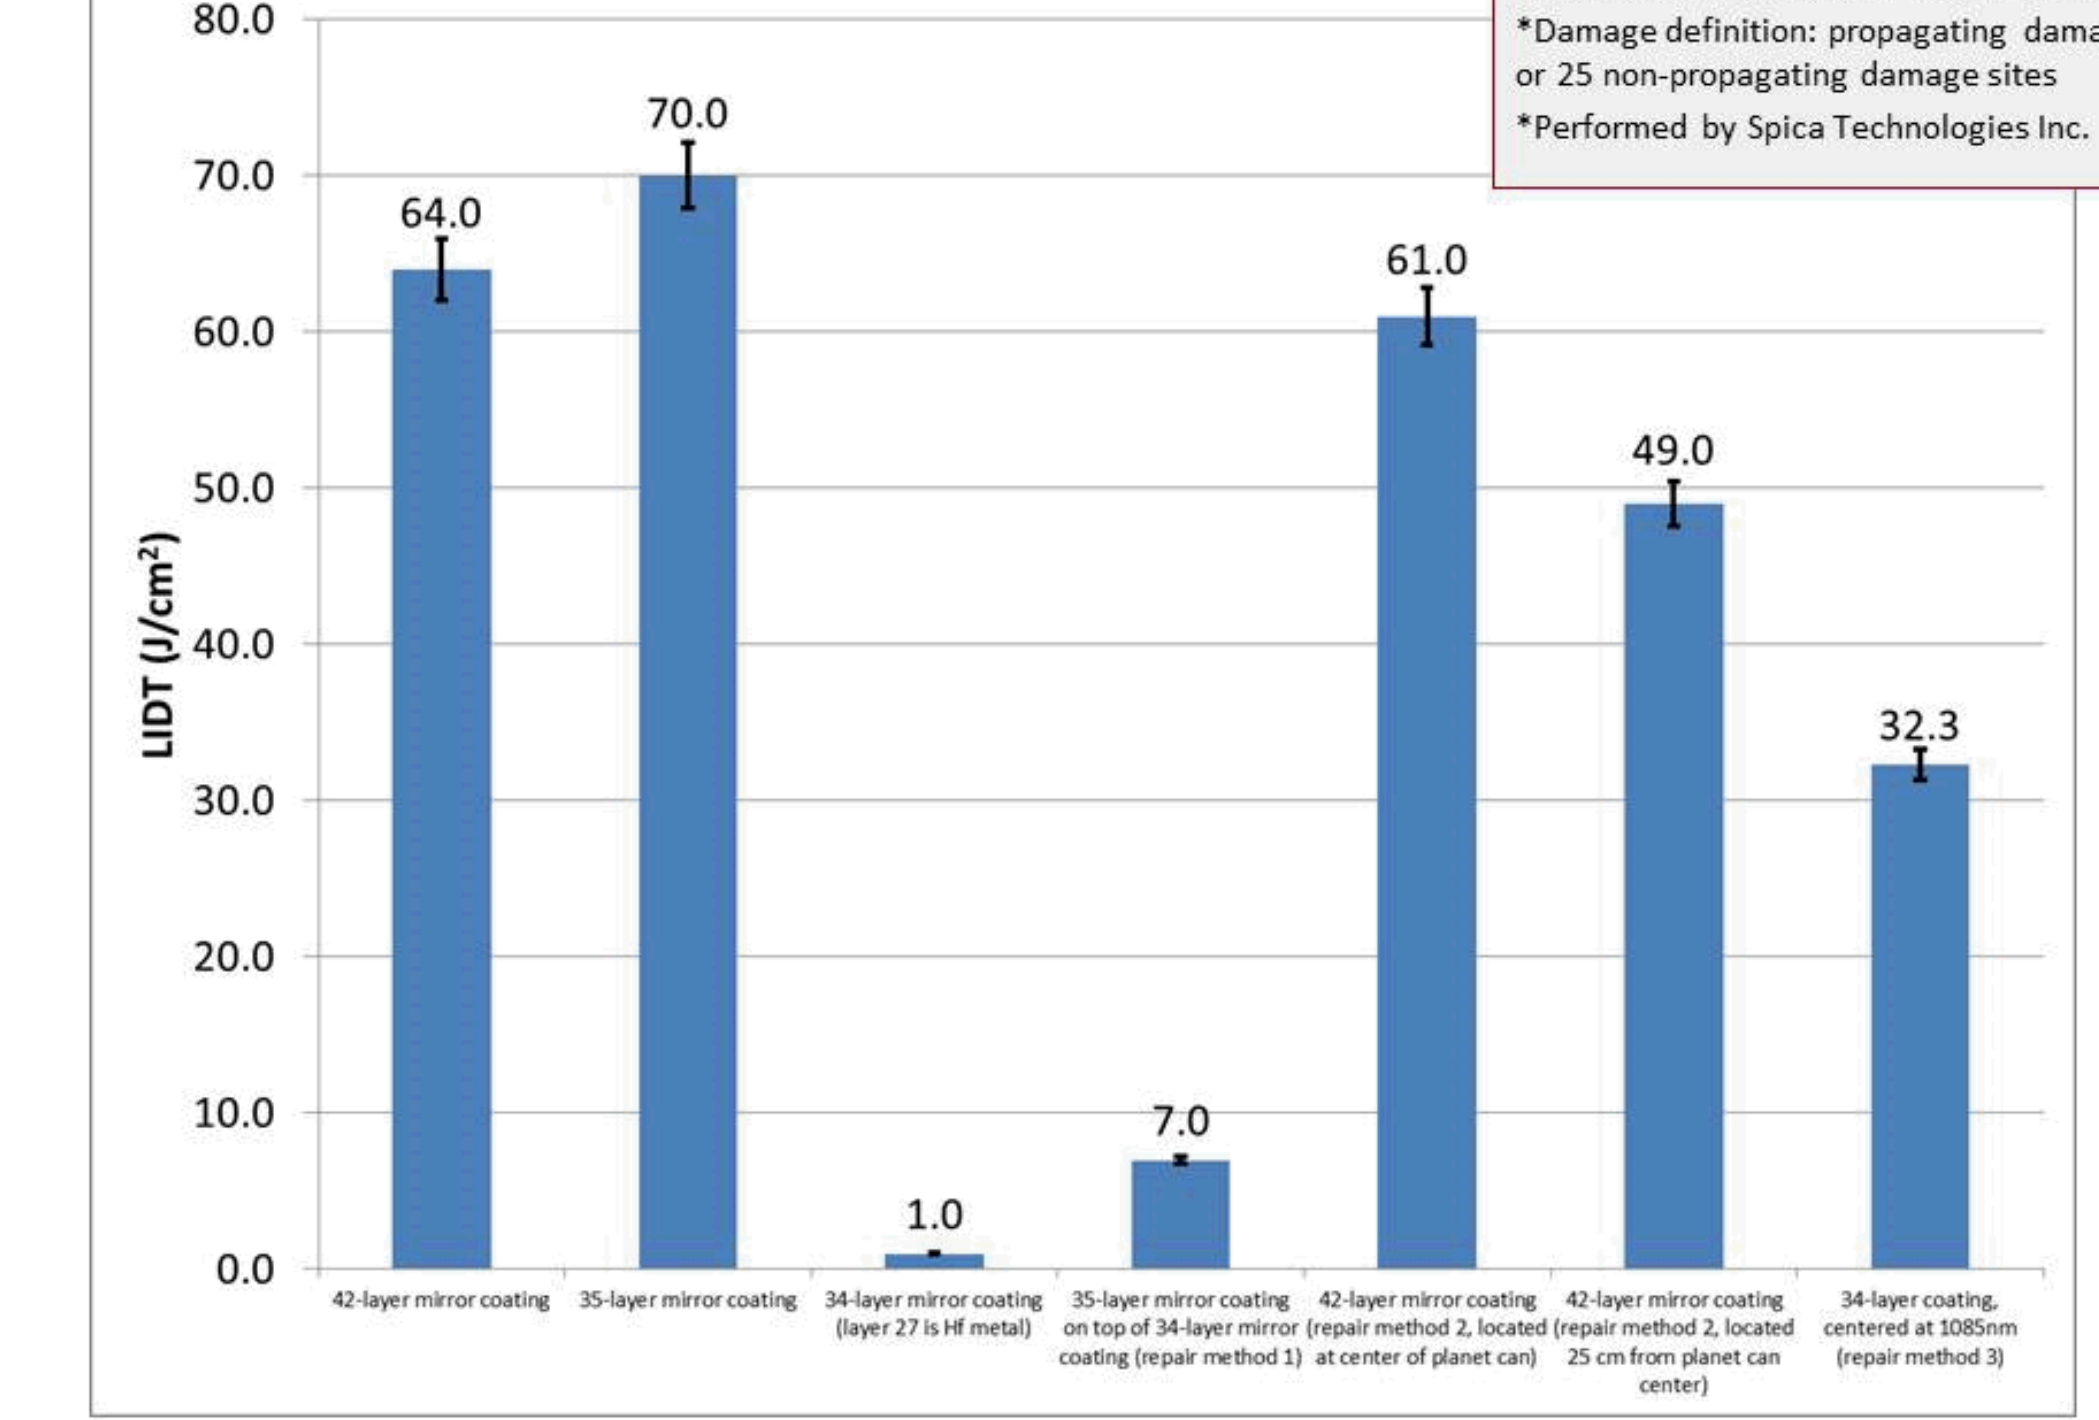
## Laser damage results

- Removing the entire coating (method 2)**
- Good laser damage thresholds achieved (49 to 61 J/cm<sup>2</sup>)
  - ~10 days required to remove 42 layers from the 65 cm diameter optic

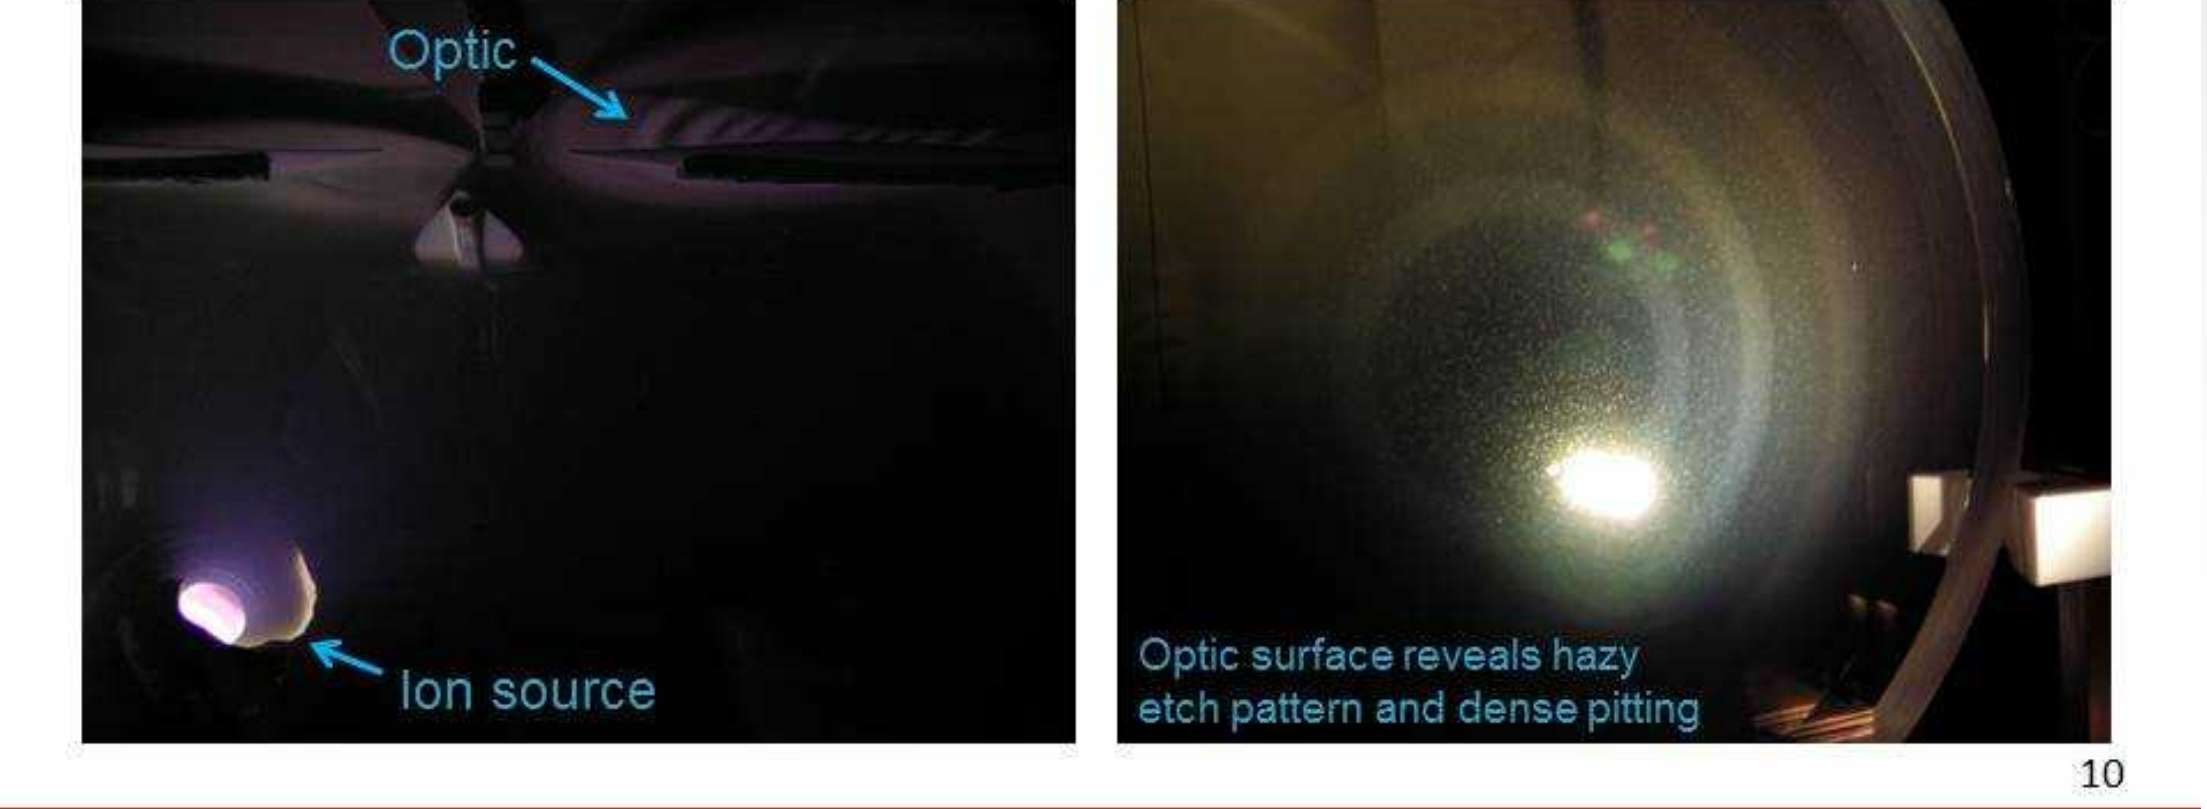
## Ion milling concerns: non-uniform etch rate

- Not a problem for small optics (~12 cm diameter)
- Faster etch rate at the center of the optic means the coating was completely removed from the center before the edges were finished. This means the bare substrate was etched as well, giving it slight curvature. At worst, we estimate the substrate radius of curvature to be 32 km.

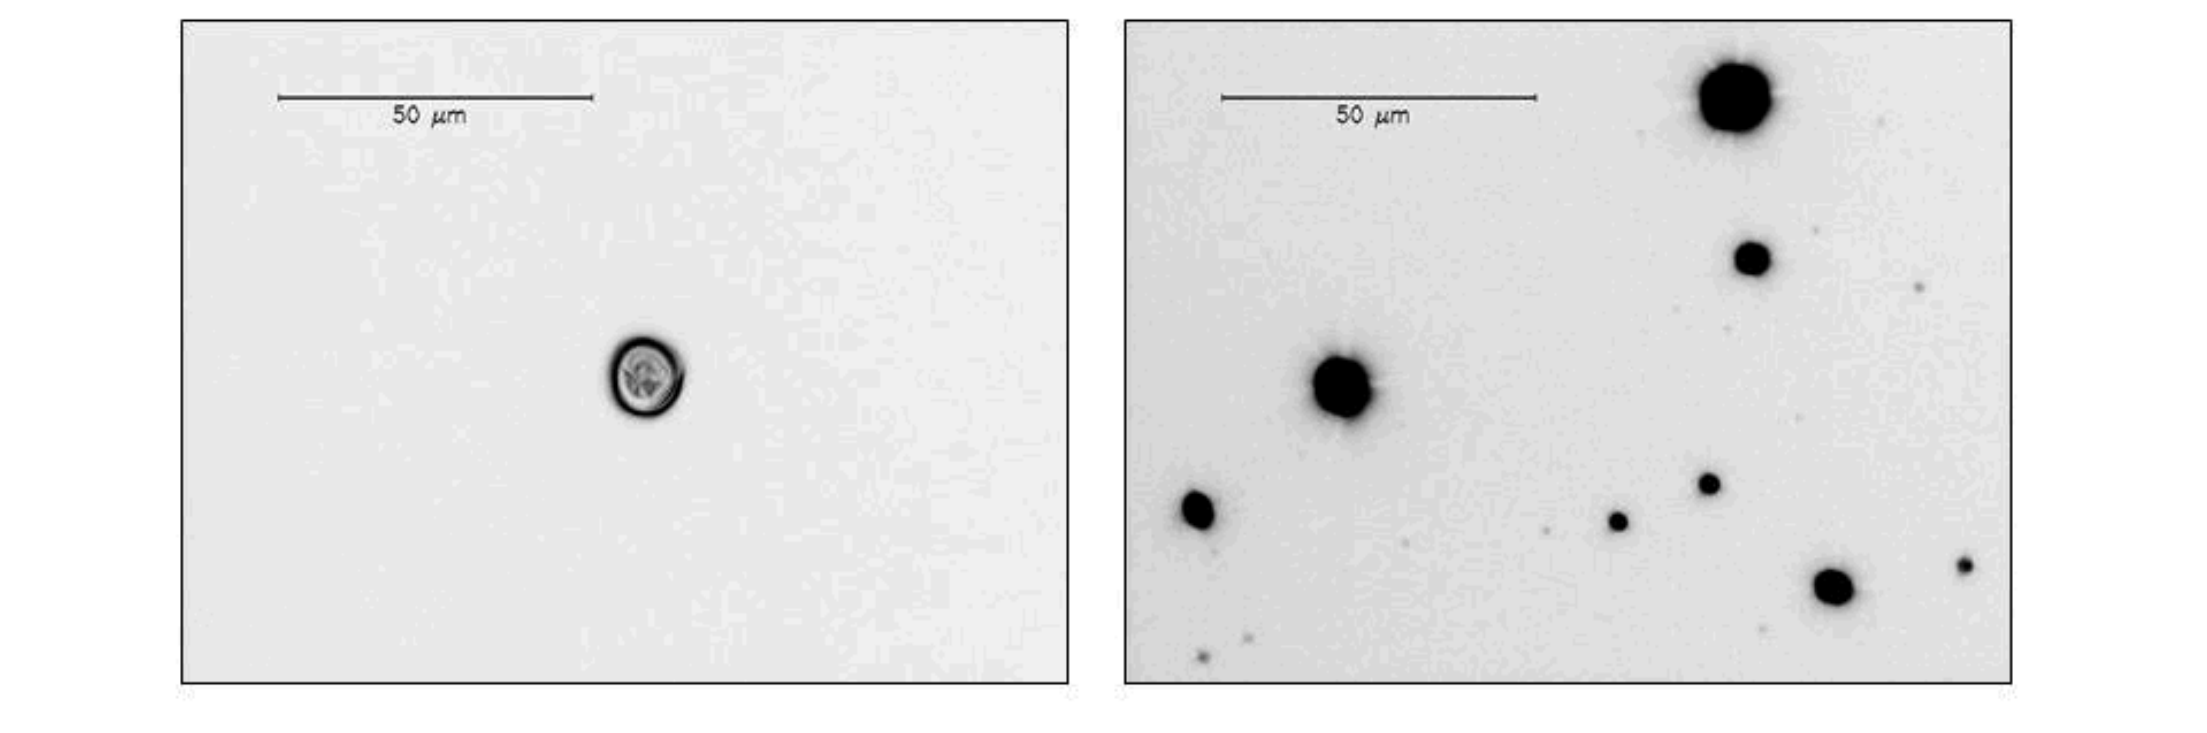
## Ion milling concerns: pitting on substrate surface

- 5 – 10 micron pits appear over entire optic surface
- Consider trying lower ion energies to reduce pitting, though this will increase the etch time

\*Despite the pitting and non-uniformity of the etch, the mirror is performing well in the Z-Backlighter beam train
