Tribological Characterization of Hohman Plating Ni-PTFE Thin Films (ENOVA)

Prepared by: Nicolas Argibay

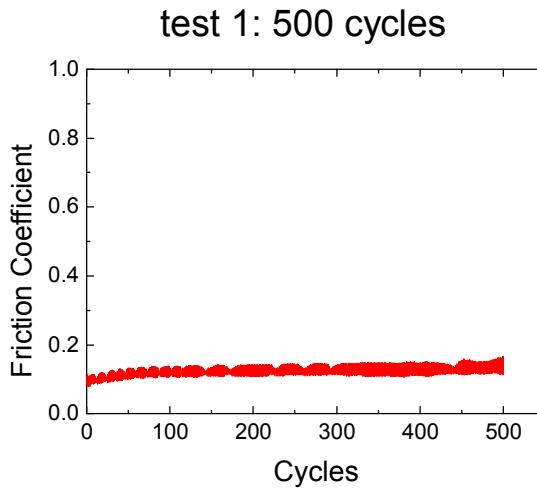
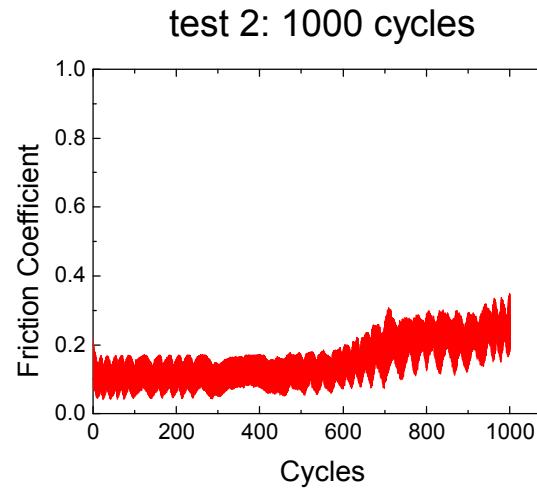
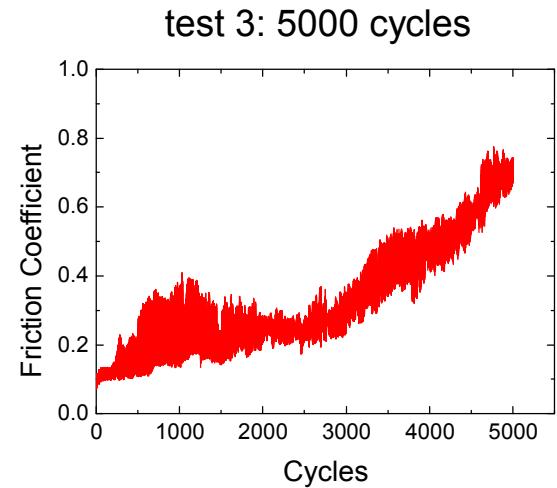
Friction data at 100 mN load

- These experiments were carried out using an 1/8" diameter 440C steel ball at 10g and 10 mm/s.
- The maximum (Hertzian) contact stress is approximately 290 MPa (42 ksi) -- relatively high

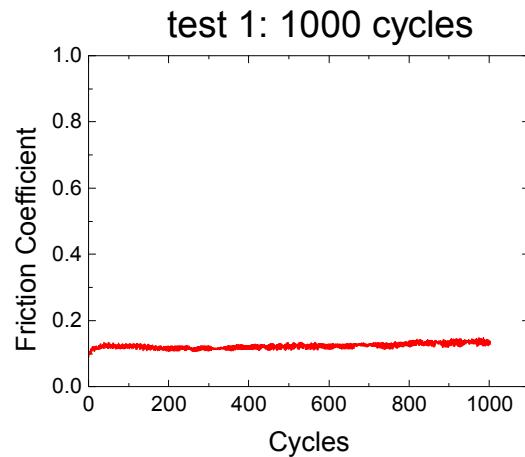
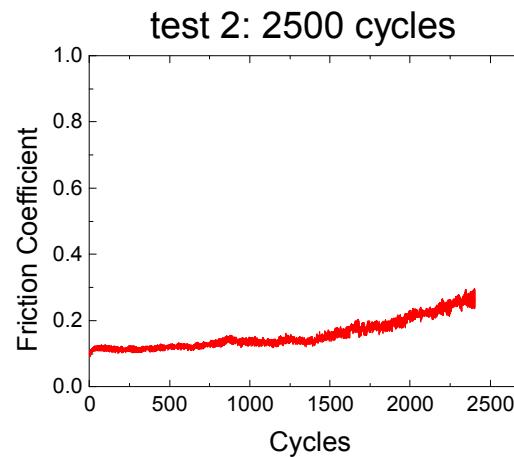
Friction data at 1 N load

- These experiments were carried out using an 1/8" diameter 440C steel ball at 100g and 10 mm/s.
- The maximum (Hertzian) contact stress is approximately 625 MPa (91 ksi)

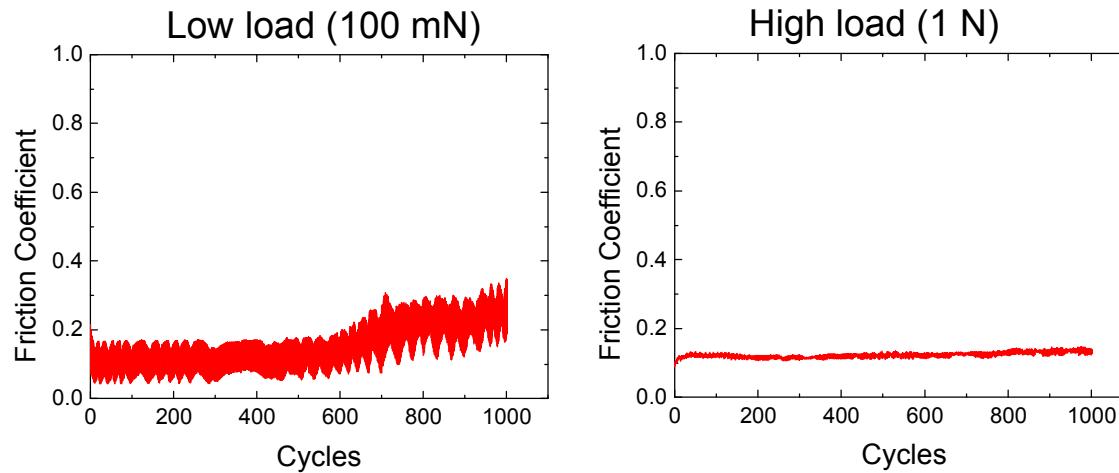
Comparison

- Key Result: The friction rose faster for the gentler contact condition (paradoxical!)
- Hypothesis: The PTFE wears off at the gentler load, exposing Ni that is wearing too slowly to expose fresh PTFE to lubricate the contact... so friction rises

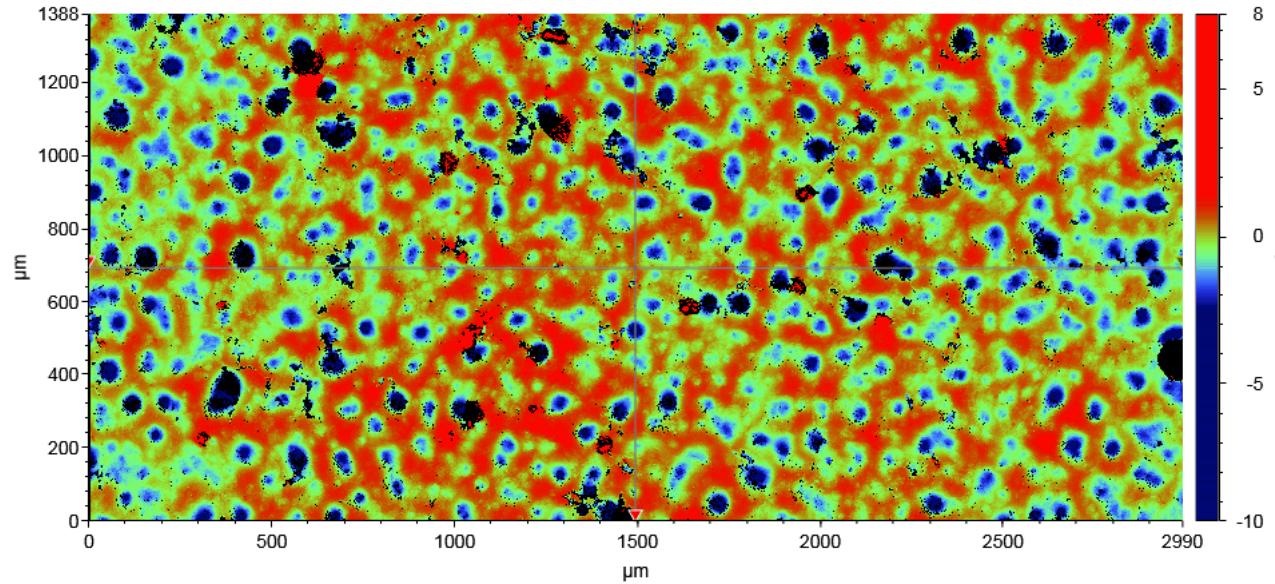
Even at relatively high loads, wear was very low

- Interferometer topographical map showing the roughness and surface texture of the Ni-PTFE coated 6061 Al block with 10 μ in surface finish

- Actual average roughness was 24 μ in (608 nm)
- The porosity is common in electroless plating of Ni coatings
- Wear was low (the 1k cycle wear track is in this image!)

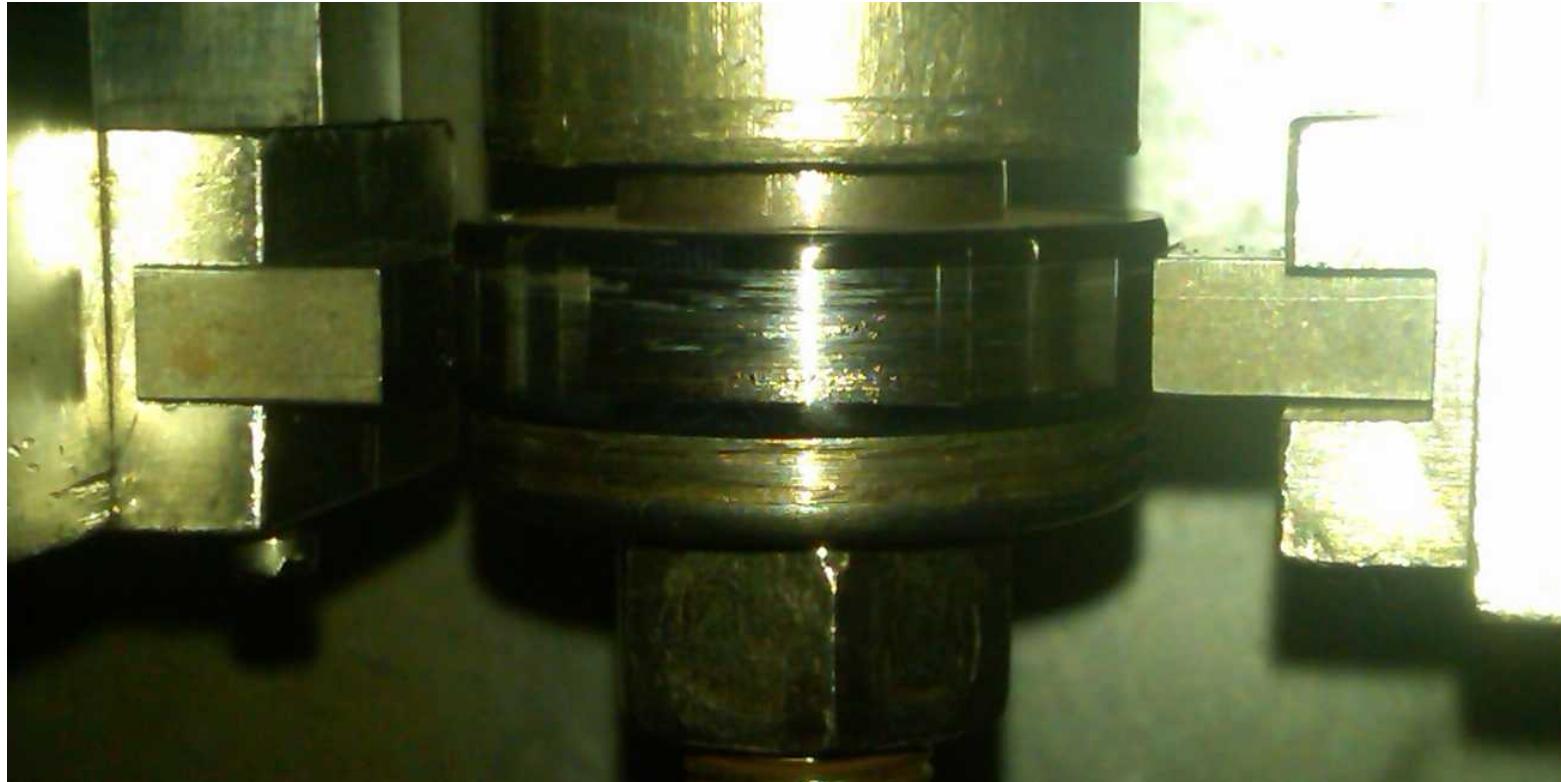
Damage on Falex test specimen does not look
commensurate, were the contact stresses similar?

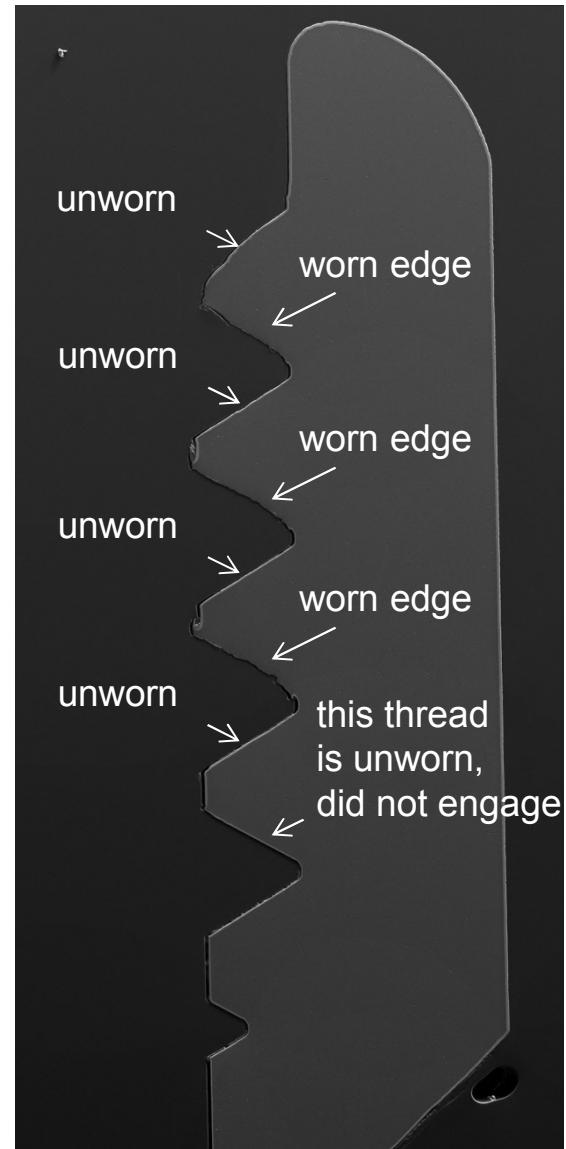
Images of sectioned cap, worn 1k cycles (seized?)

This is a stitched composite of SEM images for a worn (seized?) cap in cross-section. The next slides show closer views. You can see that the Ni-PTFE and Ni films are worn completely off only on the thread surfaces on one side (where they engage, see arrows in the image to the right)

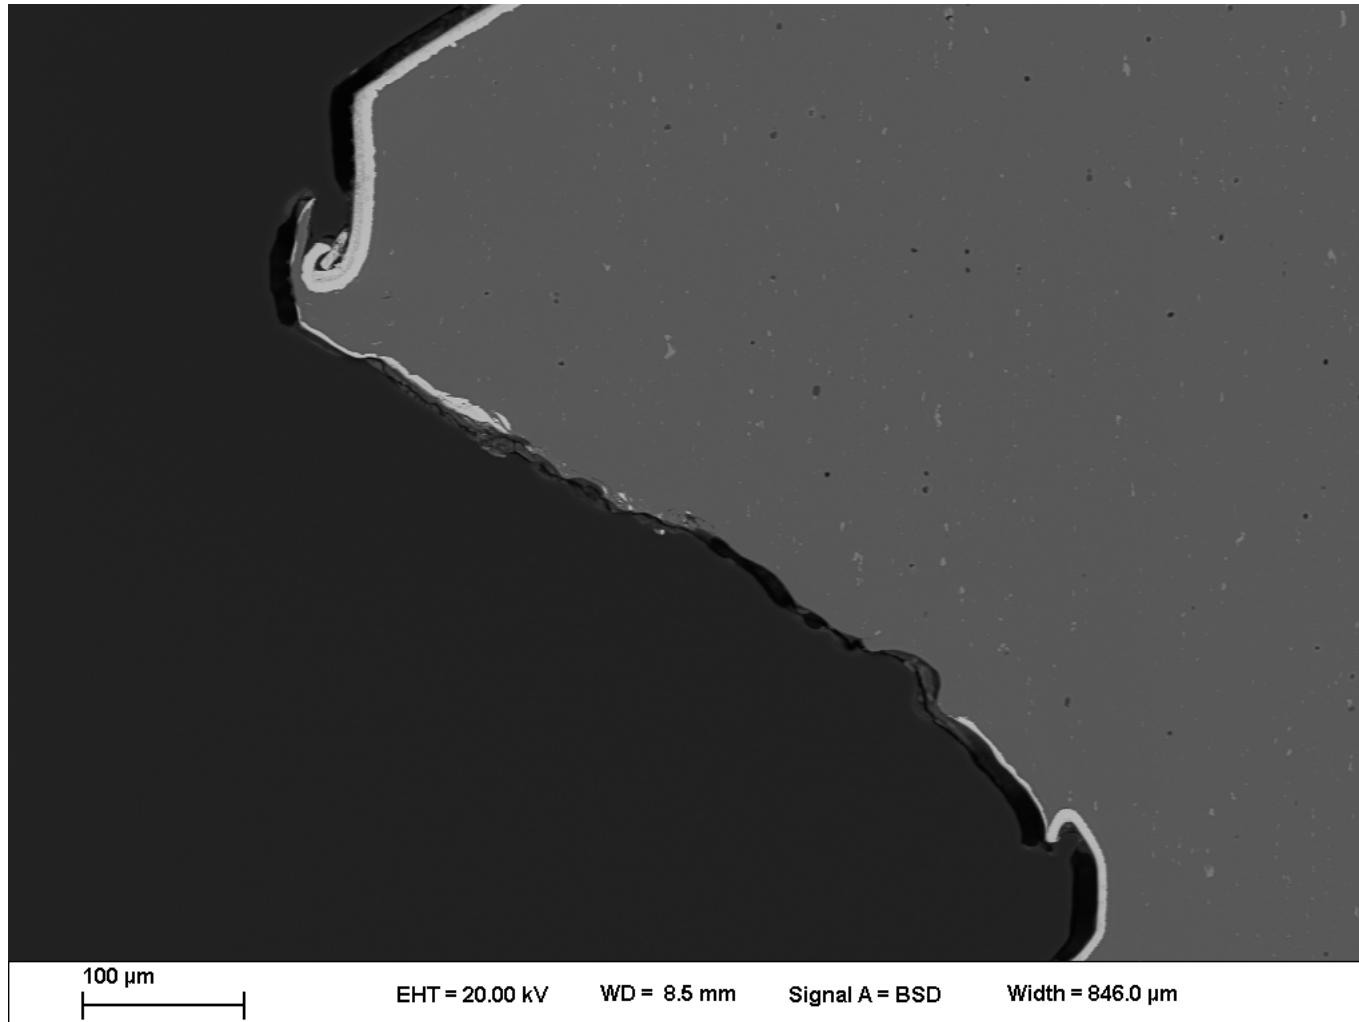
Highly damaged thread surface, coating almost completely worn through

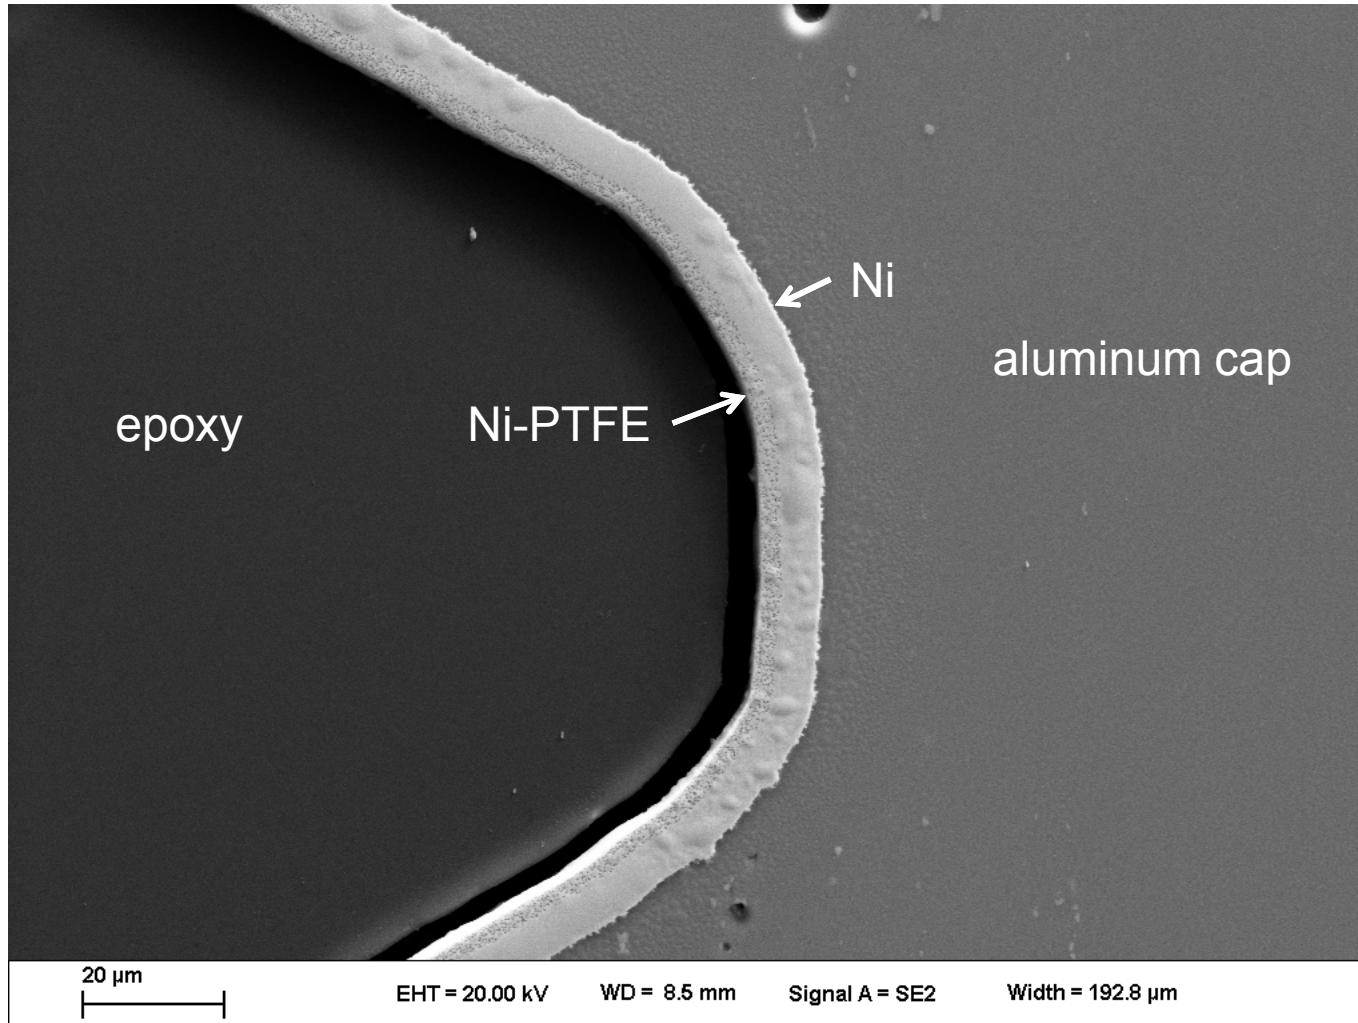
SEM of coating at the base of a thread that did not engage, so exemplifying what the coating looked like as-deposited

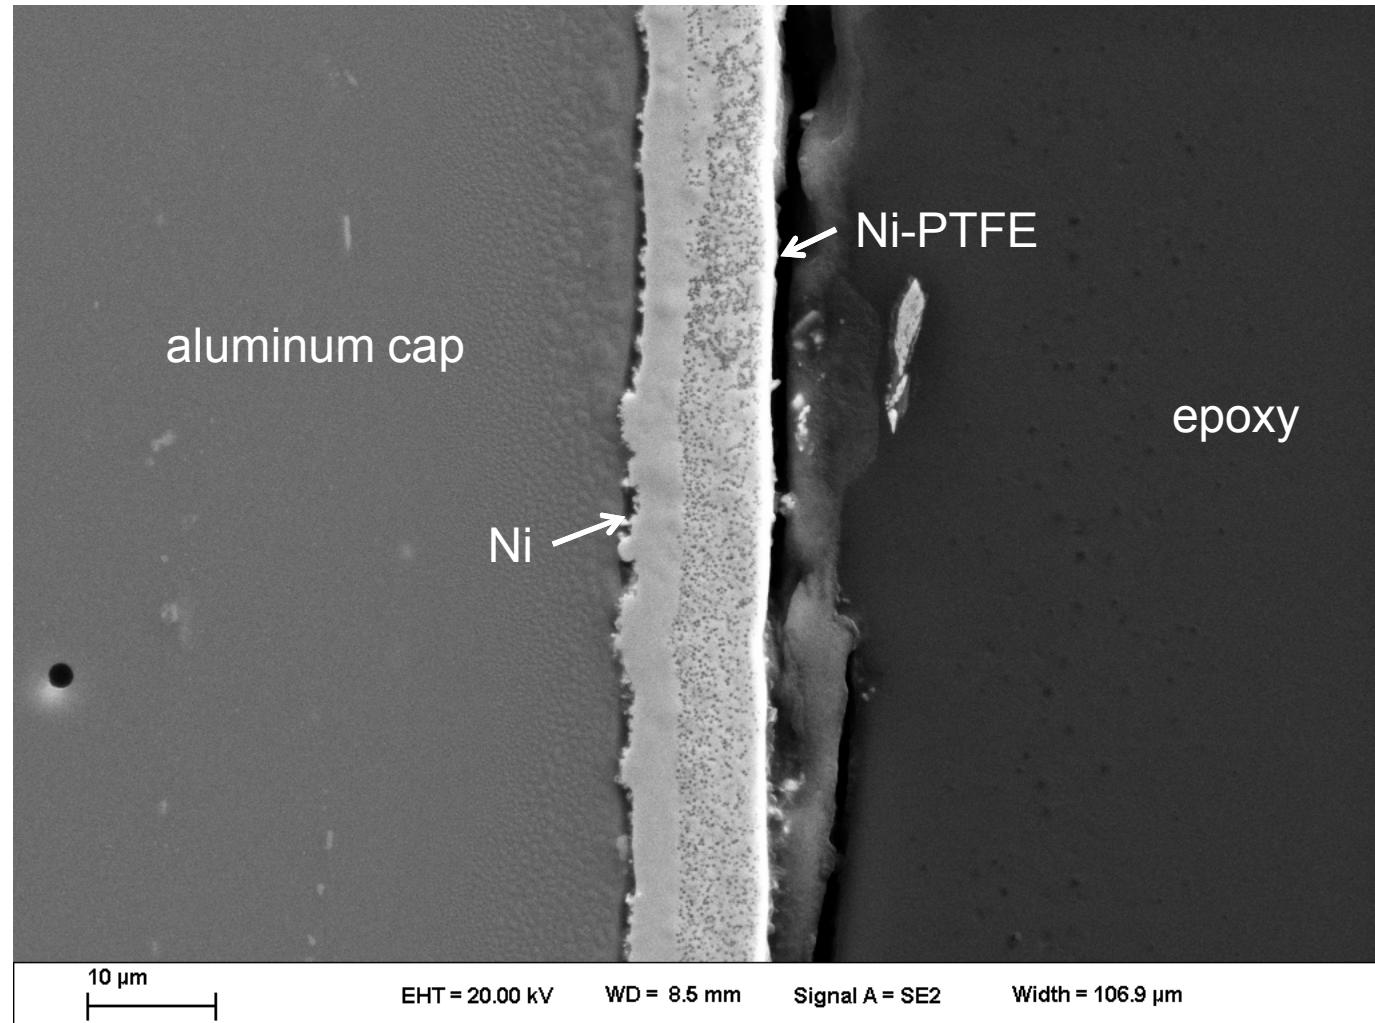
Now looking in an area near the base of the cap that also did not engage, there is evidence that the thickness of the Ni and Ni-PTFE layers is inconsistent throughout the part

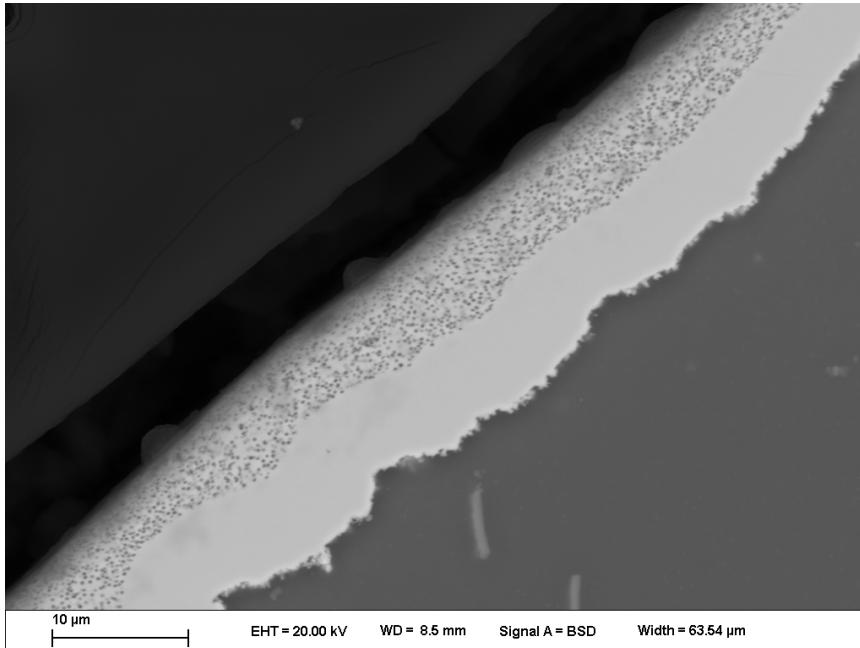
good adhesion to cap

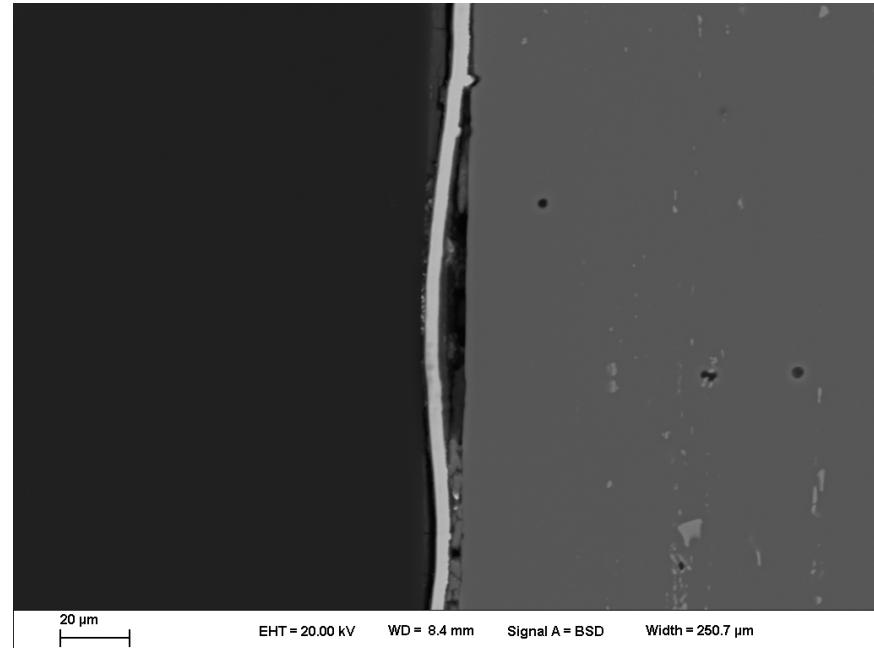
bad adhesion to cap
(and Ni-PTFE layer
apparently missing!)

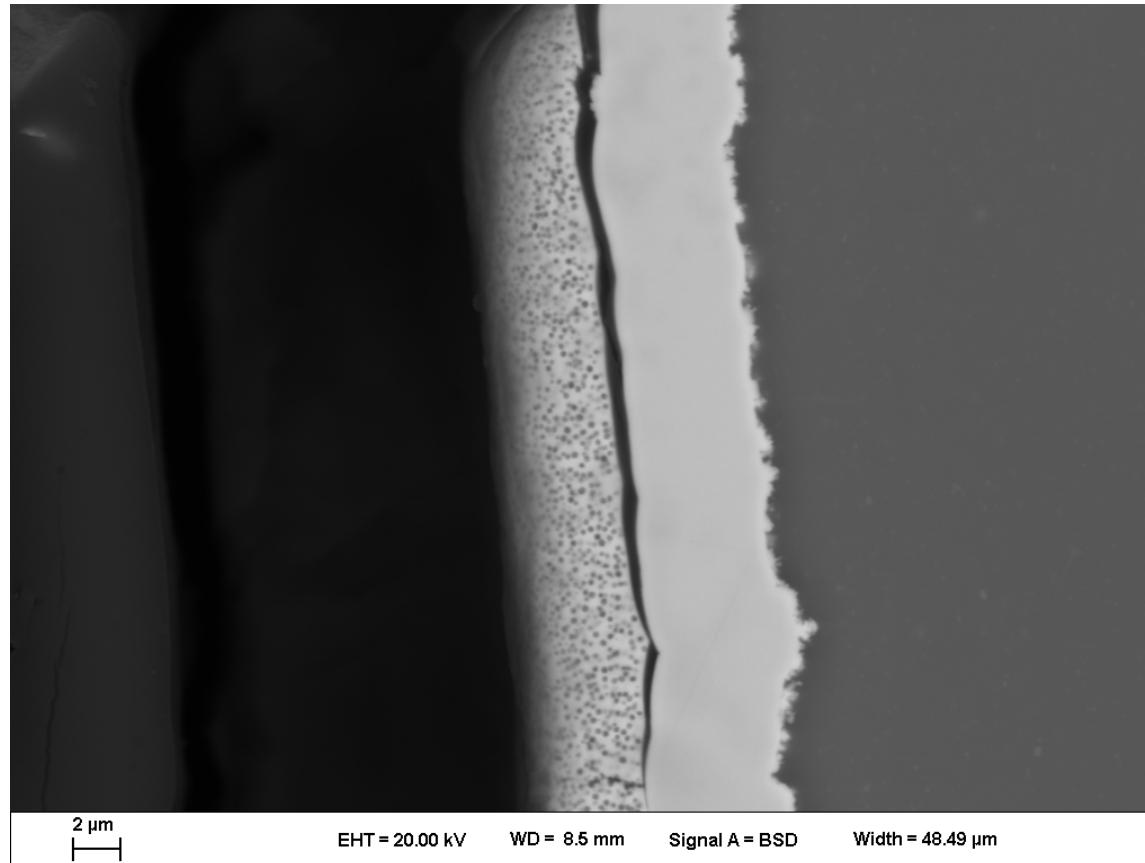
Missing Ni-PTFE in some areas...?

In some areas we saw that the Ni-PTFE layer was debonding from the Ni layer... which likely explains the missing Ni-PTFE in the previous image

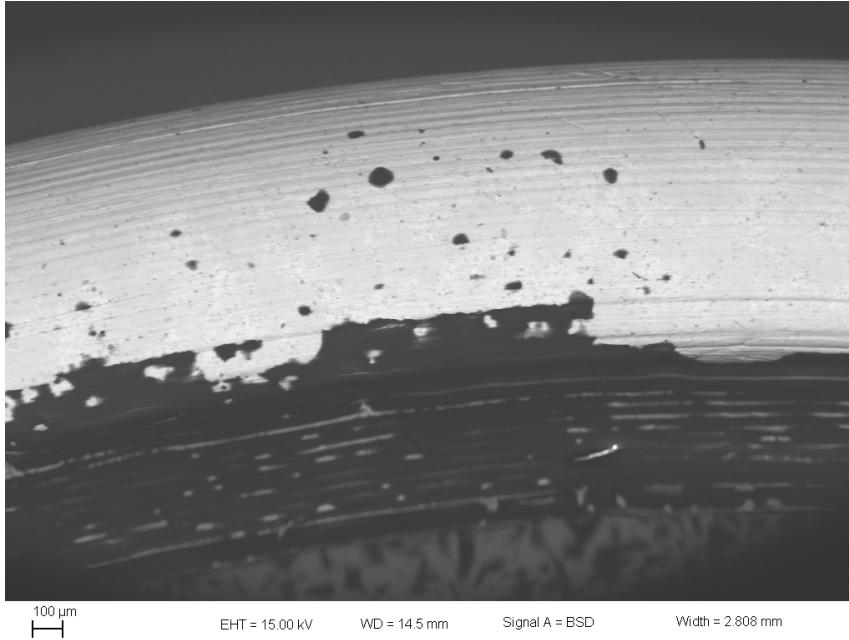
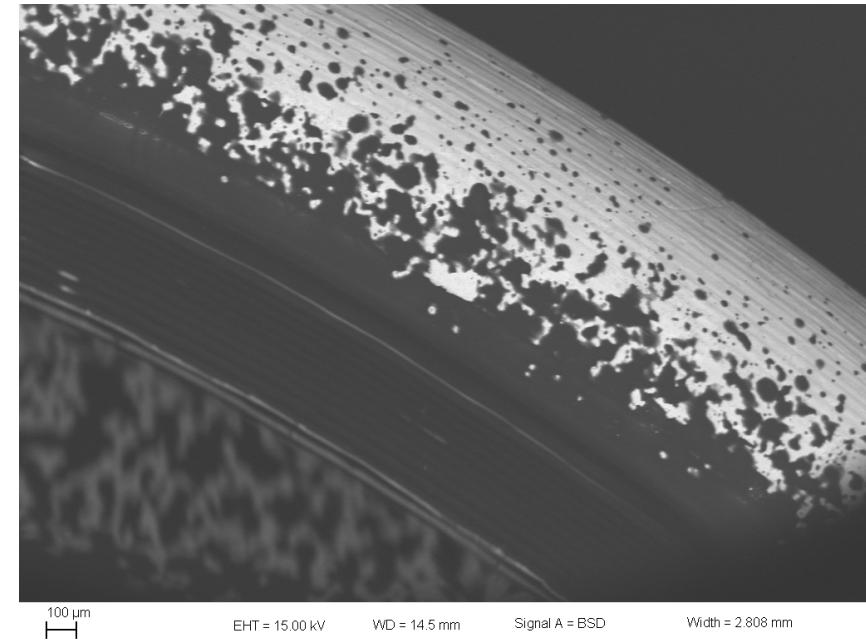
Images of as-received (bagged) caps from KCP show significant amount of carbon contamination (machining oil residue?) all over the cap surface. Origin?

- There was so much contamination on the outside of the cap that it was not easy to image (lots of charging); it almost looked like an uninterrupted contaminant layer. Also, it was possible to see the contamination as “grittiness” using a simple optical microscope.
- A significant amount of contamination (grease/oil/plating bath crud?) was introduced somewhere between manufacturing and plating; it is likely this very contaminant that is smeared during use, leaving the patchy contamination we saw in the used cap

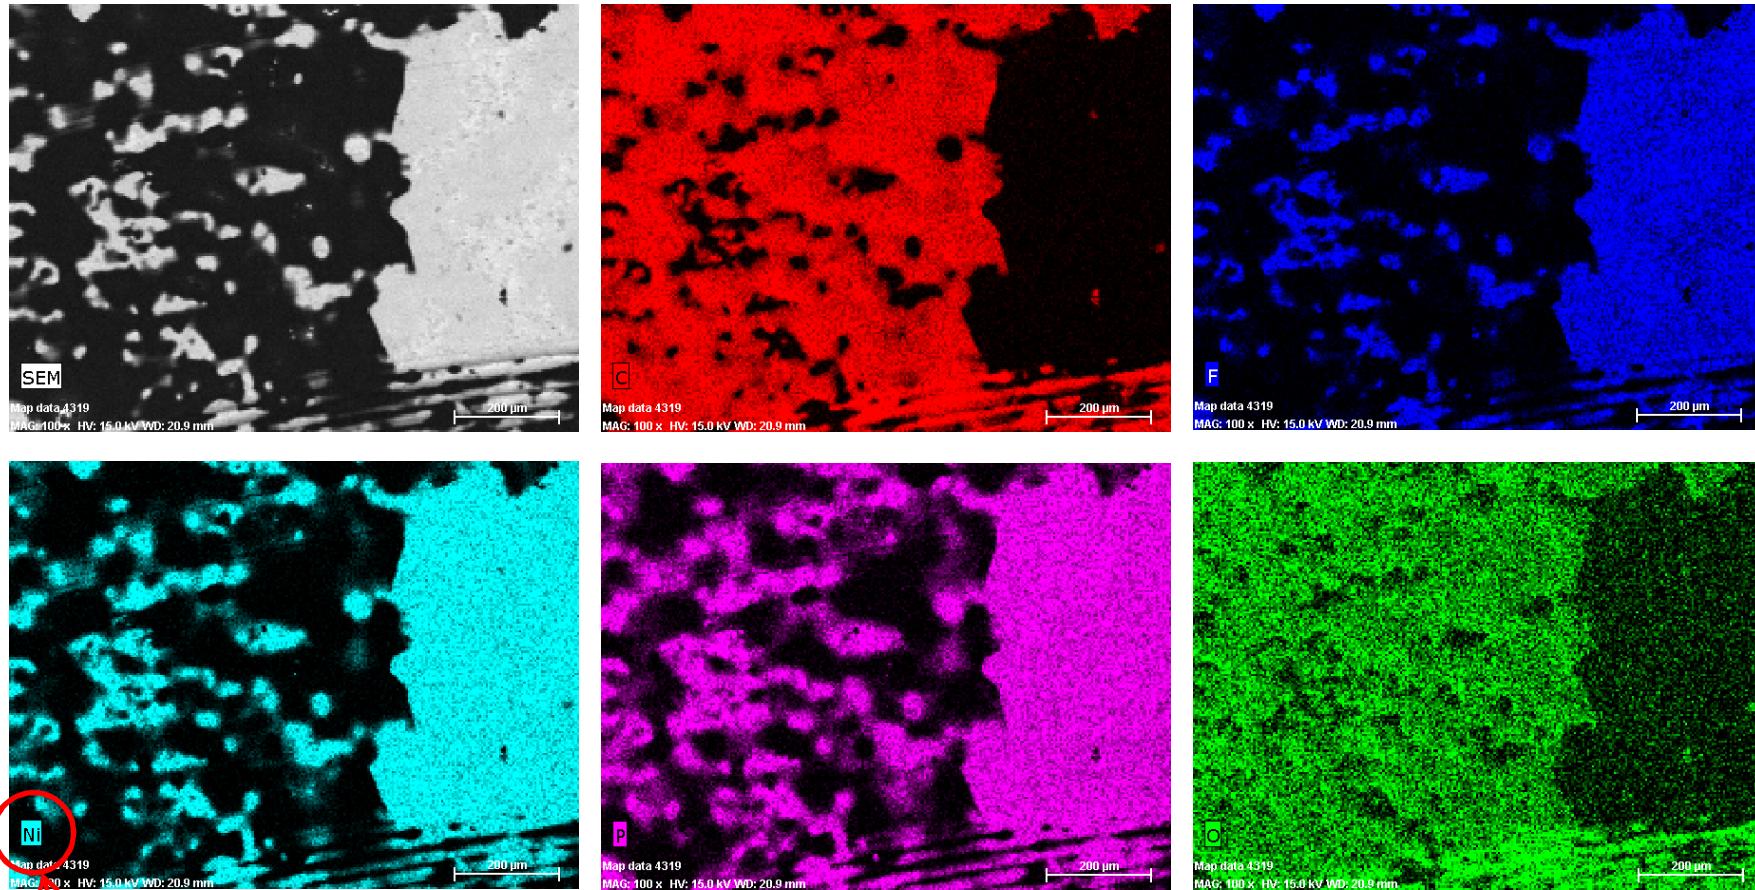
SEM and compositional EDS (Energy Dispersive Spectroscopy) maps... lots of C-O

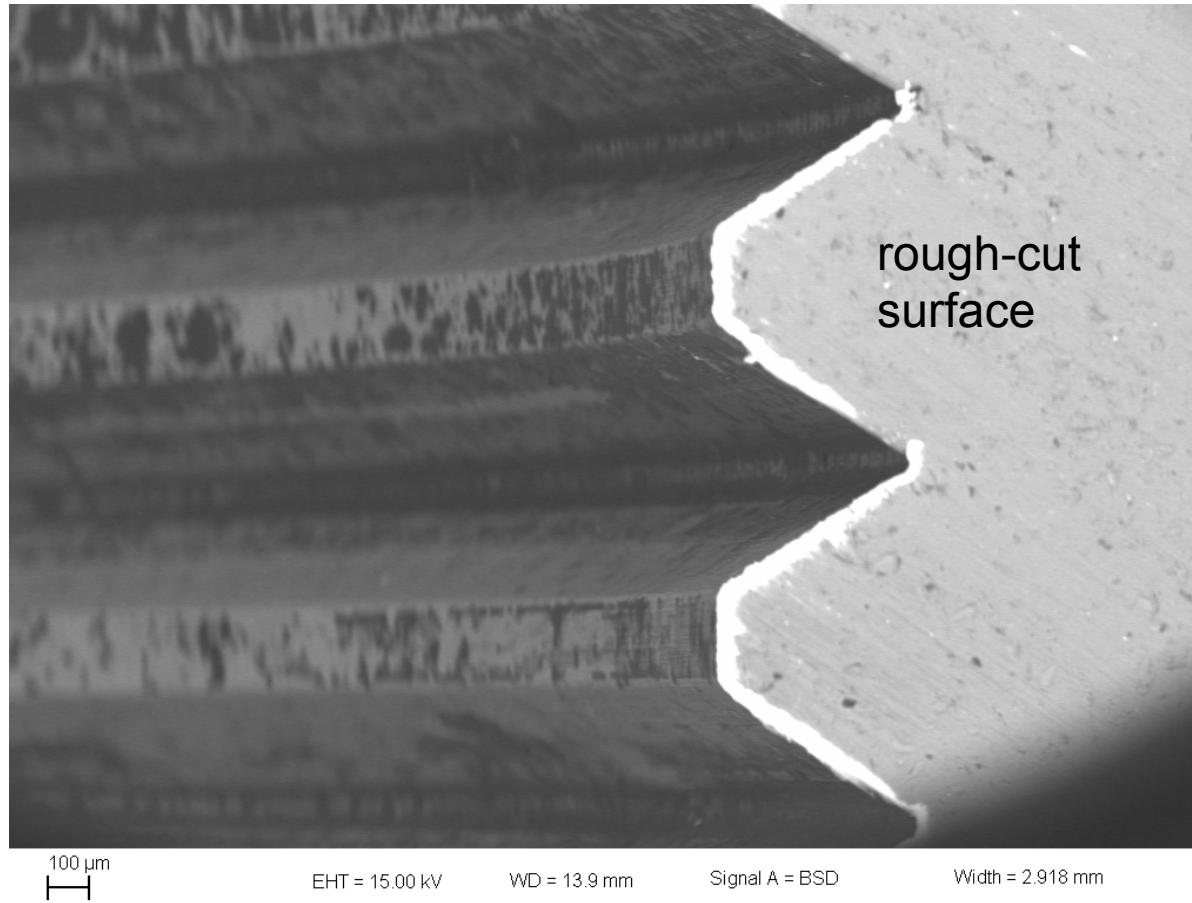
This image shows how the caps were sectioned (as-received cap shown here), this one without potting and polishing. Also clearly visible is the C-O contamination.

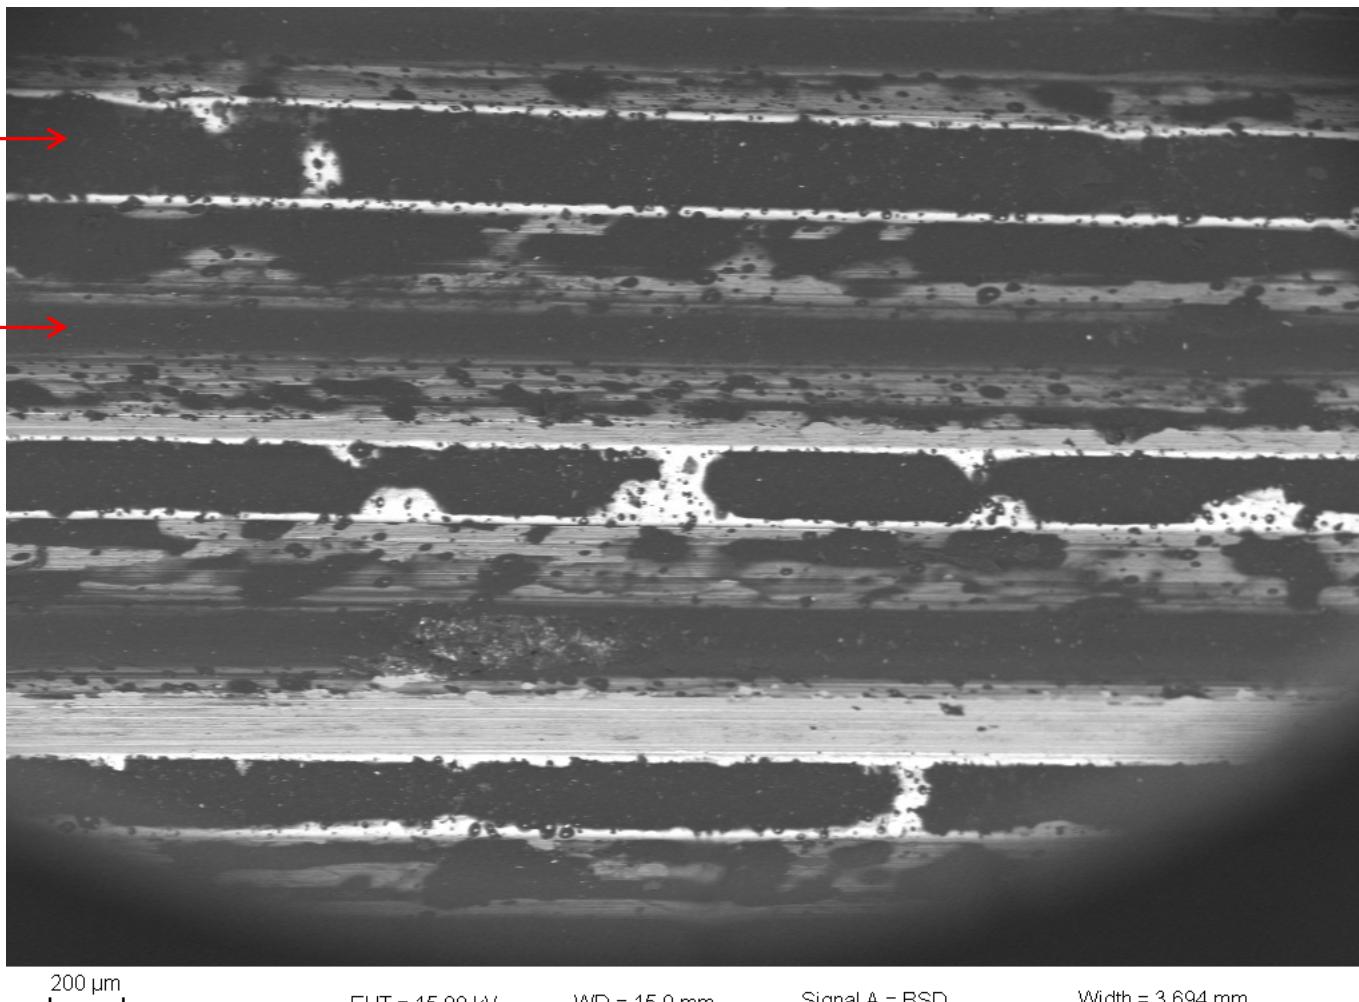
The black stuff all over the inner surface of the cap is the carbonaceous species.

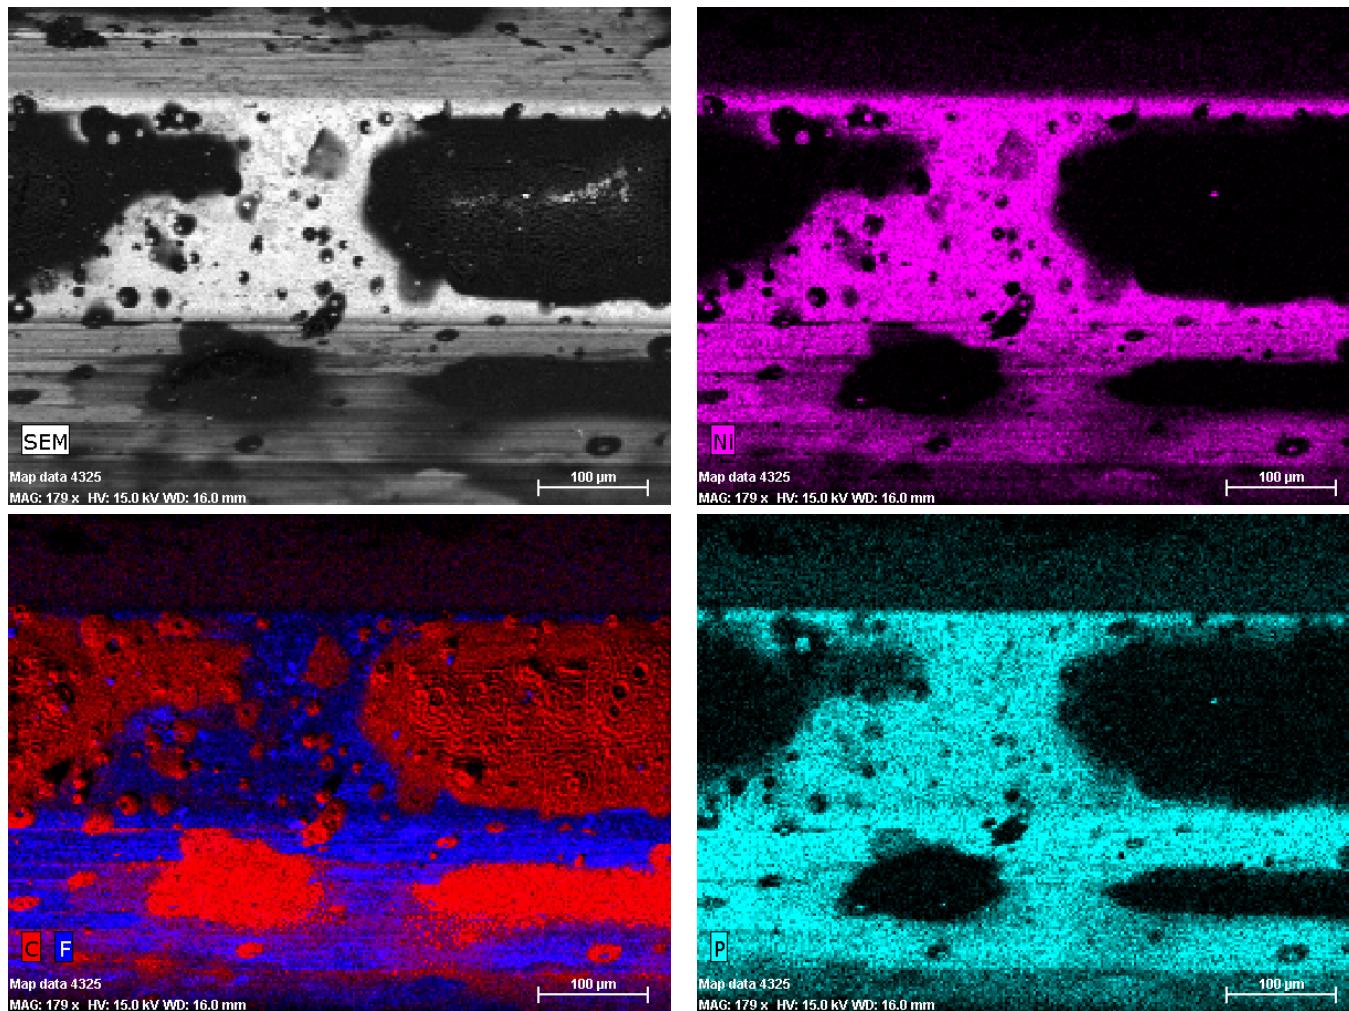
More SEM and EDS maps of the surface of an as-received cap, showing that the fluorine and phosphorus (corresponding to the Ni phosphate and PTFE) are occluded by the carbonaceous contaminant
