Effects of Charge-Induced Damage on SOI Wafers

Darlene M. Udoni and Mary A. Miller, Sandia National Laboratories, Albuquerque, NM, USA

Problem: Systematic leakage in wafer-level test structures and packaged devices causing significant yield loss

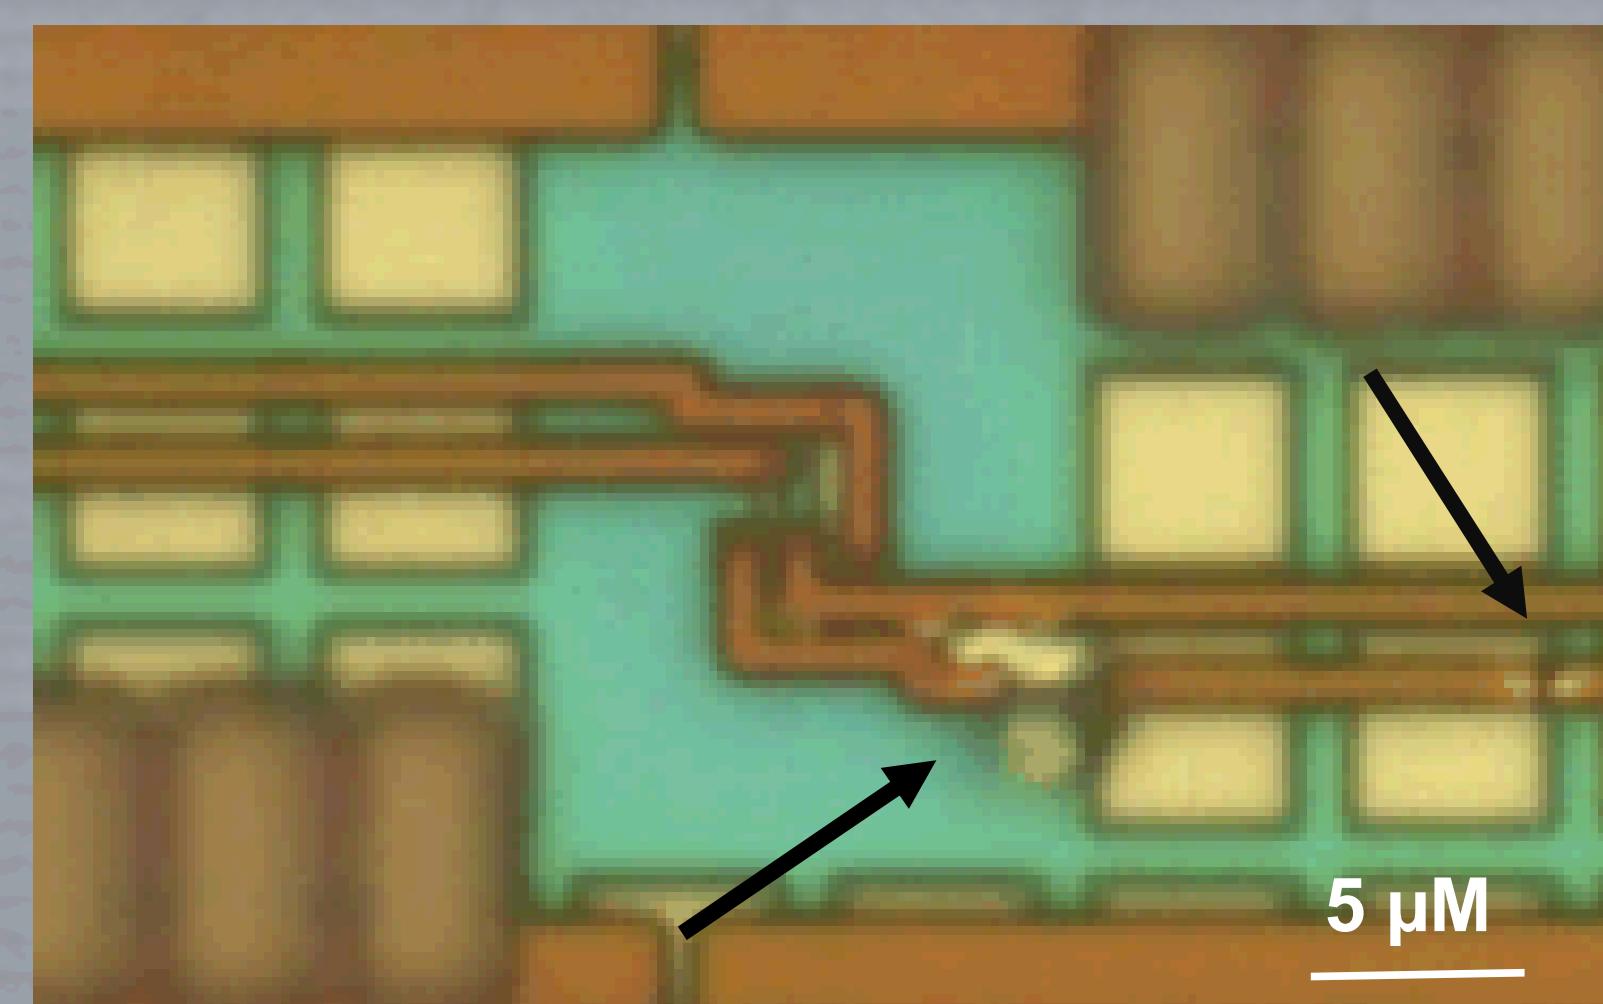
- Quick way to localize/characterize damage
- Not all failing transistors had optical damage

Cracking, metal extrusion on test structure

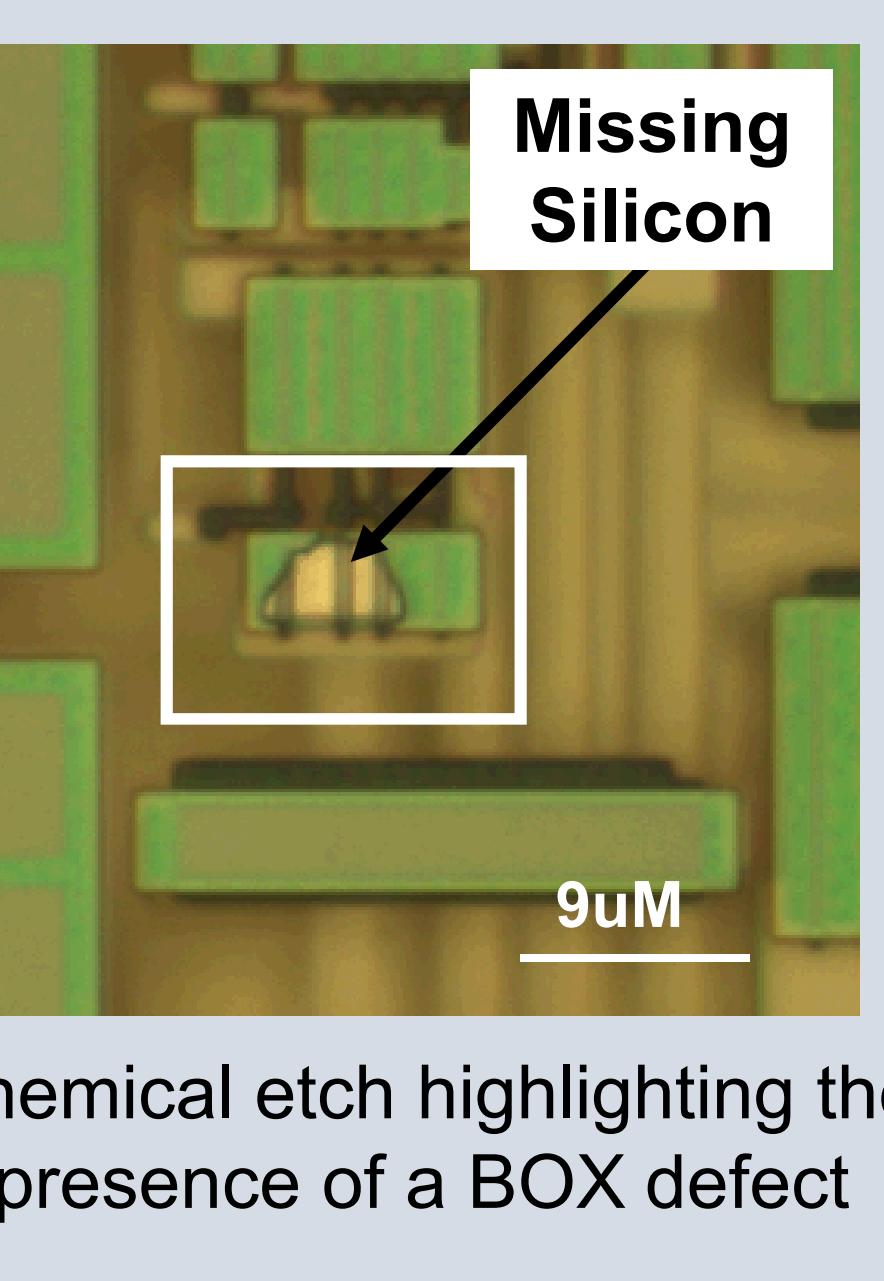
Chemical etch highlighting the presence of a BOX defect

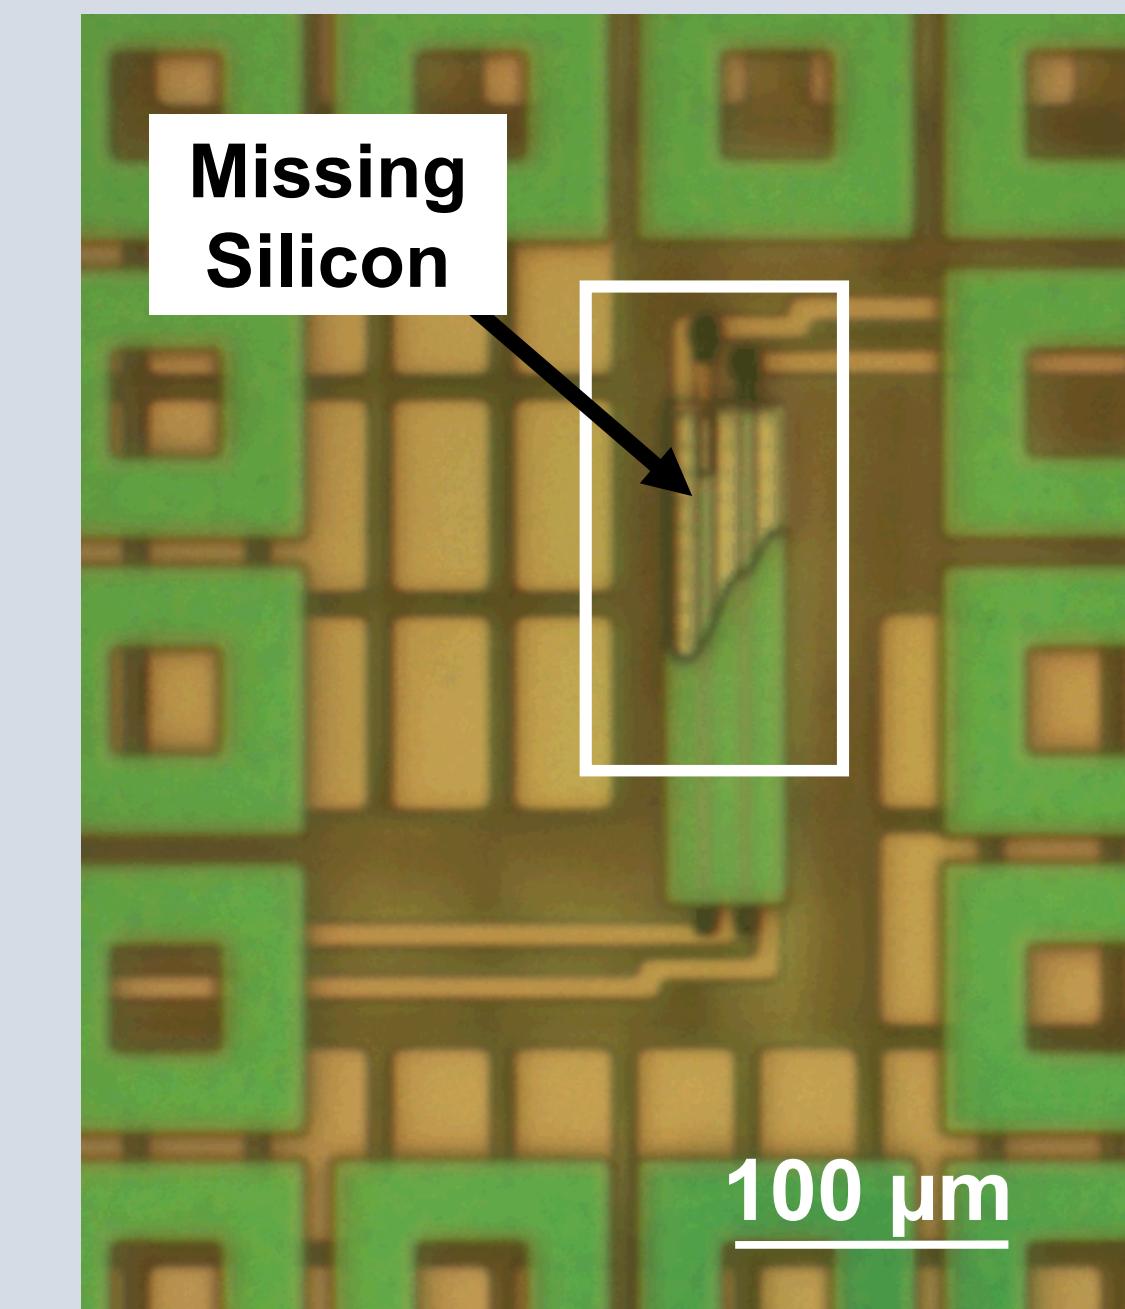
Optical image of the backside of a discrete transistor (wafer level) with the substrate Si removed. Etched silicon indicates the presence of a BOX defect.

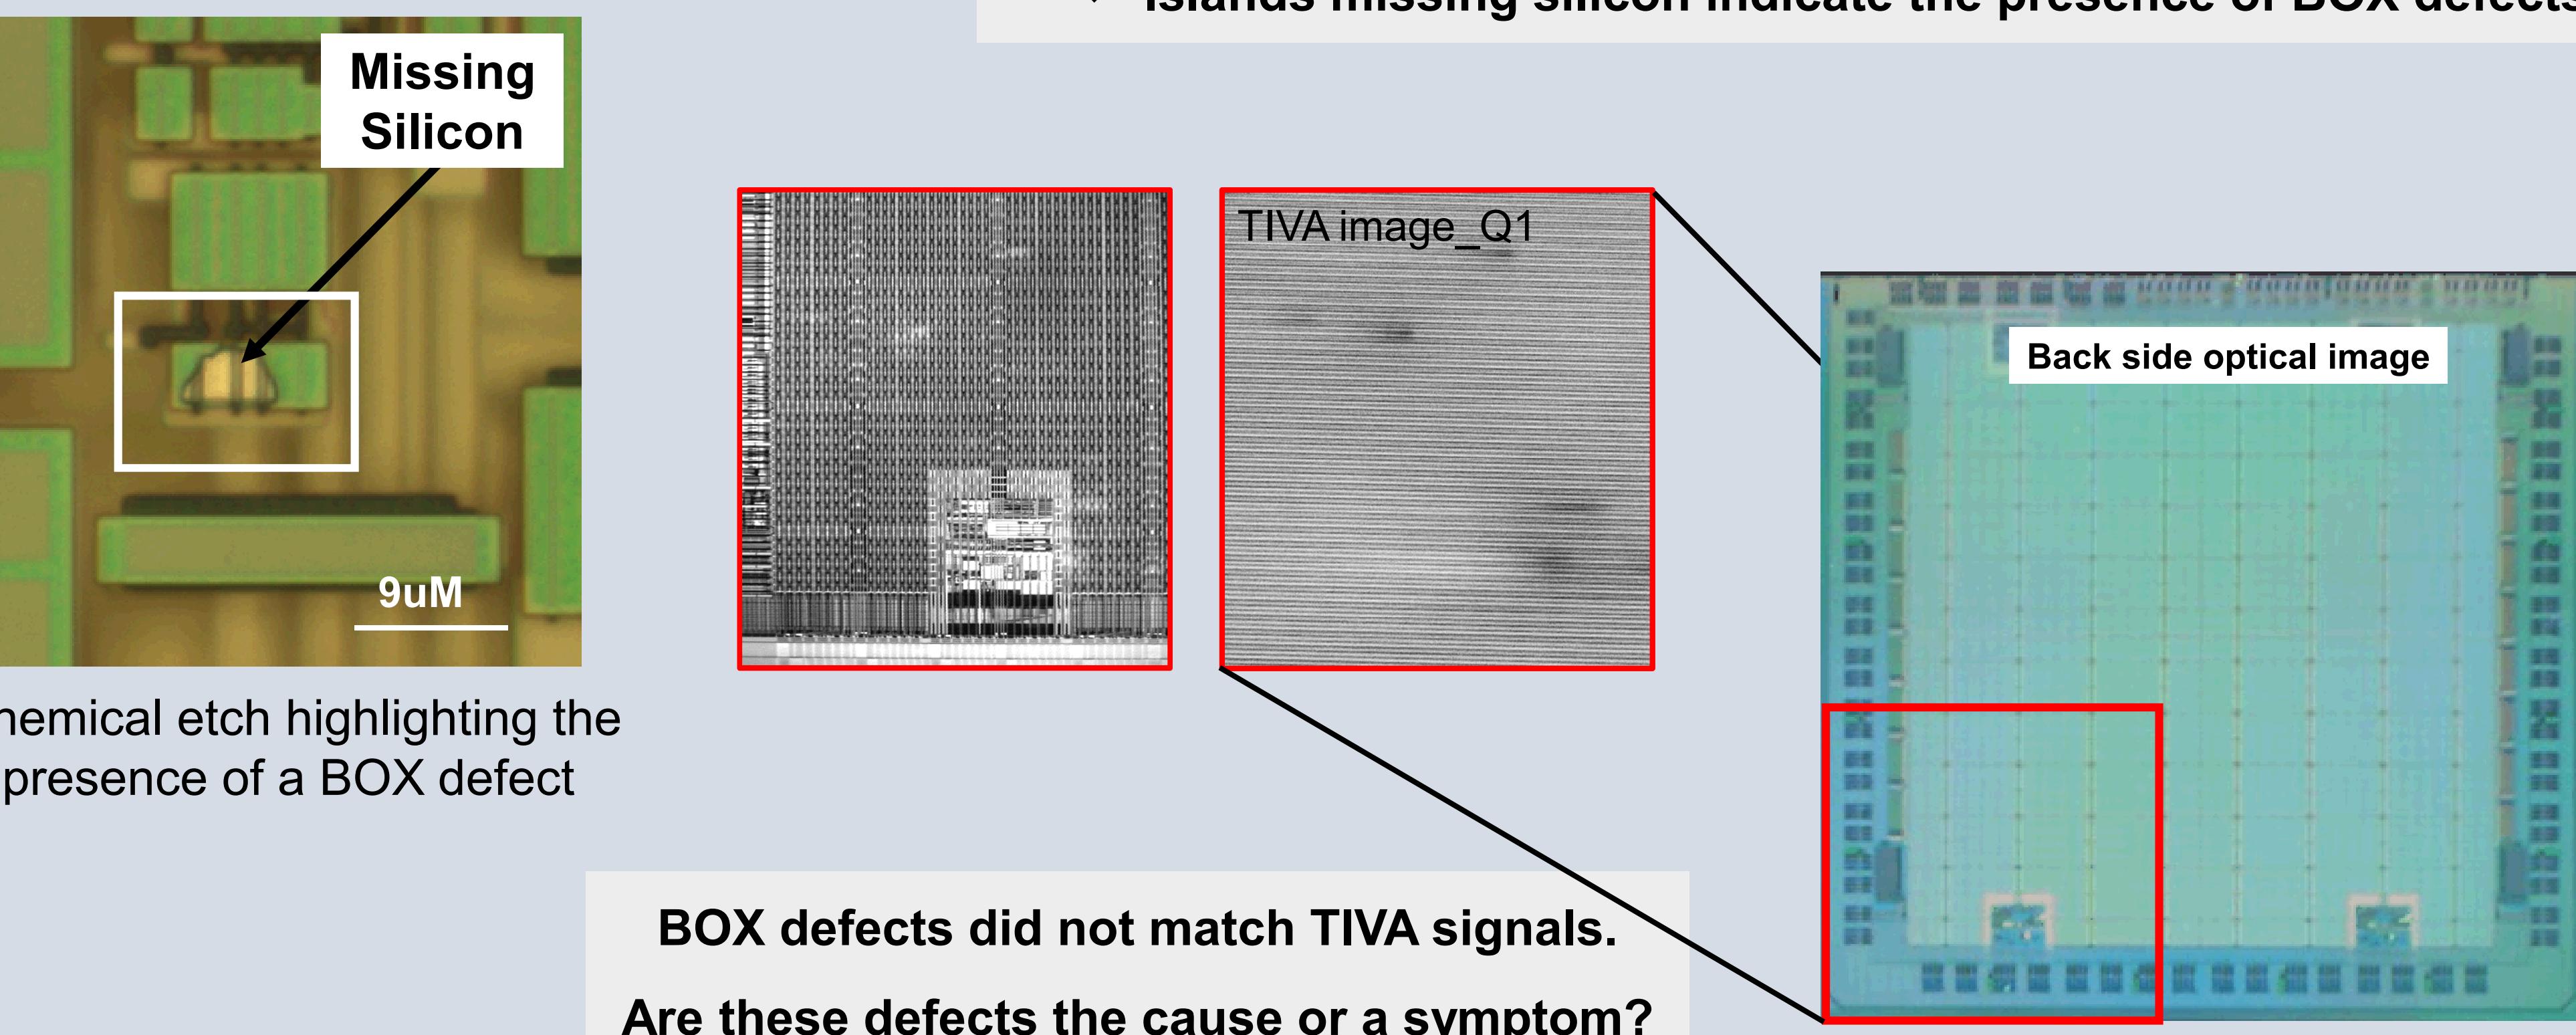
Backside optical screen for BOX defects

- Defects provide a pathway through the BOX layer where the chemical etchant attacks the Si island
- Islands missing silicon indicate the presence of BOX defects

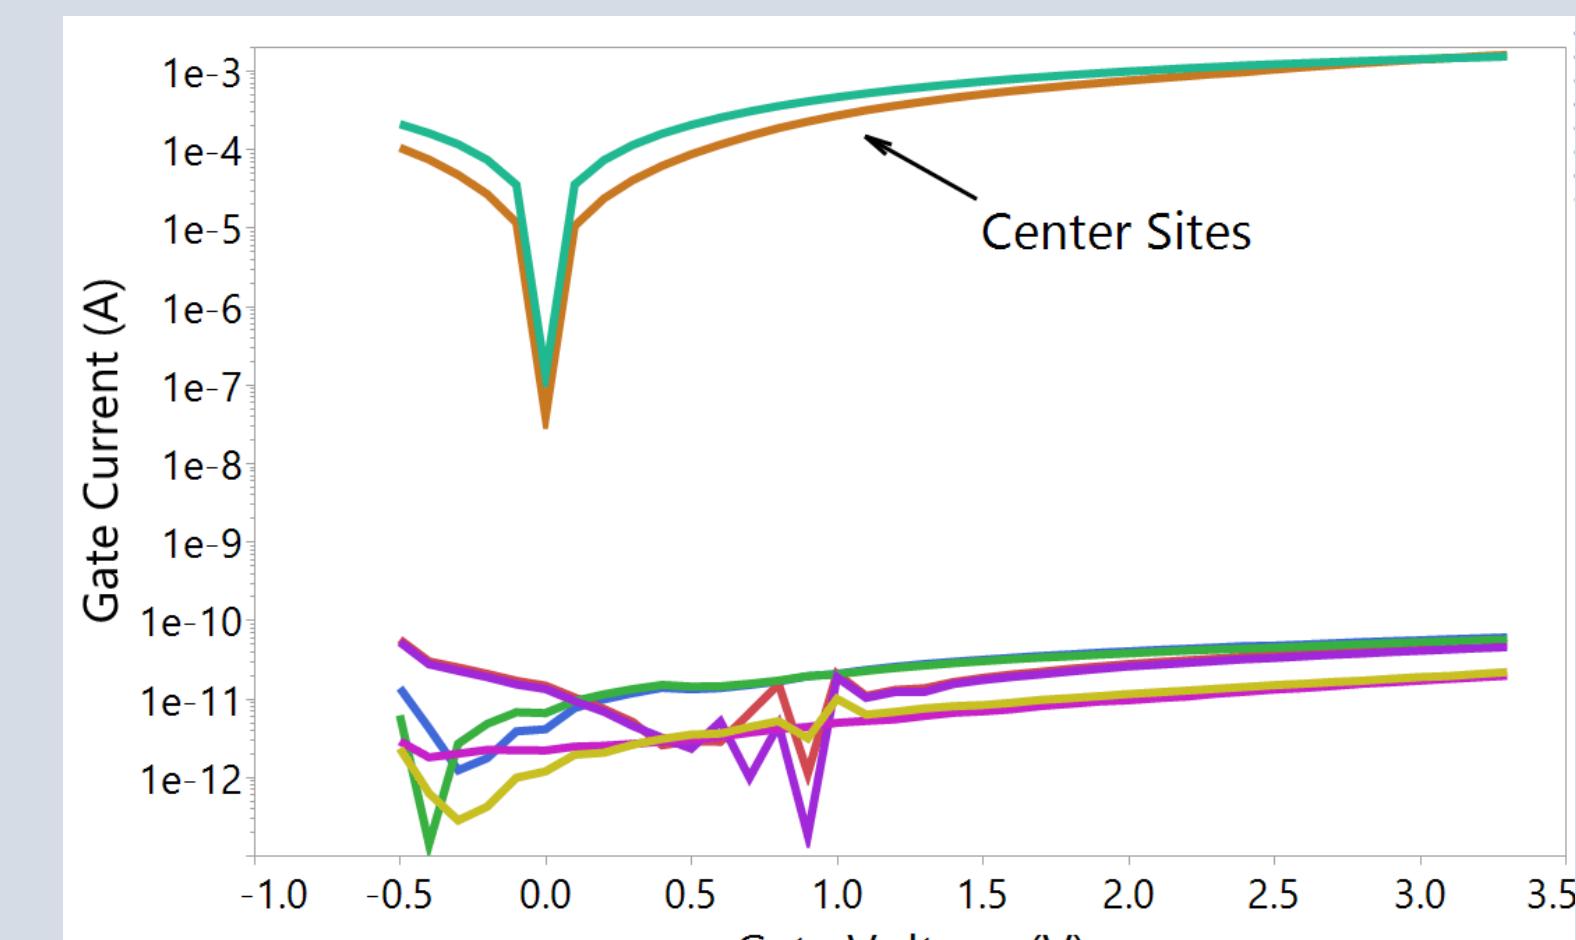
- Wafer center discrete transistors consistently failed $> 1 \text{ mA}$ gate current at 3.3 V (~nA nominal)
- Packaged die from wafer center positions (as shown in schematic) also indicated leakage-type failures that ranged from μA to mA
- Although absolute failing current varied, characteristic shape of IV curve emerged

Gate leakage from die sites across the wafer; center sites consistently fail

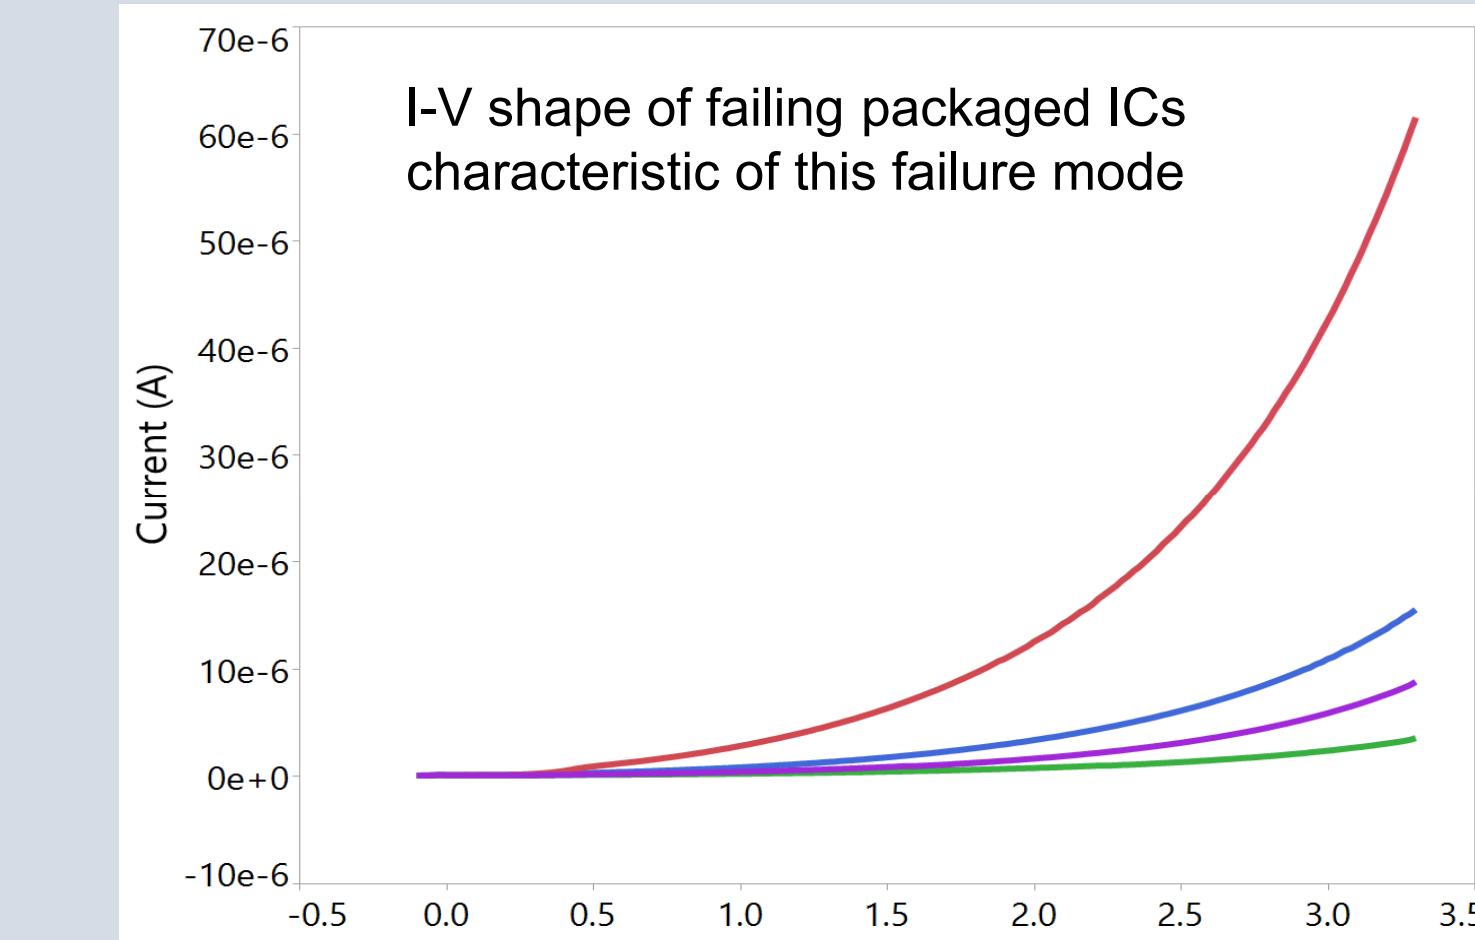
IDDS I-V sweeps of packaged failing ICs

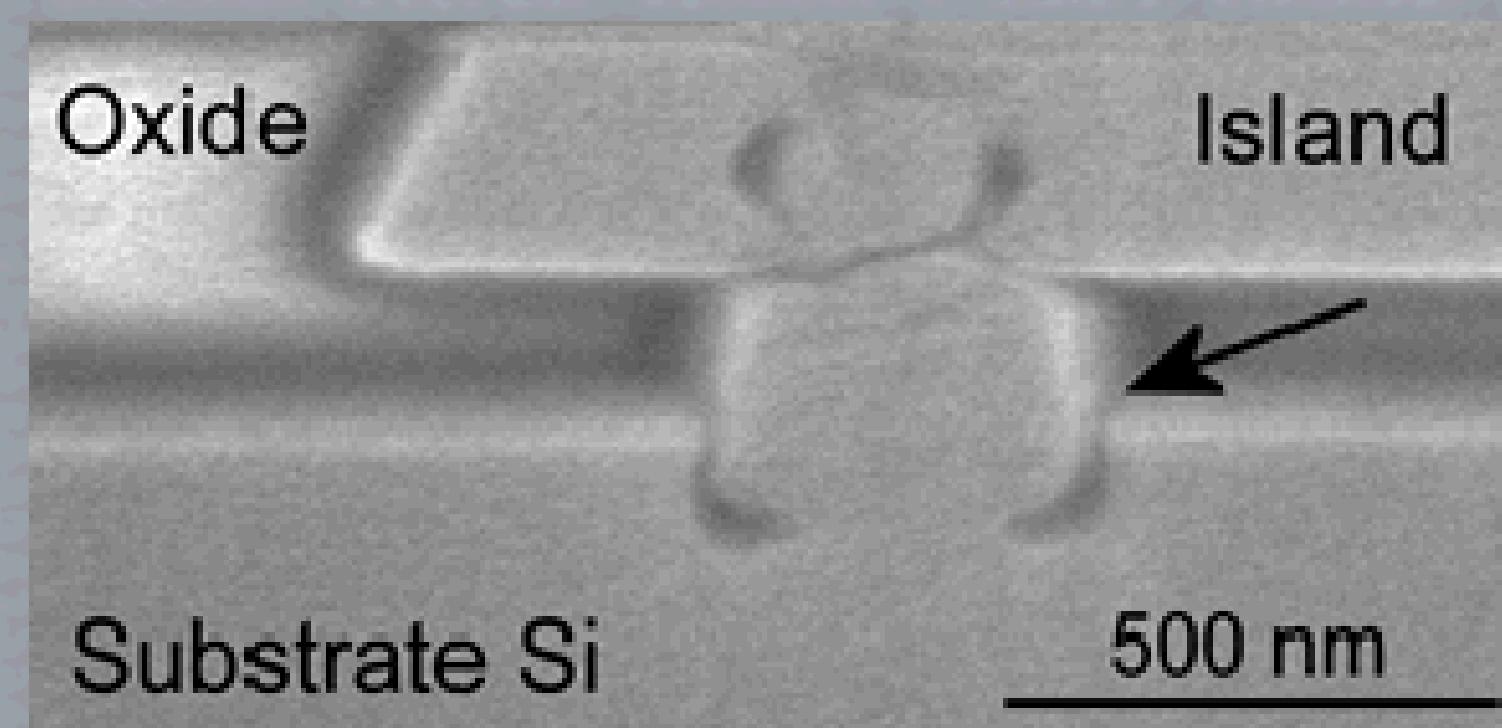
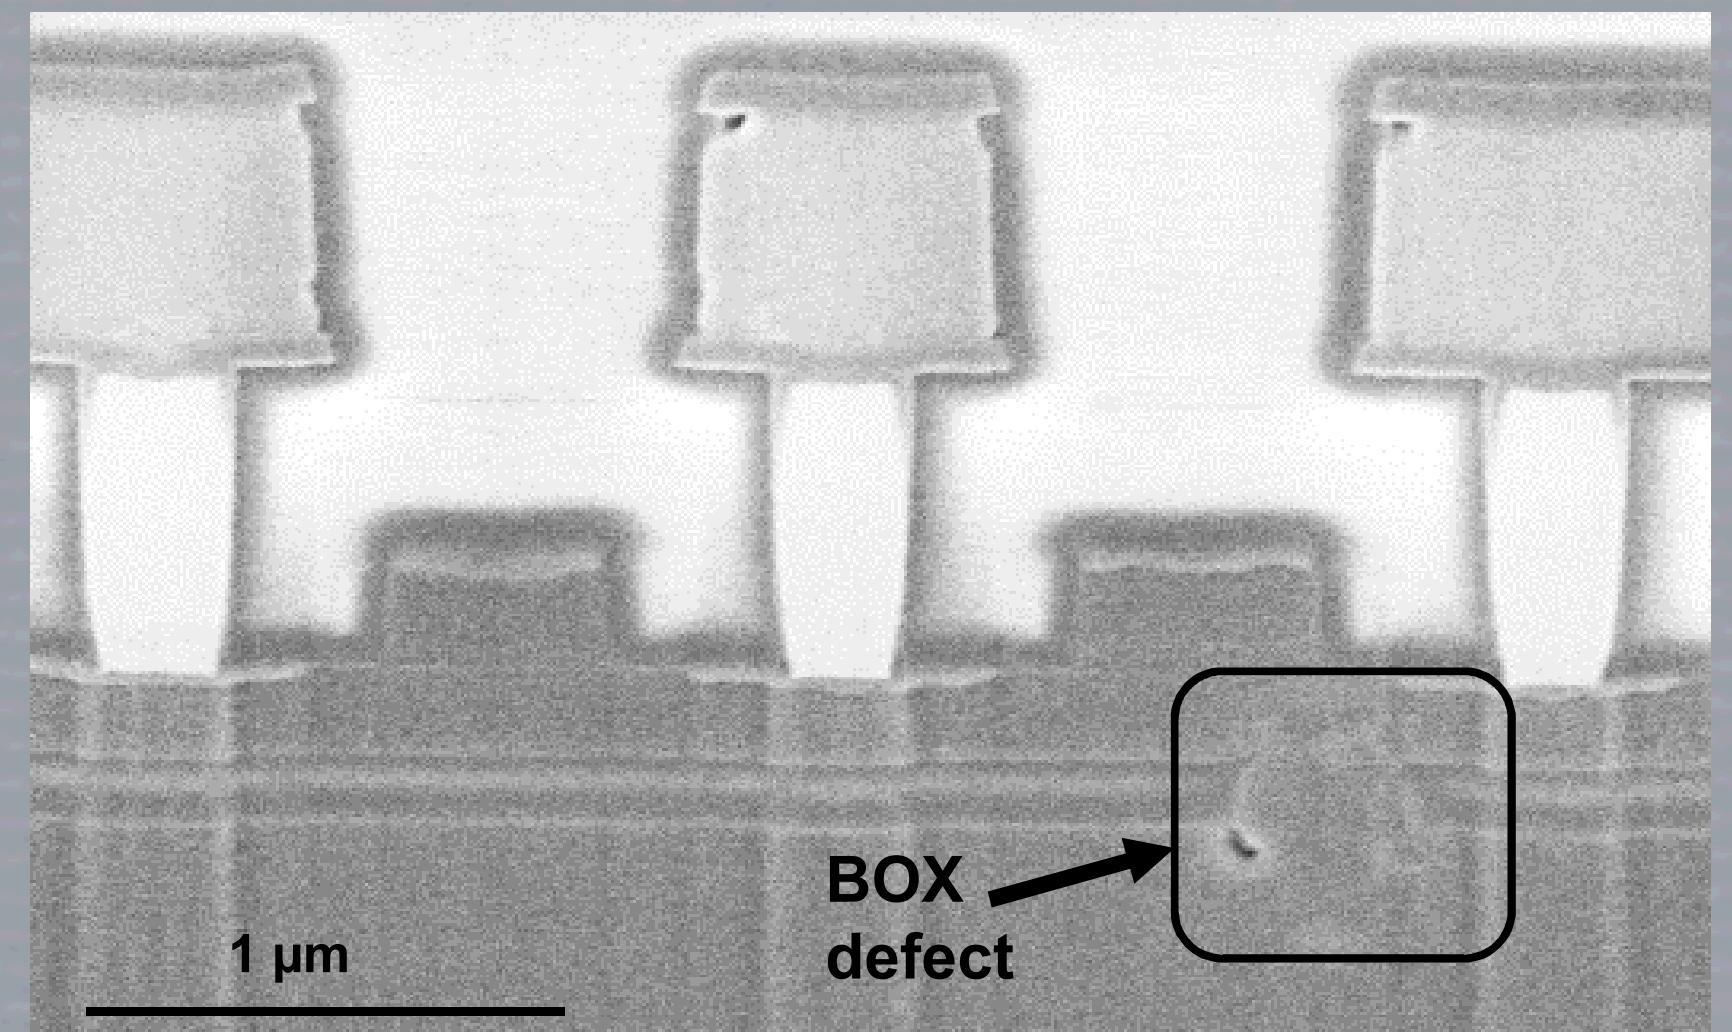
The cause of the leakage in both the test structures and packaged parts was found to be charge-induced damage from a high-velocity DI water spray nozzle within the chemical mechanical planarization tool.

- Silicon filament observed between Si island and substrate (BOX defect)
- Provides electrical connection between island to substrate
- Present in all failing discrete transistors

Cross-section through discrete transistors with optical damage

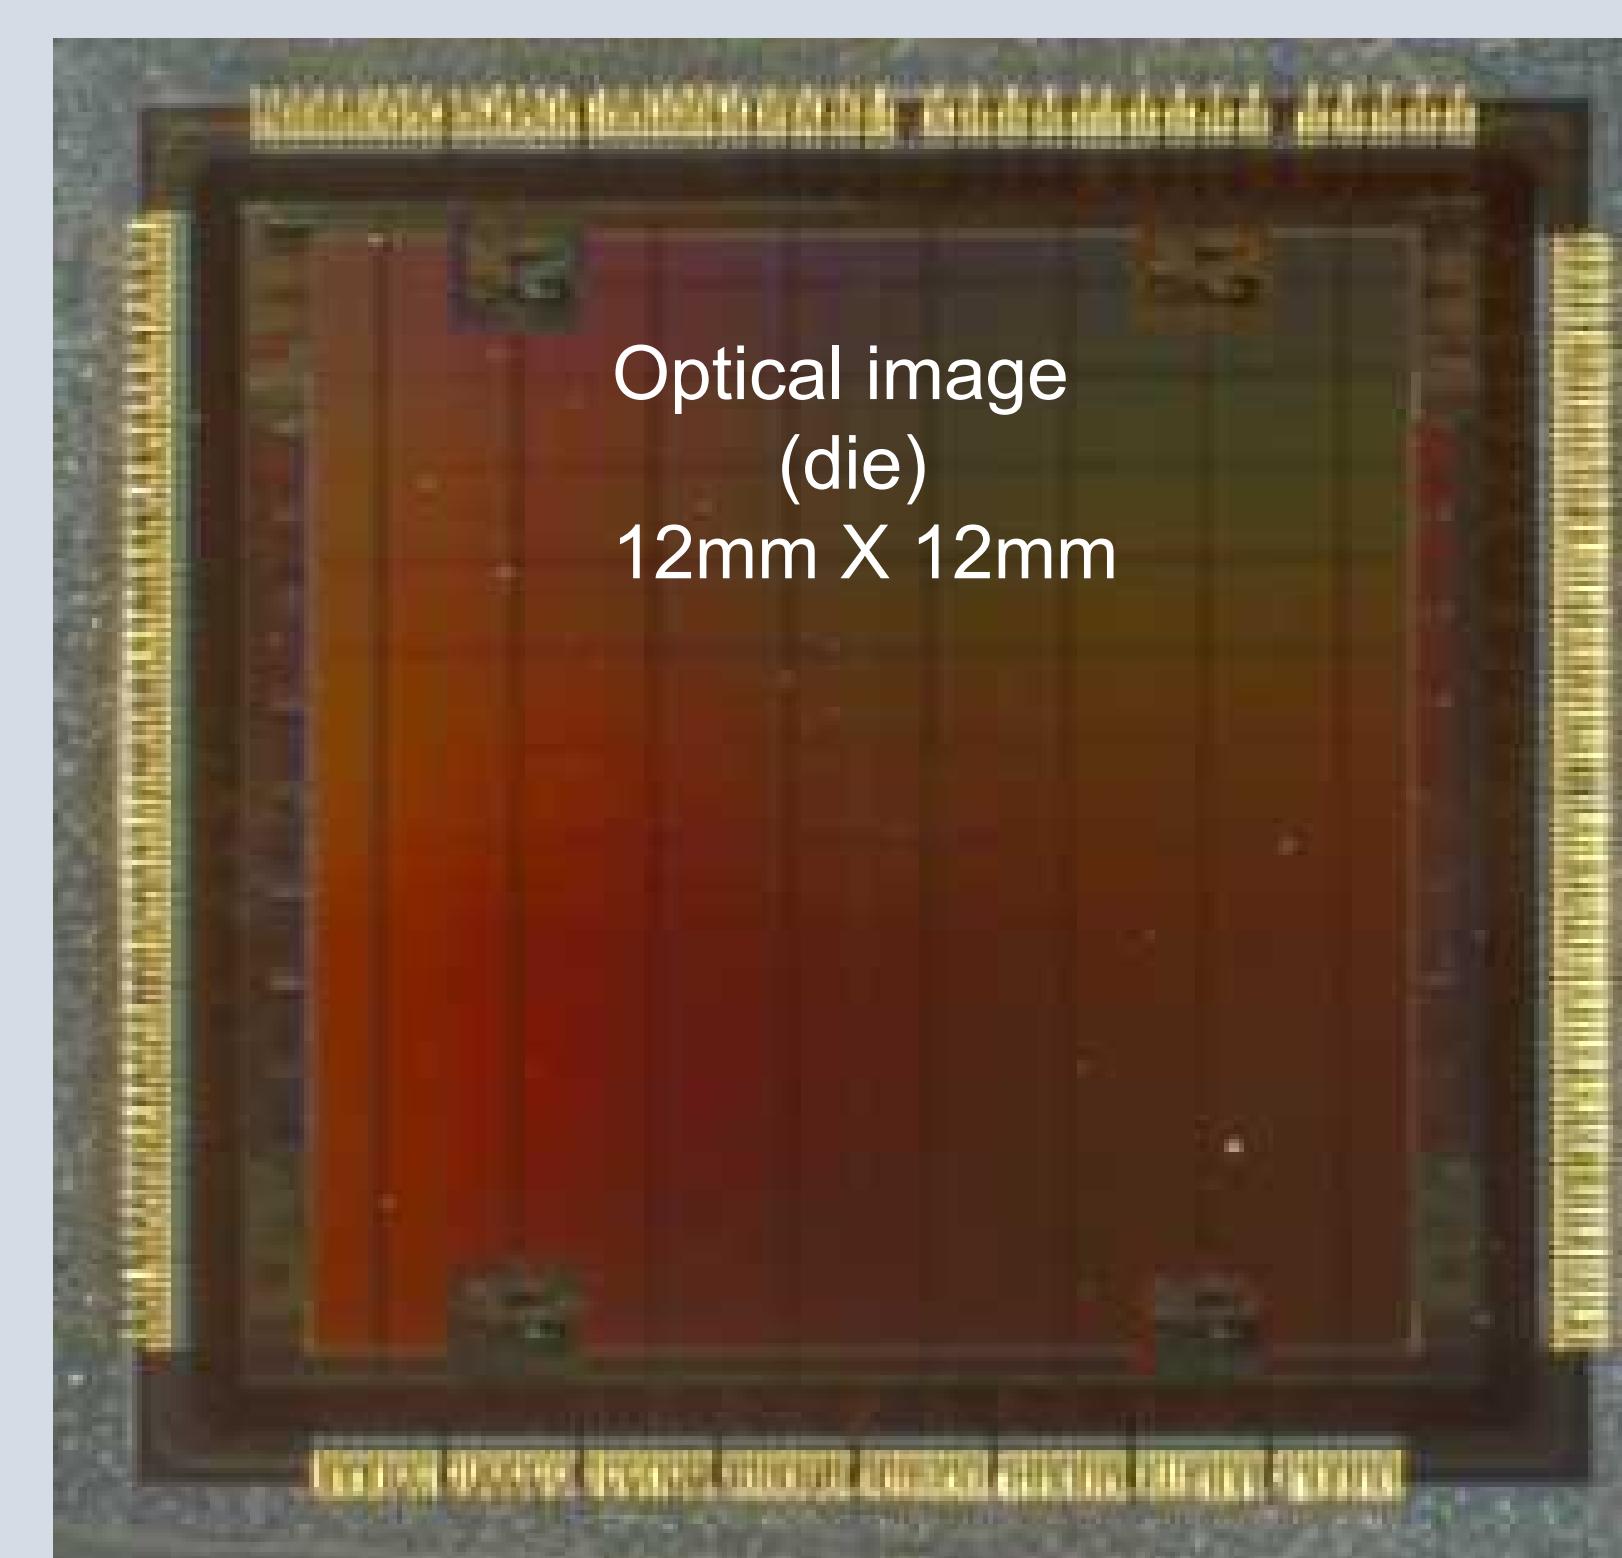
- The TIVA signals were directional with respect to the center of wafer. Depending on the die location of the packaged parts, the vector would change as depicted in the graphic
- The TIVA signals were consistently diffuse and dark

Schematic of four center die showing TIVA signal directionality
