# Directional Dependence of Mechanical Properties and Defects of LENS 304L

Cole Britt, David Keicher, and  
Shaun Whetten

Sandia National Laboratories

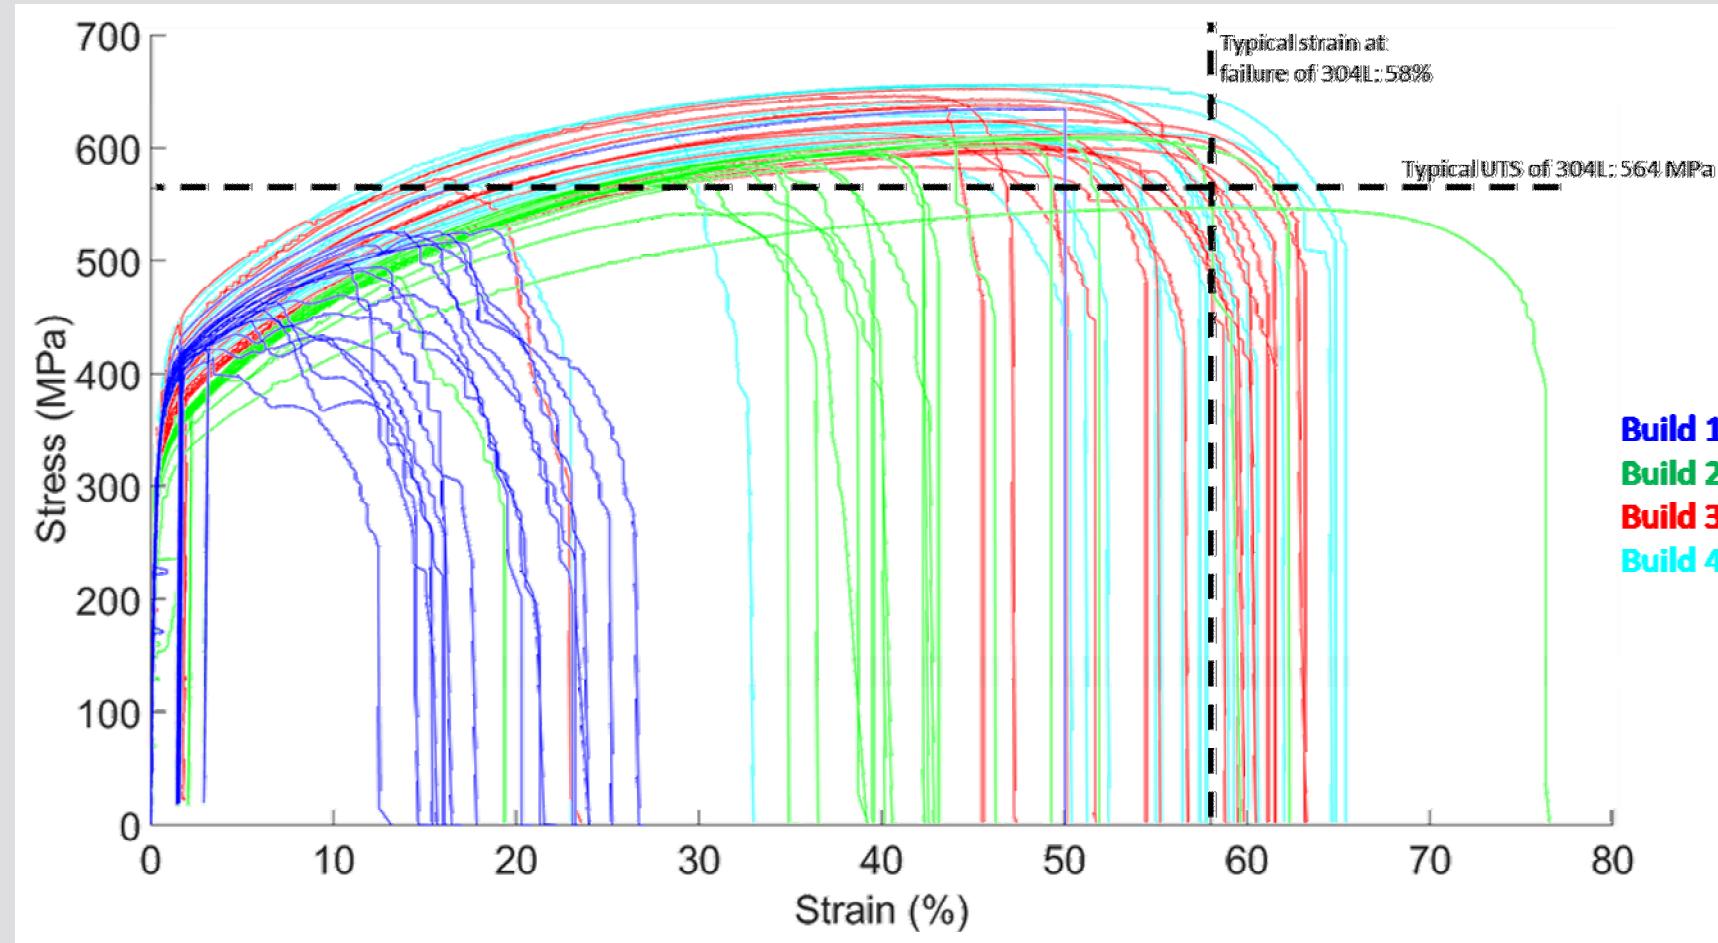
# Stress and Strain of Samples

- On average, builds 2, 3, and 4 surpassed the typical UTS for wrought 304L.
- Roughly half of the samples from builds 3 and 4 surpassed the typical strain for 304L.
- Only one sample from build 1 surpassed the typical UTS for 304L.

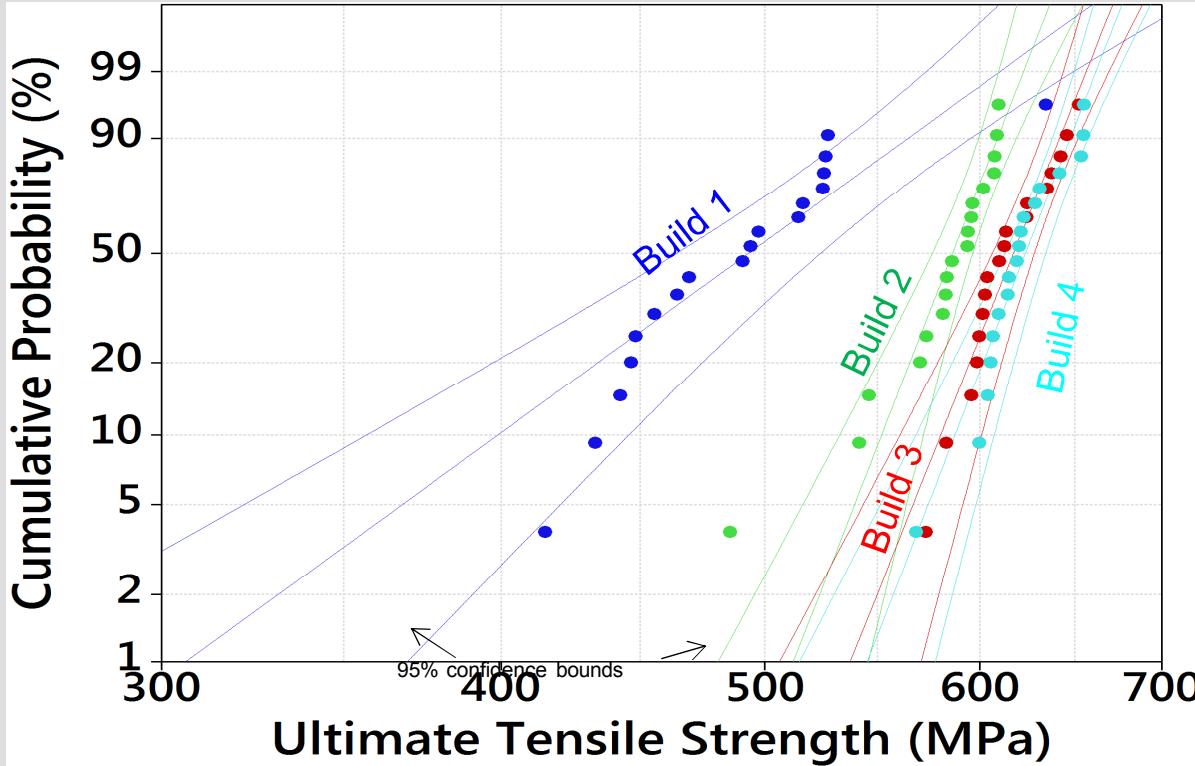
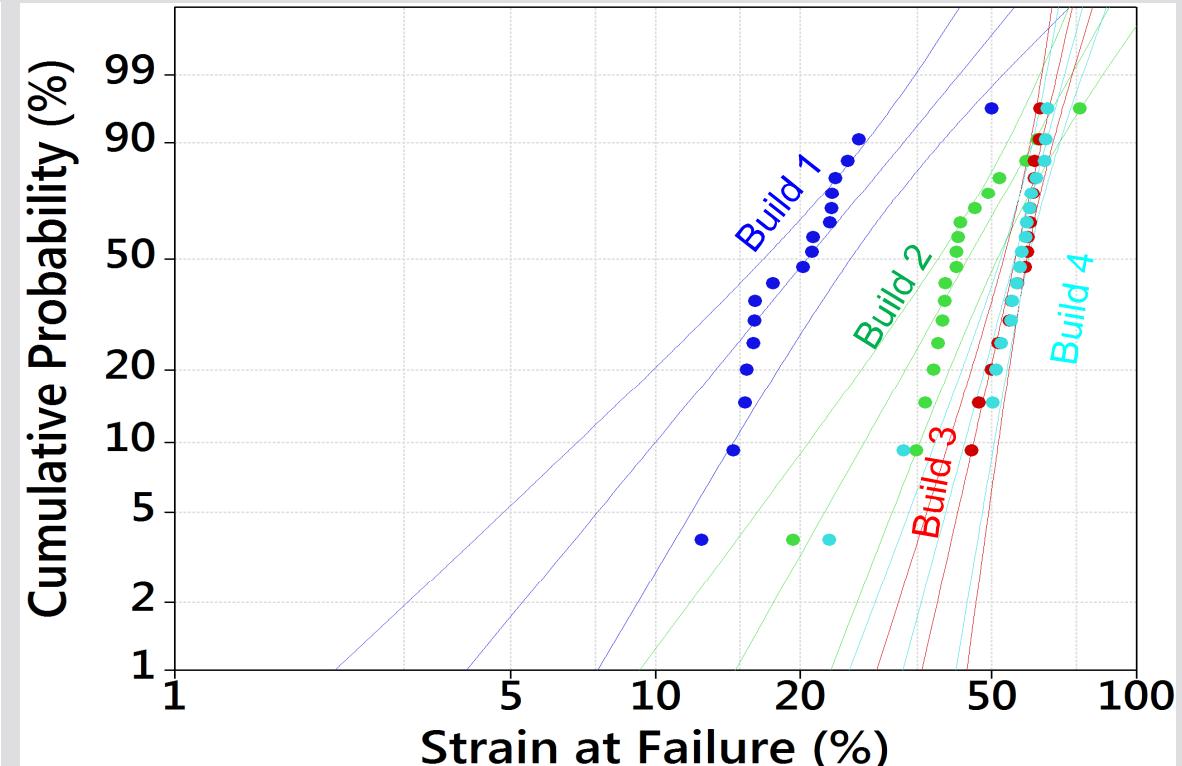
# Weibull Distributions UTS and Strain at Failure

- Samples pulled orthogonal to build planes have much lower ductility than samples pulled parallel to build plane.

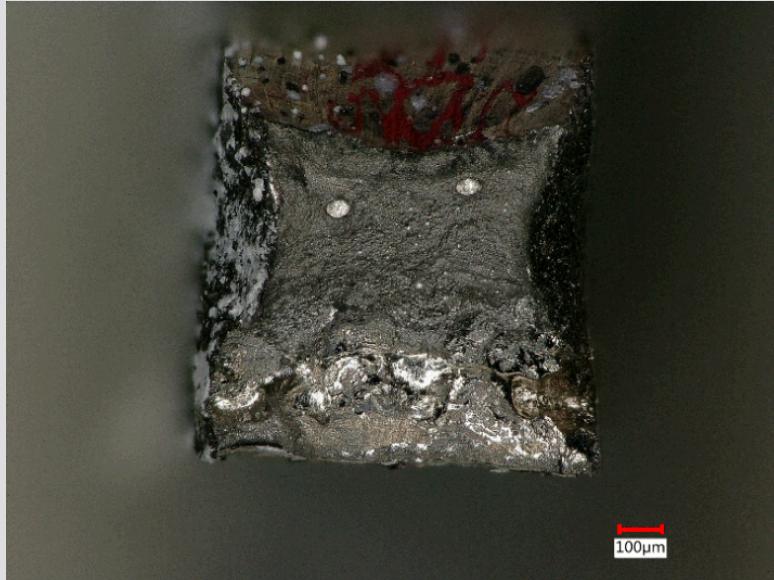
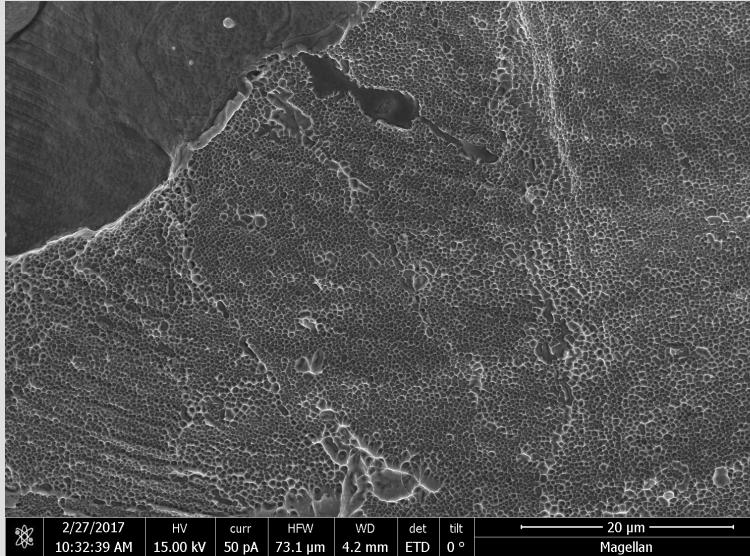
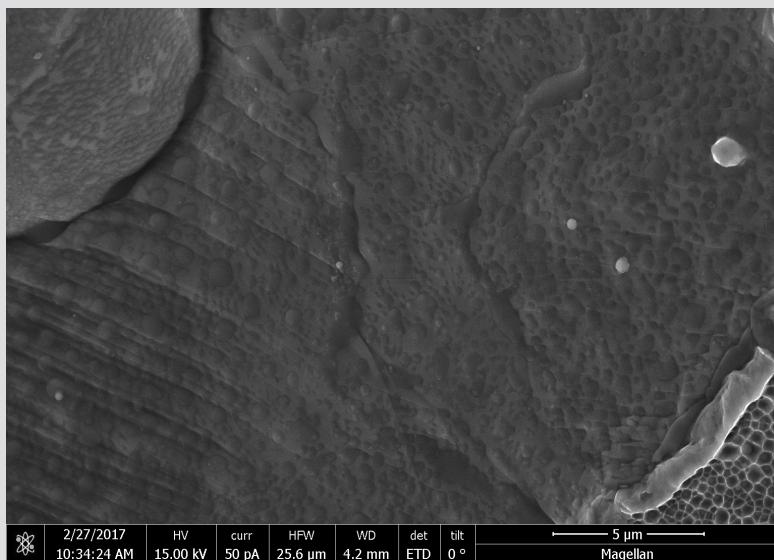
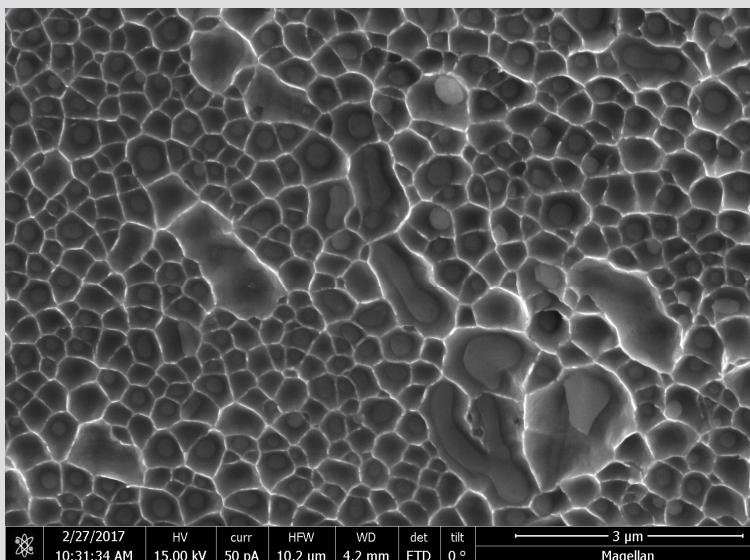
# Build 1 (Transverse to Build Plane)

- Large lack of fusion defects around one edge.
- Oxide particles are present throughout microstructure.

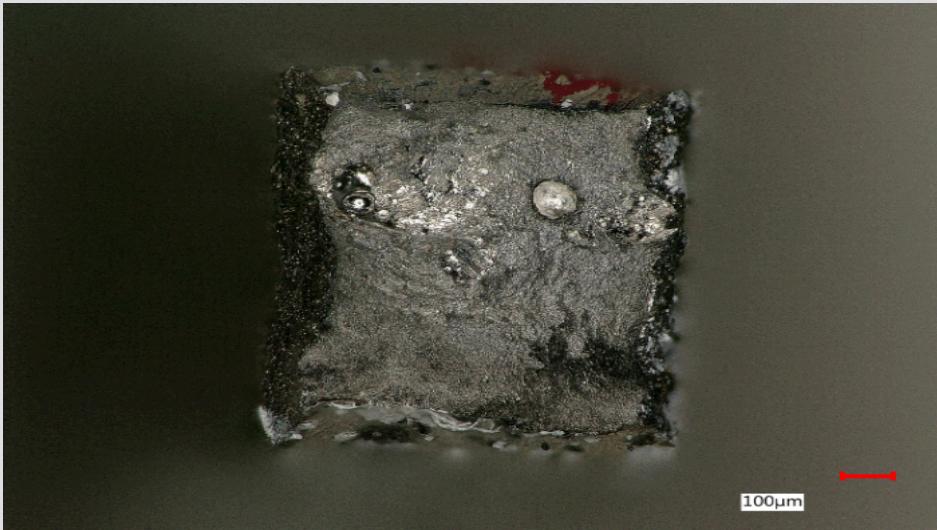
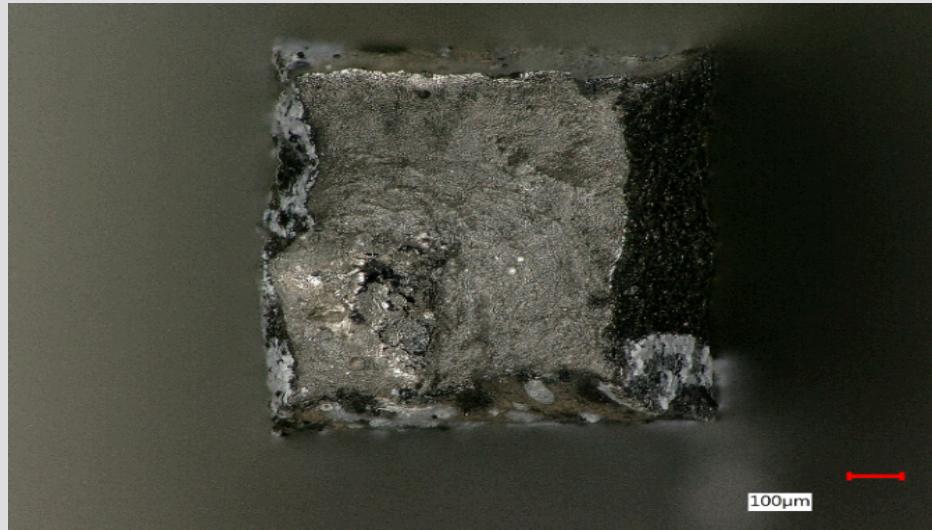
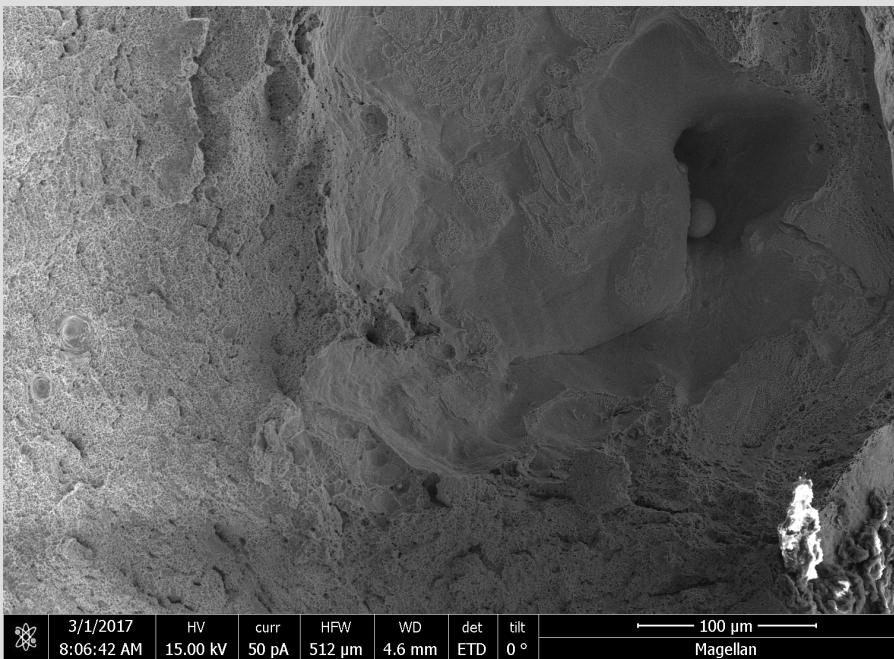
# Build 2 (Transverse to Build Plane)

- Large lack of fusion defects.
- Defect based failure mode accounts for wider distribution of the set and lower strength than sets 3 and 4.

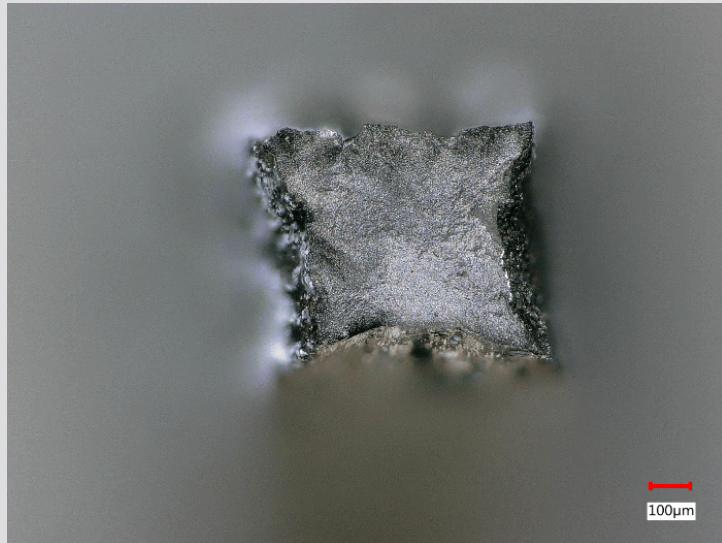
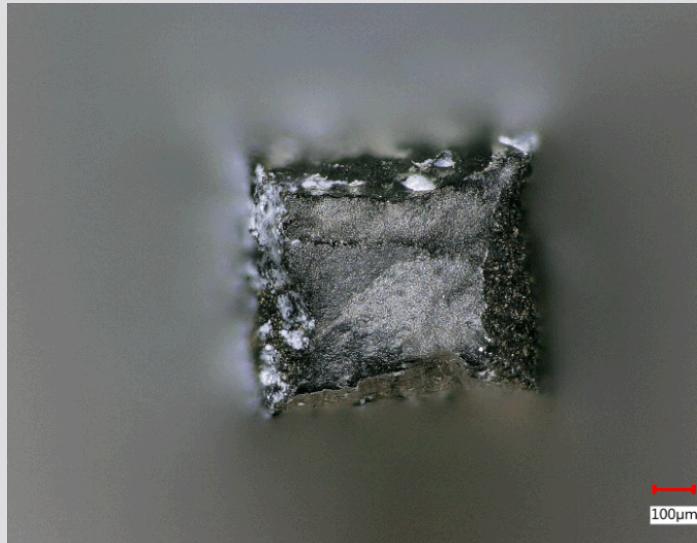
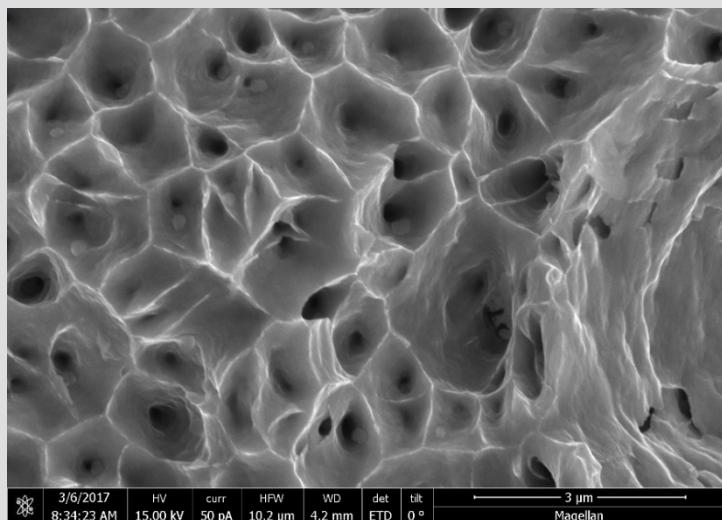
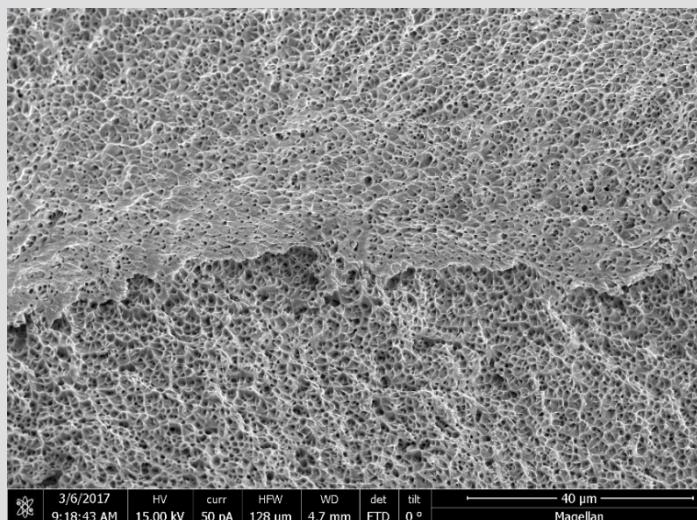
# Build 3

- More ductile fracture, with few defects in fracture surfaces
- Difference in topology, ridge behavior in some samples

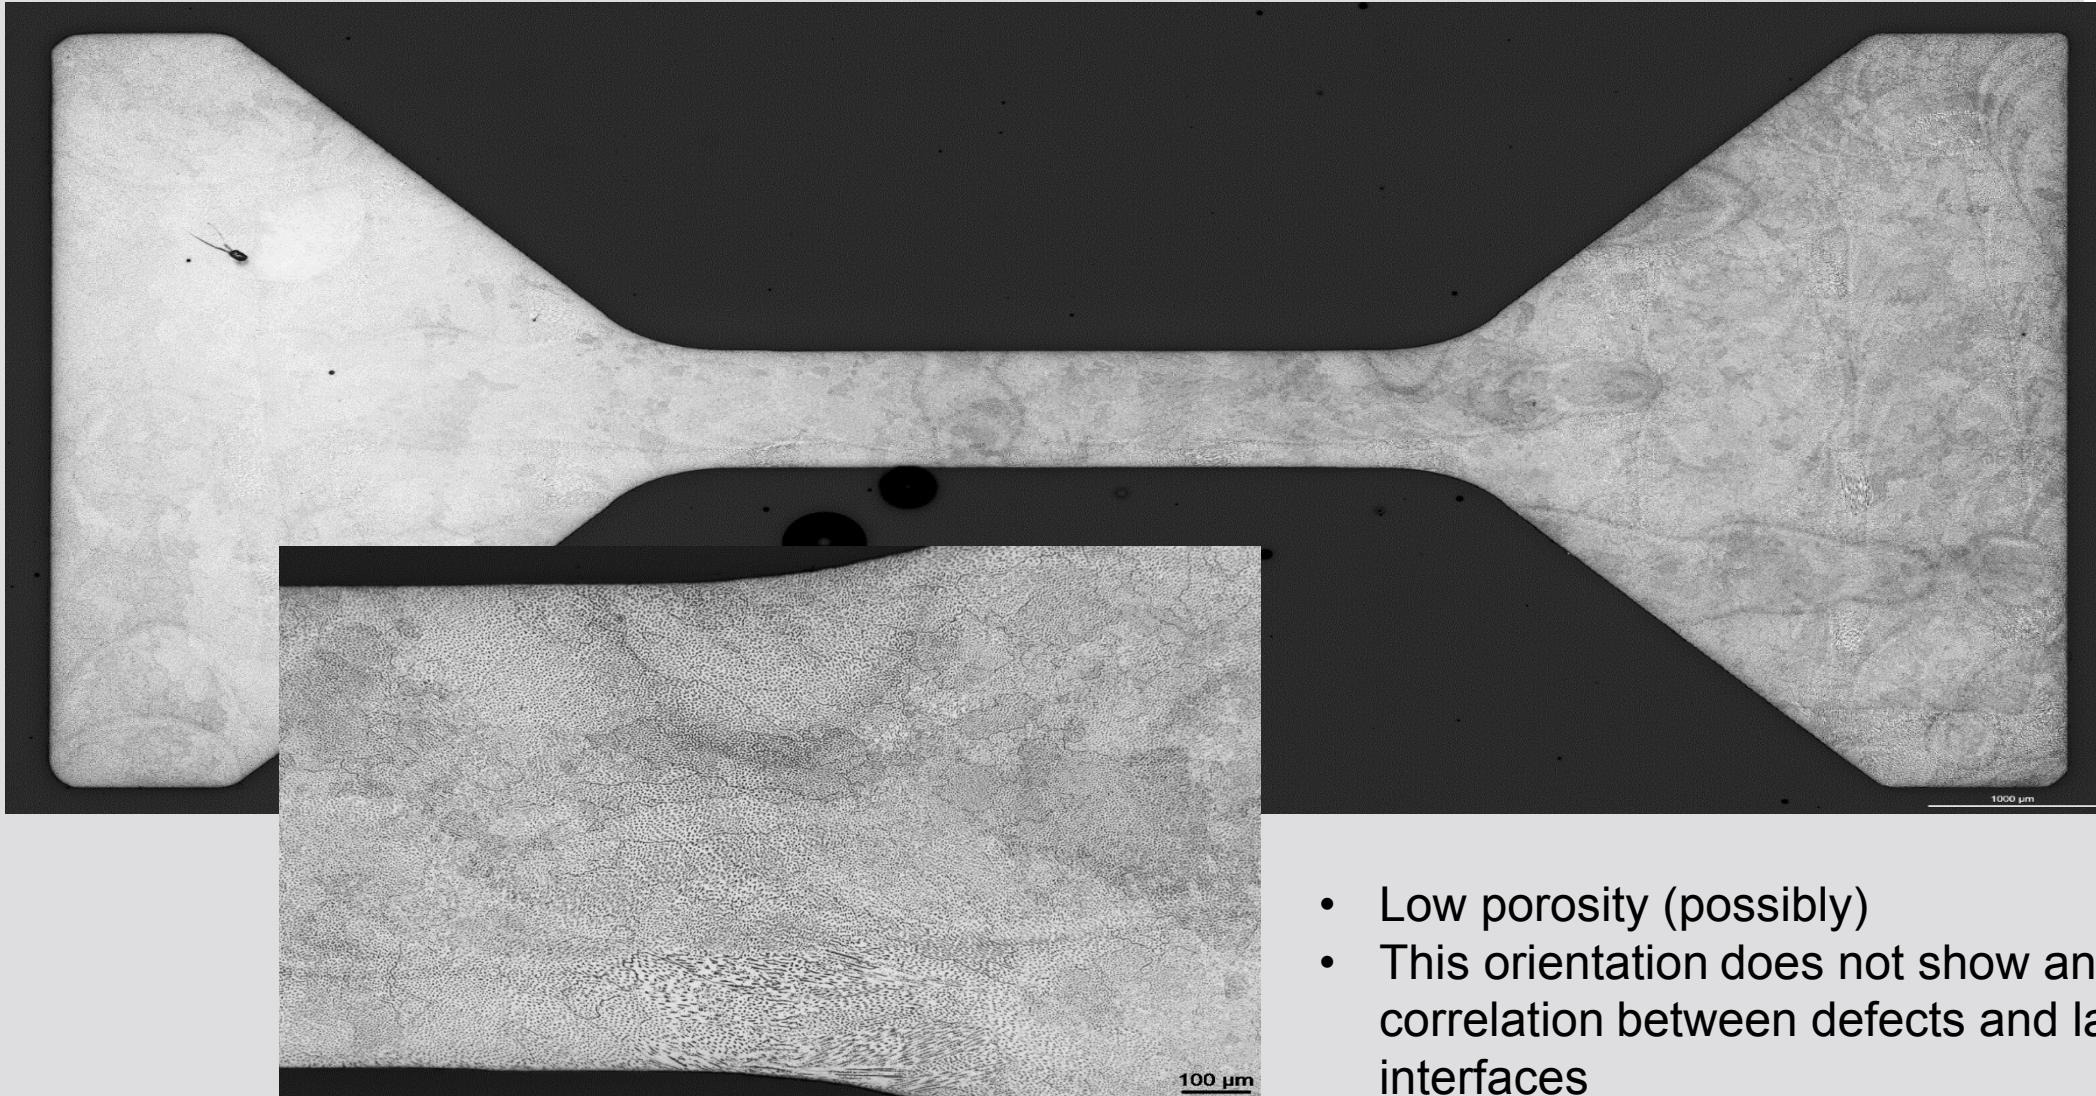
# Build 3 Metallography

- Low porosity (possibly)
- This orientation does not show any correlation between defects and layer interfaces
- Possible defects at build layer interface

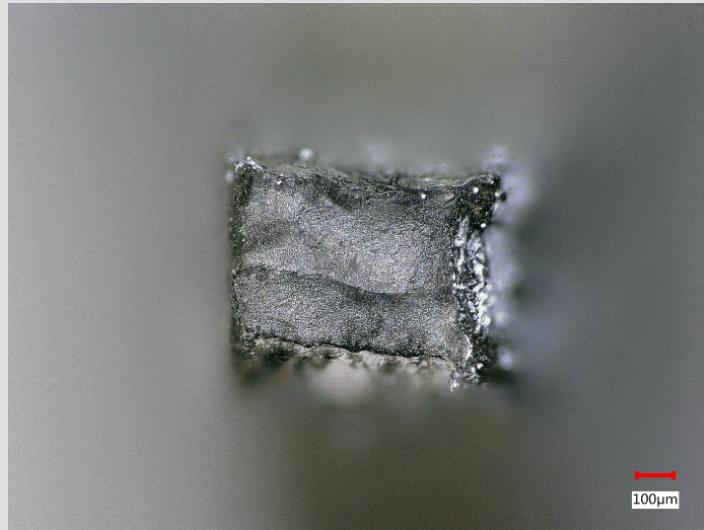
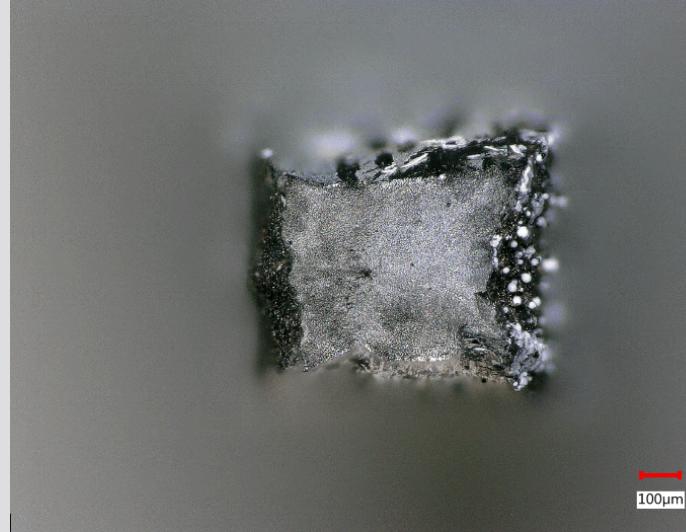
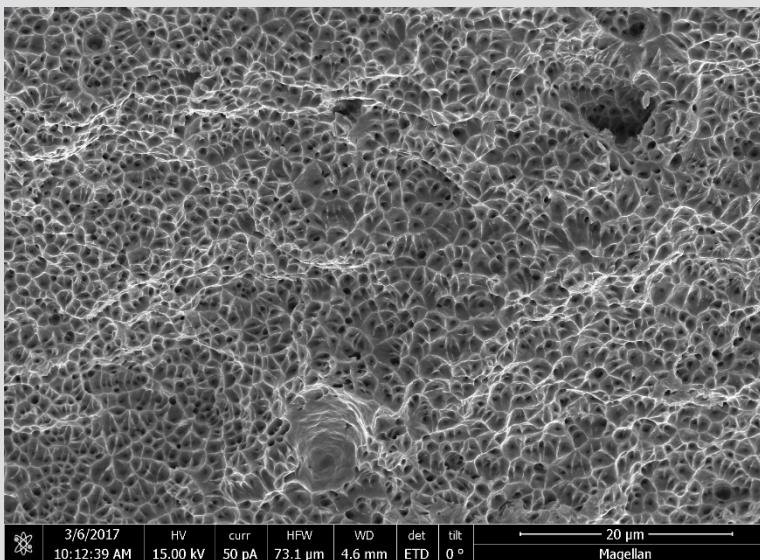
# Build 4

- More ductile fracture, with few defects in fracture surfaces
- Difference in topology, ridge behavior in some samples

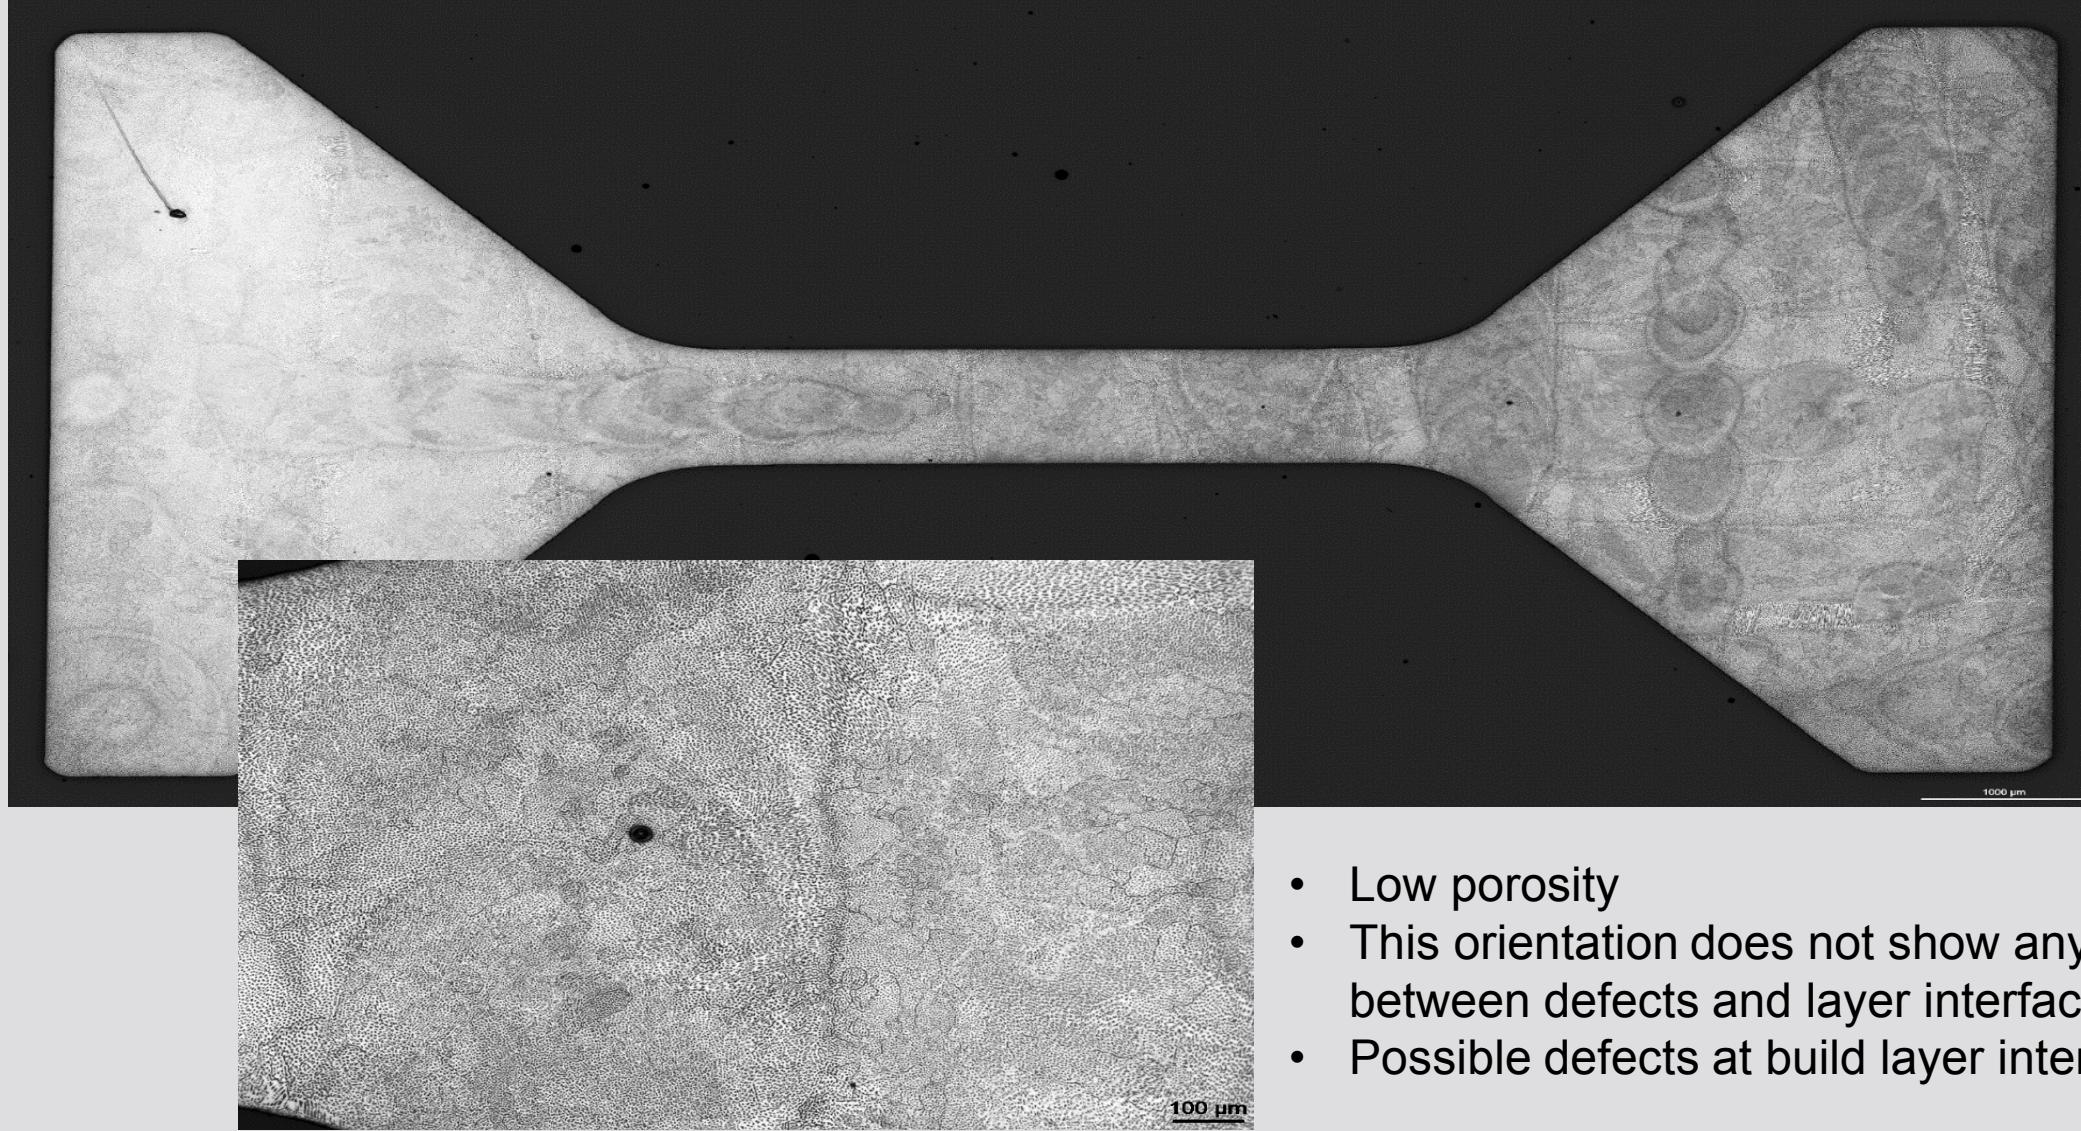
# Build 4 Metallography

- Low porosity
- This orientation does not show any correlation between defects and layer interfaces
- Possible defects at build layer interface
