**A Section 106 Evaluation of Building CP-1, Area 6, Nevada National Security Site,  
Nye County, Nevada**

**Cultural Resource Technical Report No. 114  
Division of Earth and Ecosystems Sciences  
Desert Research Institute  
Las Vegas, Nevada**

**November 2016**

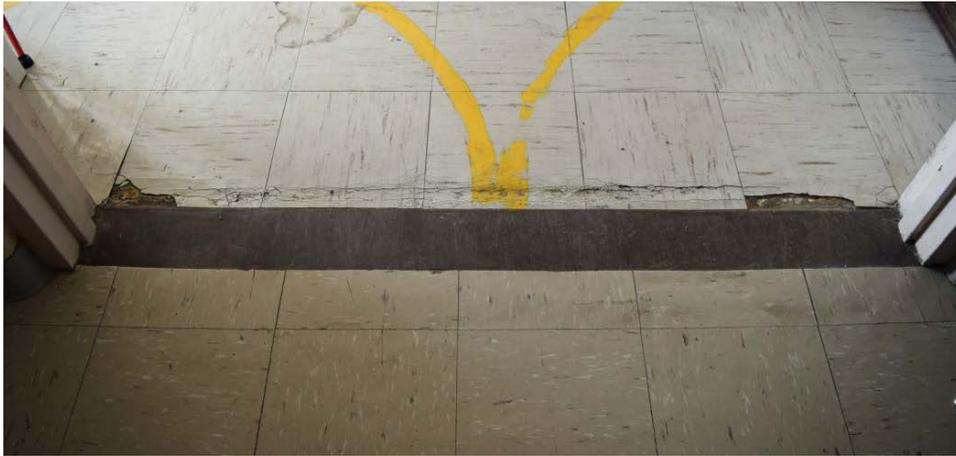
Figure 201. Cracking of concrete and tile at junction of CP-1 and CP-1B visible in main entrance lobby, Room 205 (2016).

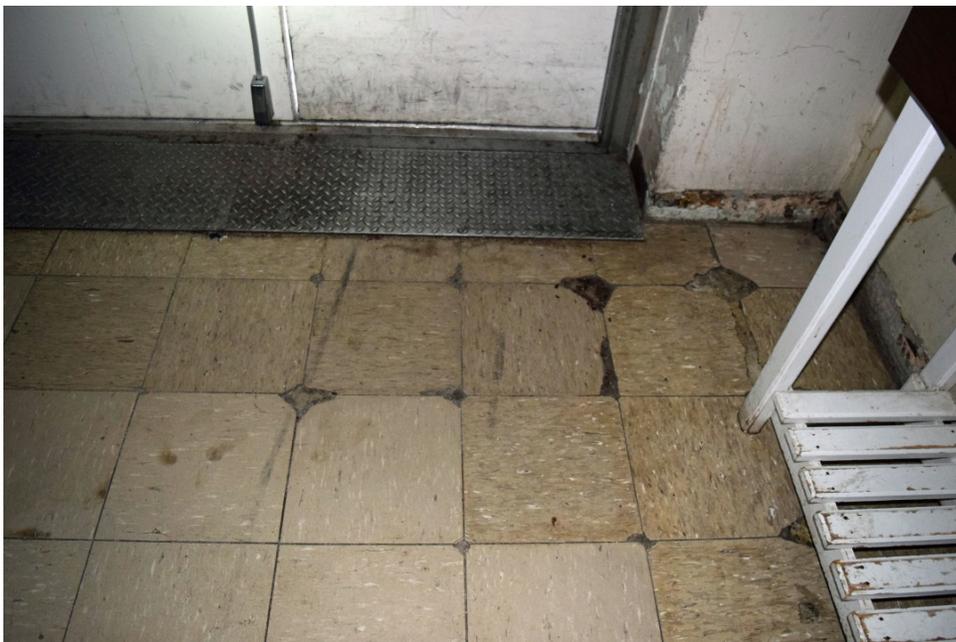
Figure 202. Cracking of concrete and tile at junction of CP-1 and CP-1A visible in basement entrance, Room 115A. Also present is baseboard damage from minor flooding through doorway and heavy use wear. Note at least two earlier generations of tile replacements from older damage. Light is also visible through door, indicating a route of insect and possibly mouse access (2016).

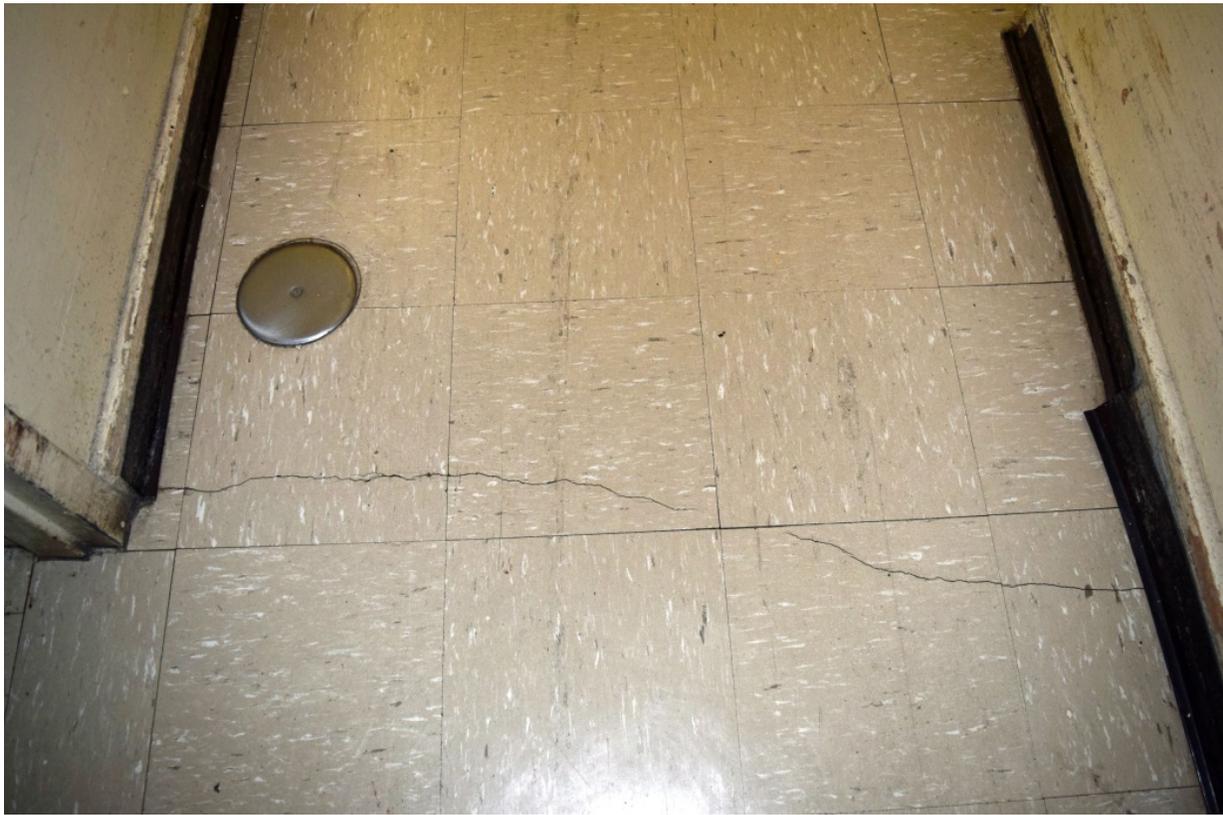
Figure 203. Crack in concrete basement corridor in CP-1. Also visible is wall and baseboard damage from kitchen carts (2016).

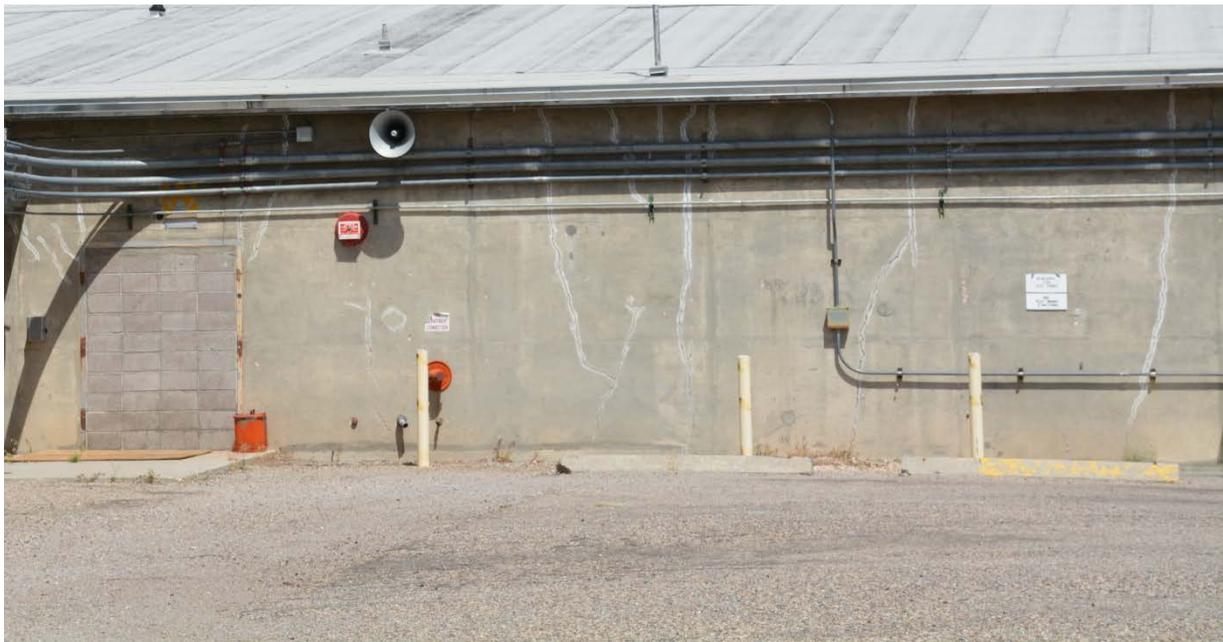
Figure 204. Wall cracks in west wall of CP-1 (2016).

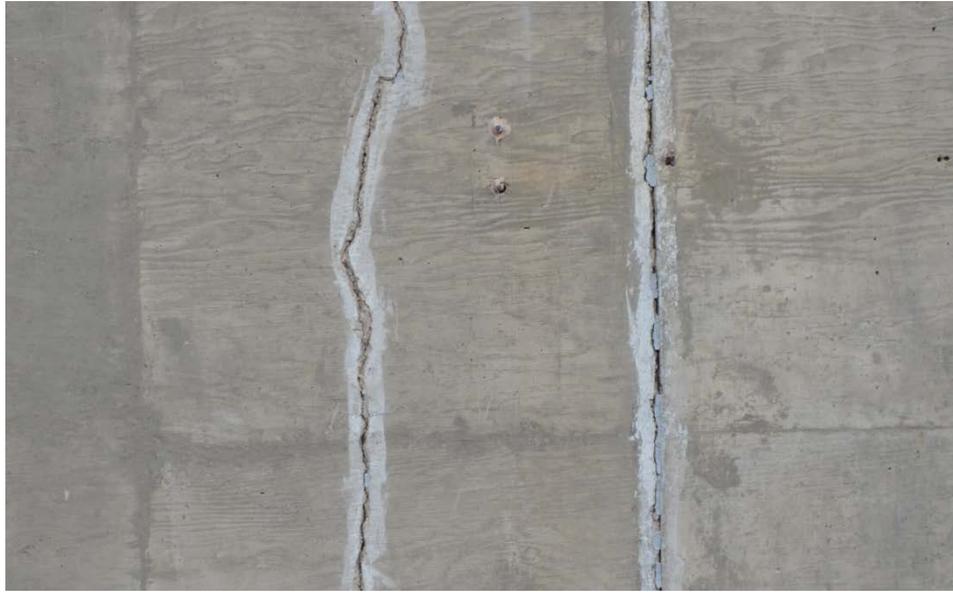
Figure 205. Detail of CP-1 west wall cracks (2016).

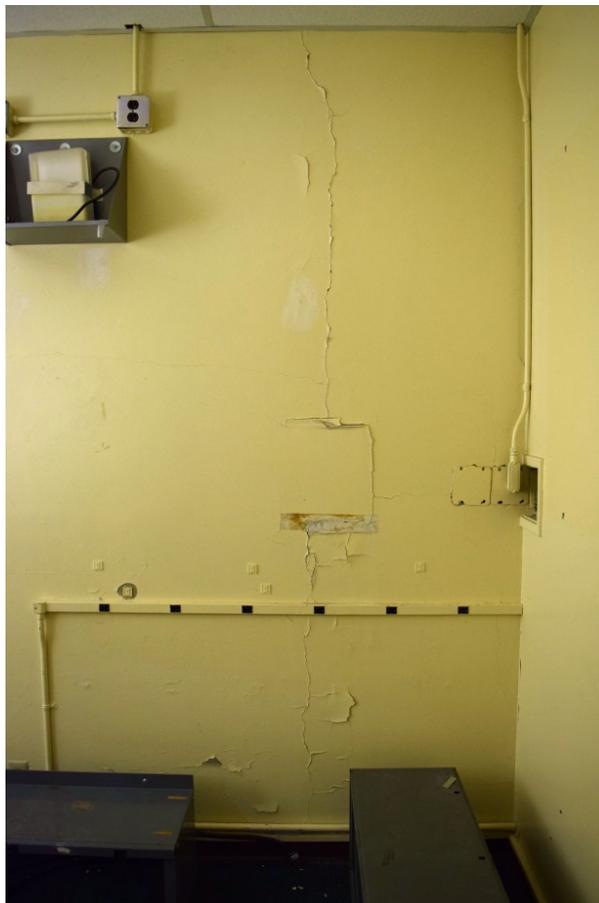
Figure 206. Crack completely through concrete in south wall of CP-1, Room 241B (2016).

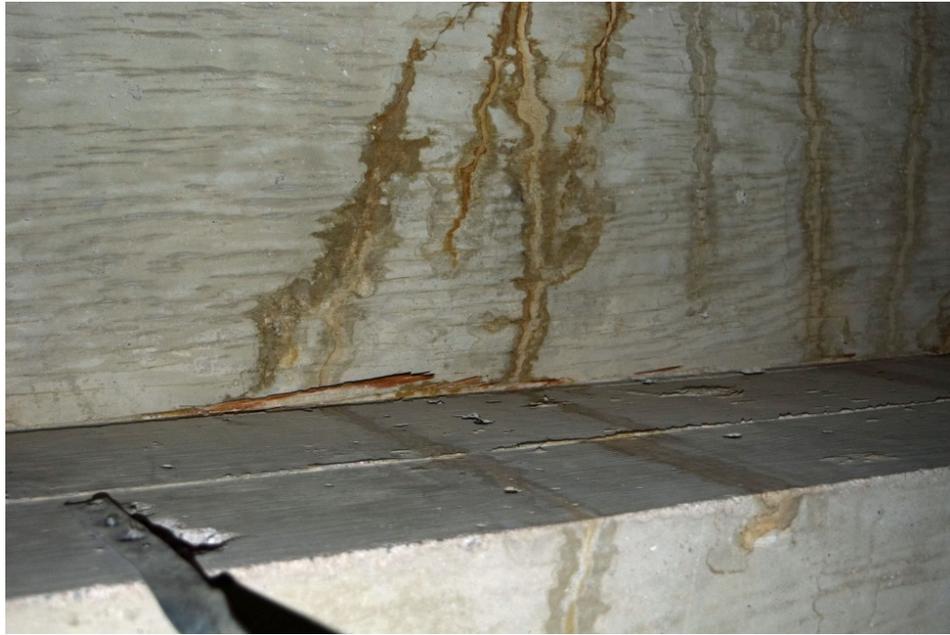
Figure 207. Water infiltration through ceiling cracks in CP-1 above Room 215 (2016).

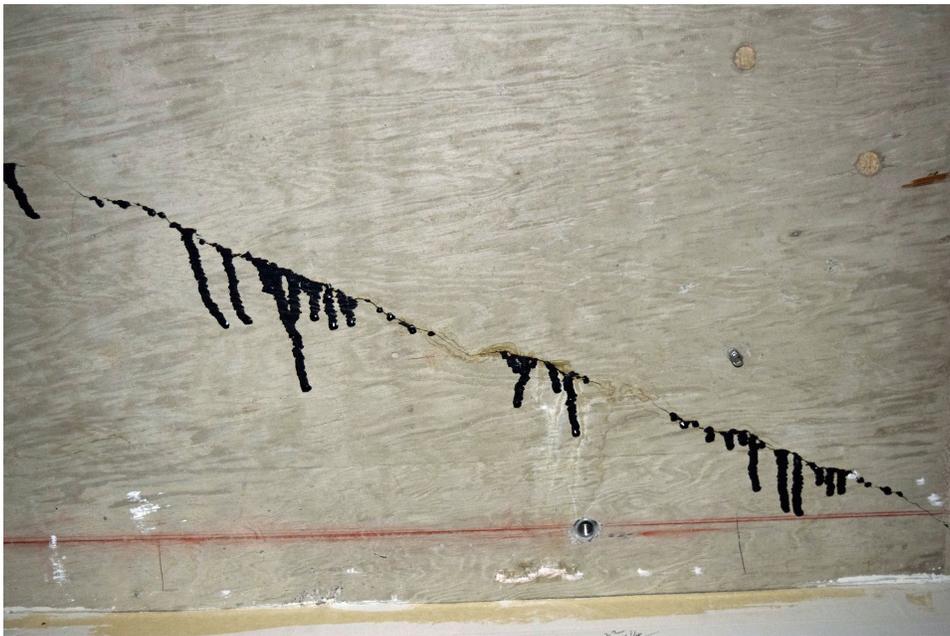
Figure 208. Tar and water infiltration through ceiling crack in CP-1 above Room 213 (2016).

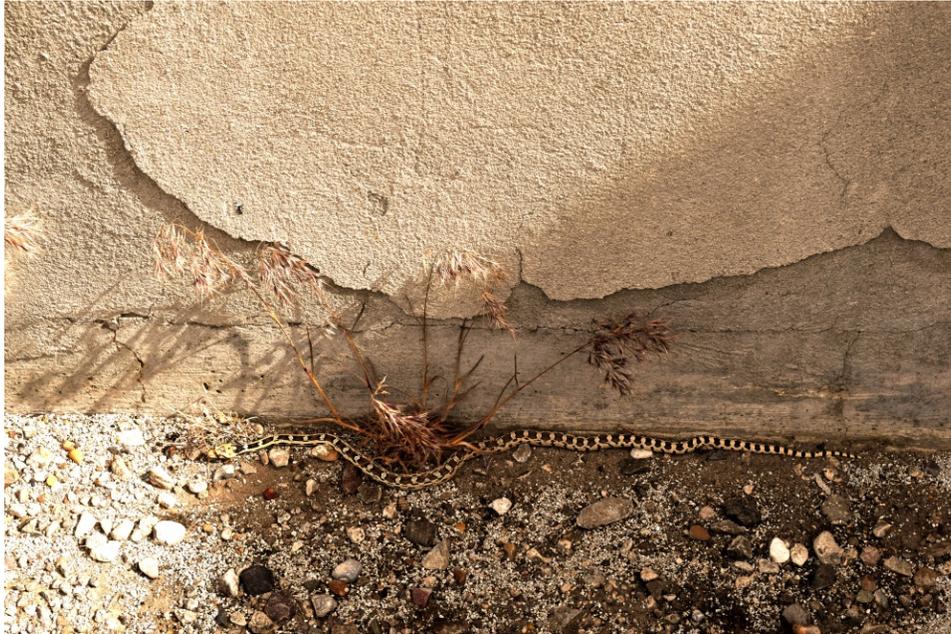
Figure 209. Erosion of stucco coating along foundation of CP-1B (2016).

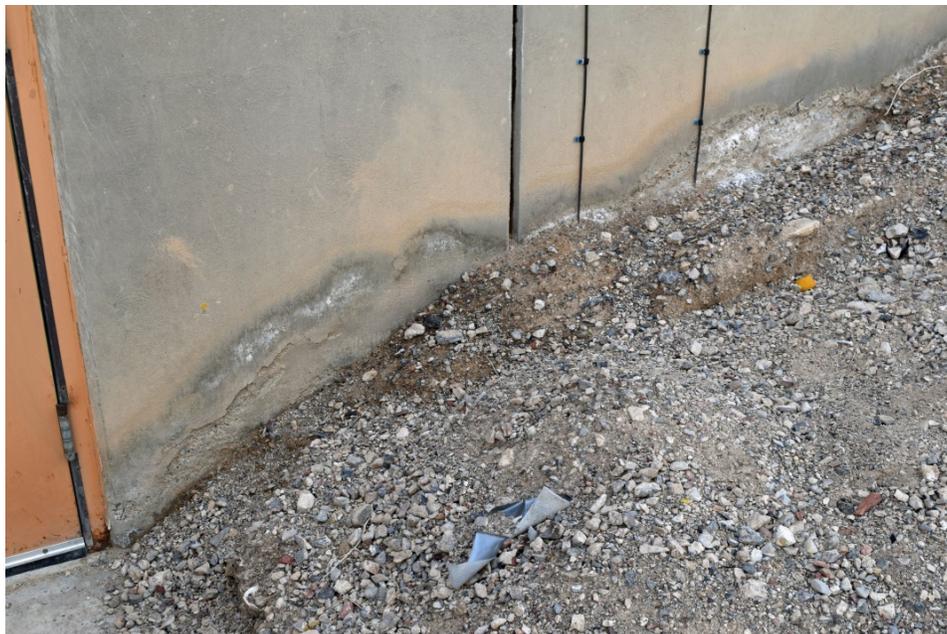
Figure 210. Erosion of exterior concrete at CP-1B.  
No waterproofing is visible (2016).

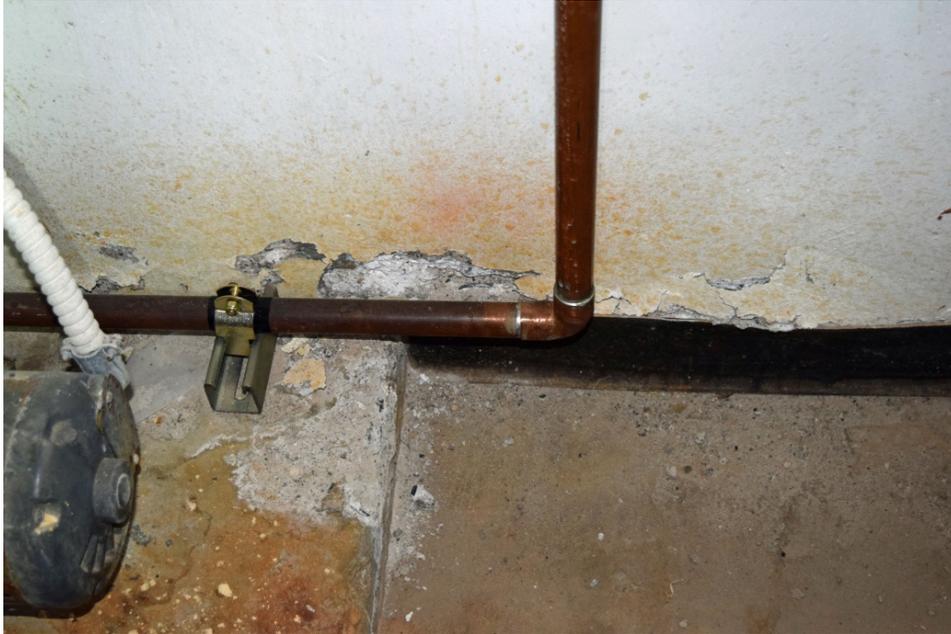
Figure 211. Exfoliation of concrete in basement Room 136 of CP-1B resulting from water infiltration through north foundation. This is the inside of the same wall shown above (2016).

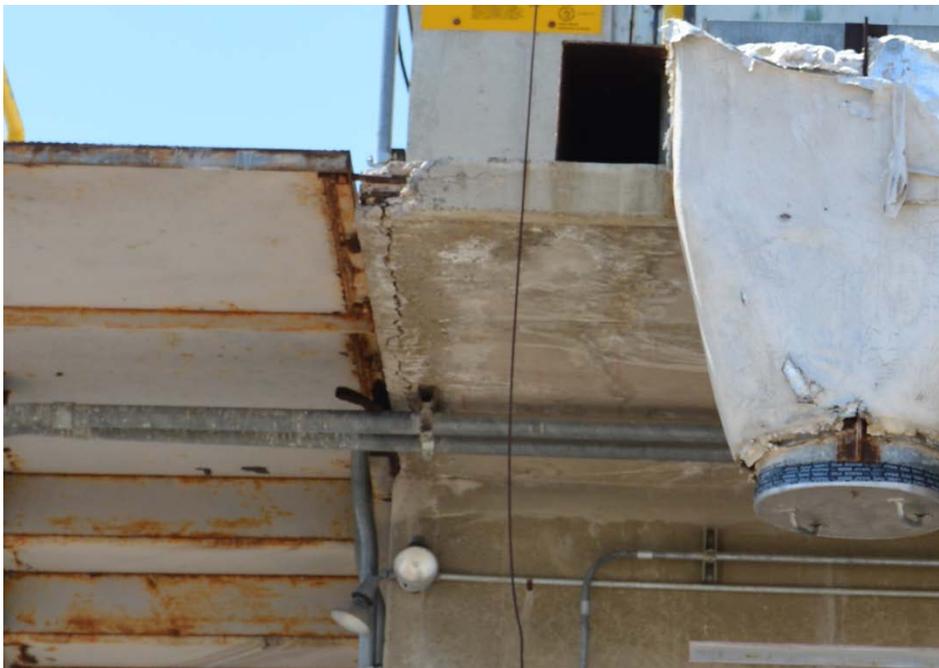
Figure 212. Concrete decay at edge of north porch on CP-1A with exposed rebar (2016).

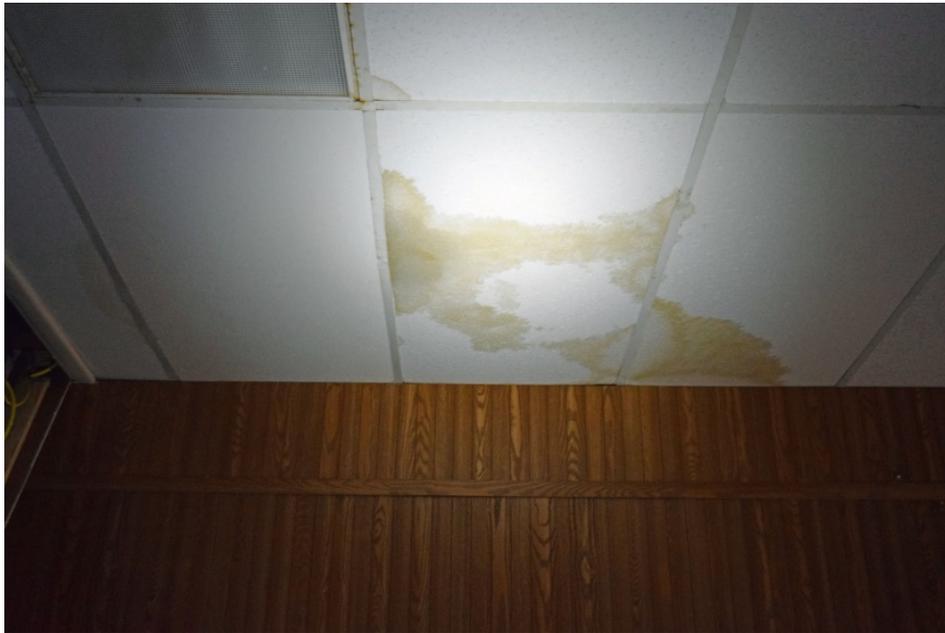
Figure 213. Water and possibly oil leakage onto ceiling of CP-1 Room 256 from air handler in attic (2016).

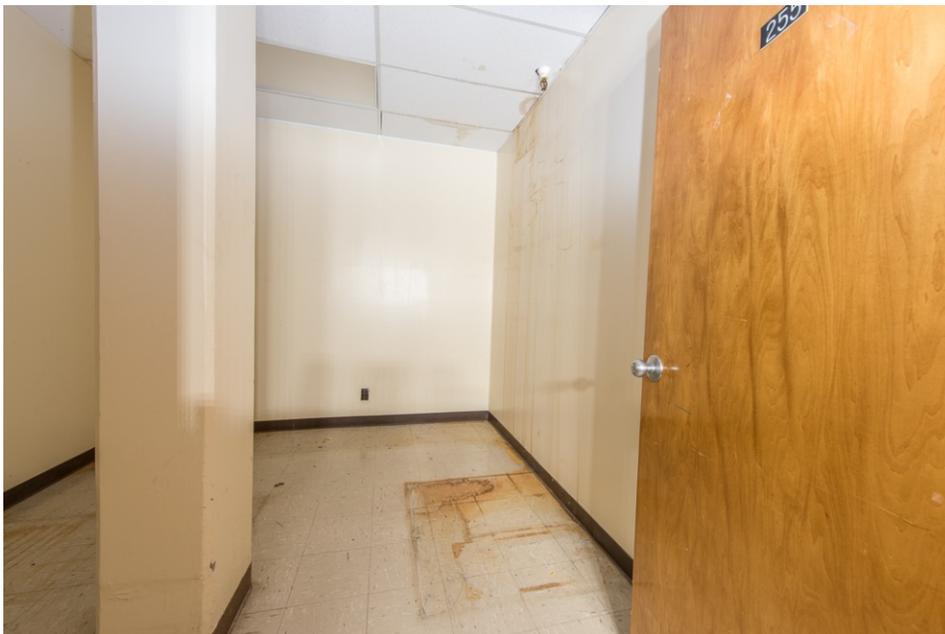
Figure 214. Water damage in ceiling, wall, and floor from ceiling leak in Room 255 (photograph DSC1612 dated 2016 on file at RSL).

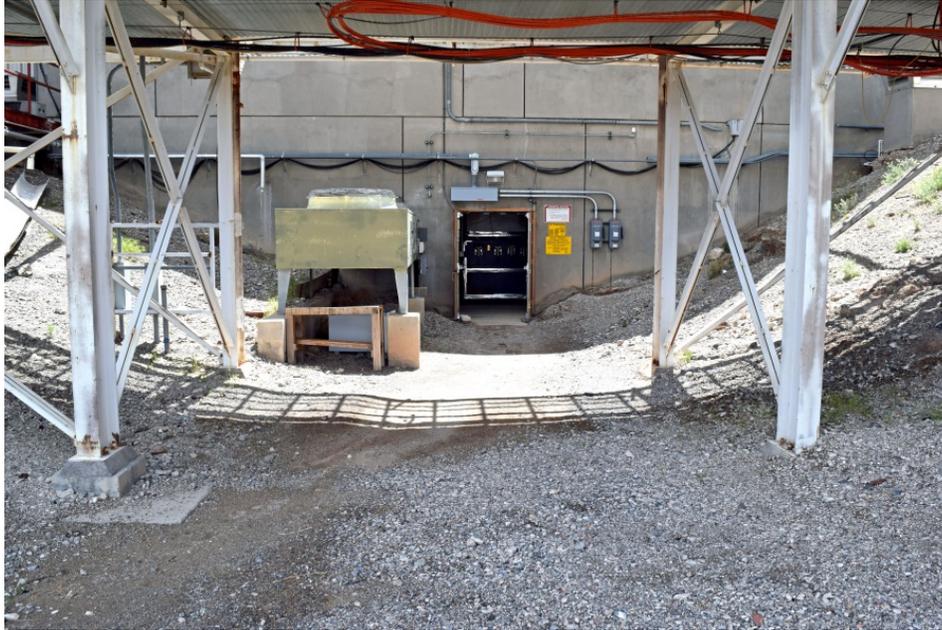
Figure 215. Stormwater channel leading to basement door of CP-1B Room 137 (2016).

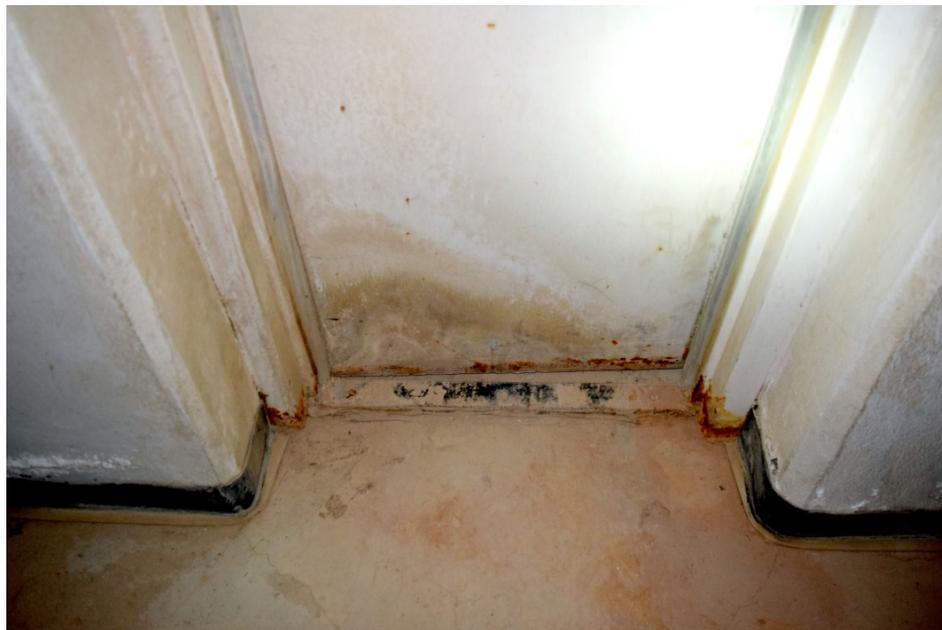
Figure 216. Silt accumulation and damage to steel door and frame to Room 137B from water entering through the door shown above and traversing entire length of Room 137 (2016).

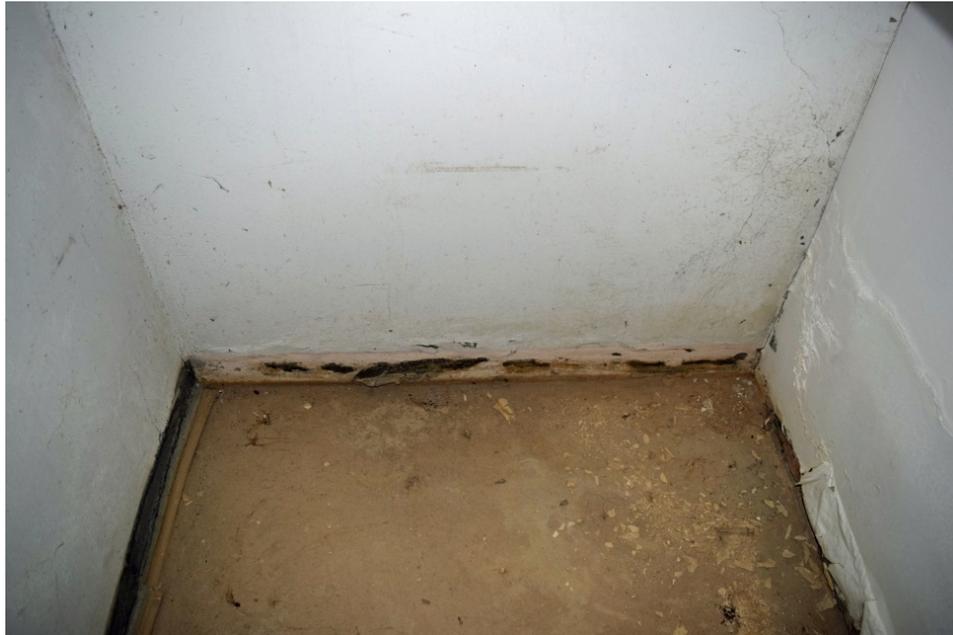
Figure 217. Silt accumulation, drywall damage, and baseboard failure in Room 137B. Again, water has entered through the basement door shown above (2016).

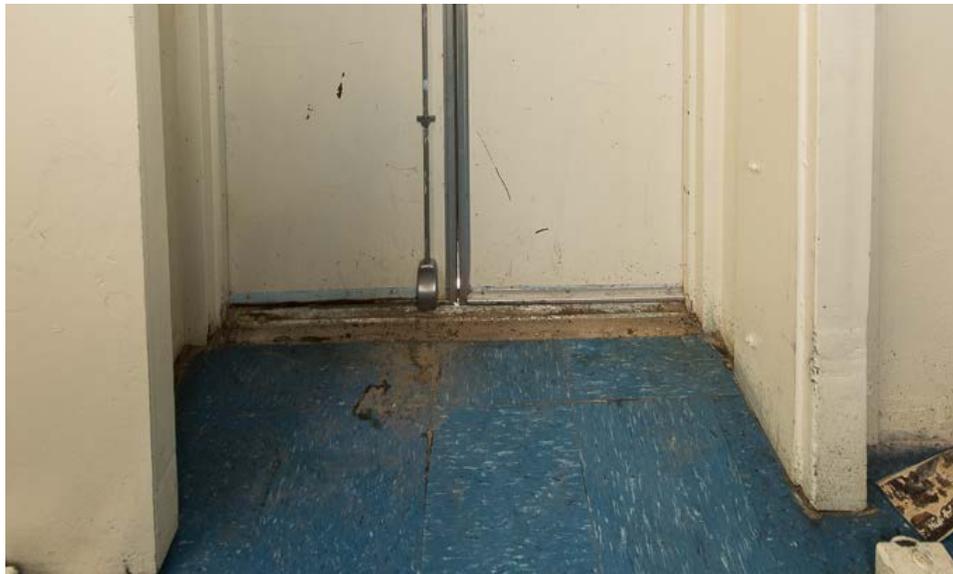
Figure 218. Silt and floor damage from water entering west door of CP-1B (photograph DSC\_2524 dated 2016 on file at RSL).

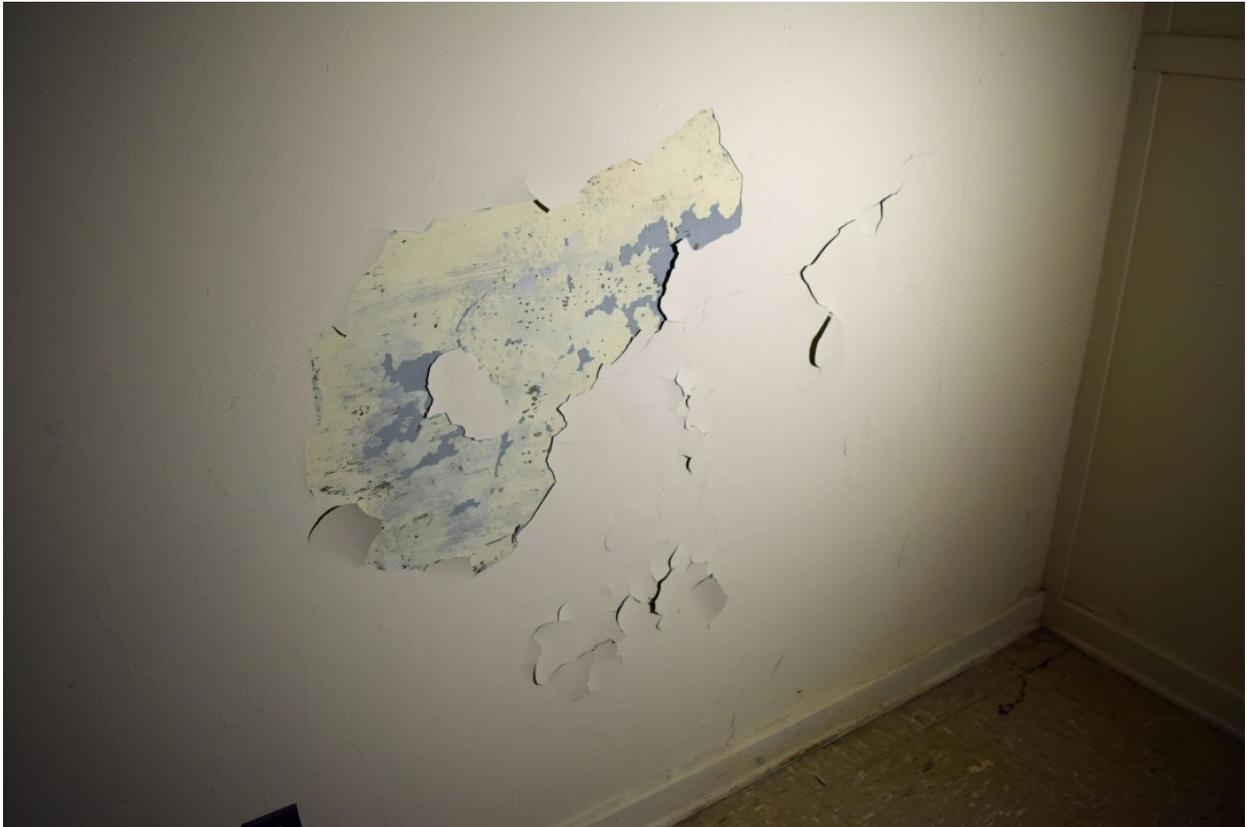
Figure 219. Failure of paint to adhere to concrete, interior of south wall, CP-1 (2016).

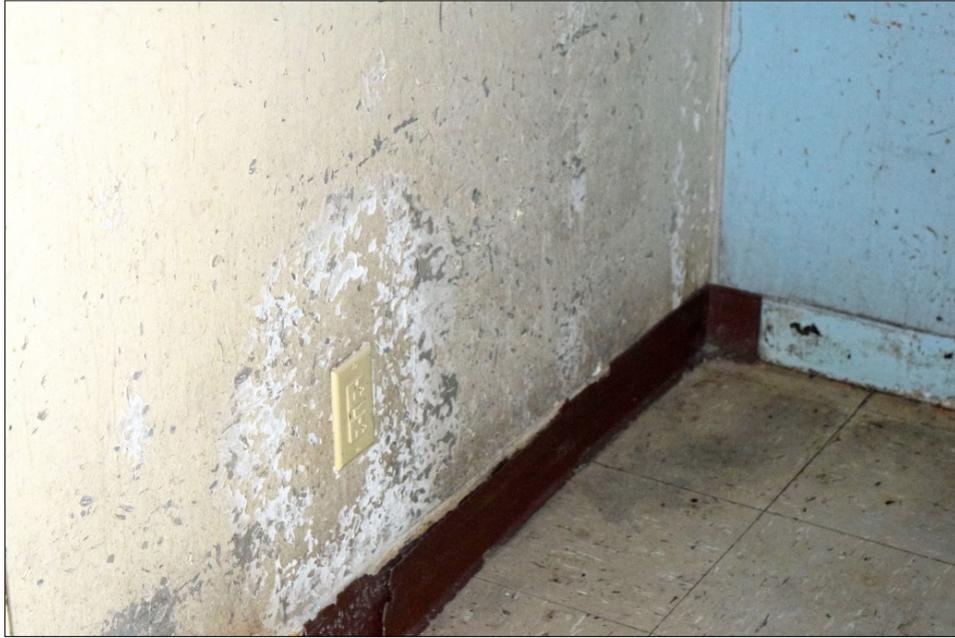
Figure 220. Wall damage caused by kitchen carts in CP-1 basement (2016).

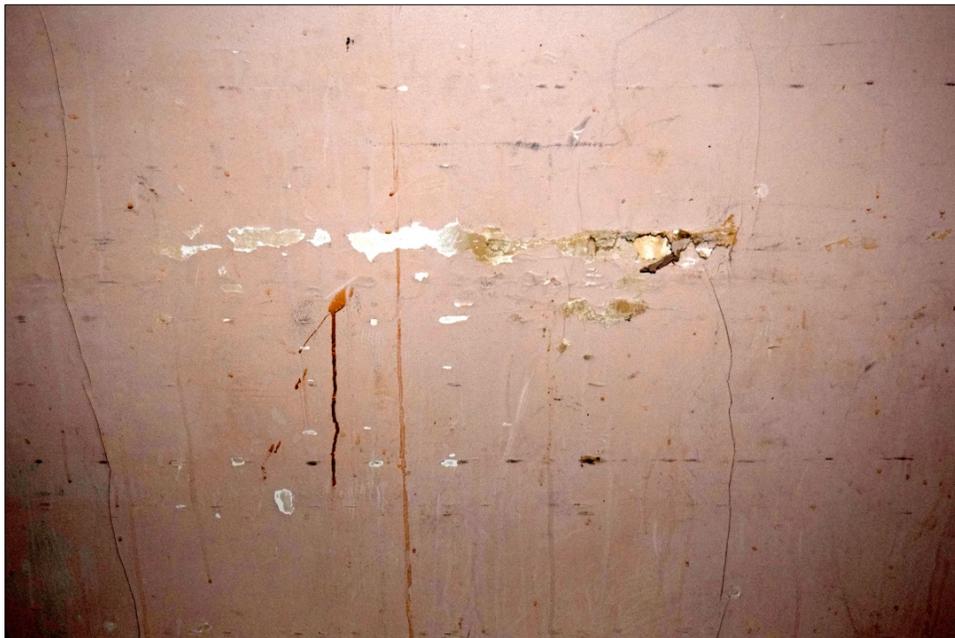
Figure 221. Wall damage caused by kitchen carts in CP-1 basement corridor. Also visible are vertical cracks likely from seismic activity (2016).

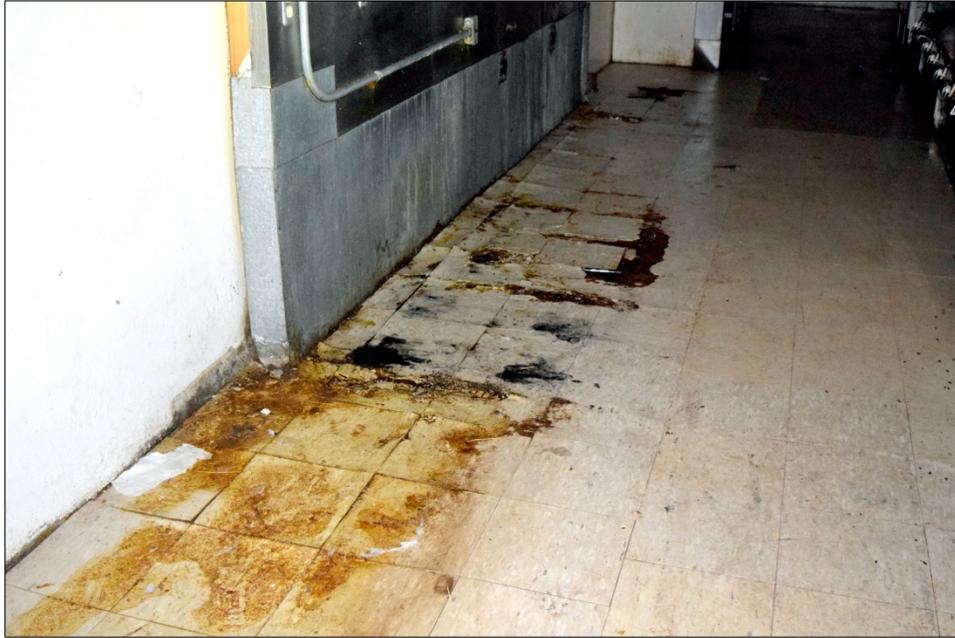
Figure 222. Floor damage below and behind removed equipment in Kitchen, CP-1 Room 112 (2016).

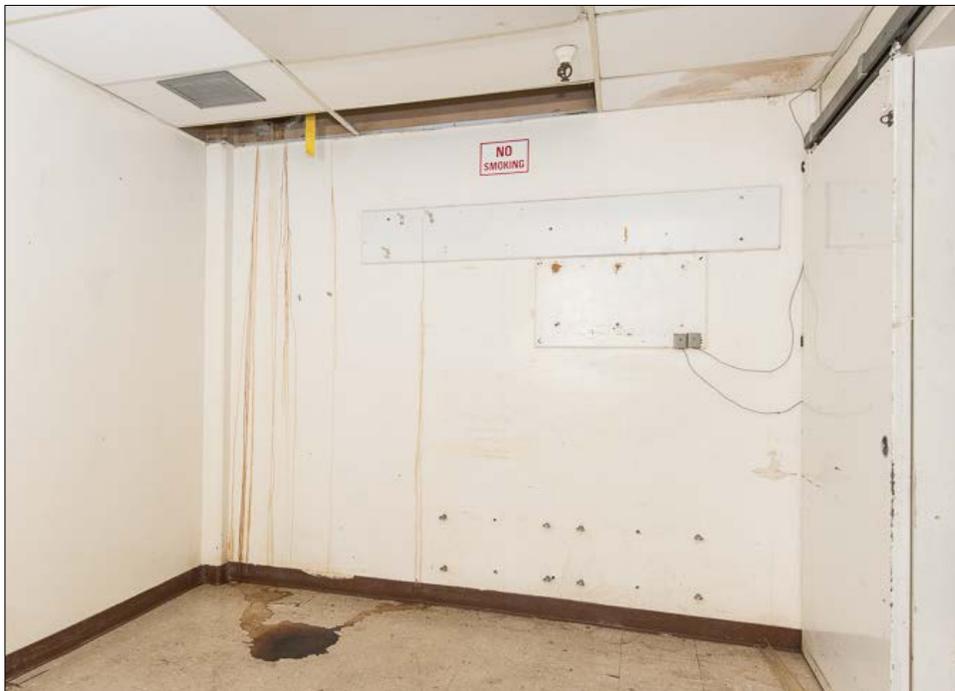
Figure 223. Kitchen grease flowing down wall and pooling on floor from vent due to removal of lower part of duct. Ceiling also has water damage (2016)

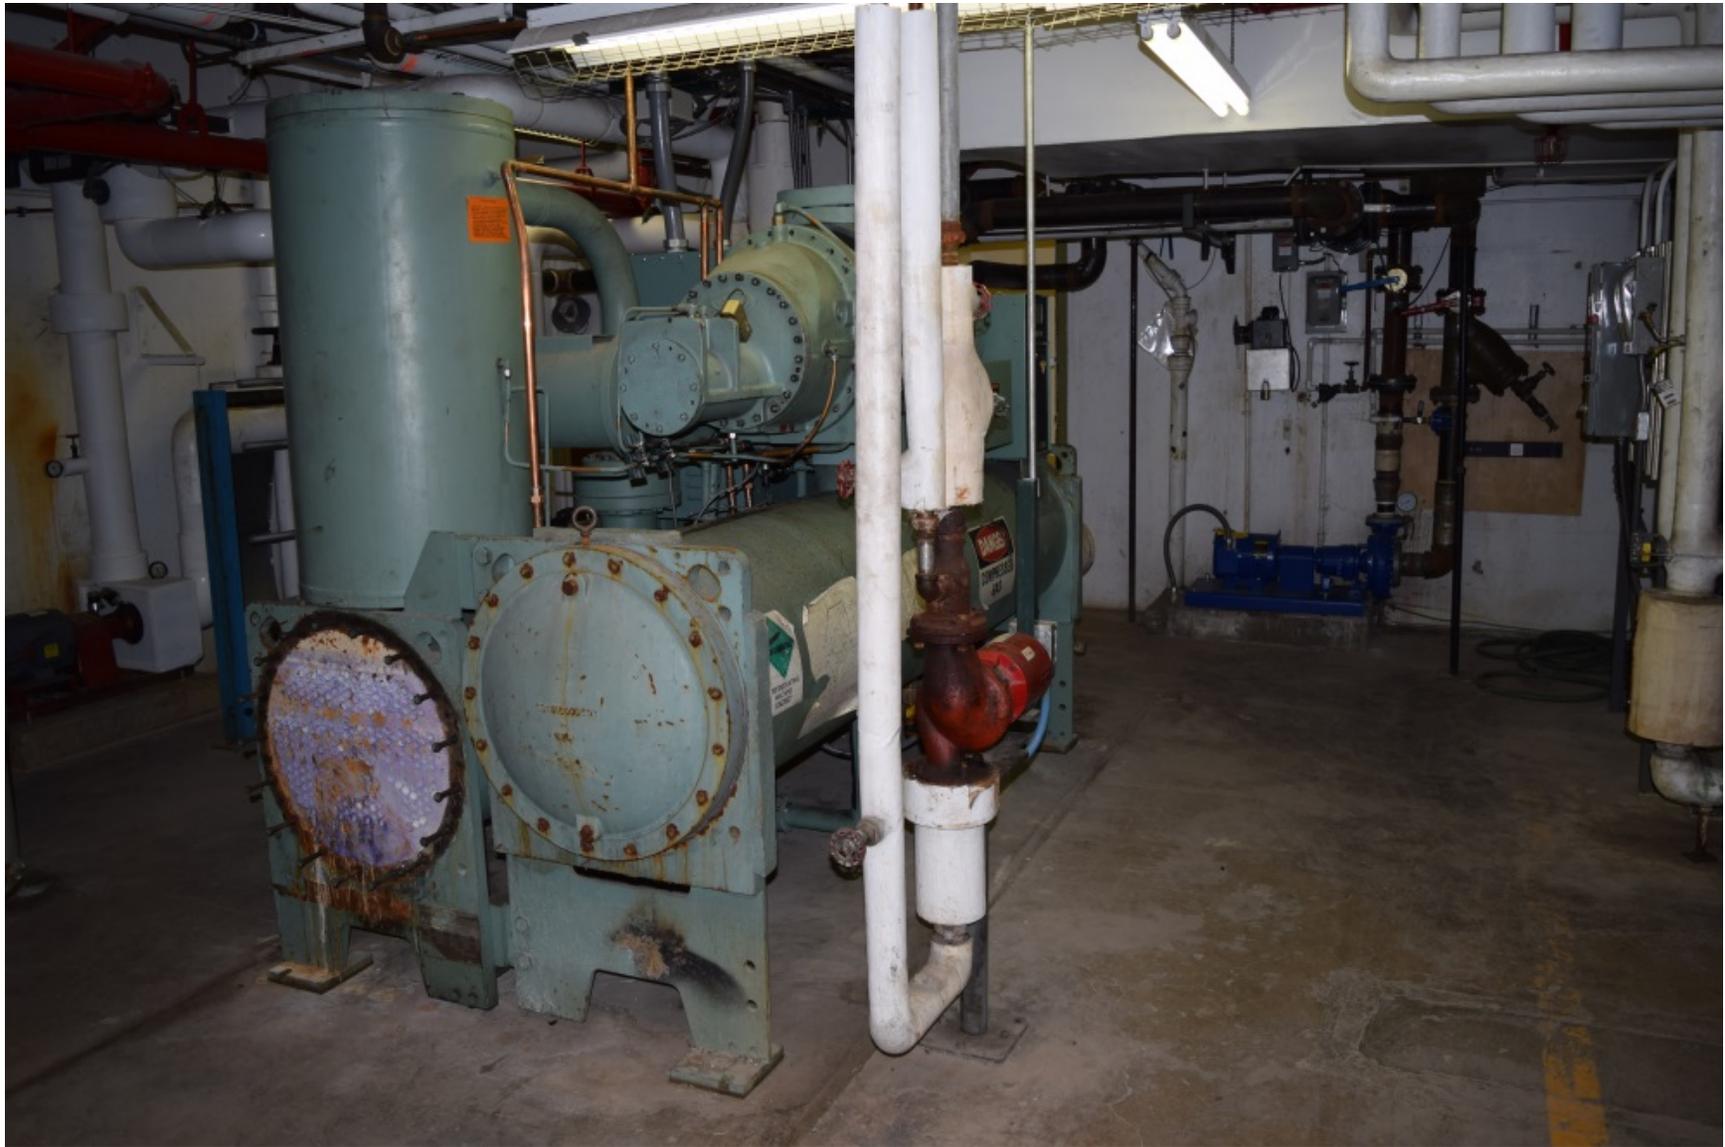
Figure 224. Broken CP-1 chiller in Room 116 with end removed (2016).

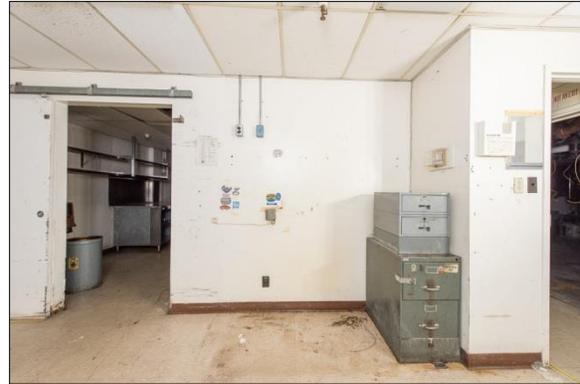
Western section of the room, note damage and leak from suspended ceiling, view southwest (DSC2912).
