North Slope of Alaska ARM Facilities
Monthly Status Update
Sandia National Labs

September 2019

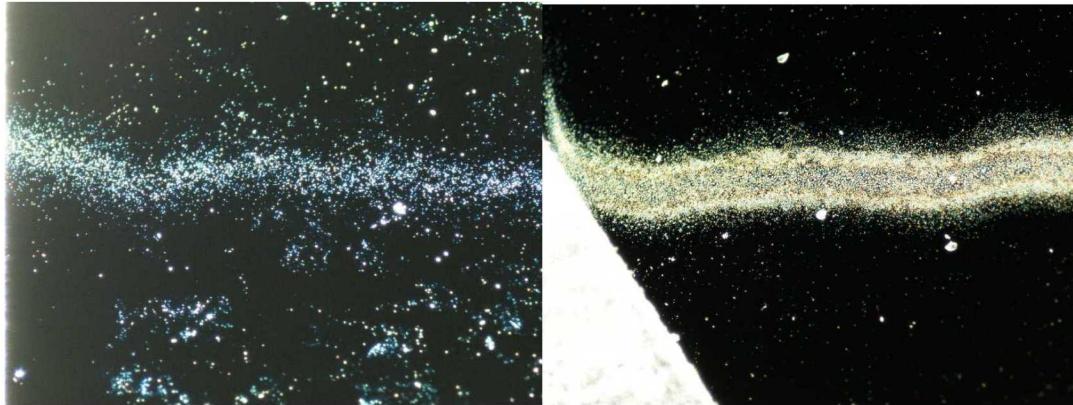
Figure 1: Examples of ideal TBI grid sample loading from July SGP and Aug AMF3 TBS campaigns

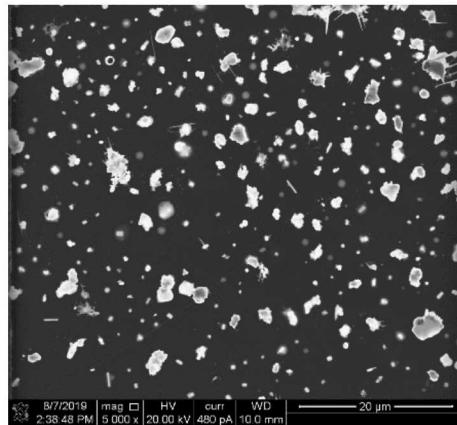
Figure 2: 5000x magnified view of TBI sample grid
