**North Slope of Alaska ARM Facilities**  
**Monthly Status Update**  
**Sandia National Labs**

**October 2019**

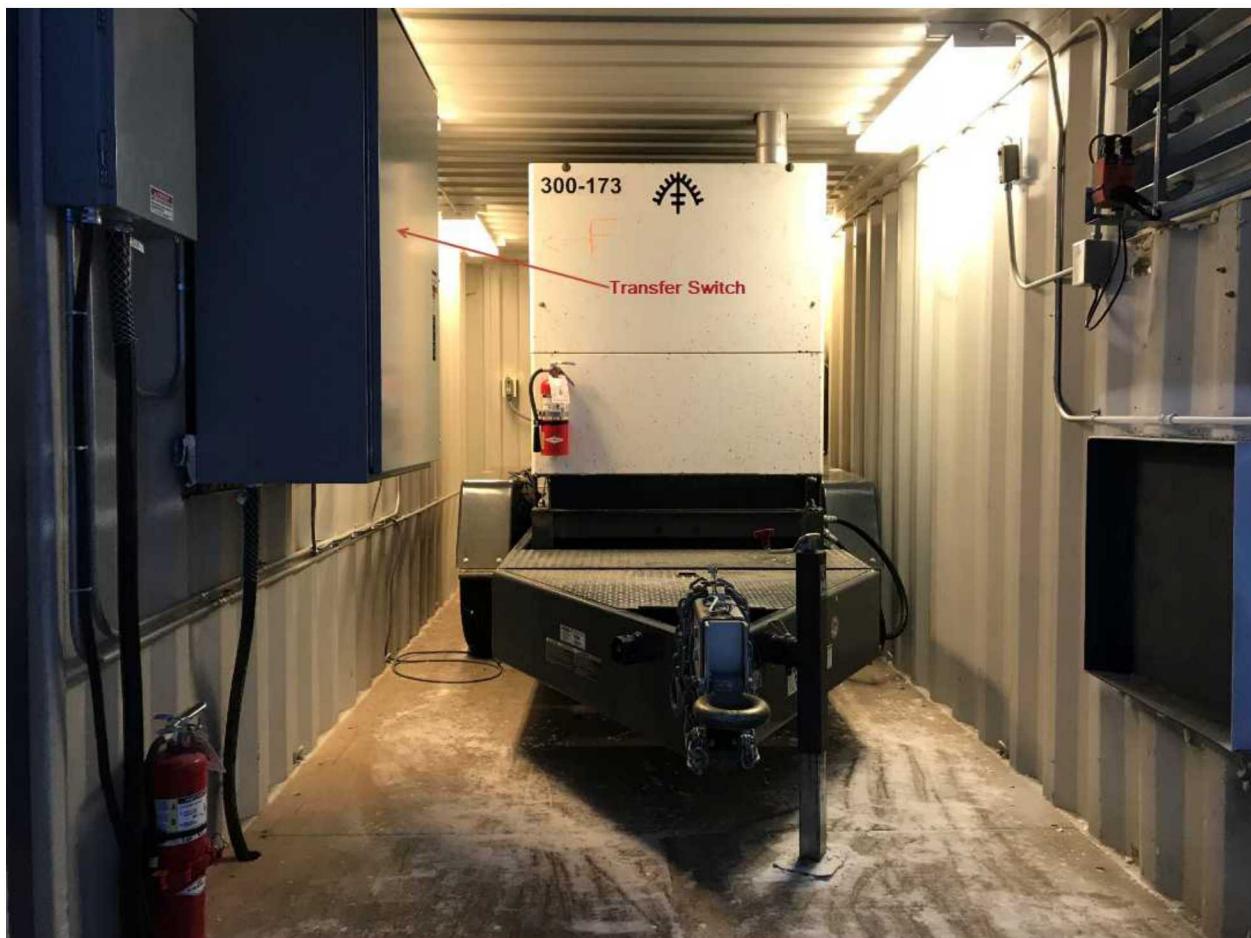
Repaired transfer switch was installed and tested in the north generator shelter, in preparation for winter. The transfer switch's purpose is to start the north generator if the turbines fail.

2019/10/26, CM-2019-AMF3-VSN-3078: Ops upgraded the power at the AMF3 facility by adding an automatic transfer switch (ATS) between the Capstone Microturbines and the North 80 kW CAT gen-set. Site operations and

Sandia personnel installed the ASCO 7000 series automatic transfer switch in the north generator shelter and prepped/ran all non-live cabling. Site operations switched the facilities load from the Capstone Microturbines to the South CAT 80 kW gen-set and powered down the Capstone Microturbines. Sandia personnel re-routed the turbine and north generator line power to the automatic transfer switch and then back to the manual transfer switch on the back of the generator shelters that supply the main power feed to the site. This will allow the auto transfer switch to function between the Microturbines and the north gen-set, but allow for a manual back up in case the auto transfer switch fails. In the case of a failure, the site can be manually switched to and operate off of the south gen-set. Upon completion of wiring, the Capstone Microturbines were brought back online and site operations swapped the facilities load from the south gen-set back to the turbines. All applicable lock out, tag out SOP was observed and followed. All site instrumentation were fully back online by 23:26 UTC.

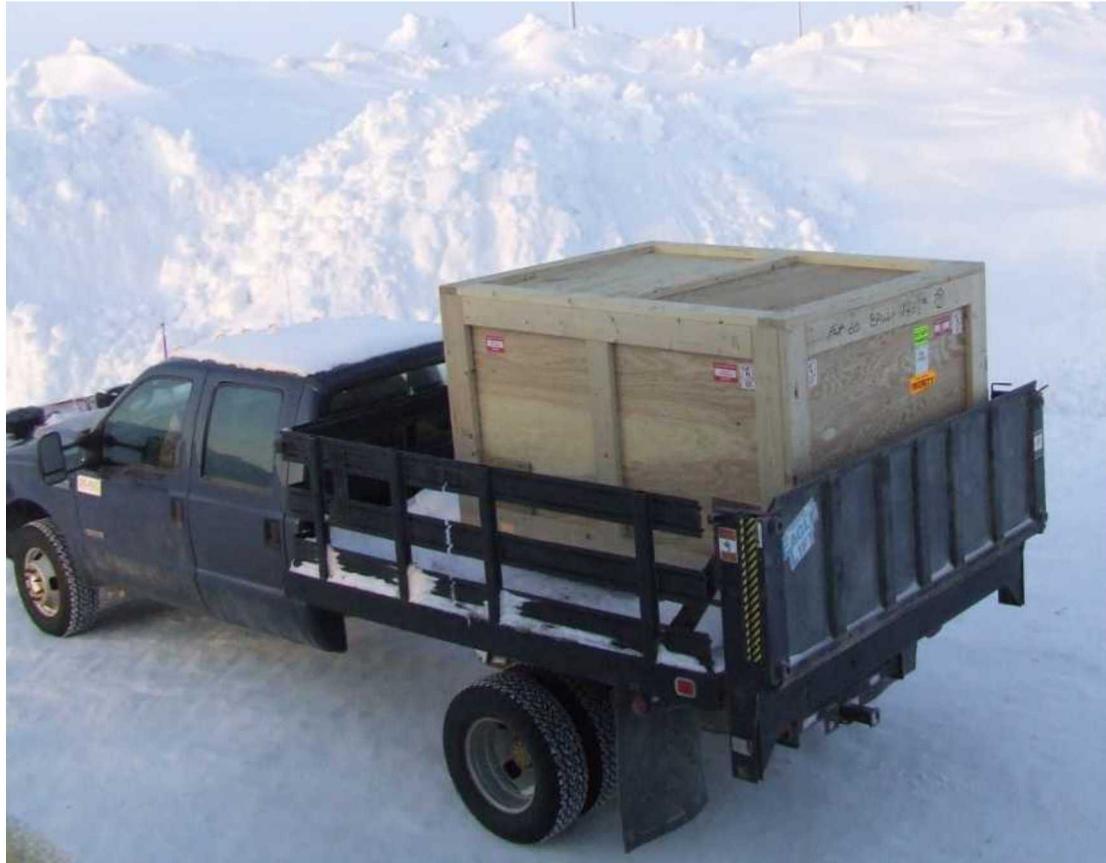
Ford F350 is back in service after 12/26/18 accident; site operators are very happy with its return.
