SOFT Poster
P4.151

Failure of a Lithium-filled Target and Some Implications for Fusion Components

R.E. Nygren, D.L. Youchison, J. R. Michael, J. D. Puskar, T.J. Lutz
Sandia National Laboratories, Albuquerque, New Mexico, USA

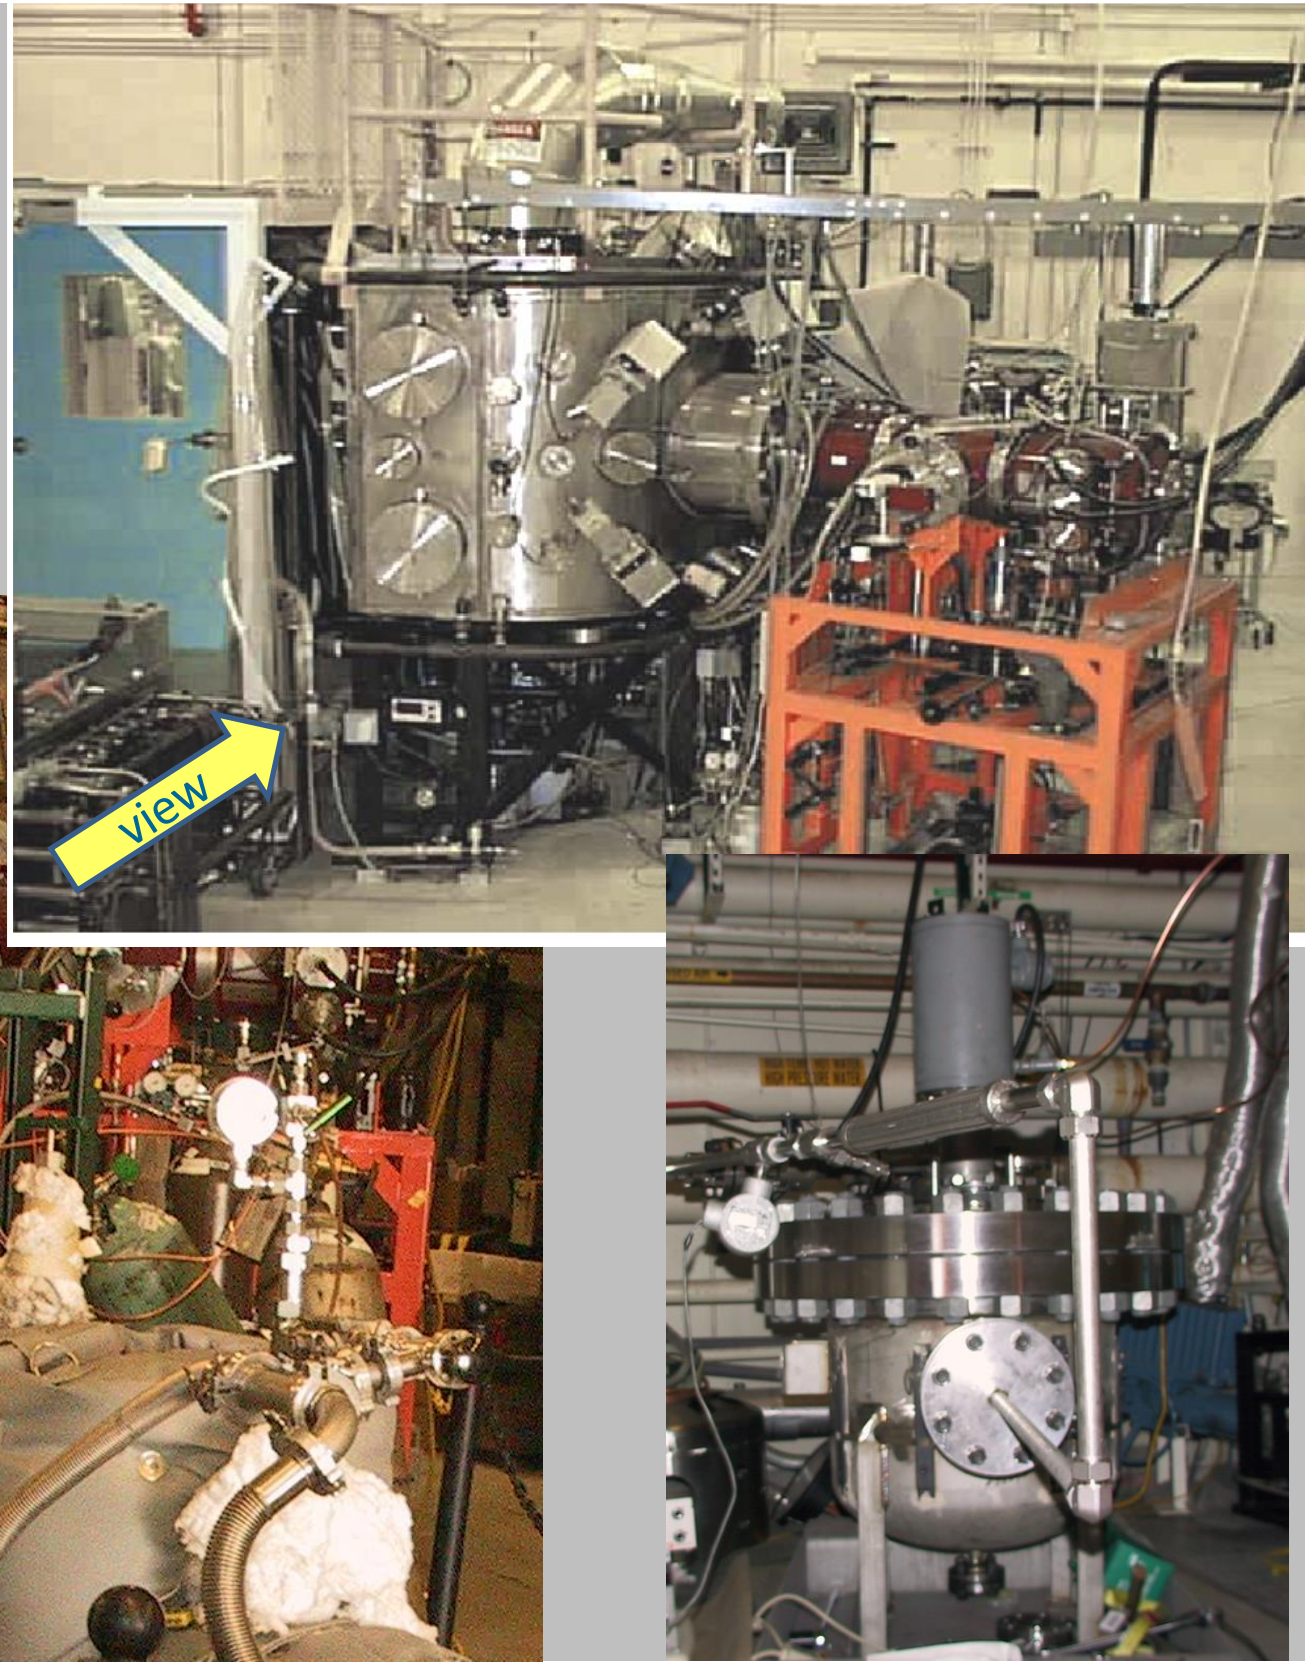
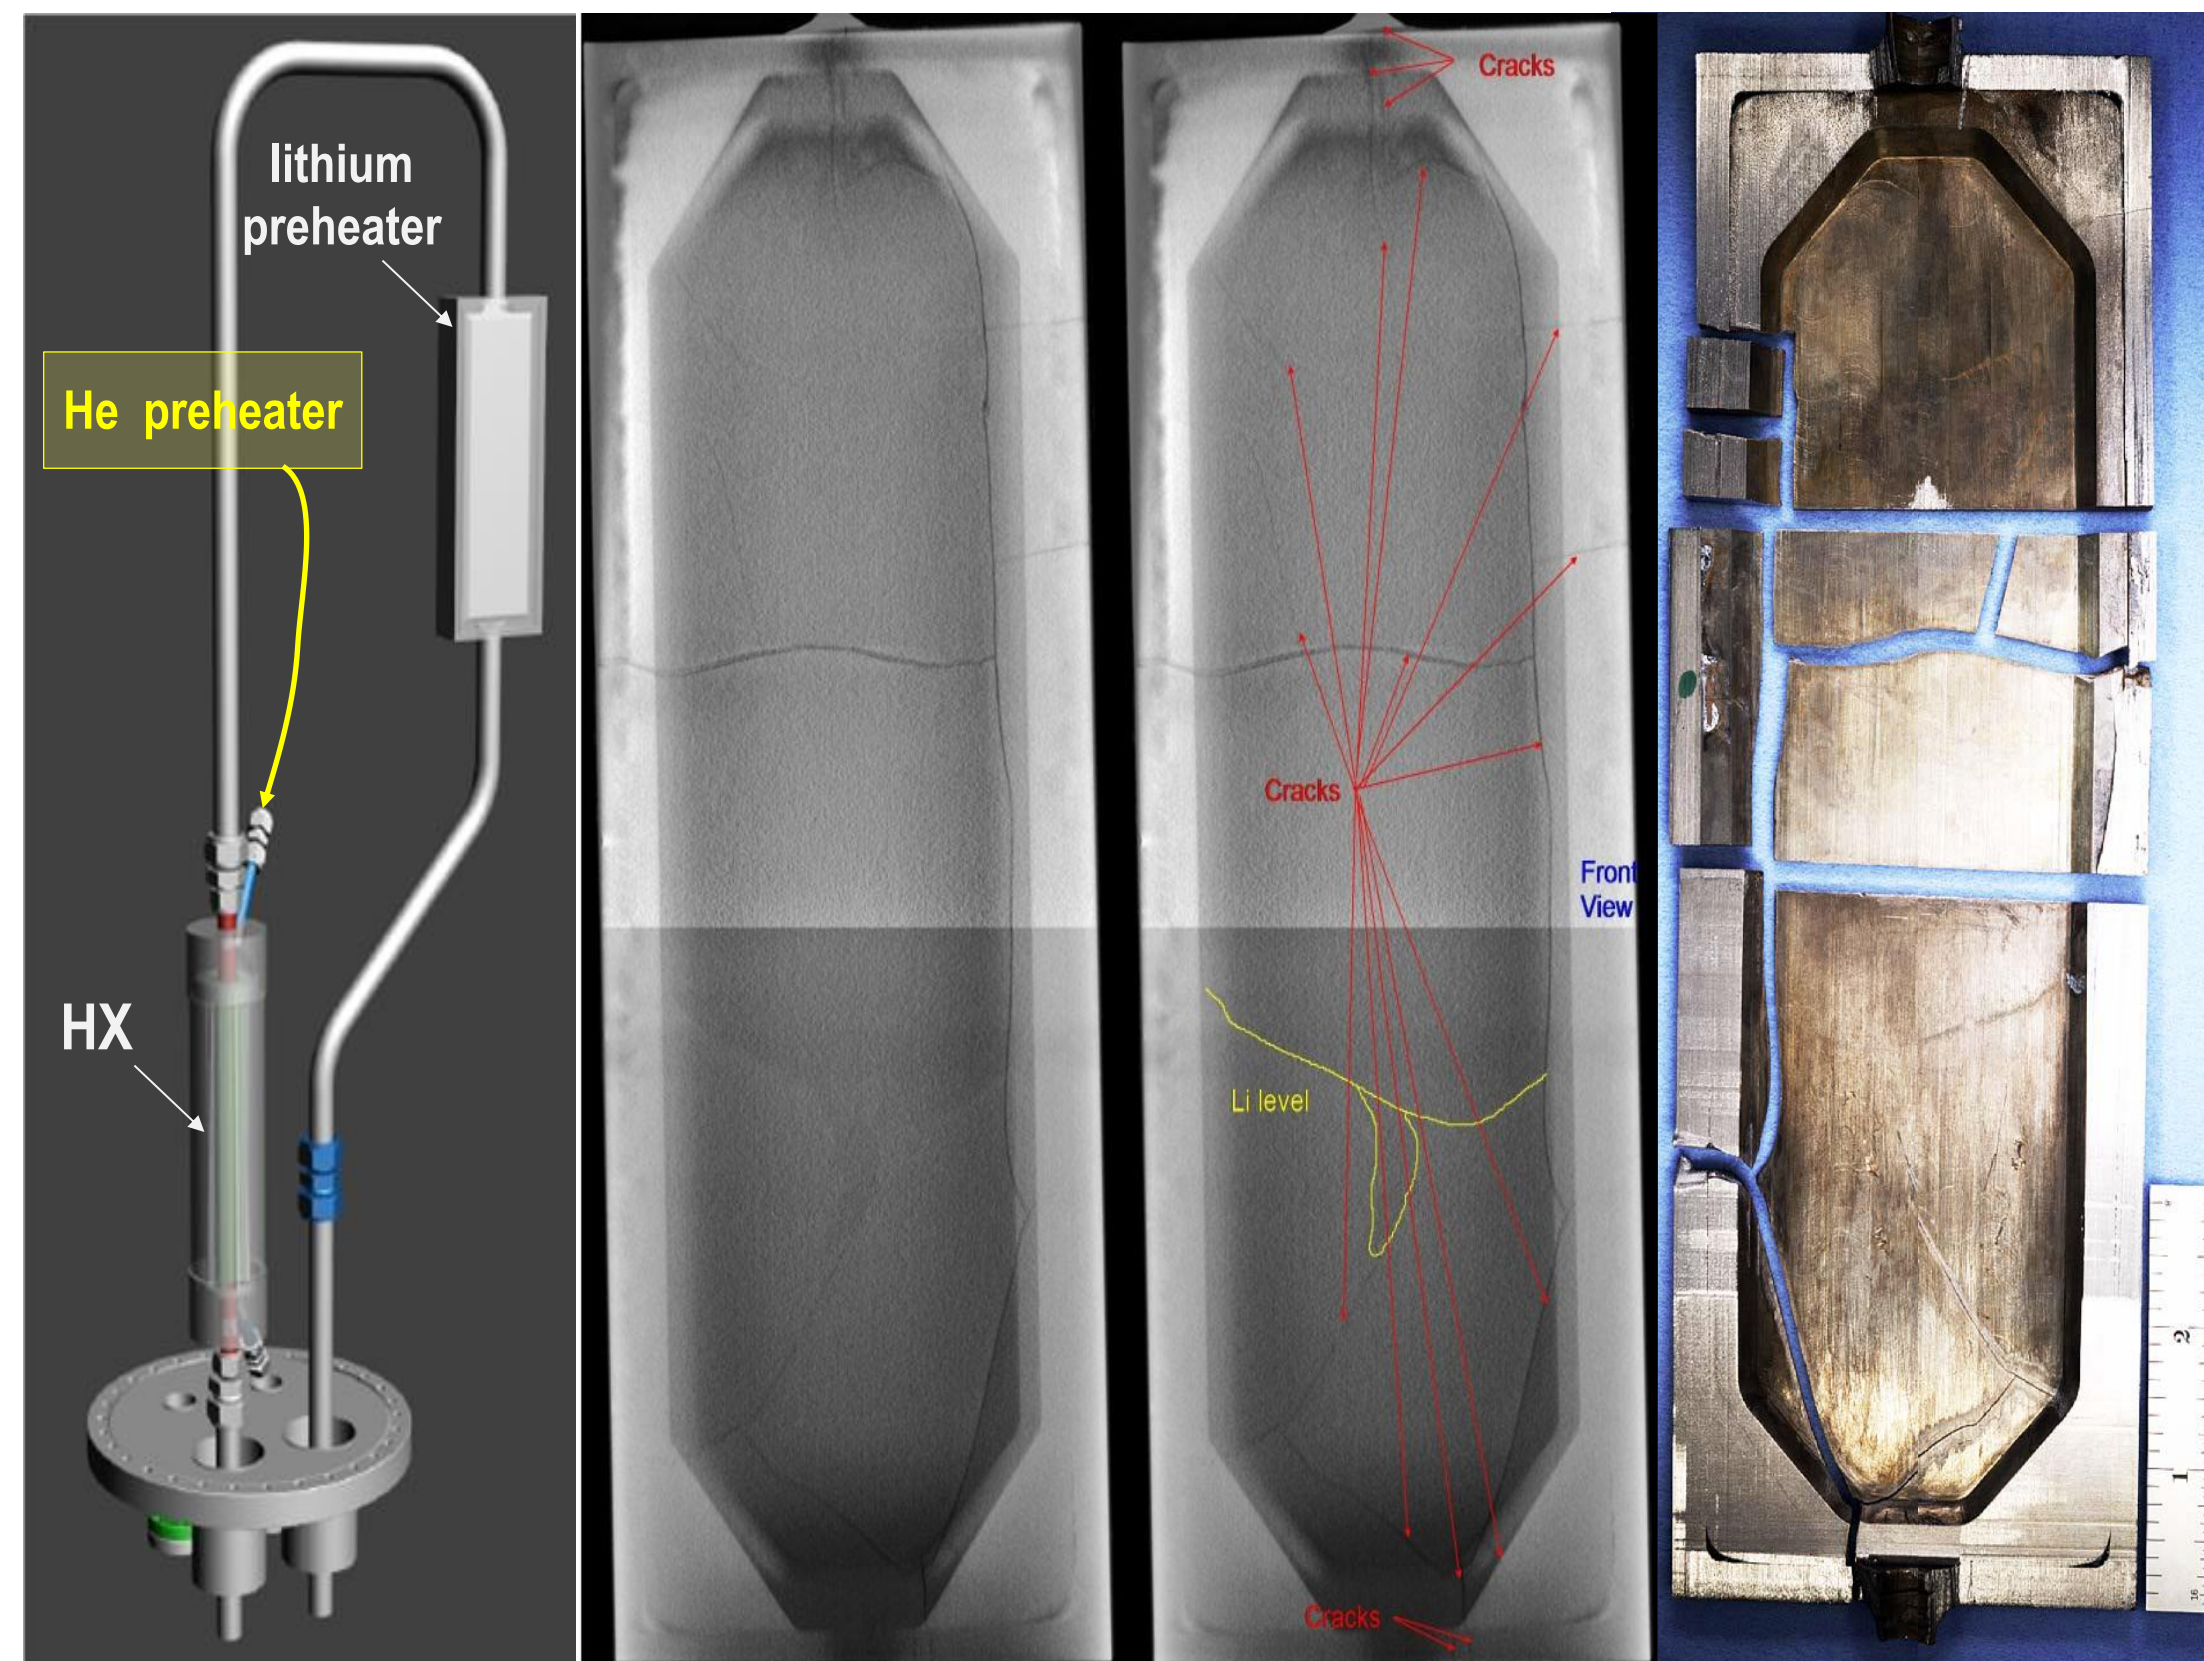
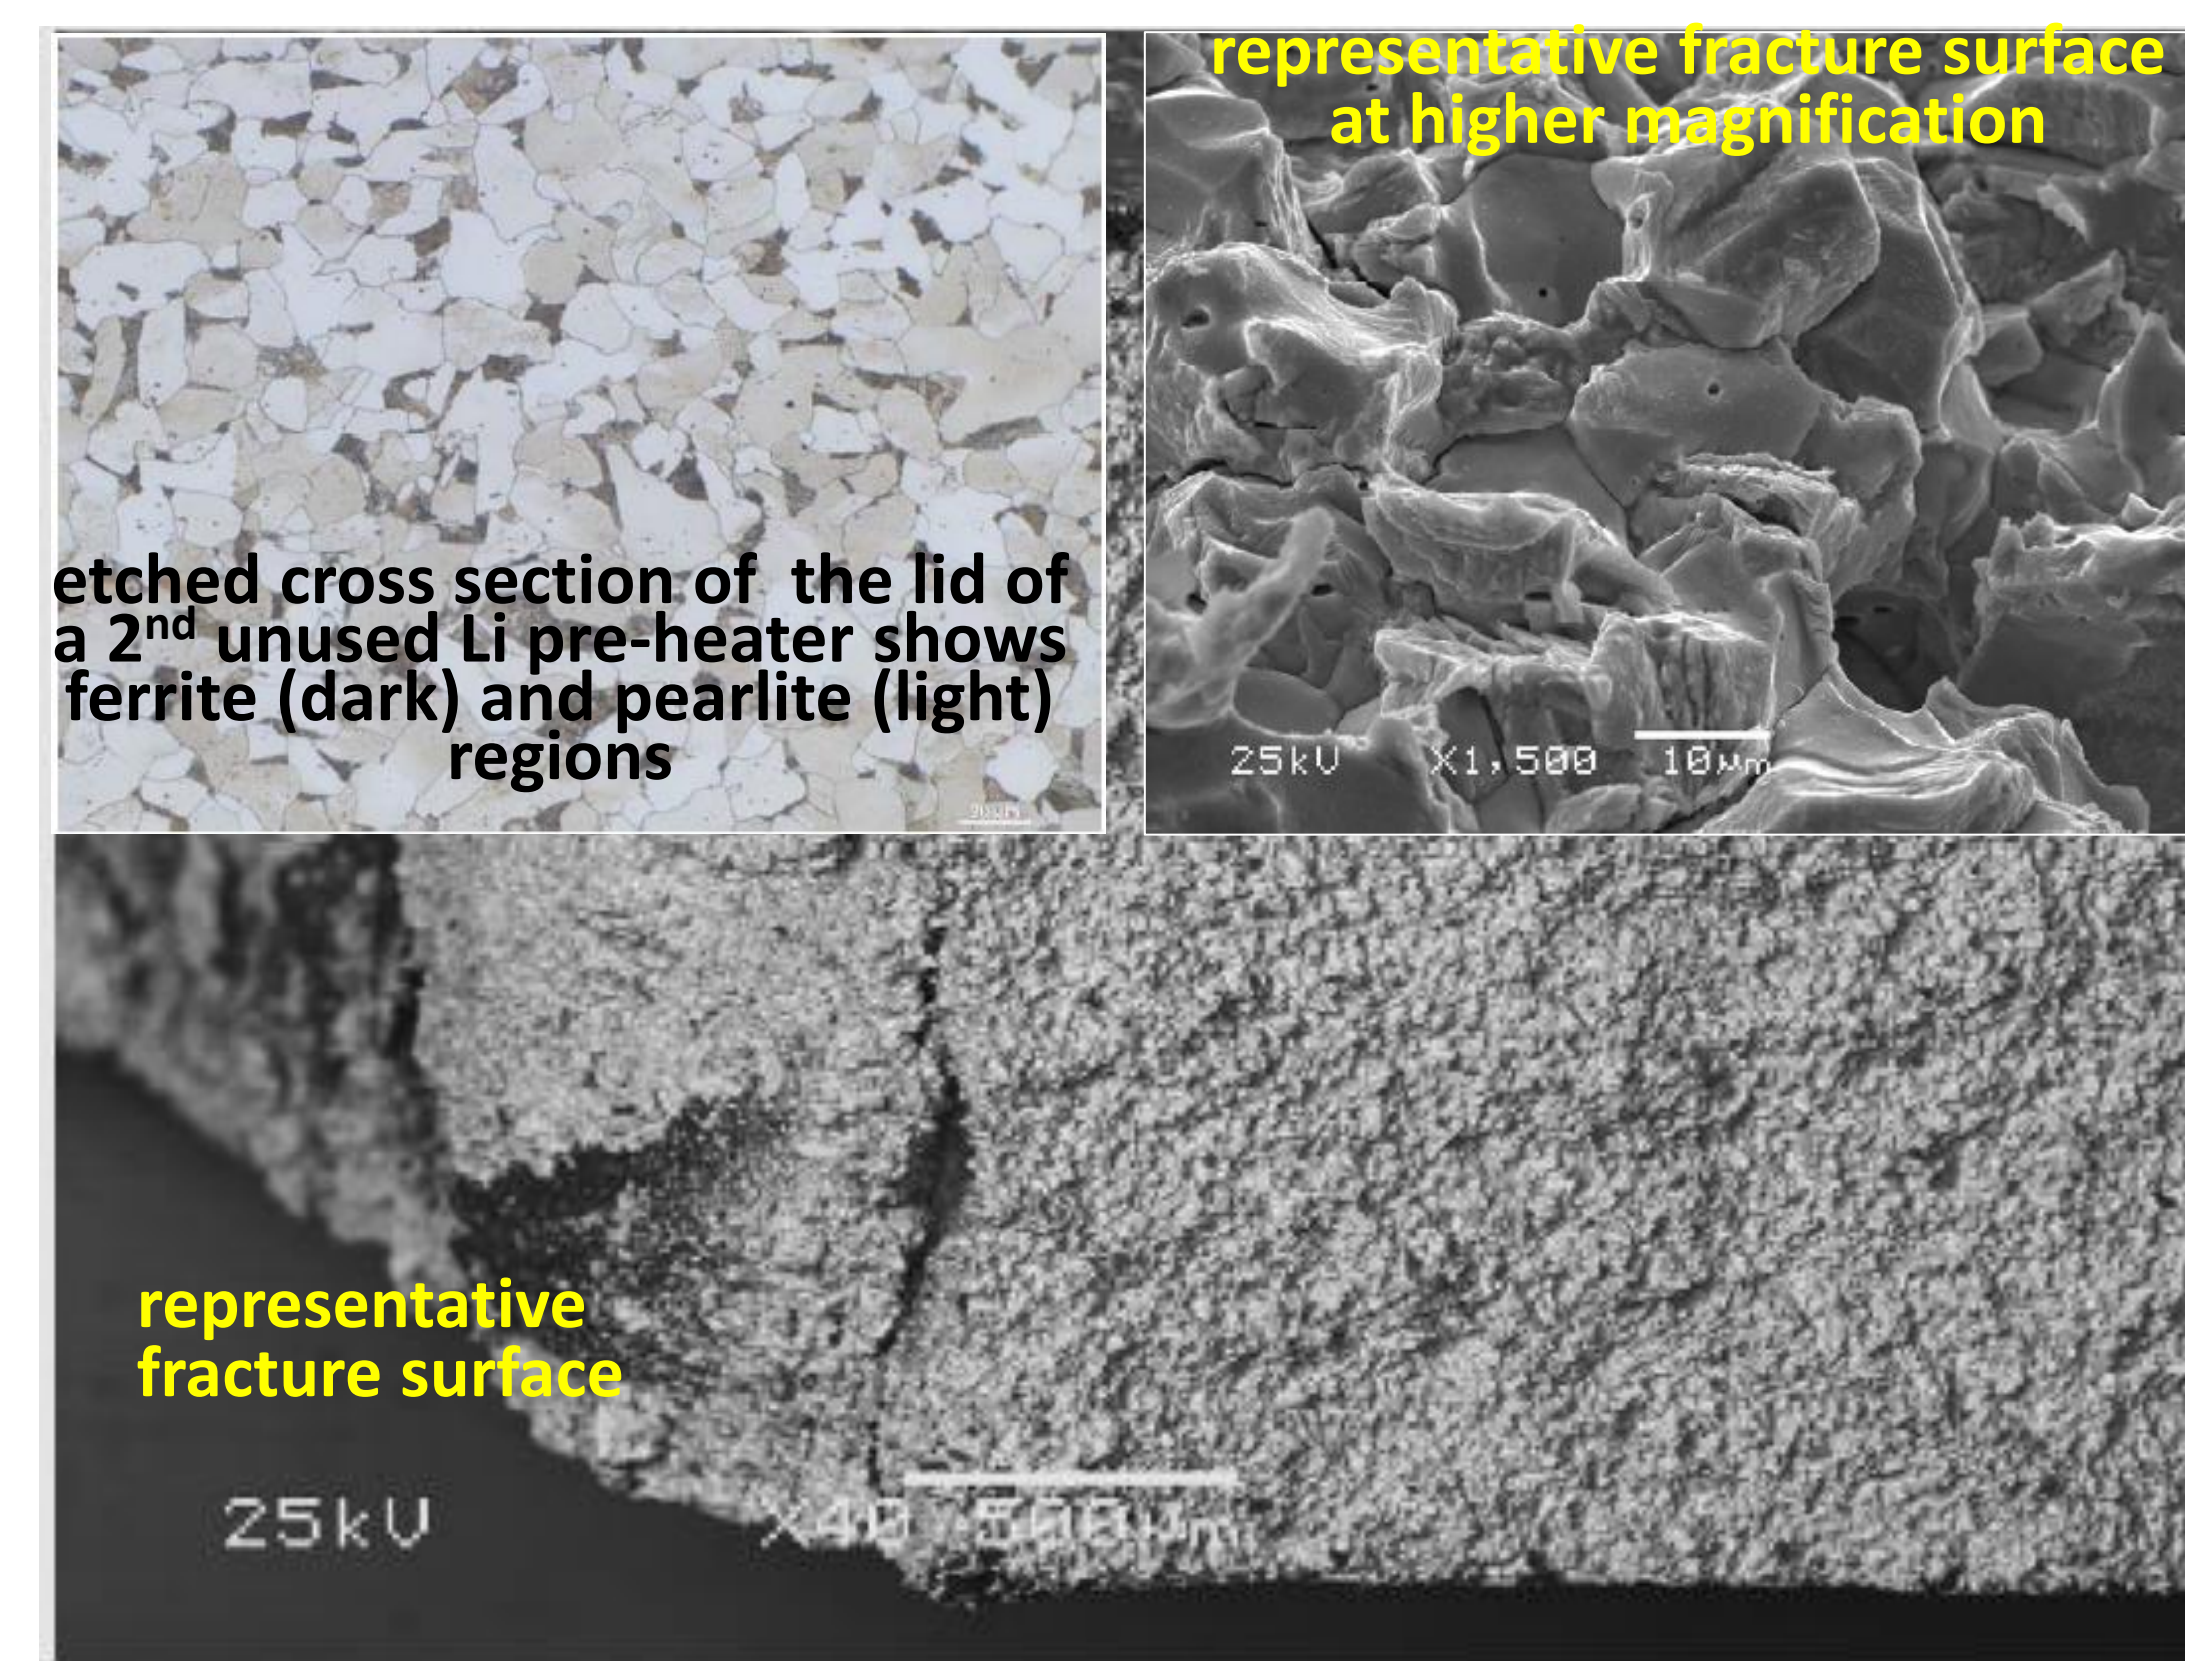
Views of the EB1200 chamber before (right) and after (below) we attached the lithium loop. The photo (lower right) shows the heated furnace and rotary pump.
