# Diagnosis of factors impacting yield in multilayer devices for superconducting electronics

N. Missert, M. W. Jenkins, P. Tangyunyong, W. Mook *Sandia National Laboratories*  
I. Vernik, A. Kirichenko, O. Mukhanov *Hypres*

# Increasing SCE circuit complexity necessitates adaptation of failure analysis techniques developed for CMOS

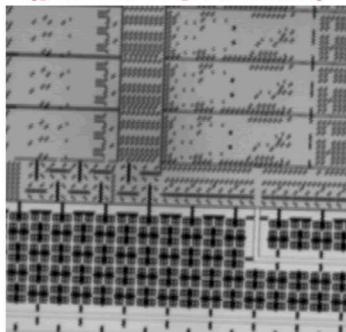
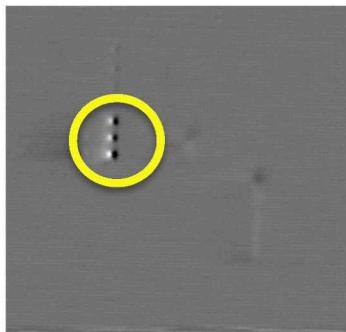
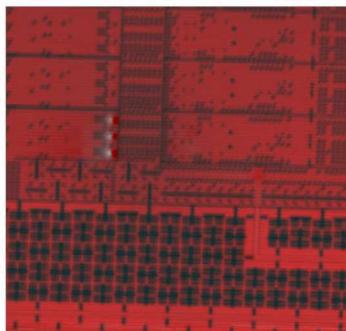
FAILED DIE: D5  
(pin 8, 5  $\mu$ A bias)

NO TIVA SIGNAL

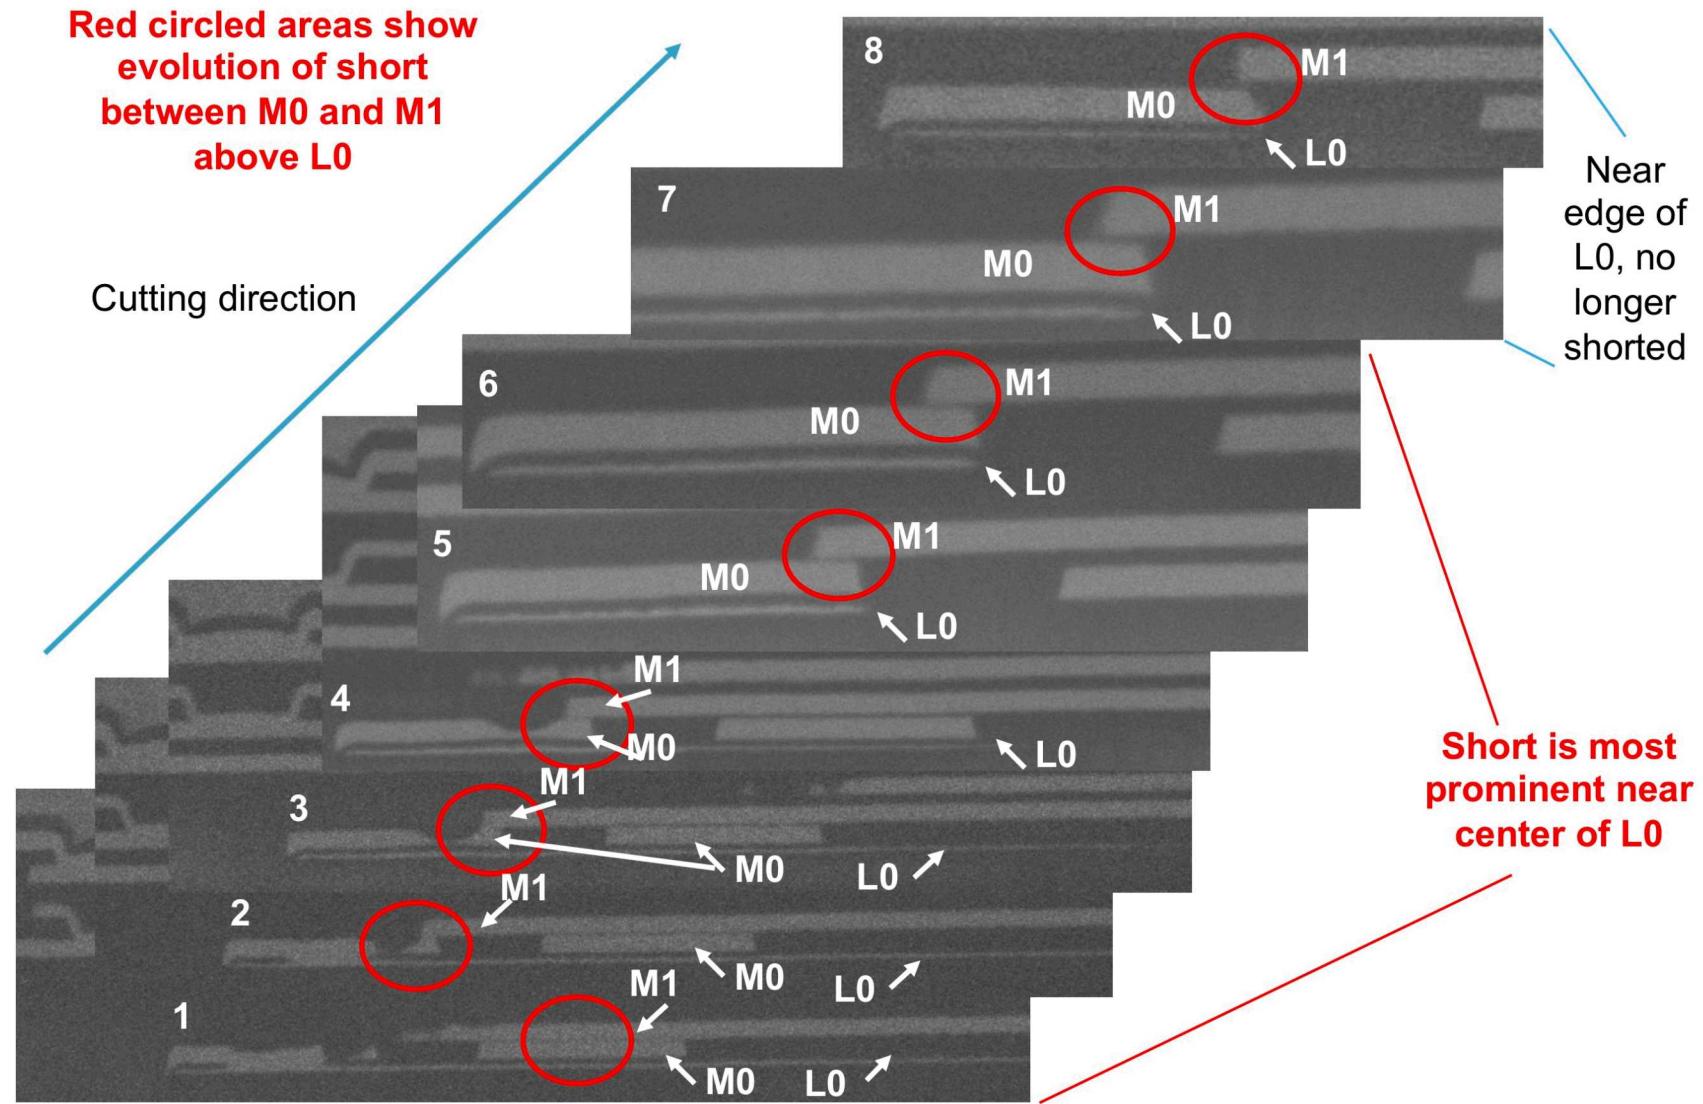
# R2- strong TIVA signal, resistor wiring: M1 shorted to M0 only above L0

These decoder resistors **should not** be biased when RF pins 8,9 are biased – implies short to ground (M0): **follow resistor wiring to find possible short**

Resistor R1,R2,R3 all identical No defects observed

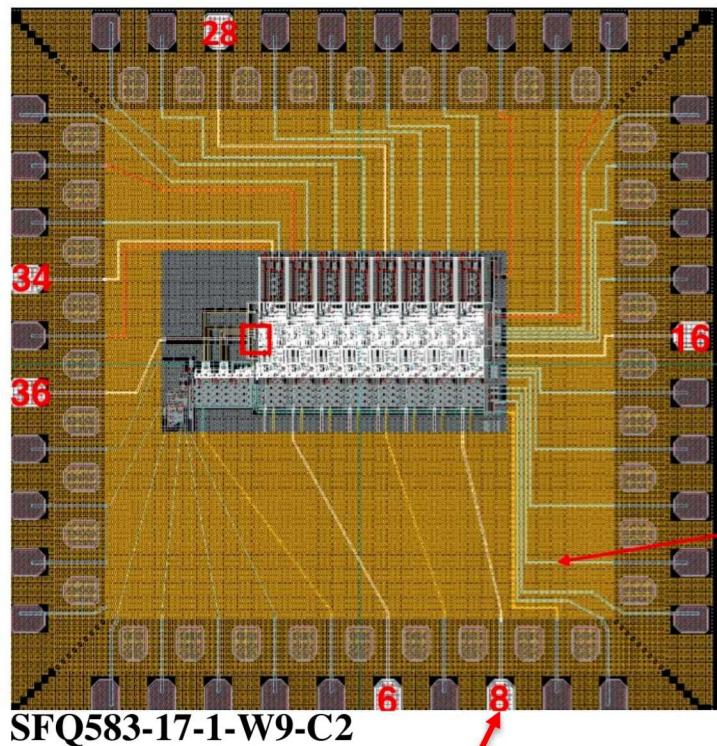
C2 is non-operational (no clock propagation)  
although other die from same wafer did work

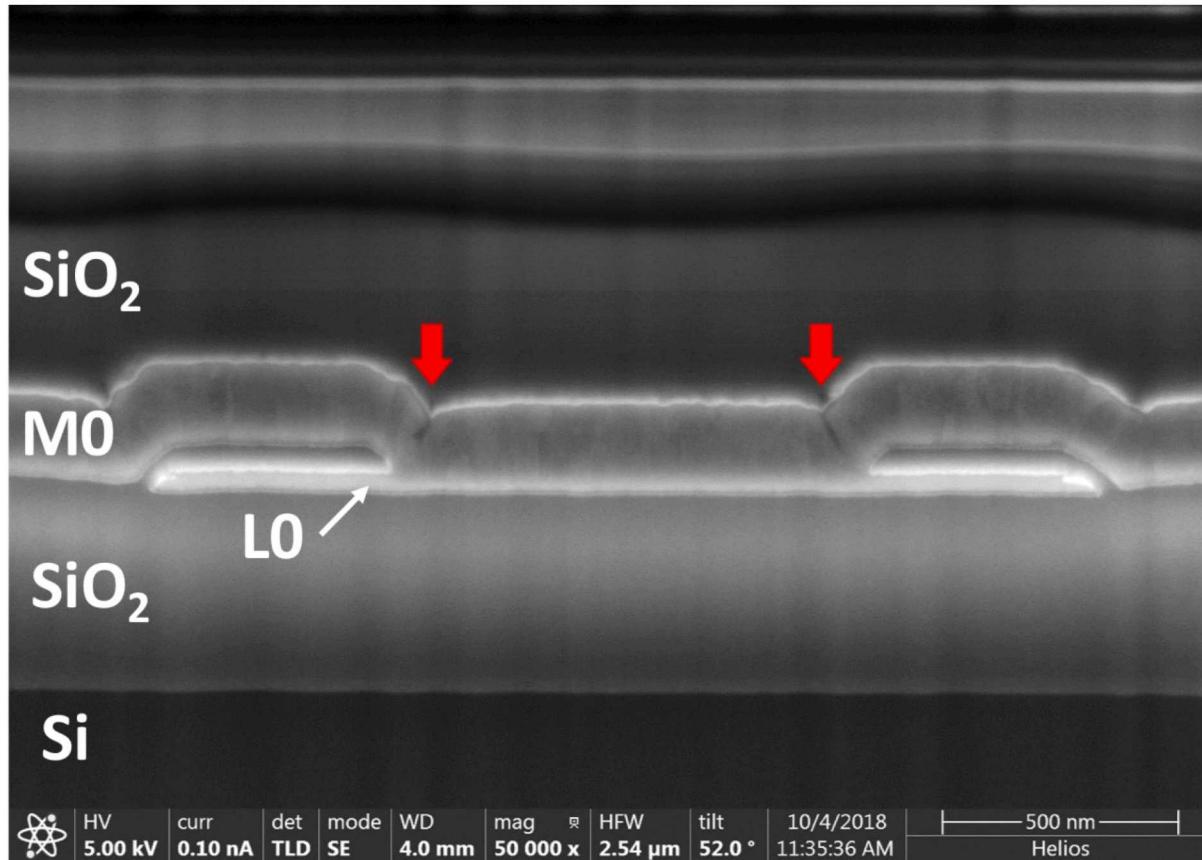
## L0 to M0 contact area

Away from M0 contact:  
L0 is 56 nm thick

At contact to M0:  
L0 is 10 nm thick

All L0 to M0 contacts in  
areas with TIVA signals  
show similar etching  
into L0

Thin L0 is not likely to  
cause problems unless  
L0 is completely etched  
under the M0 contact –  
not the case on this die

Seam in M0 contact layer at edges of via to L0 (red arrows) reduces expected critical current through this area – needs to carry 1 mA – Nb without seam can carry > 30 mA  
unlikely seam is responsible for ALU failure

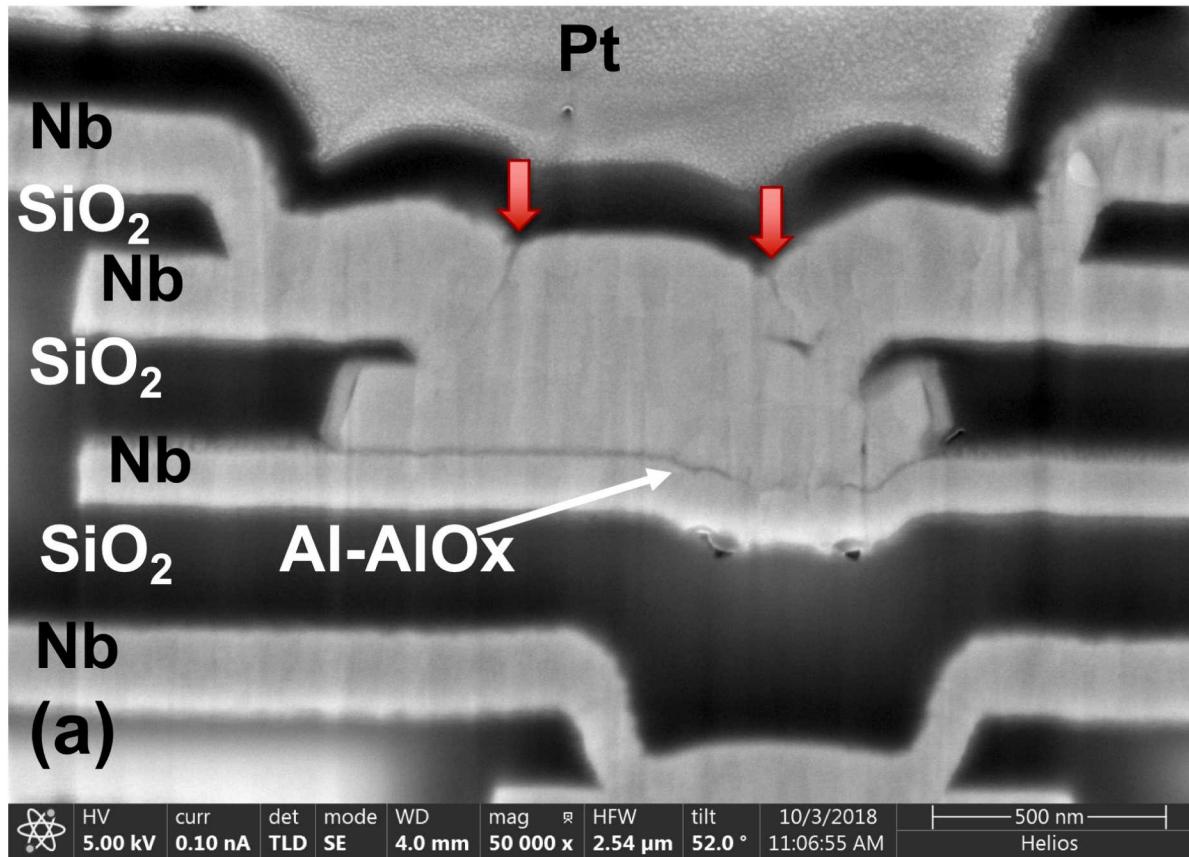
## JJ above via

Again, seam in Nb wiring layers above JJ reduces expected critical current through this area – needs to carry 1 mA – Nb without seam can carry > 30 mA unlikely seam is responsible for ALU failure

CMP leaves depression in SiO<sub>2</sub> above via

Junction morphology is disrupted above via

Similar morphology observed at all JJs directly above vias at TIVA signal locations containing JJs

**Expect this defect would result in compromised JJ properties – likely fatal flaw**

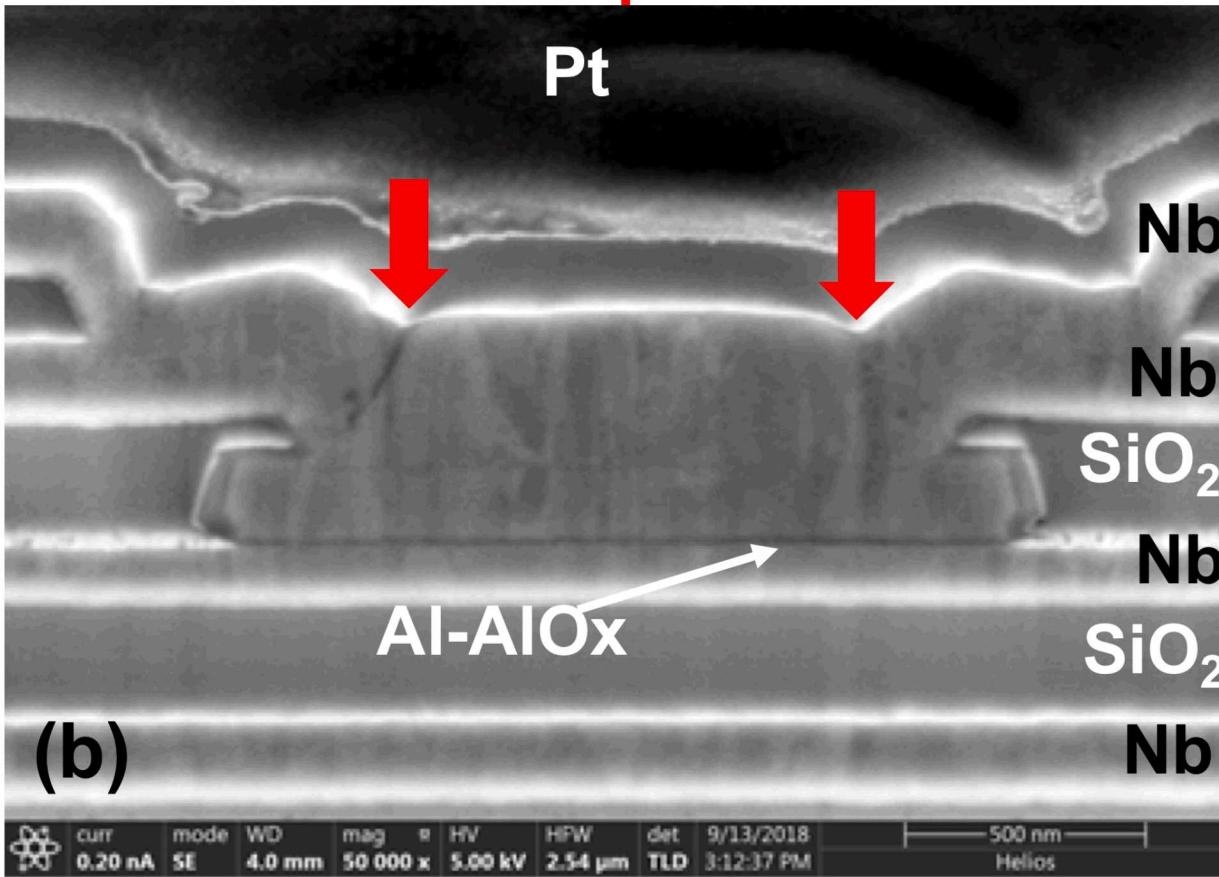
JJ above planar M4

JJs above planar M4 have no morphology issues in junction area

Voids leading to seam in Nb wiring are likely responsible for observed TIVA signal

Again, seam in Nb wiring layers above JJ reduces expected critical current through this area – needs to carry 1 mA – Nb without seam can carry > 30 mA unlikely seam is responsible for ALU failure
