WIPP Events and the Lasting Impact

Sean Dunagan
Sandia National Laboratories

IGSC Safety Case Symposium 2018
October 11, 2018

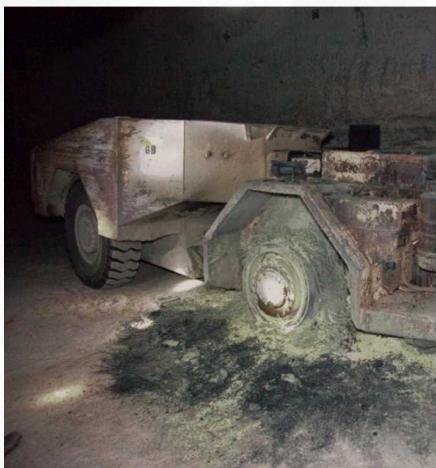
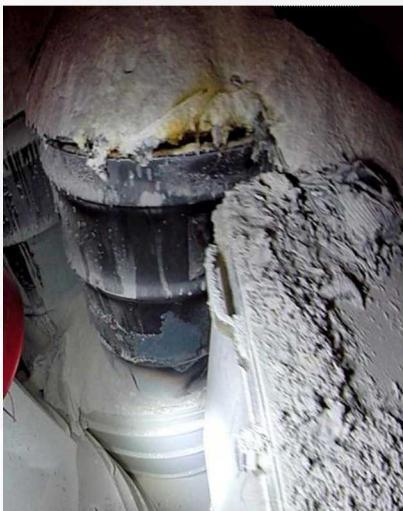
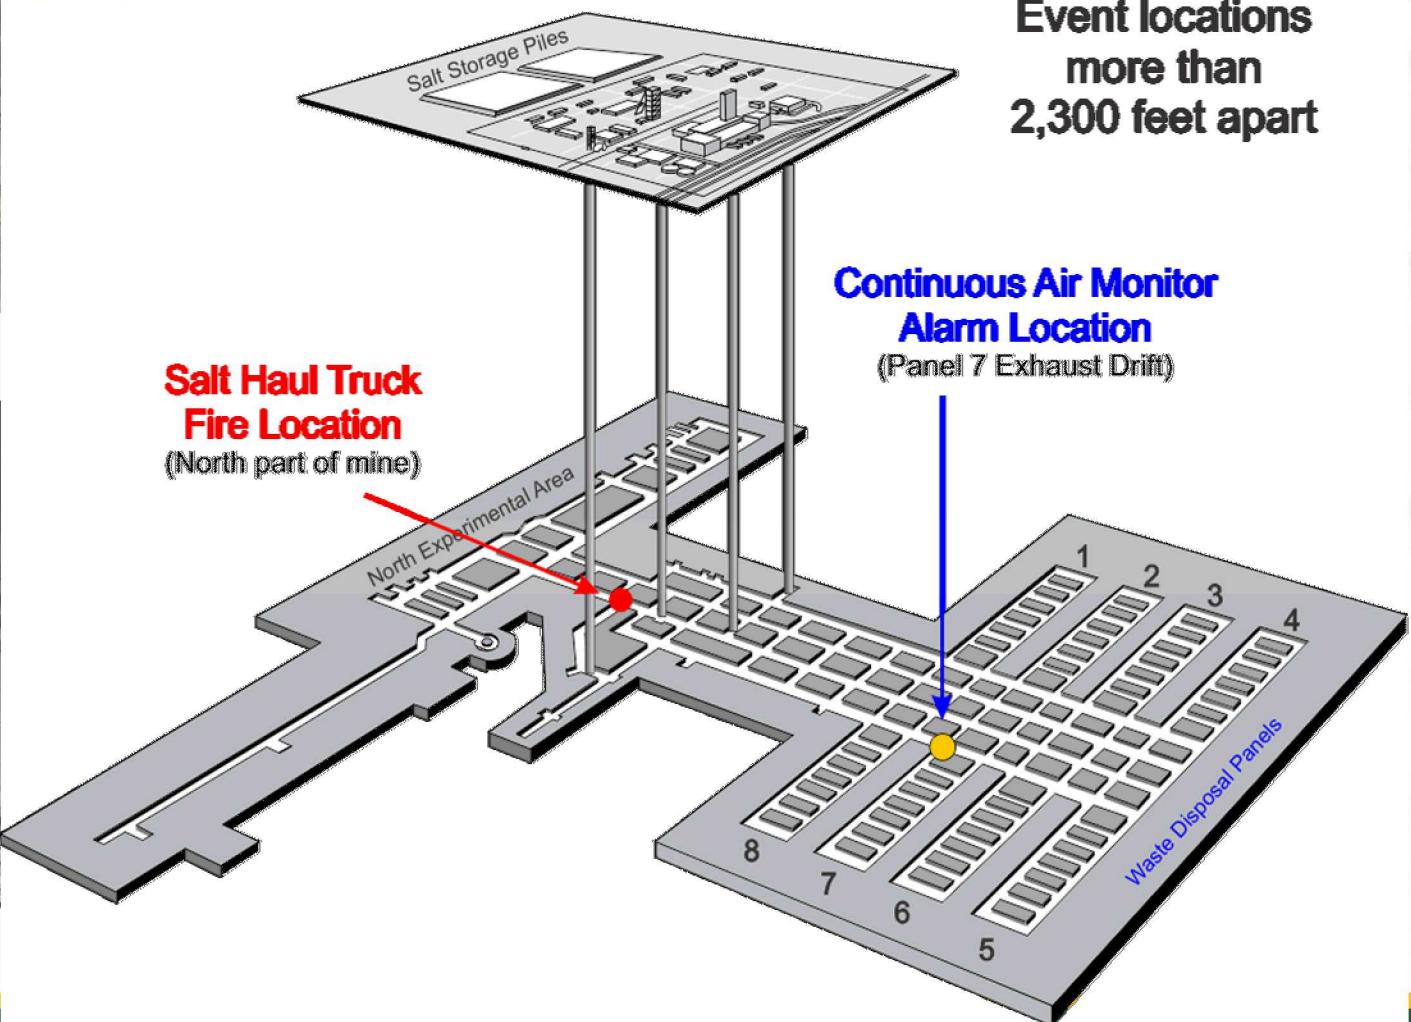
WIPP Incidents

February 5, 2014 Truck Fire:

- All operations at the repository ceased following salt haul truck fire in the WIPP underground.
- An investigation team was deployed to determine the cause of the fire.

February 14, 2014 Radiological Incident:

- A continuous air monitor detected airborne radiation in the underground.
- WIPP's ventilation system automatically switched to high-efficiency particulate air (HEPA) filtration mode when airborne radiation was detected
- Underground and the WIPP mine remains in filtration mode at this time.
- Extensive sampling and monitoring conducted by DOE, New Mexico, and Carlsbad Environmental Monitoring Research Center
- Efforts by the DOE and Nuclear Waste Partnership are ensuring workers are fully protected during recovery and restart.

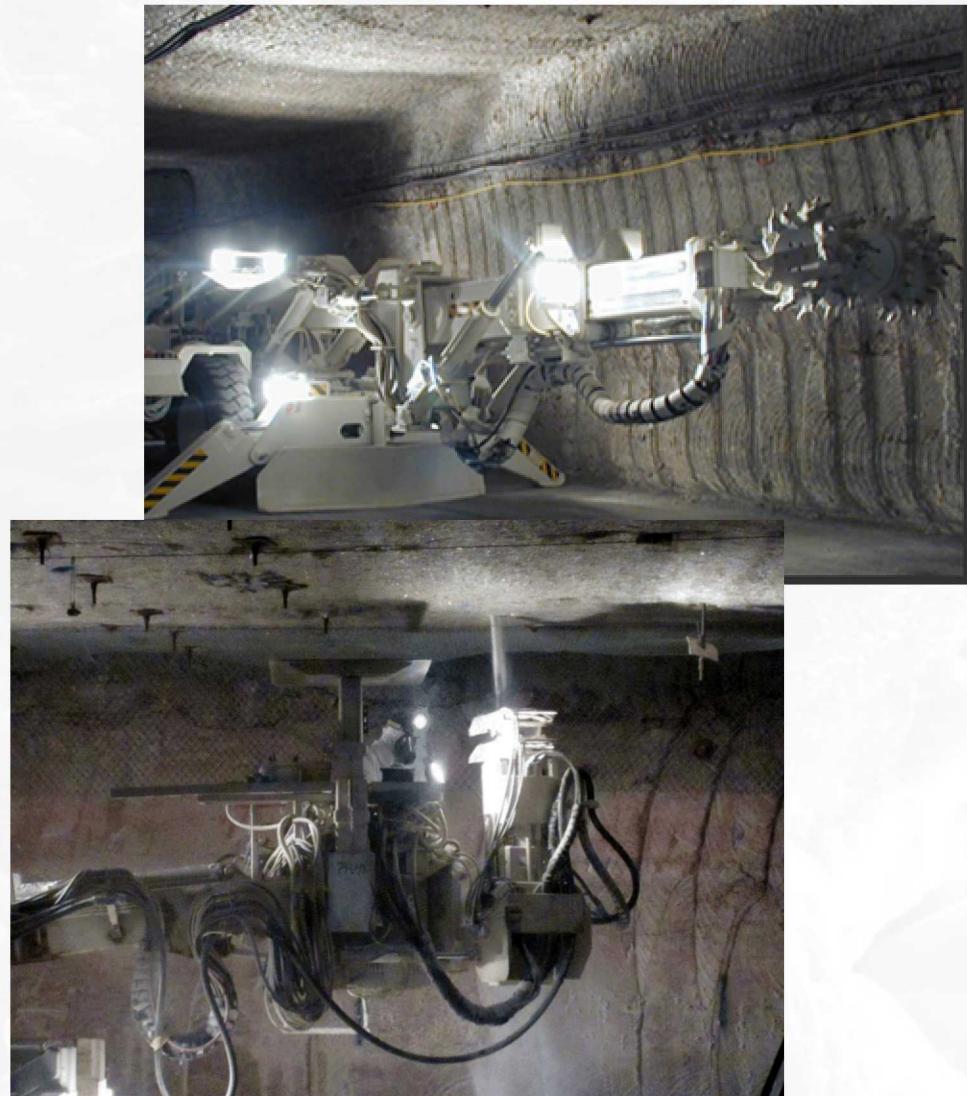
Ground Control Challenges

Limitations:

- 9 – months with no ground control following incidents
- Low ventilation rates limited bolting operations
- Need for workers to operate in personal protective clothing and respirators

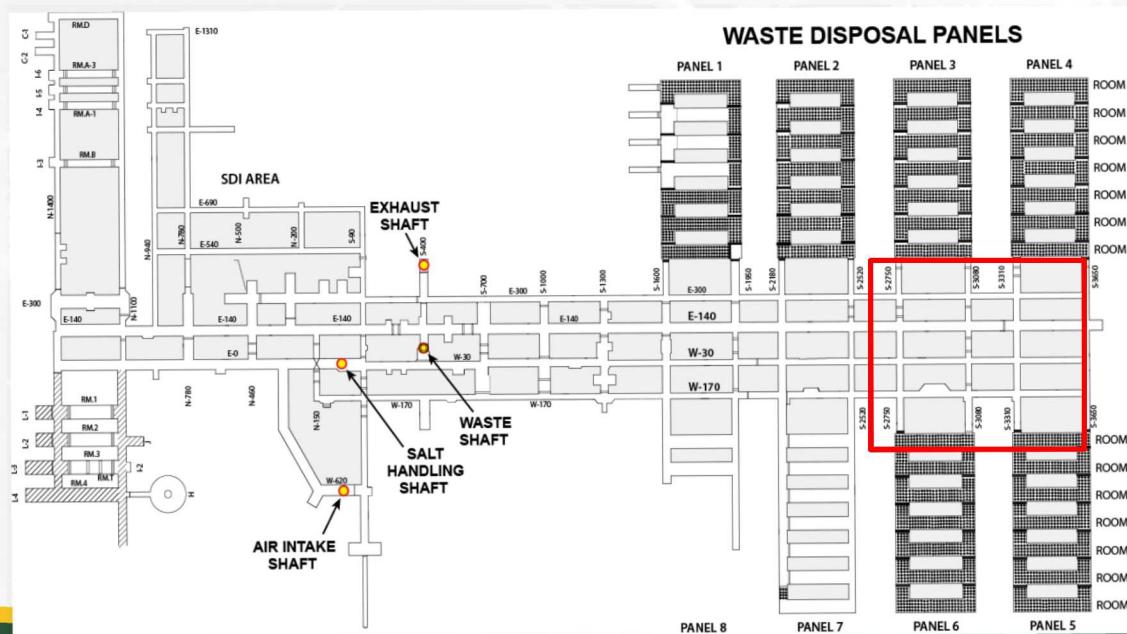
Far South End Closure Progress

- Initiated preparations for the withdrawal from the far south end (Panel 9)
- Cribbing, ventilation curtains and geo-mechanical instrumentation installed in the south mains
- Regulatory approvals for final closures - 2+ years with implementation to follow
