## **WIPP Events and the Lasting Impact**

Sean Dunagan

*Sandia National Laboratories*

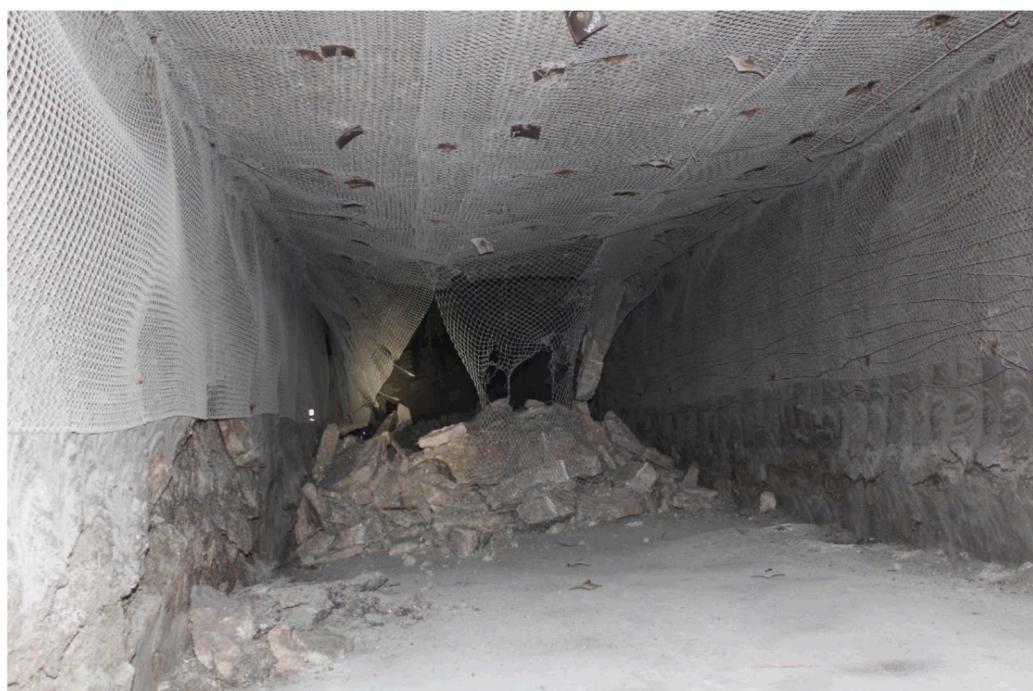
Reduced ground control efficiency led to additional prohibited areas due to mine stability concerns. The longer prohibited areas remained inaccessible the more structural instability developed. The accumulation of instabilities led to multiple significant rock falls in September, October, and November of 2016 (Figures 1, 2, and 3).

**Figure 1. Roof fall in WIPP Panel 4 access drift (WIPP Update Oct 3, 2016).**

Following the first two rock falls, a controlled withdrawal from the south end of the WIPP underground was implemented in October 2016 (WIPP Update Oct 14, 2016). Lack of ground control efficiency resulted in loss of disposal area. Following these rock falls, DOE and NWP declared ground control the number one priority moving forward into resumption of operations.

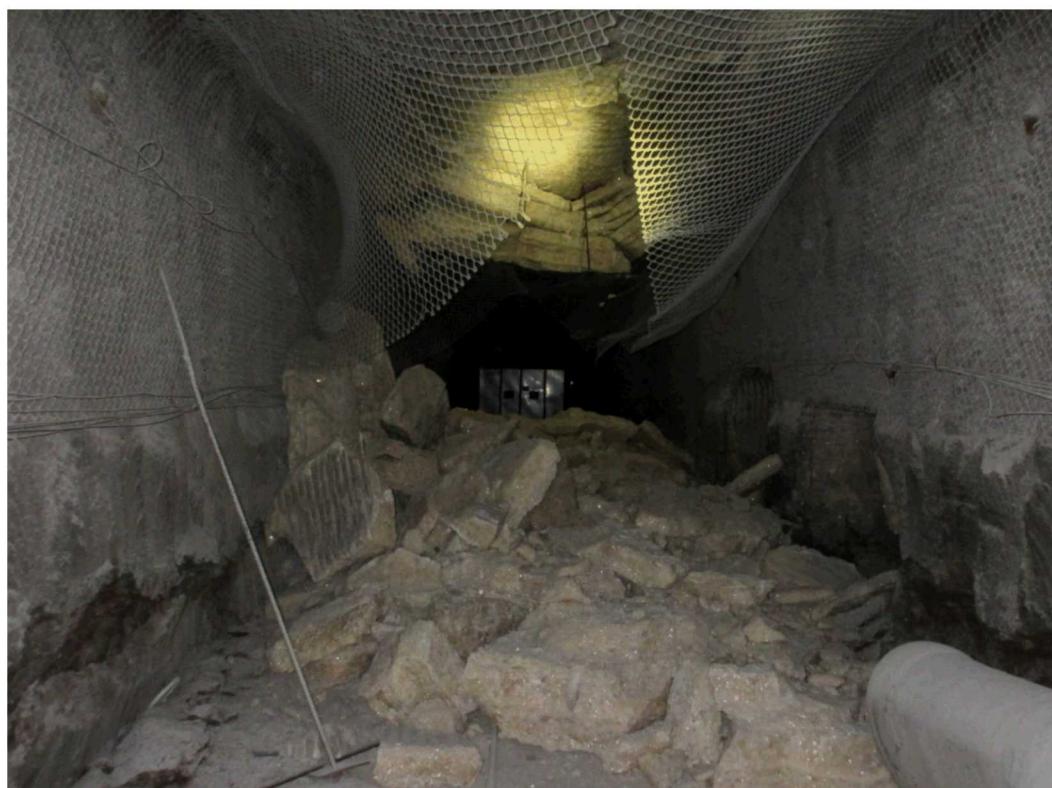
**Figure 2. Roof fall in WIPP Panel 3 access drift (WIPP Update Oct 5, 2016).**

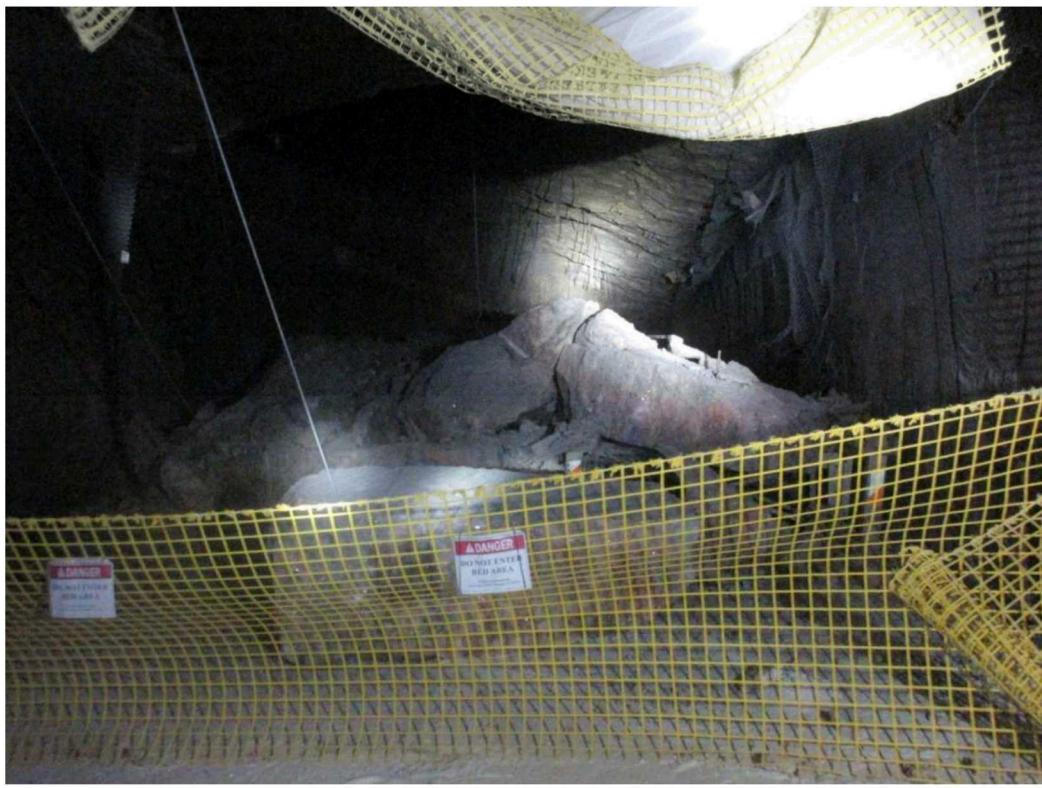
**Figure 3. Roof fall in WIPP Panel 7 Room 4 (WIPP Update Nov 4, 2016).**
