**United States Department of Energy  
Sandia National Laboratories, California  
Arroyo Seco Improvement Program  
Annual Report for 2019**

Robert C. Holland  
Environmental Management Department  
Sandia National Laboratories, California

January 2020

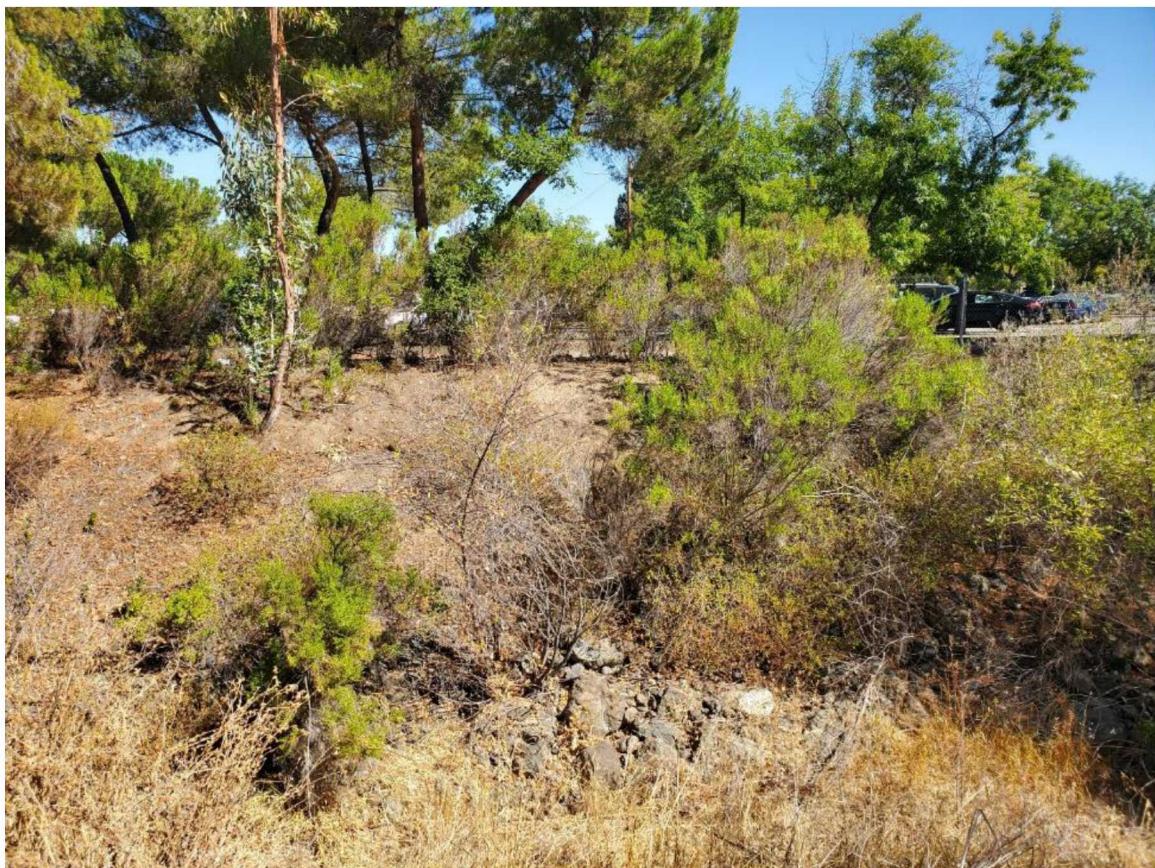
**Figure 9. Photo Monument 5-A looking northeast, post-construction, 2019**

Overall the site contains dense native shrubs on the slope and willows in the channel. Willow stakes had 82% survival, which does not meet the performance criteria. Sandbar willow (*Salix exigua*) is present and widespread on site and is spreading upstream in the channel, which provides high willow cover. These natural sandbar willow recruits have been included in the count of surviving trees. The one remaining coast live oak appeared healthy. Table 3 shows the proposed and actual plantings and survival rates as noted during a 2018 survey.

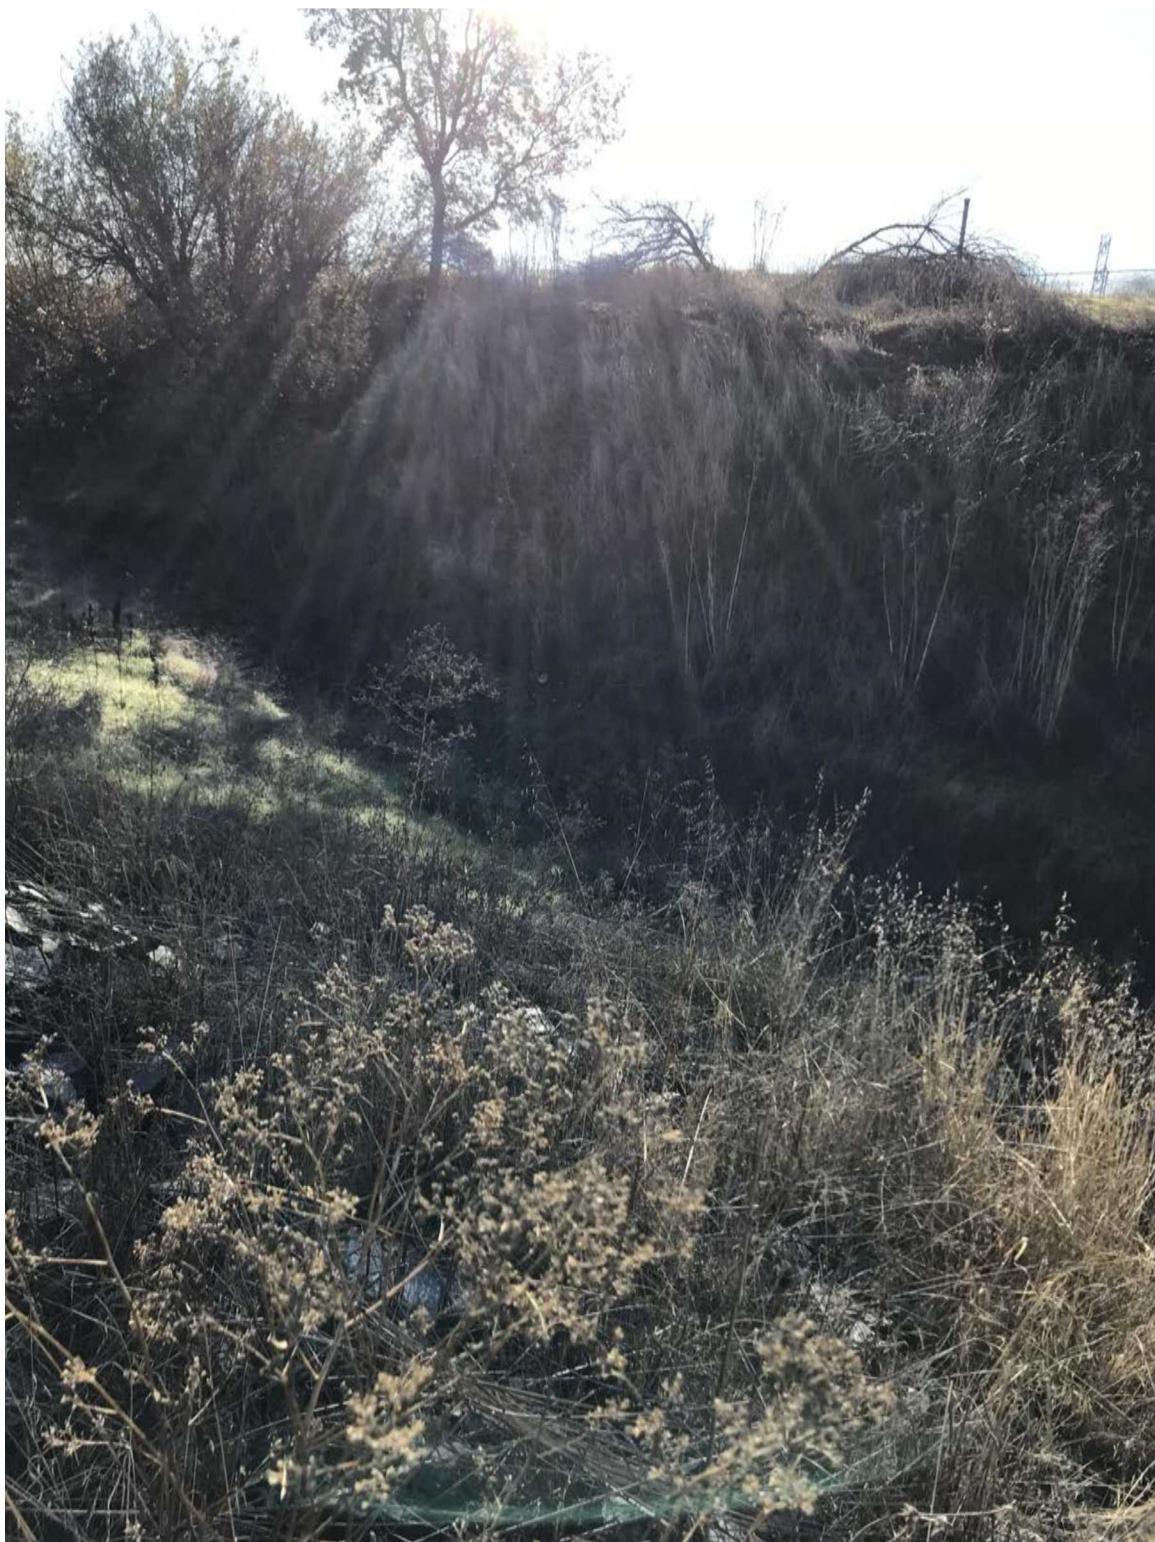
**Figure 36. Photo Monument 16-B looking southeast, post-construction, 2019**

Although this site has not met tree survival performance criteria and an additional 17 willows or other trees are required to meet the tree survival performance criteria, the existing willows are large, dense, growing vigorously, and form a canopy over the riparian corridor. Furthermore, as noted in previous reports, there is no room for additional willow plantings at Site 16, especially if the existing willows continue to grow as expected. We recommend the existing willows qualify as having met performance criteria for tree survival at this site and the site is considered complete.

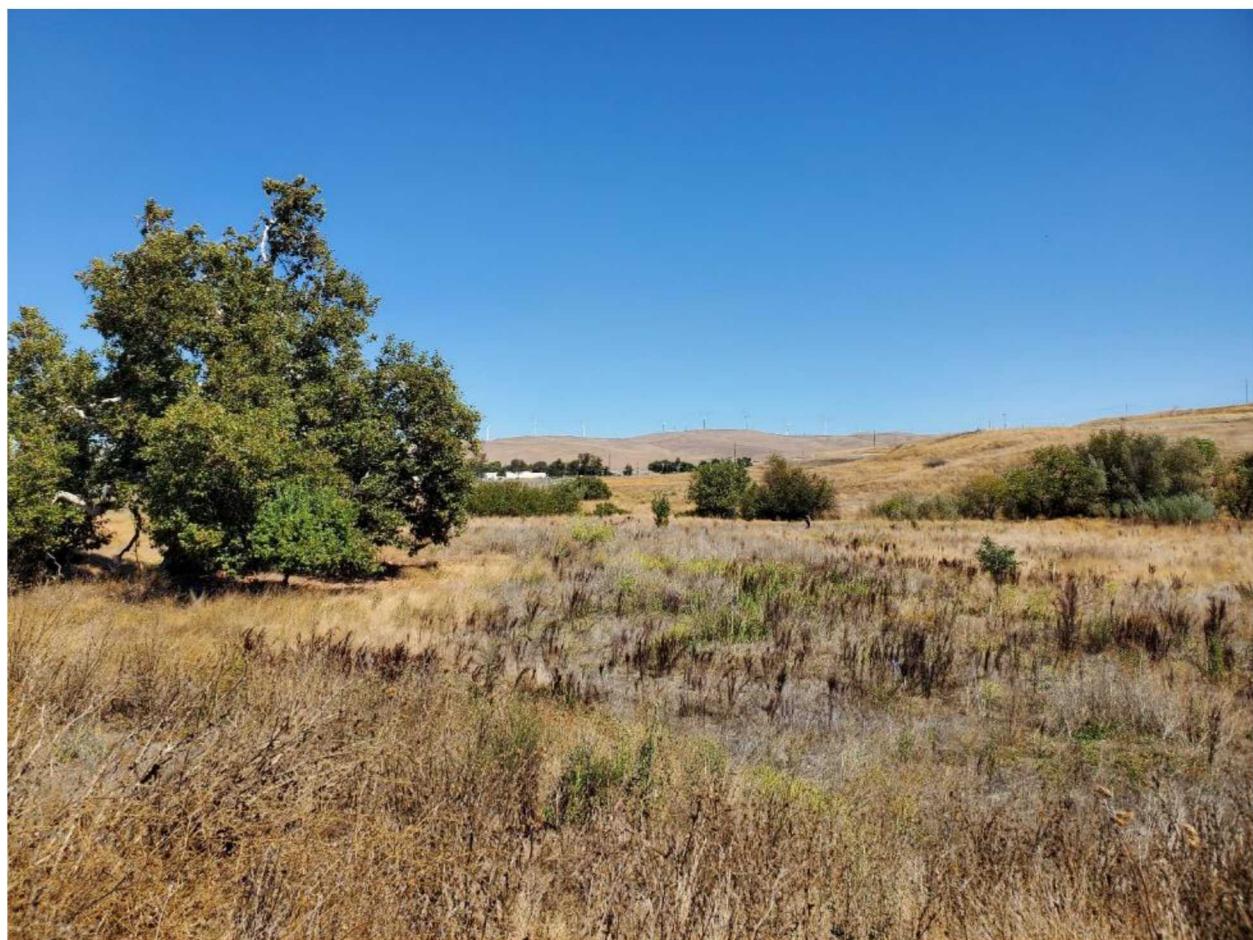
**Figure 43. Photo monument 17-1 looking north, post construction 2019**

Due to heavy rainfall during the winter of 2016-2017, and consequent high flows in the Arroyo Seco, damage occurred to the inlet to the inset floodplain, and also to the two outlet structures from the inset floodplain. SNL/CA personnel repaired this damage during 2018.

Additional trees are required to meet the permit requirements including 22 Maples, 19 California sycamore, 6 Coast live oak, 4 Valley oak, and 13 Fremont cottonwood. We recommend substituting Coast live oak and Valley oak for the maples, since maple is not likely to do well based on the site conditions.
