Subject: *Transmittal of the Sandia National Laboratories/New Mexico Five-Day Report for the Accidental Slug Discharge at the Albuquerque Bernalillo County Water Utility Authority (ABCWUA) Industrial Wastewater Permit No. 2069 Outfall*

This letter represents the five-day written notification for elevated fluoride levels at the Building 858N, Acid Waste Neutralization (AWN) System in accordance with the ABCWUA Sewer Use and Wastewater Ordinance § 3-6-5(B), Reports of Potential Problems. This AWN System is covered under the ABCWUA Industrial Wastewater Permit No. 2069G. The immediate notification to the ABCWUA occurred at 21:42 on August 1, 2019.

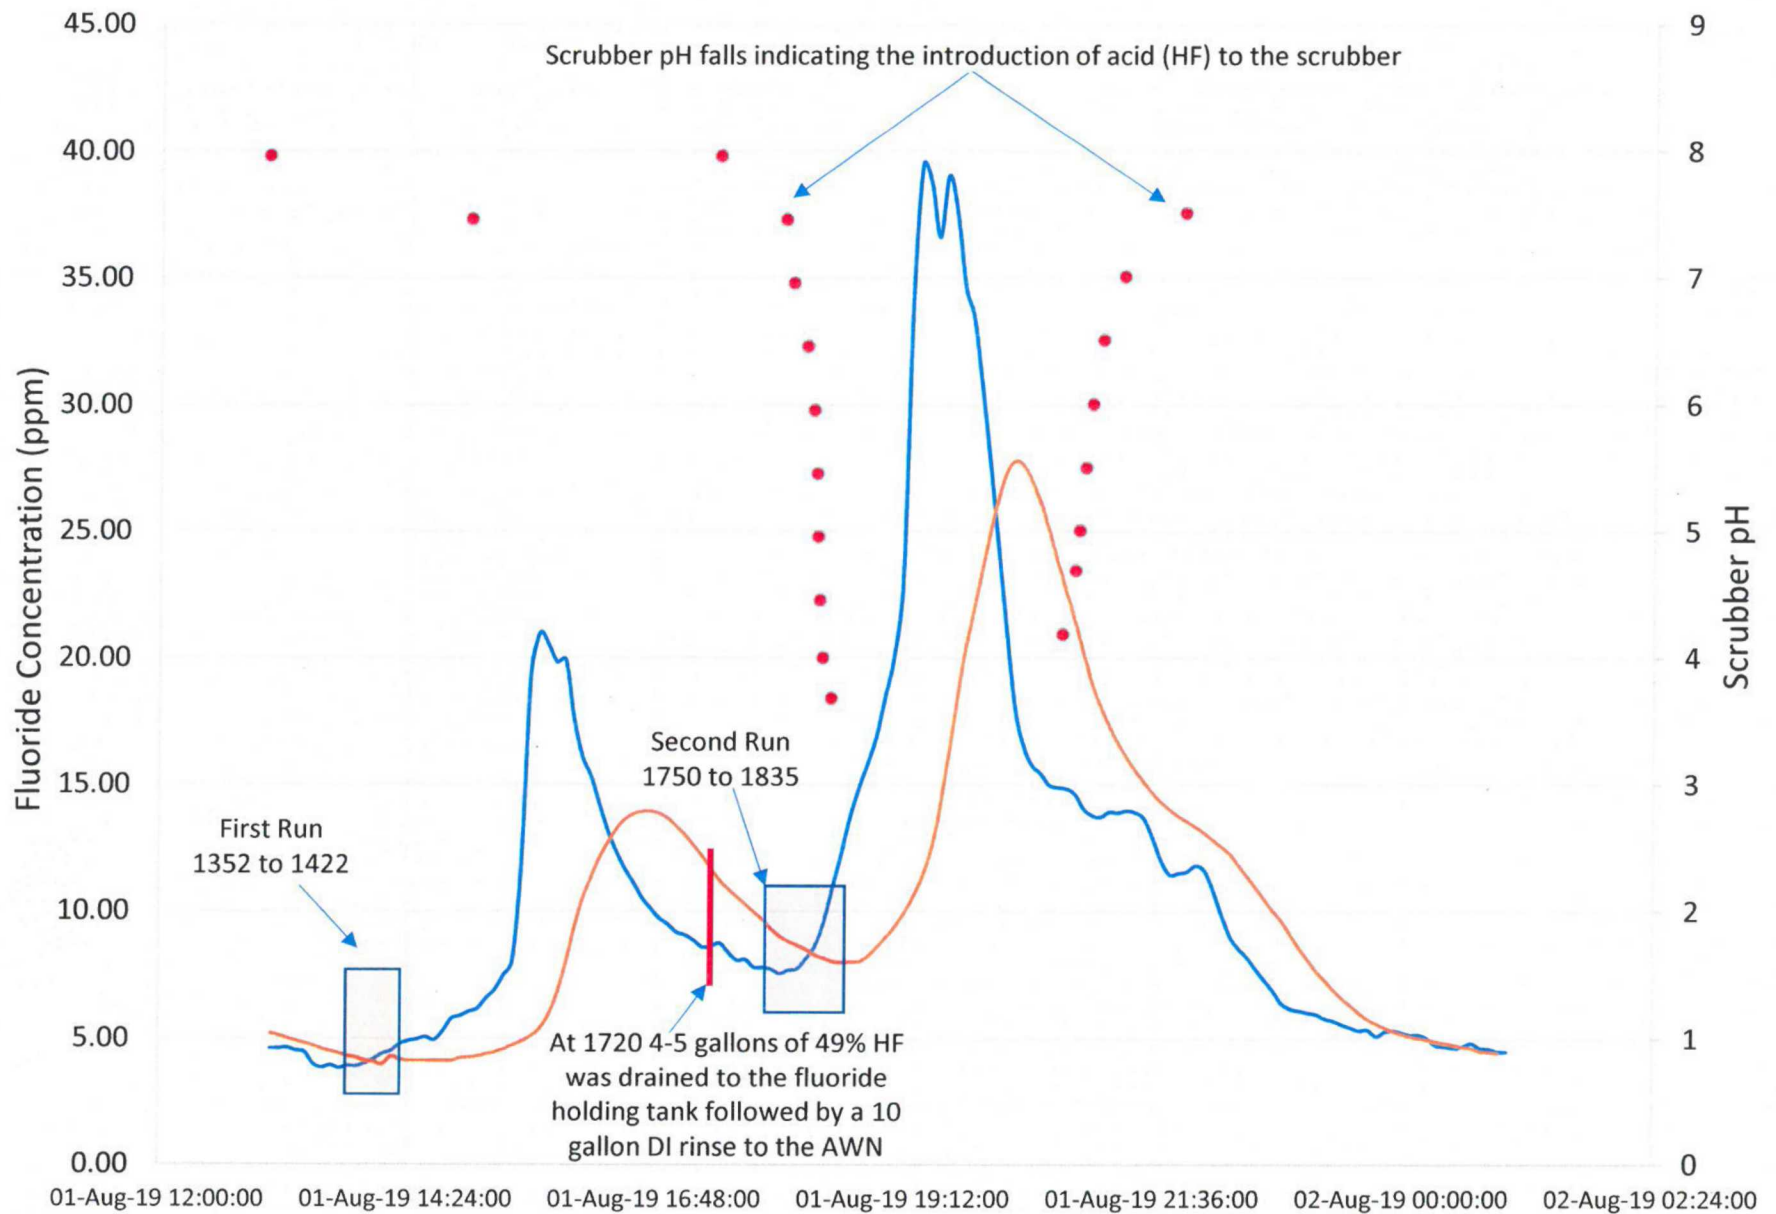
The attached Chart 1 represents fluoride concentrations within the AWN System. The blue curve represents the fluoride concentration in the first of the four AWN tanks. The orange curve is the fluoride concentration after the fourth tank and is discharged to the sanitary sewer. The red dots indicate the potential of hydrogen (pH) of the scrubber reservoir water. The data shows that as the pH of the scrubber water decreases, the fluoride levels increase. This is a strong indication that the HF is getting into the scrubber water (as it is designed to do). The transparent red rectangles show the different runs that occurred and their corresponding times. The solid red line indicates the time the 49% HF tank was emptied to the fluoride holding tank. This corresponding data shows that fluoride levels continued to drop, indicating the elevated fluoride levels are from activity-level work and not mechanical failure.

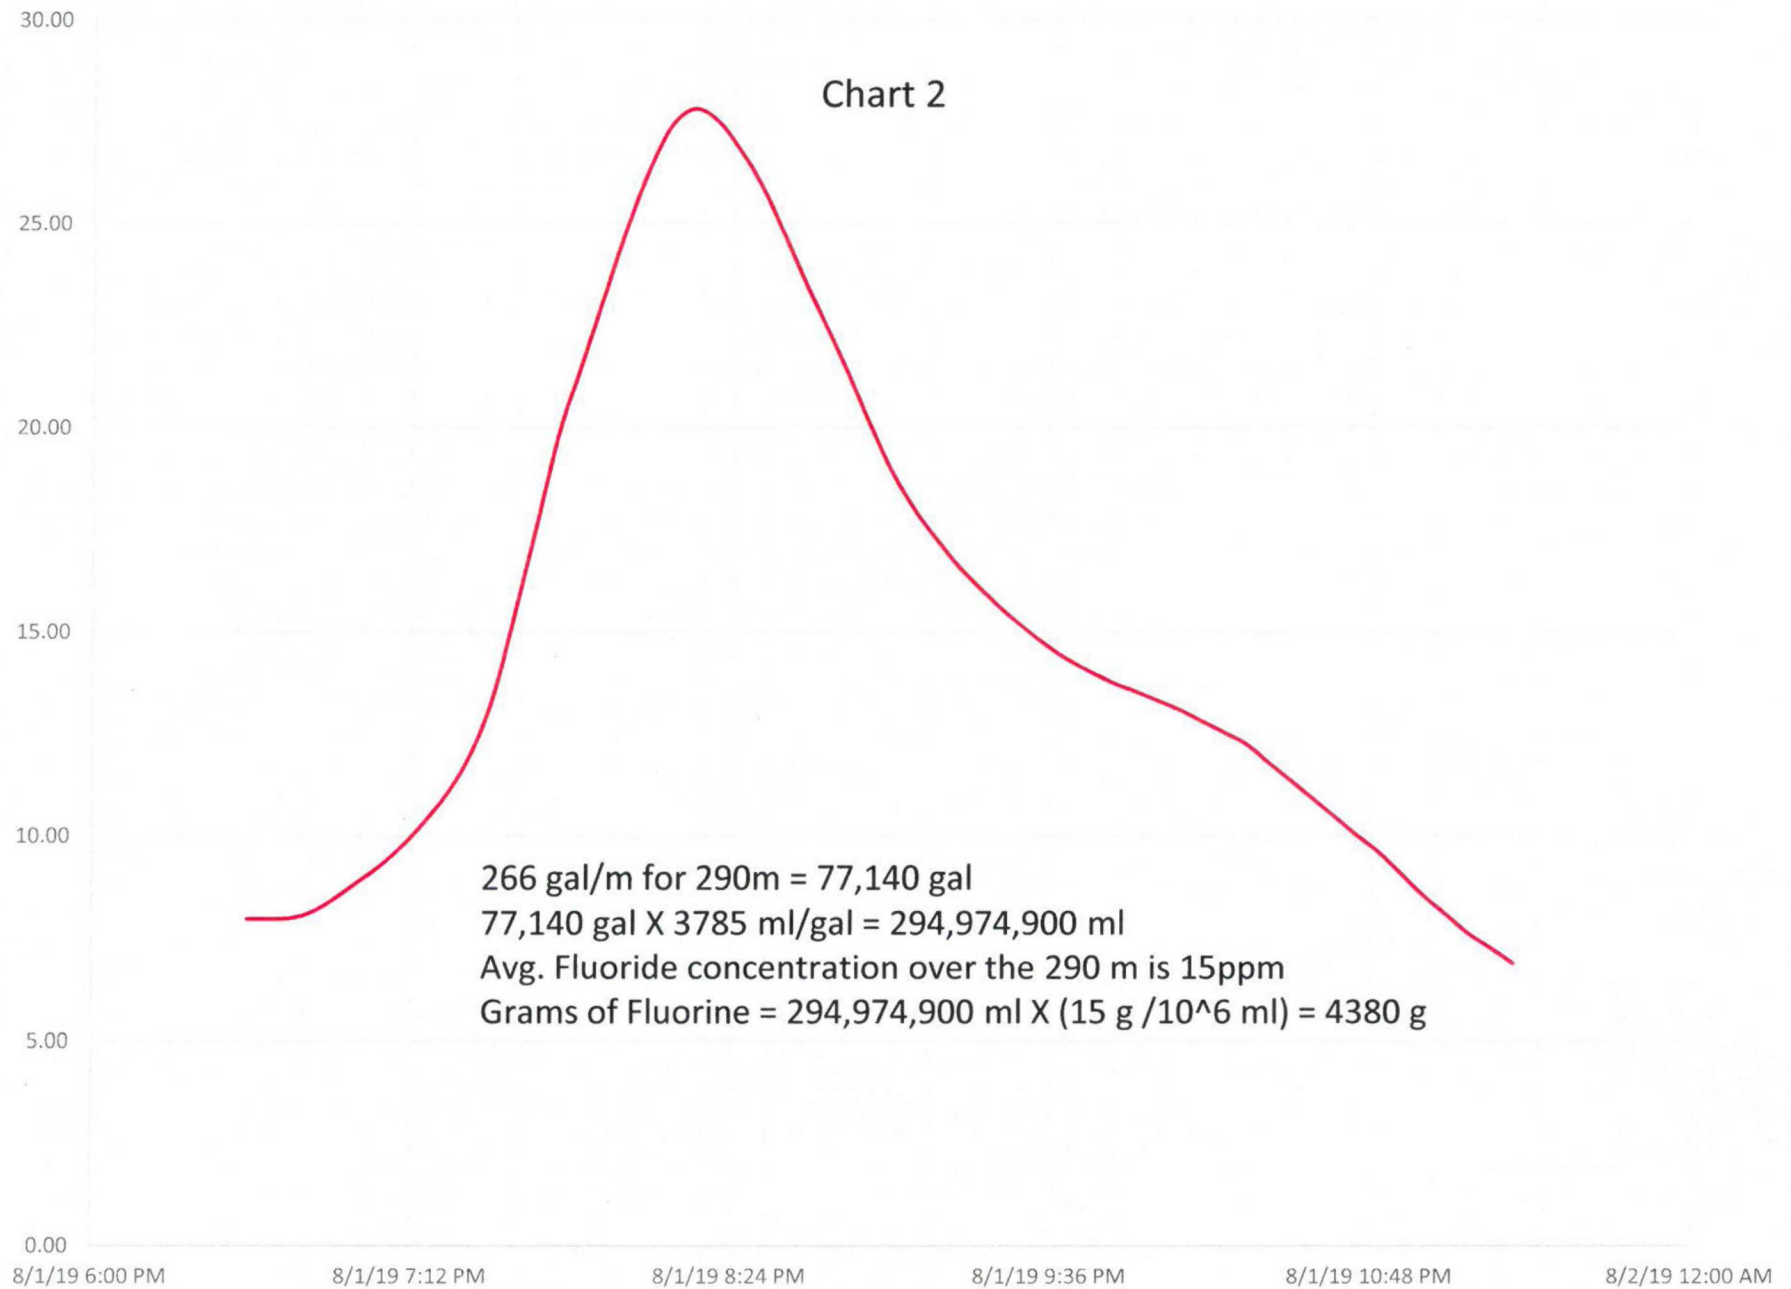
Chart 2

A graph of the fluoride concentrations (Chart 2), provided from the AWN monitoring system, shows fluoride levels over the 24-hour period for August 11, 2019. The graph identifies normal operating levels of fluoride at approximately 8 ppm along with the elevated fluoride spike. Engineers have determined fluoride concentrations for the 24-hour average were 7.8 ppm, well below the ABCWUA Sewer Use and Wastewater Control Ordinance Daily Maximum Composite Limit of 22.7 ppm. Additionally, Chart 1 identified the total weight of the fluoride during a 290-minute period was approximately 4,380 grams. During this period, wastewater flow levels were monitored at approximately 260 gallons per minute.
