K/ETO-155  
ORNL/TM-12840

### Investigation of Breached Depleted UF<sub>6</sub> Cylinders at the K-25 Site

INVESTIGATION OF BREACHED DEPLETED UF<sub>6</sub>  
CYLINDERS AT THE K-25 SITE

Date Published: October 1994

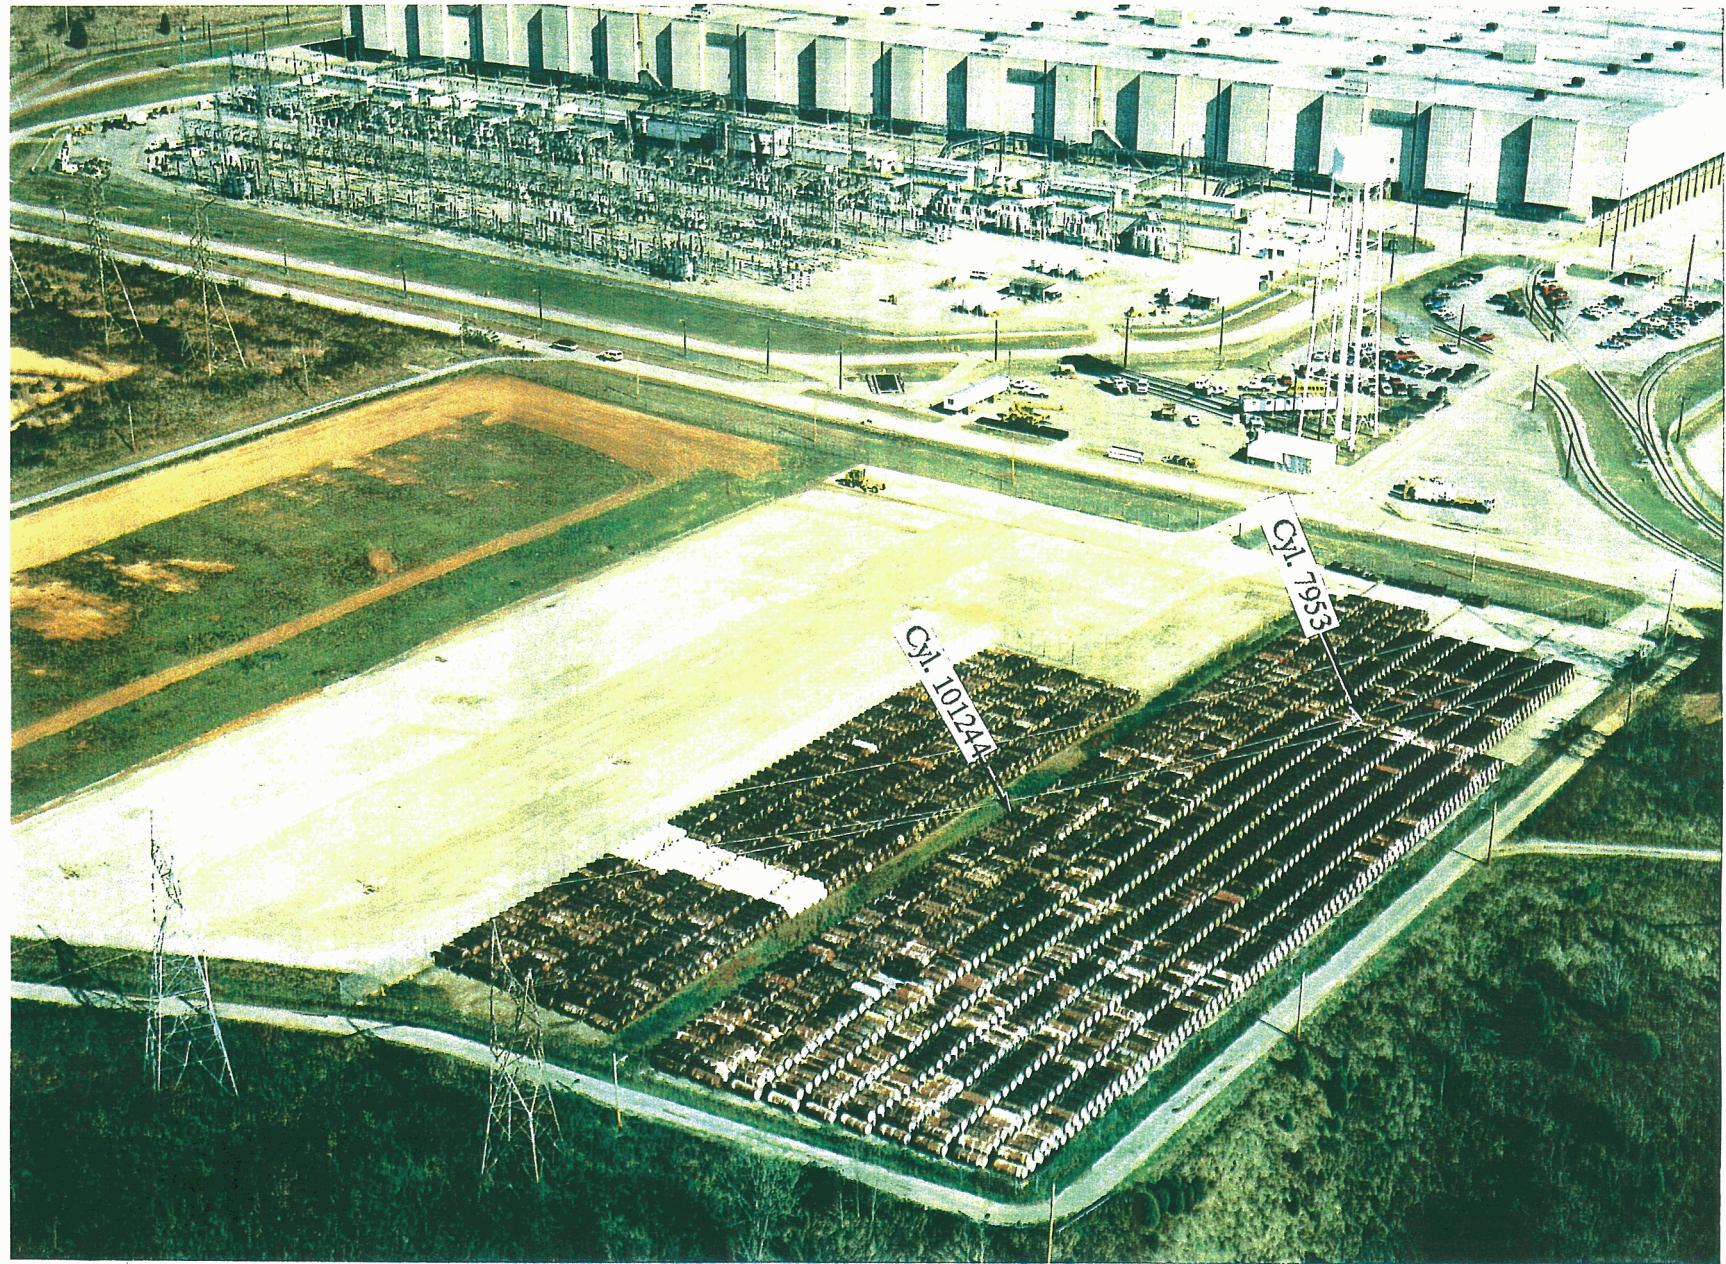
Fig. 1. K-1066-K yard. Photograph illustrates locations of failed Cylinders 101244 and 7953.

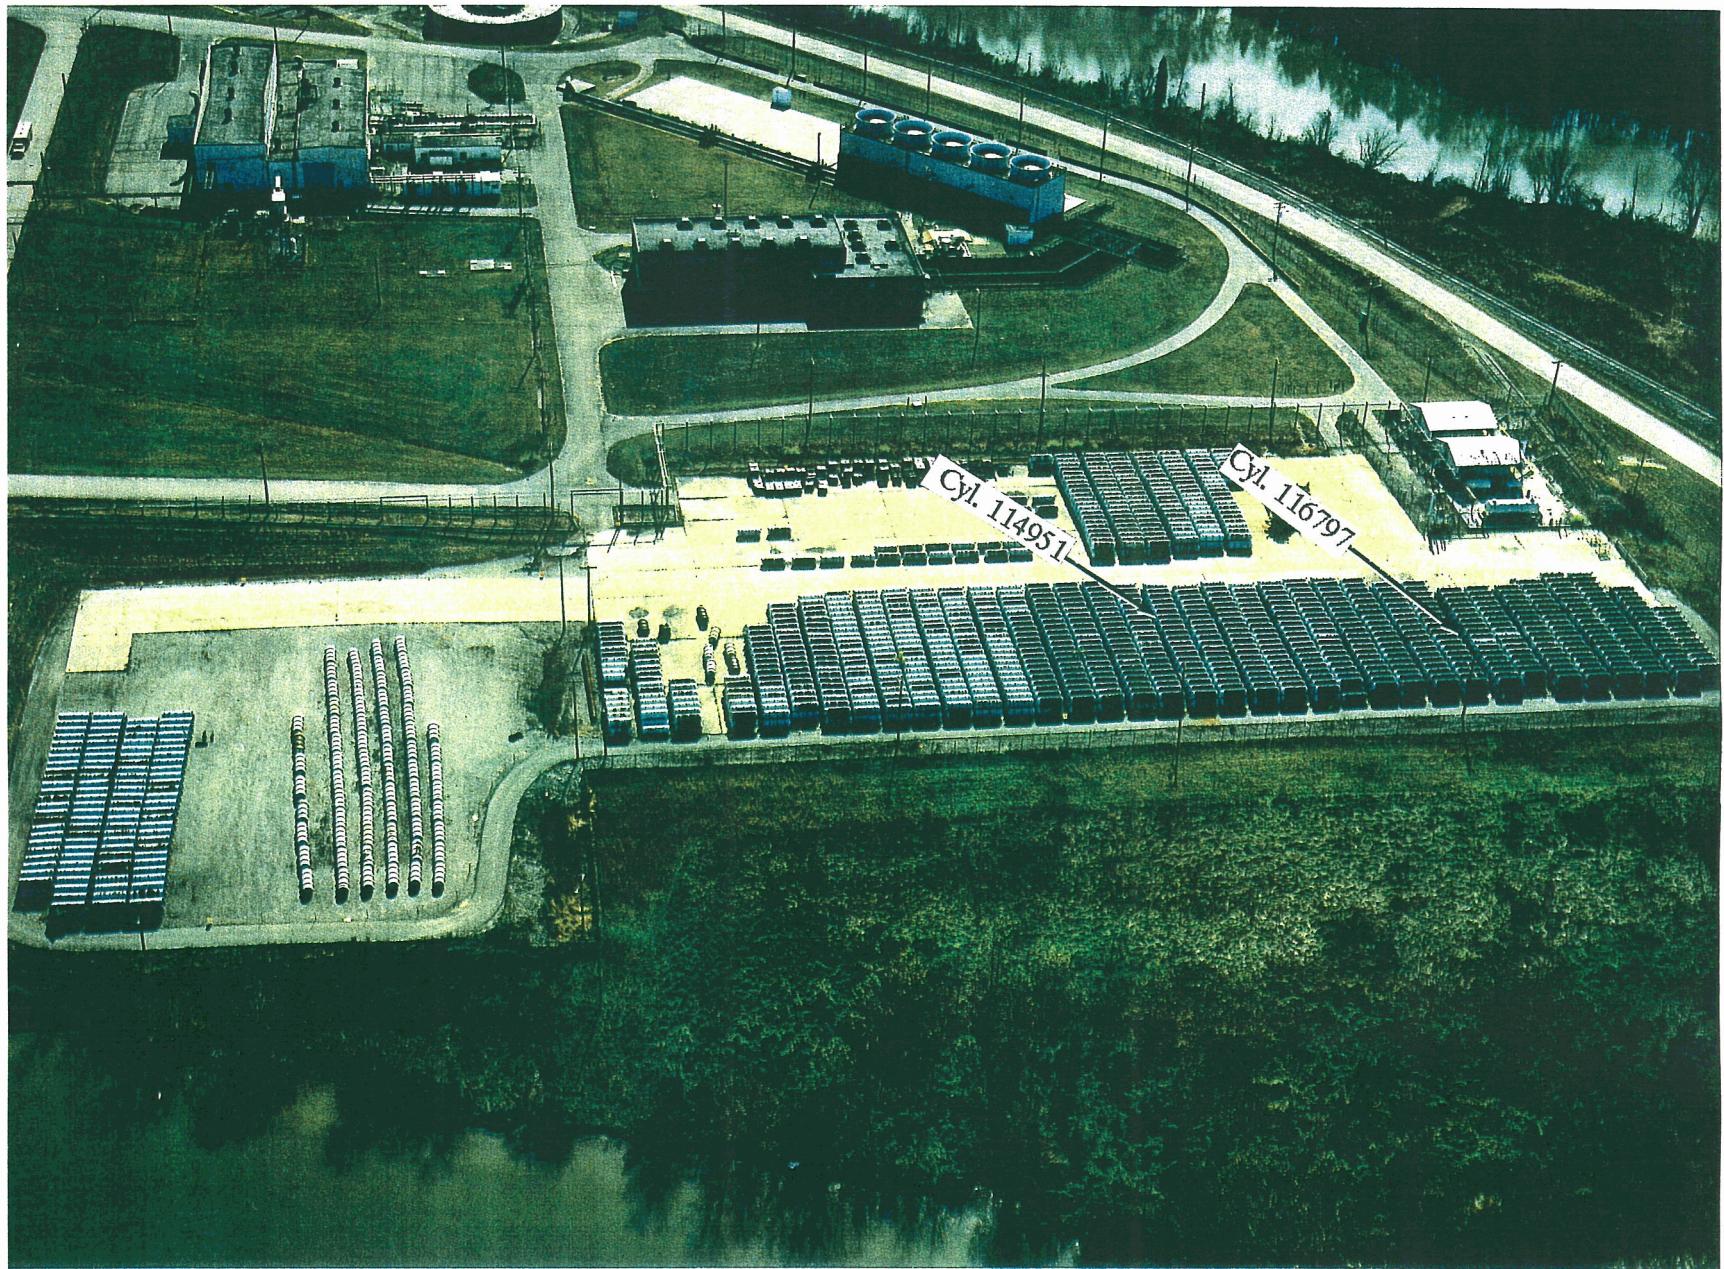
Fig. 2. K-1066-E yard. Photograph illustrates locations of failed Cylinders 114951 and 116797. Note the path of rust from breached Cylinder 114951.

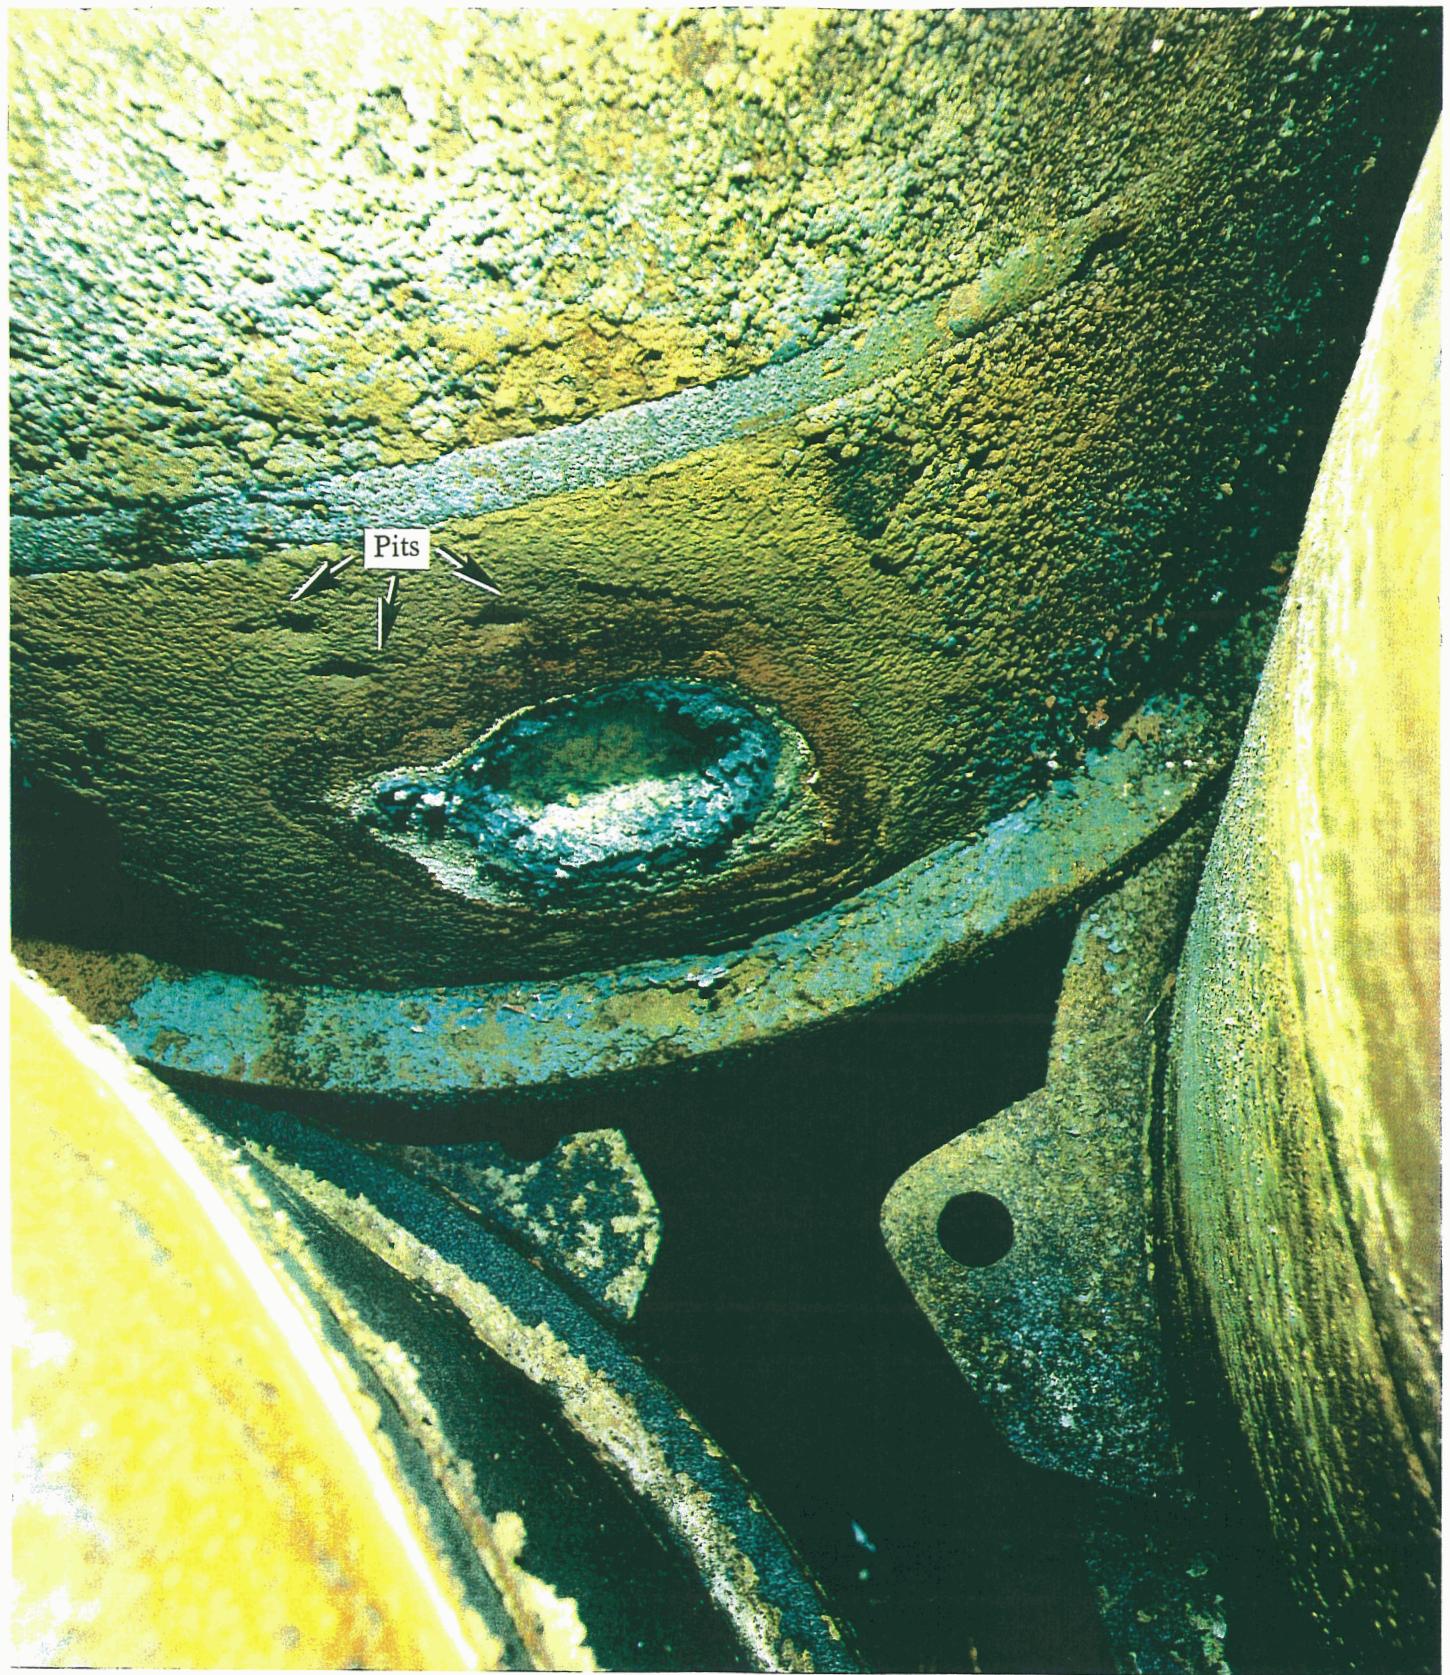
Cylinder 101244 was the first of four breached cylinders to be identified at K-25. As shown in Figure 3, the breach in Cylinder 101244 appeared as a slightly elliptical, approximately 6-in.-diam hole located at the bottom (6 o'clock position) at the plug end of the cylinder on the plug side of the stiffening ring. The location of the failure was different from two previous failures investigated at PORTS, which were both induced by a lifting lug impinging into the side of the cylinders.<sup>1</sup> The discovery of the hole followed from the observation of greenish salt deposits that had fallen onto the saddles supporting the cylinders directly under the failed cylinder. Three relatively deep pits can be seen in Figure 3 between the hole and the girth weld joining the dished head to the cylinder body; however, there is no evidence of salt leakage at any of the pit sites. Although the cylinder was in an upper tier location at the time the failure was discovered, the bottom surface of the cylinder at the valve end showed rust markings which indicated that it had previously rested on support saddles. The cylinder had been moved from K-1066-G yard to K-1066-K between 1983 and 1984, and these apparent saddle markings indicate that the cylinder probably occupied a ground-level

position in G-yard. Even though Cylinder 101244 was in an upper tier position, there were no salt deposits or unusual corrosion manifestations on the adjoining or underlying cylinders. This is a consequence of the 6 o'clock location of the hole and the separation distance between the underlying cylinders, which was wider than the hole.

Fig. 3. Breached Cylinder 101244 in stacked position as discovered. Note the three significant pits between the breach and the cylinder head weld.

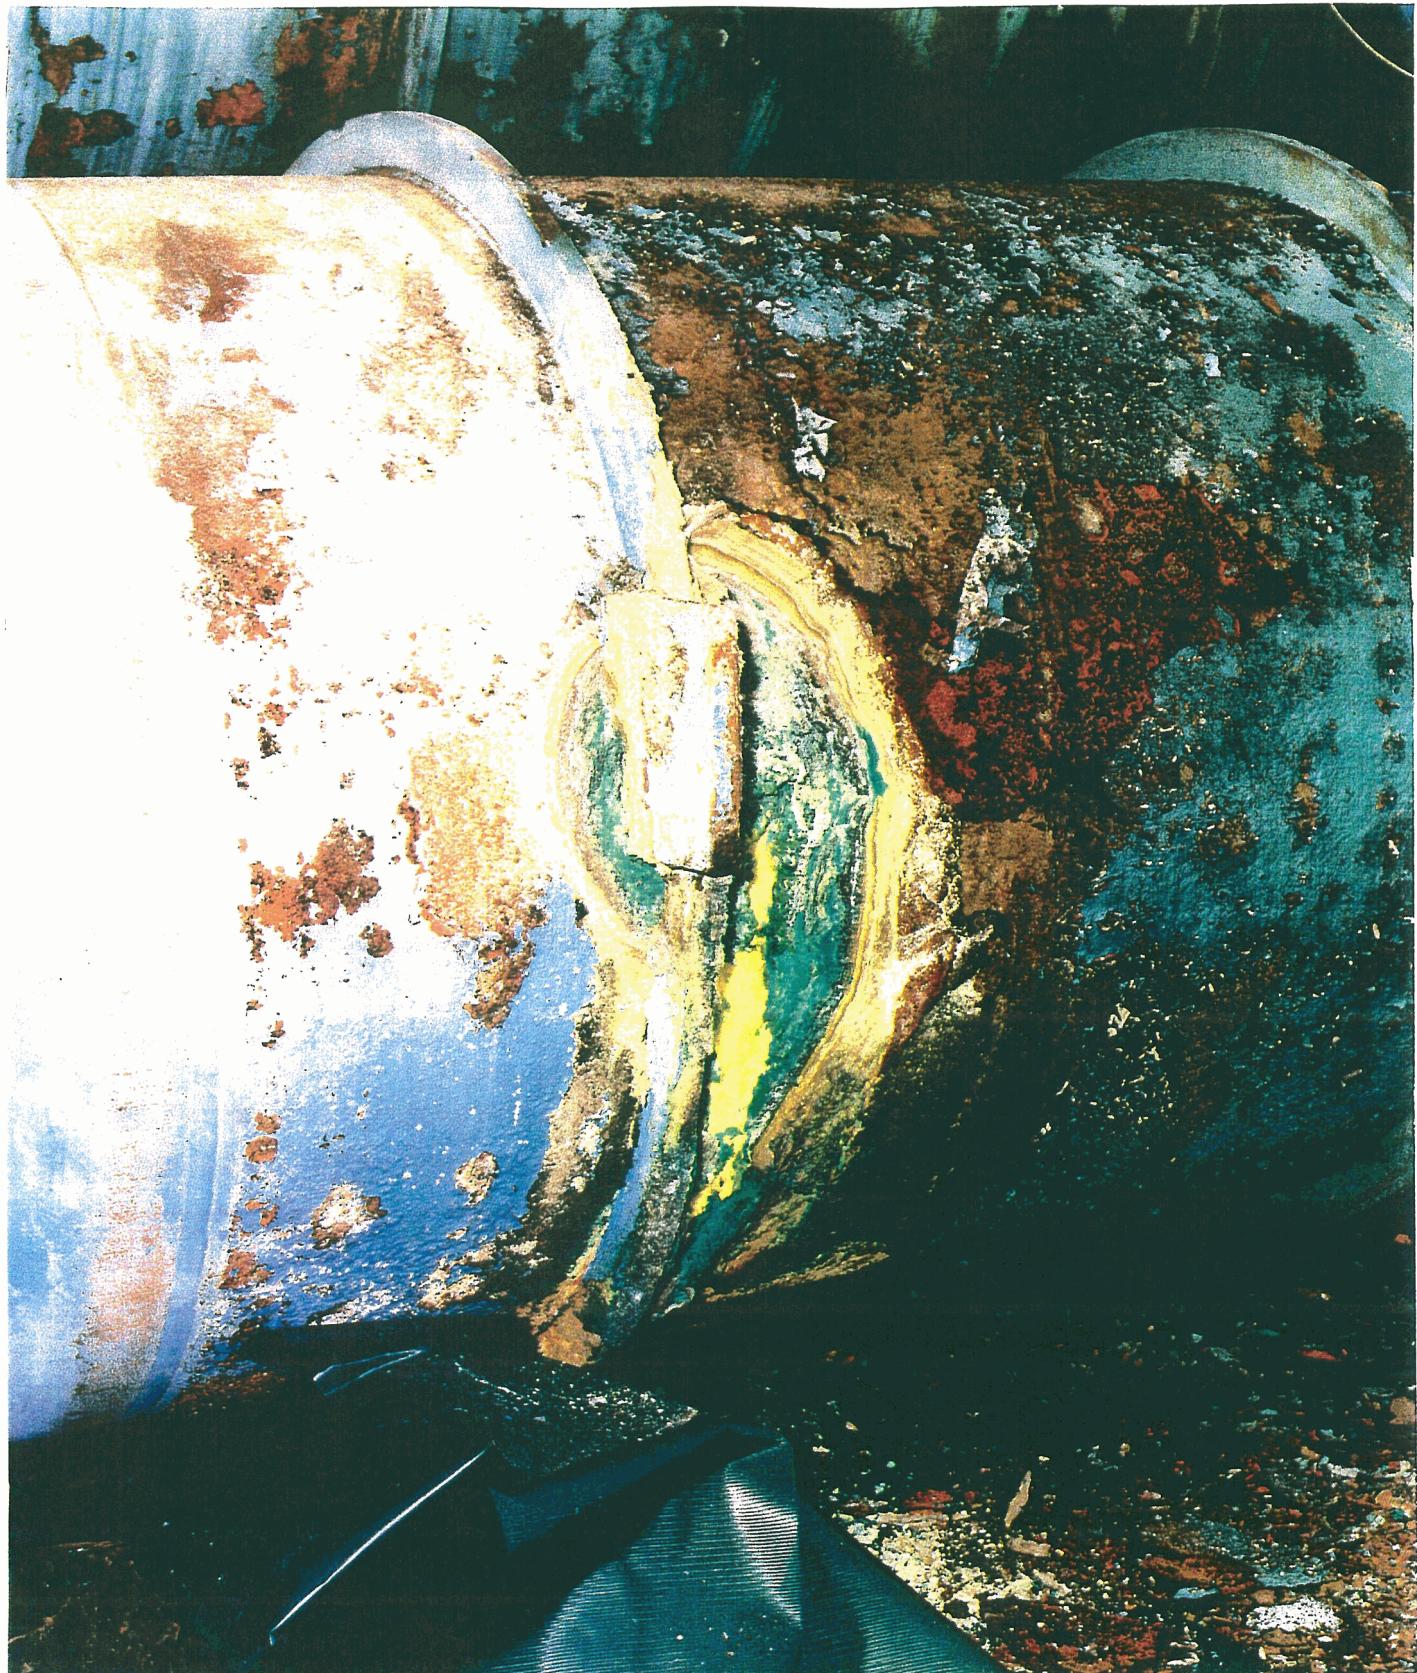
Approximately 3 weeks after the discovery of the above-mentioned cylinder breach, a relatively large hole was found in Cylinder 114951 located in the K-1066-E storage yard. The cylinder was in the lower tier and supported by wooden saddles. The hole, pictured in Figure 4, was approximately 8 to 12 in. wide by 15 to 17 in. long and was located behind the stiffening ring at the valve end of the cylinder at approximately the 4 o'clock position. The lifting lug of an adjacent cylinder faced directly into the hole, and as shown in Figure 5, much of the lug was missing due to corrosive attack. This adjacent cylinder also showed significant scaling of the cylinder surfaces near the stiffening ring (see Figure 5). Likewise, the cylinder immediately above the hole (Cylinder 114921) showed extensive rusting and scaling, pictured in Figure 6, which by its proximity to the breach appears to have been associated with gaseous reaction products emanating from the hole. Although slightly larger, the hole was almost identical in shape and position to one examined in an earlier investigation<sup>1</sup> at PORTS (Cylinder 115688). The salt within the area of the hole was also similar in coloring to that of the PORTS cylinder, but the exterior surface of the salt was more recessed.

The breach in Cylinder 114951 was caused by the lifting lug of an adjacent cylinder, which induced a small through-wall crack near a stiffening ring weld. The root causes of the failure were the same as those addressed in a previous investigation of two UF<sub>6</sub> storage cylinders at PORTS,<sup>1</sup> namely, inadequate spacing between cylinders and the deviation of the offending lifting lug from its intended horizontal position. Another key factor was that the

offending lifting lug came in contact with Cylinder 114951 exactly at the point where the stiffening ring was welded to the cylinder shell. Because of the constraint of the stiffening ring, any deformation of the shell at this point would cause a tear in the shell, as opposed to a dent if deformation occurs a slight distance away. The hole size at the time of discovery in Cylinder 114951 was slightly larger than the largest hole found at PORTS (Cylinder 4G115688), but the position of the hole, its general shape, and the appearance of reaction products in and around the hole are almost identical. Using a model that was derived to account for the hole growth observed in the two PORTS cylinders, the hole size in Cylinder 114951 is predicted to require an elapsed time of 16 years following the initial breach (see Appendix C). This elapsed time matches very closely the period between the time that Cylinder 114951 was stacked (1976) and the time the hole was discovered (1992). Thus, it can be concluded that the breach in this cylinder was induced at the time of stacking.

Fig. 4. Breached Cylinder 114951 after neighboring cylinders have been relocated.

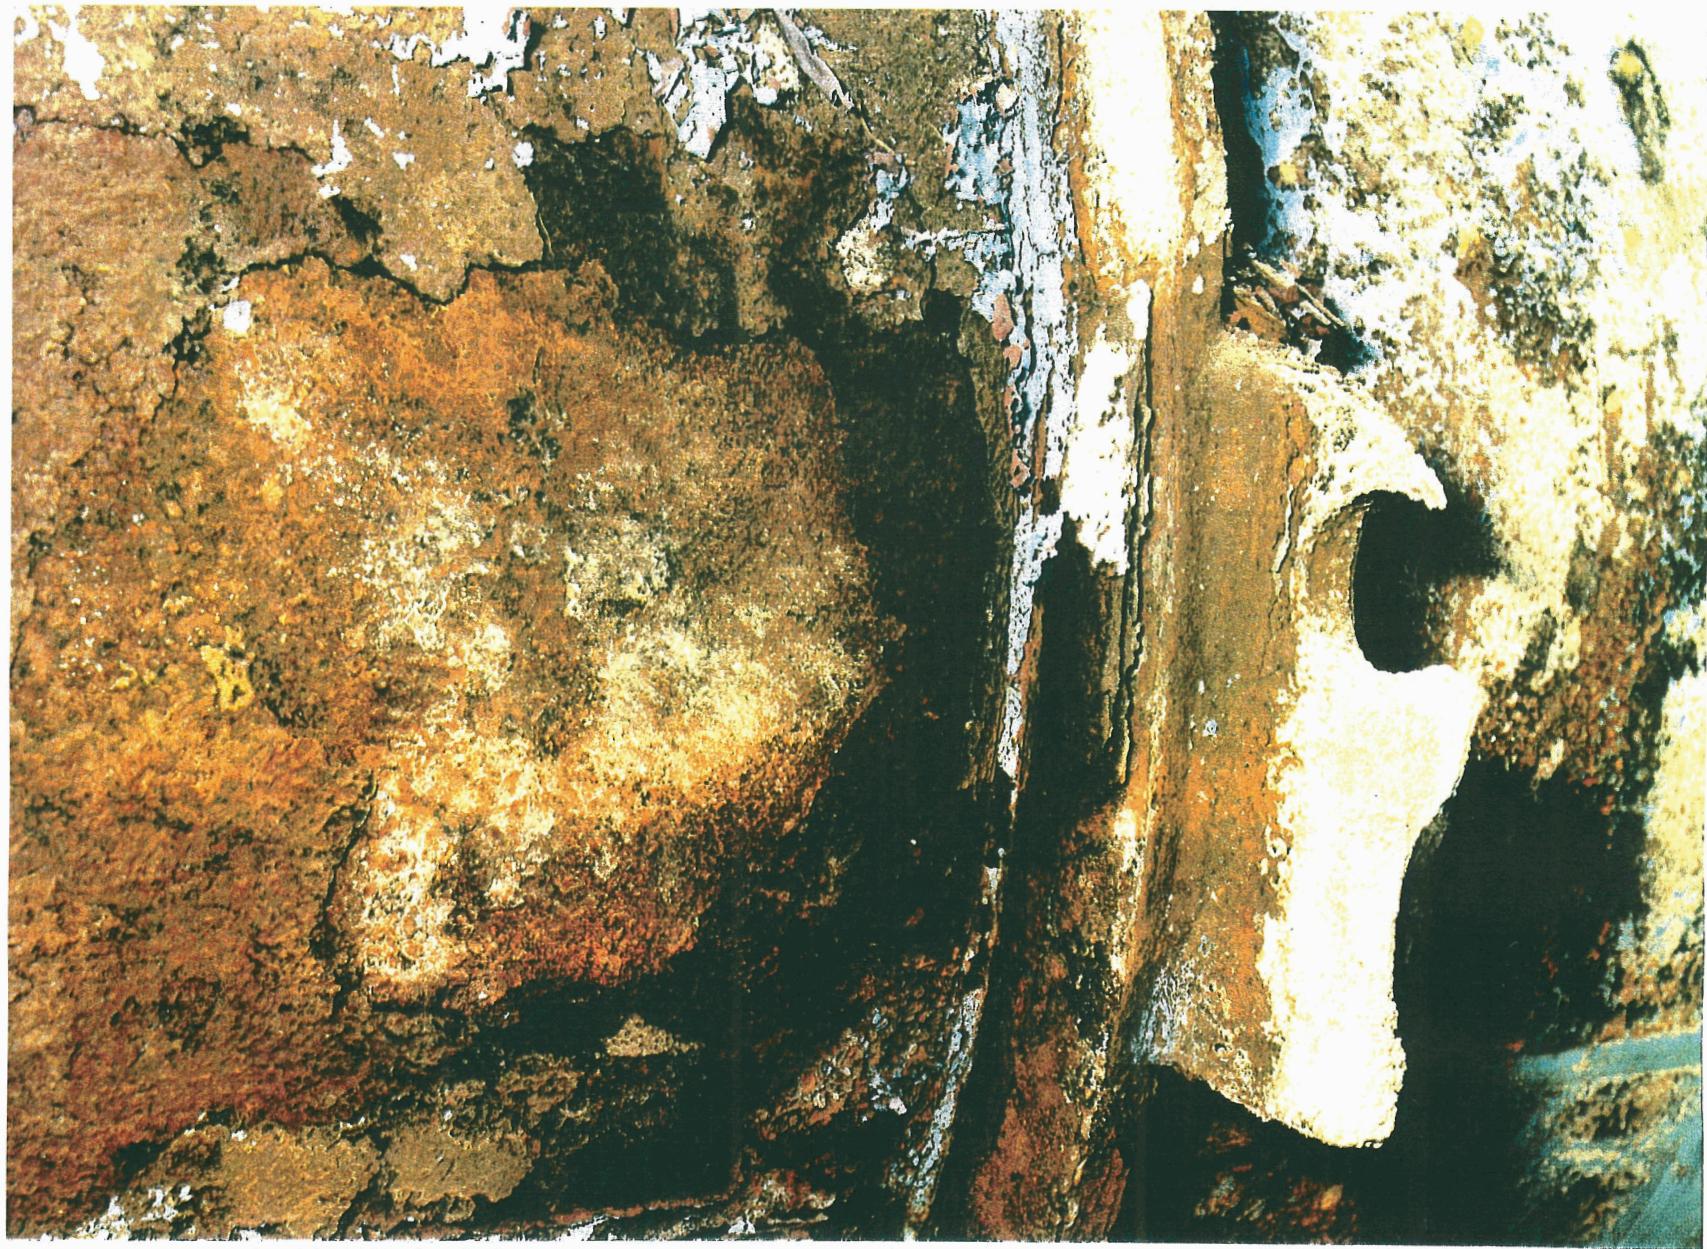
Fig. 5. Cylinder 115017 after being relocated. Note the extensive wastage of the lifting lug. This lug is believed to have impacted and caused the breach in Cylinder 114951. Also note the cylinder wall wastage - an effect of corrosive materials released from breached Cylinder 114951.

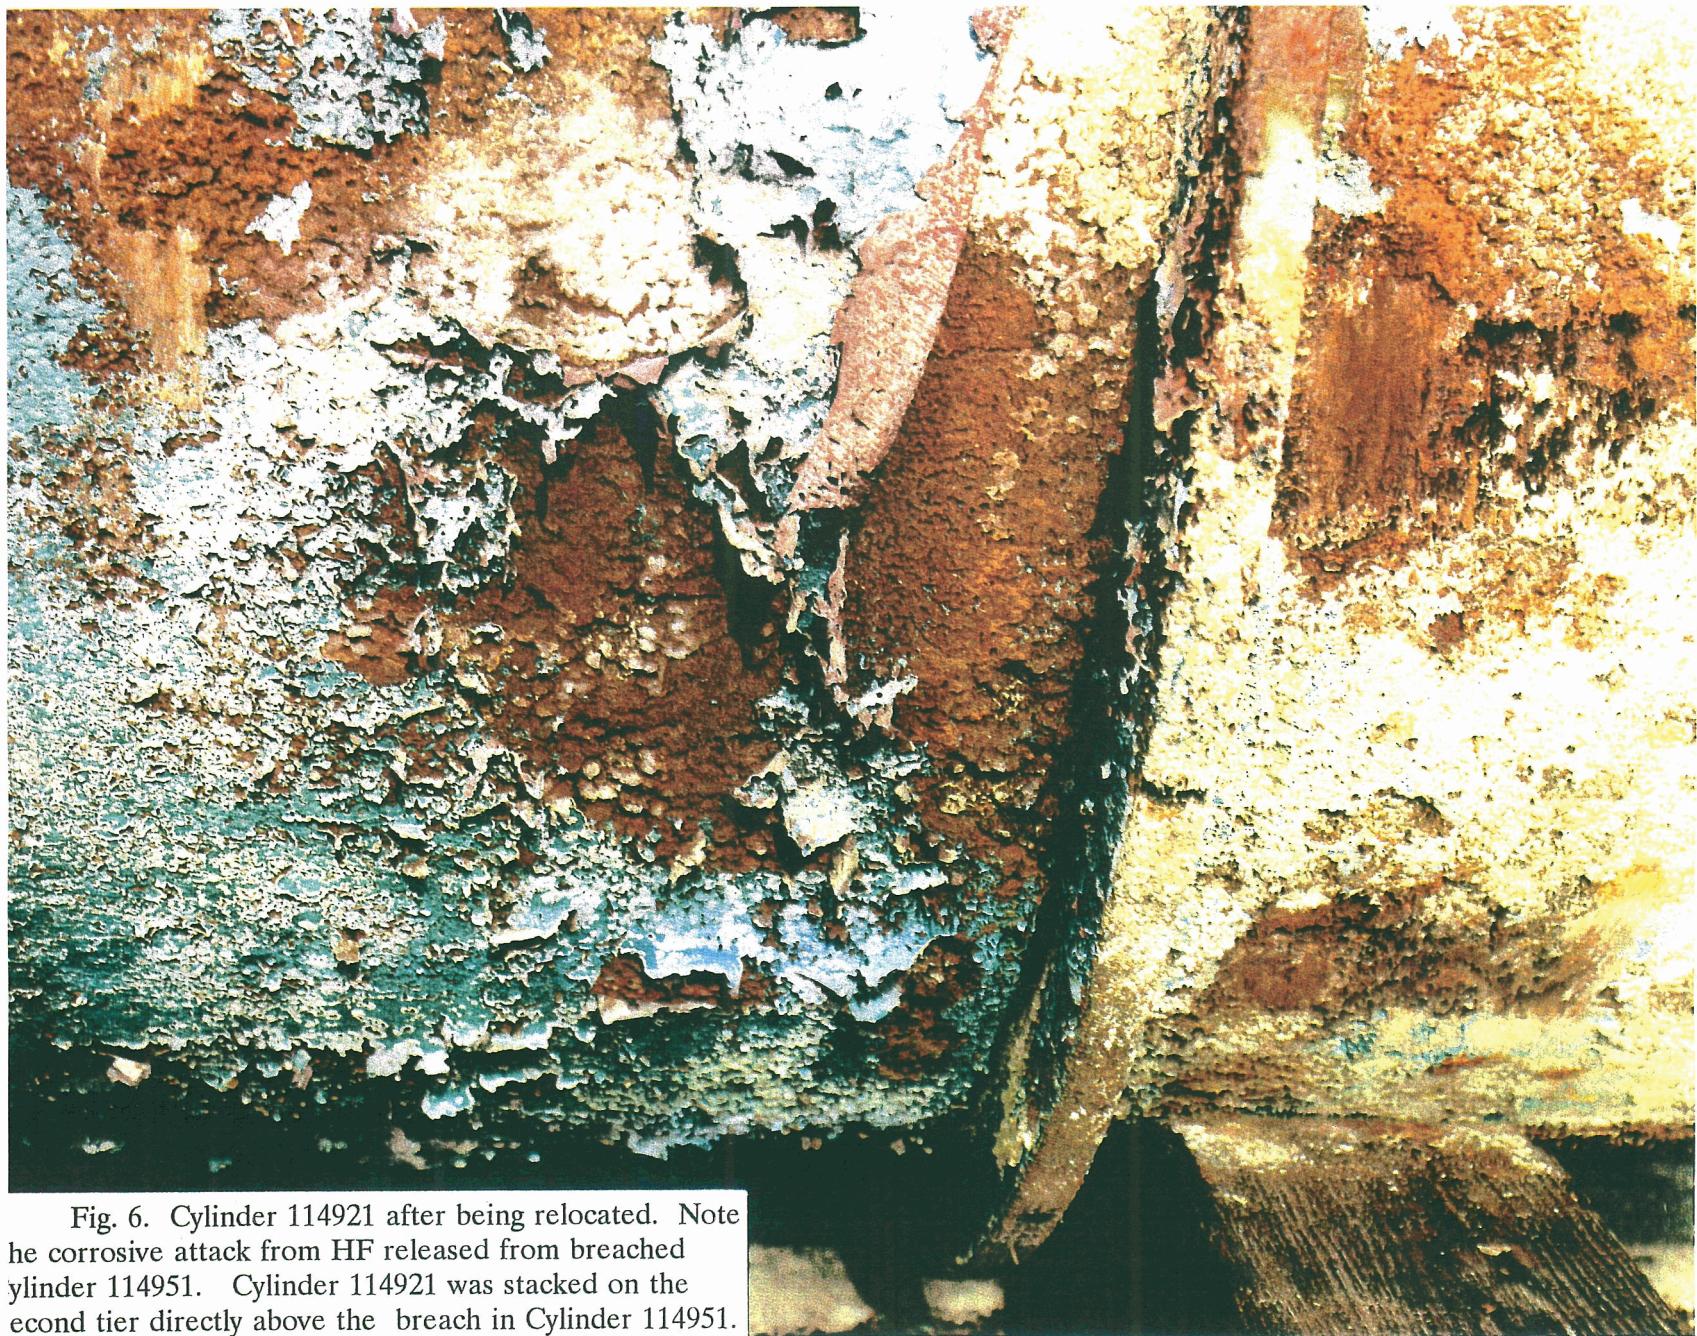
Fig. 6. Cylinder 114921 after being relocated. Note the corrosive attack from HF released from breached cylinder 114951. Cylinder 114921 was stacked on the second tier directly above the breach in Cylinder 114951.

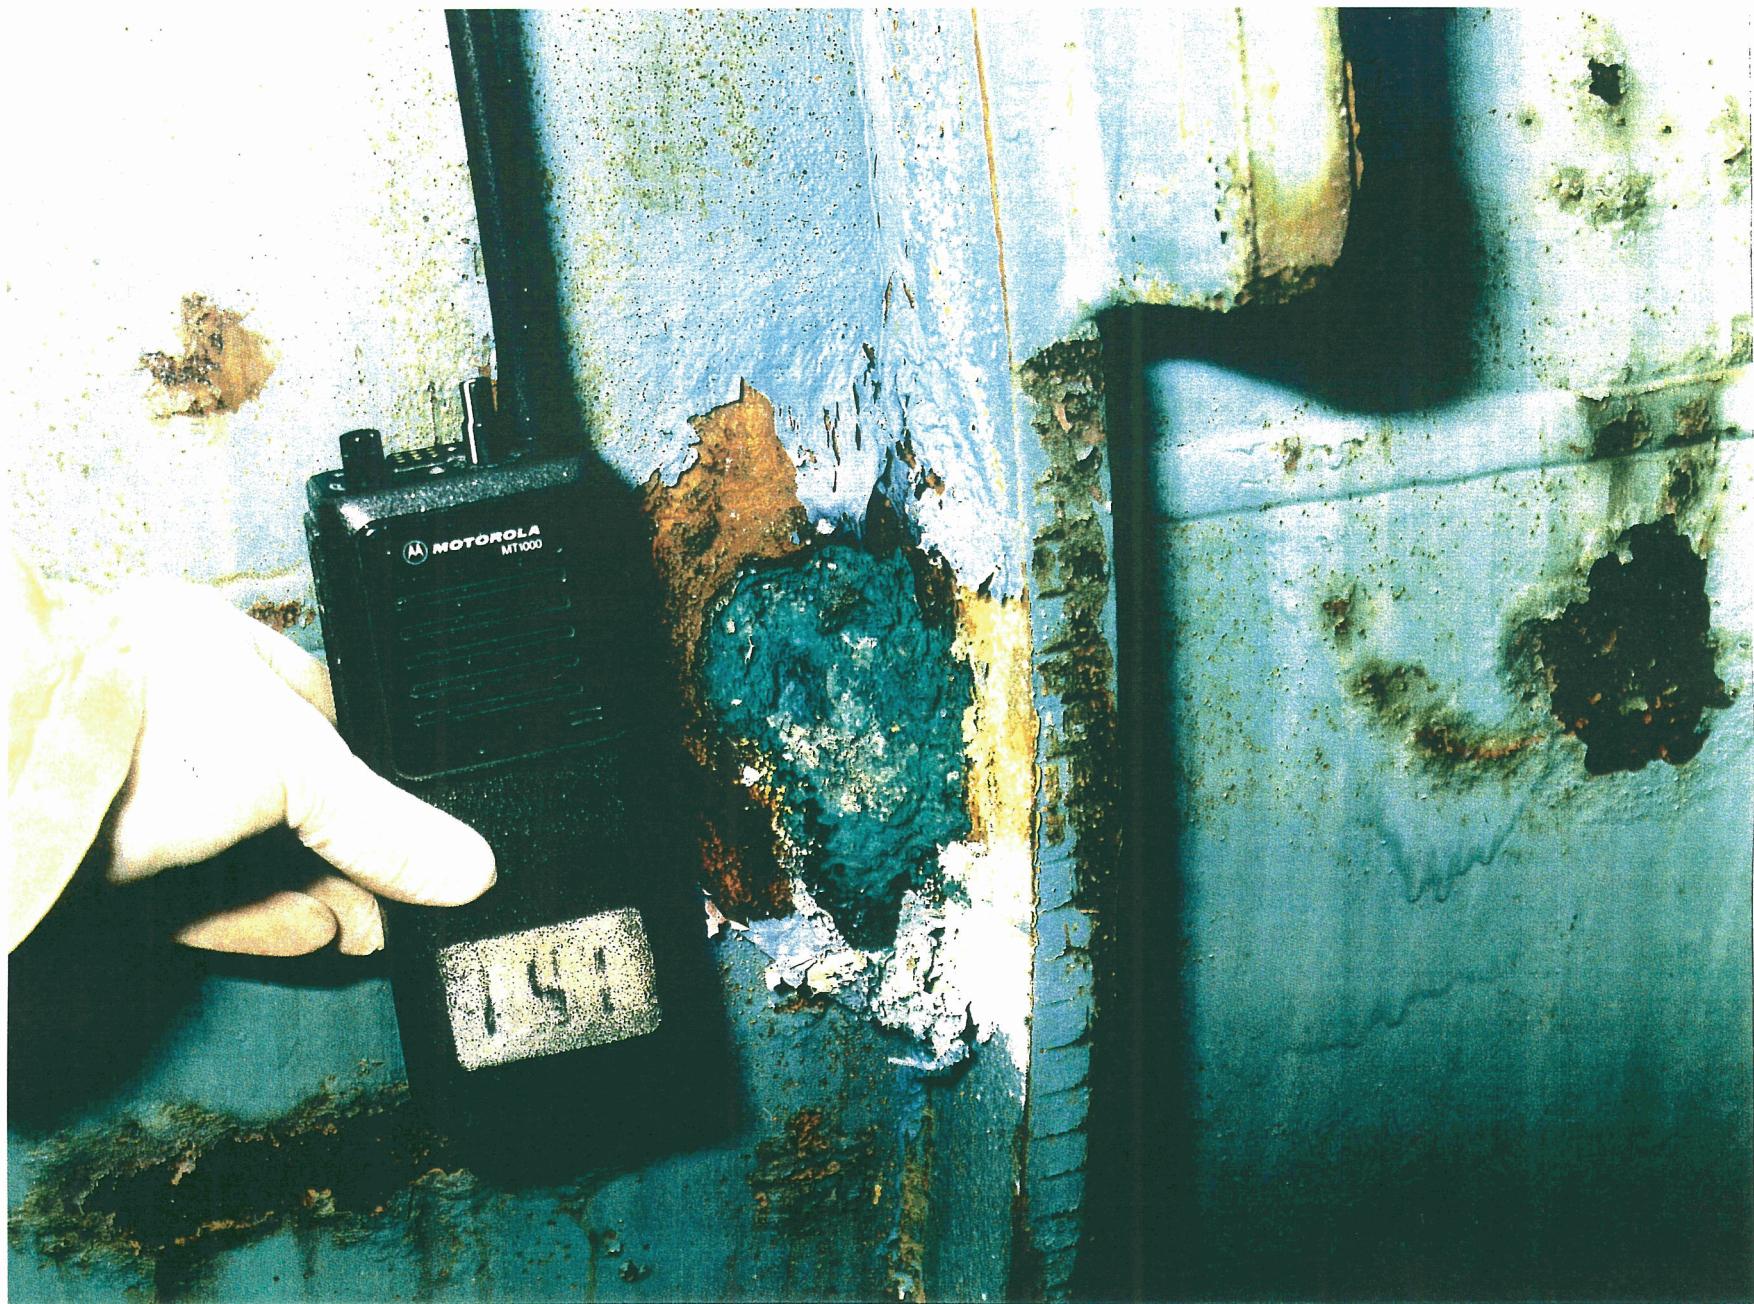
Further inspection of the K-1066-E yard uncovered one other breached cylinder, again with the hole directly under the lifting lug of an adjacent cylinder. This hole was relatively small, approximately 2-in. diam, and was located immediately behind the stiffening ring at the valve end of the cylinder near the 9 o'clock position (viewed from the valve end). The hole was almost completely obscured by the lifting lug of the adjacent cylinder and could only be seen with the aid of a mirror. Its appearance, shown in Figure 7, was very similar to that of the second cylinder failure examined at PORTS (Cylinder 127985).<sup>1</sup> Both cylinders were likewise located in lower tier positions. There was no evidence of salt deposits on the ground, and except for the opposing lifting lug, no evidence of corrosion of neighboring cylinders.

Like Cylinder 114951, the breach in Cylinder 116797 was located on the side and resulted from a crack induced by a neighboring lifting lug, which impinged on the area where the shell was joined to an end stiffening ring. The root causes were the same for Cylinder 116797 and for two storage cylinders which had been breached by the same mechanism at the PORTS.<sup>1</sup> The shape and size of the hole were much smaller than in the case of Cylinder 114951 and were almost identical to the smaller-hole PORTS Cylinder (4G127985). However, unlike the PORTS cylinder which had been stored for a period of only 4 years, Cylinder 116797 had been stored for an estimated 14 to 15 years. The correlation between hole size and storage time found for all the other cylinders that failed by the mechanical impingement of a lifting lug would predict the hole to have grown to at least 10 in. If the hole growth in Cylinder 116797 is to fit the model established for these other cylinders (see Appendix C), then the 2-in. hole in this cylinder must have started growing only 4 or 5 years before its discovery. Accordingly, even though it resulted from the impingement of a lifting lug at the time of stacking, the breach could not have fully opened until at least 10 years after this event. The credibility of this postulate can be argued from a recent observation at the PGDP, in which the breach in a mechanically damaged thin-wall storage Cylinder (120037) did not occur until a substantial time after the initial lug impingement. In this case, the cylinder was found to have a small crack near the stiffening ring, which had obviously occurred by impingement of a lifting lug when it was placed in the storage yard several years earlier. Although there was

no indication that the crack was open to the UF<sub>6</sub> when it was first discovered, a small leak did develop a few days after the impinging lug was removed. Either the lifting lug causing the crack had occluded the crack from the atmosphere until the cylinder was moved, or the crack was only partially through the wall and was propagated during the move. Since the breach in Cylinder 116797 would have started as a similar-sized crack, a similar explanation can be applied to the delayed start of hole growth. In this case, however, crevice corrosion occurring from the outside could also have contributed to the ultimate propagation of the crack.

Fig. 7. Breached Cylinder 116797. Photograph taken after neighboring cylinders were relocated.

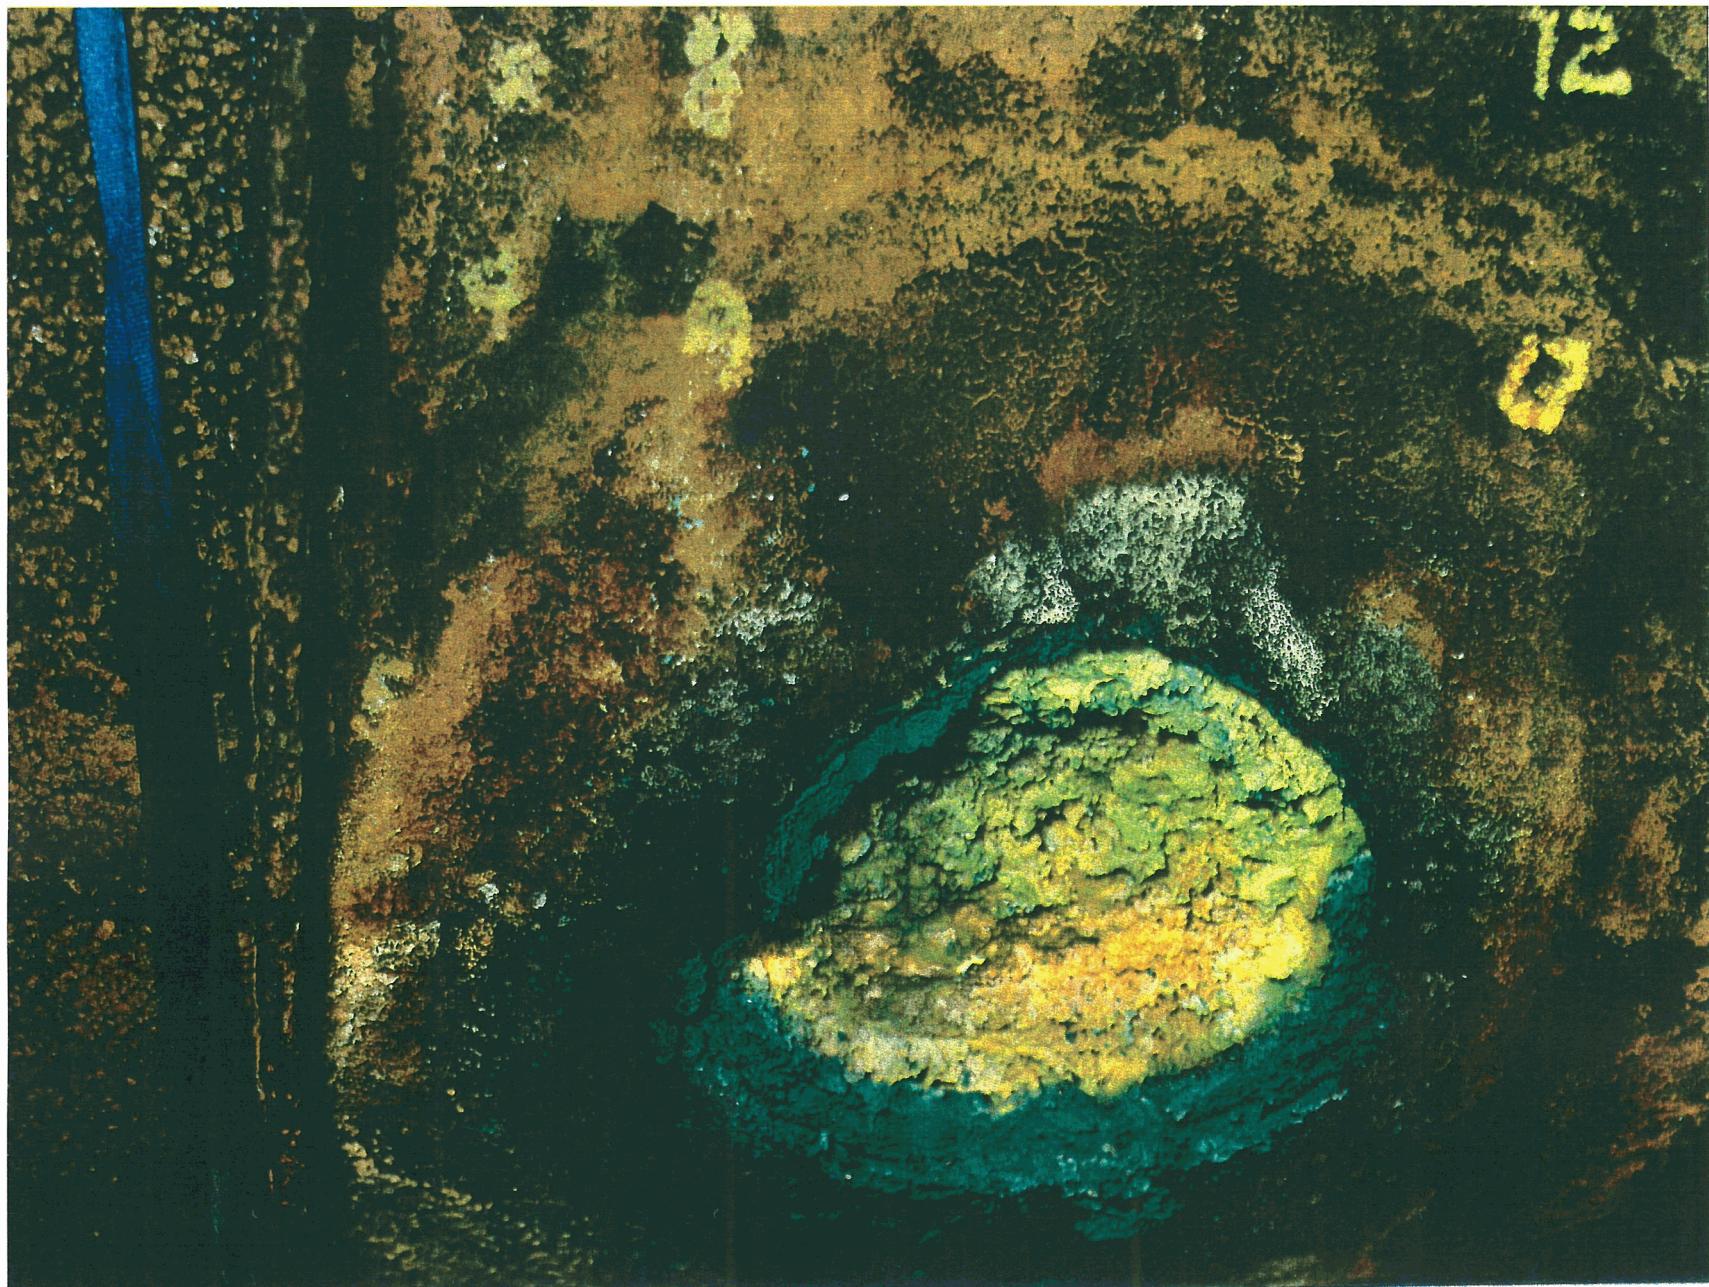
A fourth breached cylinder at K-25 (Cylinder 7953) was found in the K-1066-K yard approximately 4 months after discovery of the first breached cylinder in the same yard. Like the first cylinder, the hole was in the bottom (6 o'clock position) of the cylinder, but the hole was considerably larger, approximately 9 in. diam. The cylinder was in a bottom tier position, and despite its relatively large size, the hole could not be seen without the aid of mirrors

because of the limited ground clearance and separation distance between cylinders. Direct photographing of the hole (see Figure 8) was not possible until the cylinder could be rotated 90° from its original position. The identification of the hole was aided by the observation of greenish salt deposits lying on the concrete surface directly beneath the hole, shown in Figure 9. The hole was located on the plug side of the cylinder approximately 6 in. from the middle stiffening ring. There was extensive external corrosion of the bottom surface of the cylinder, as evidenced by the heavy rust covering (see Figure 8), and by iron oxide scale that had sloughed off the cylinder onto the concrete pad below (see Figure 9). Adjacent cylinders at the lower level also showed a higher-than-normal extent of external corrosion of the lower surfaces; however, this appeared to be the result of the cylinders being located in a low spot in the yard, which retained water, rather than any effects from the failed cylinder.

Fig. 8. Breached Cylinder 7953 after being relocated and turned approximately 45°.
