K/ETO-155  
ORNL/TM-12840

### Investigation of Breached Depleted UF<sub>6</sub> Cylinders at the K-25 Site

INVESTIGATION OF BREACHED DEPLETED UF<sub>6</sub>  
CYLINDERS AT THE K-25 SITE

Date Published: October 1994

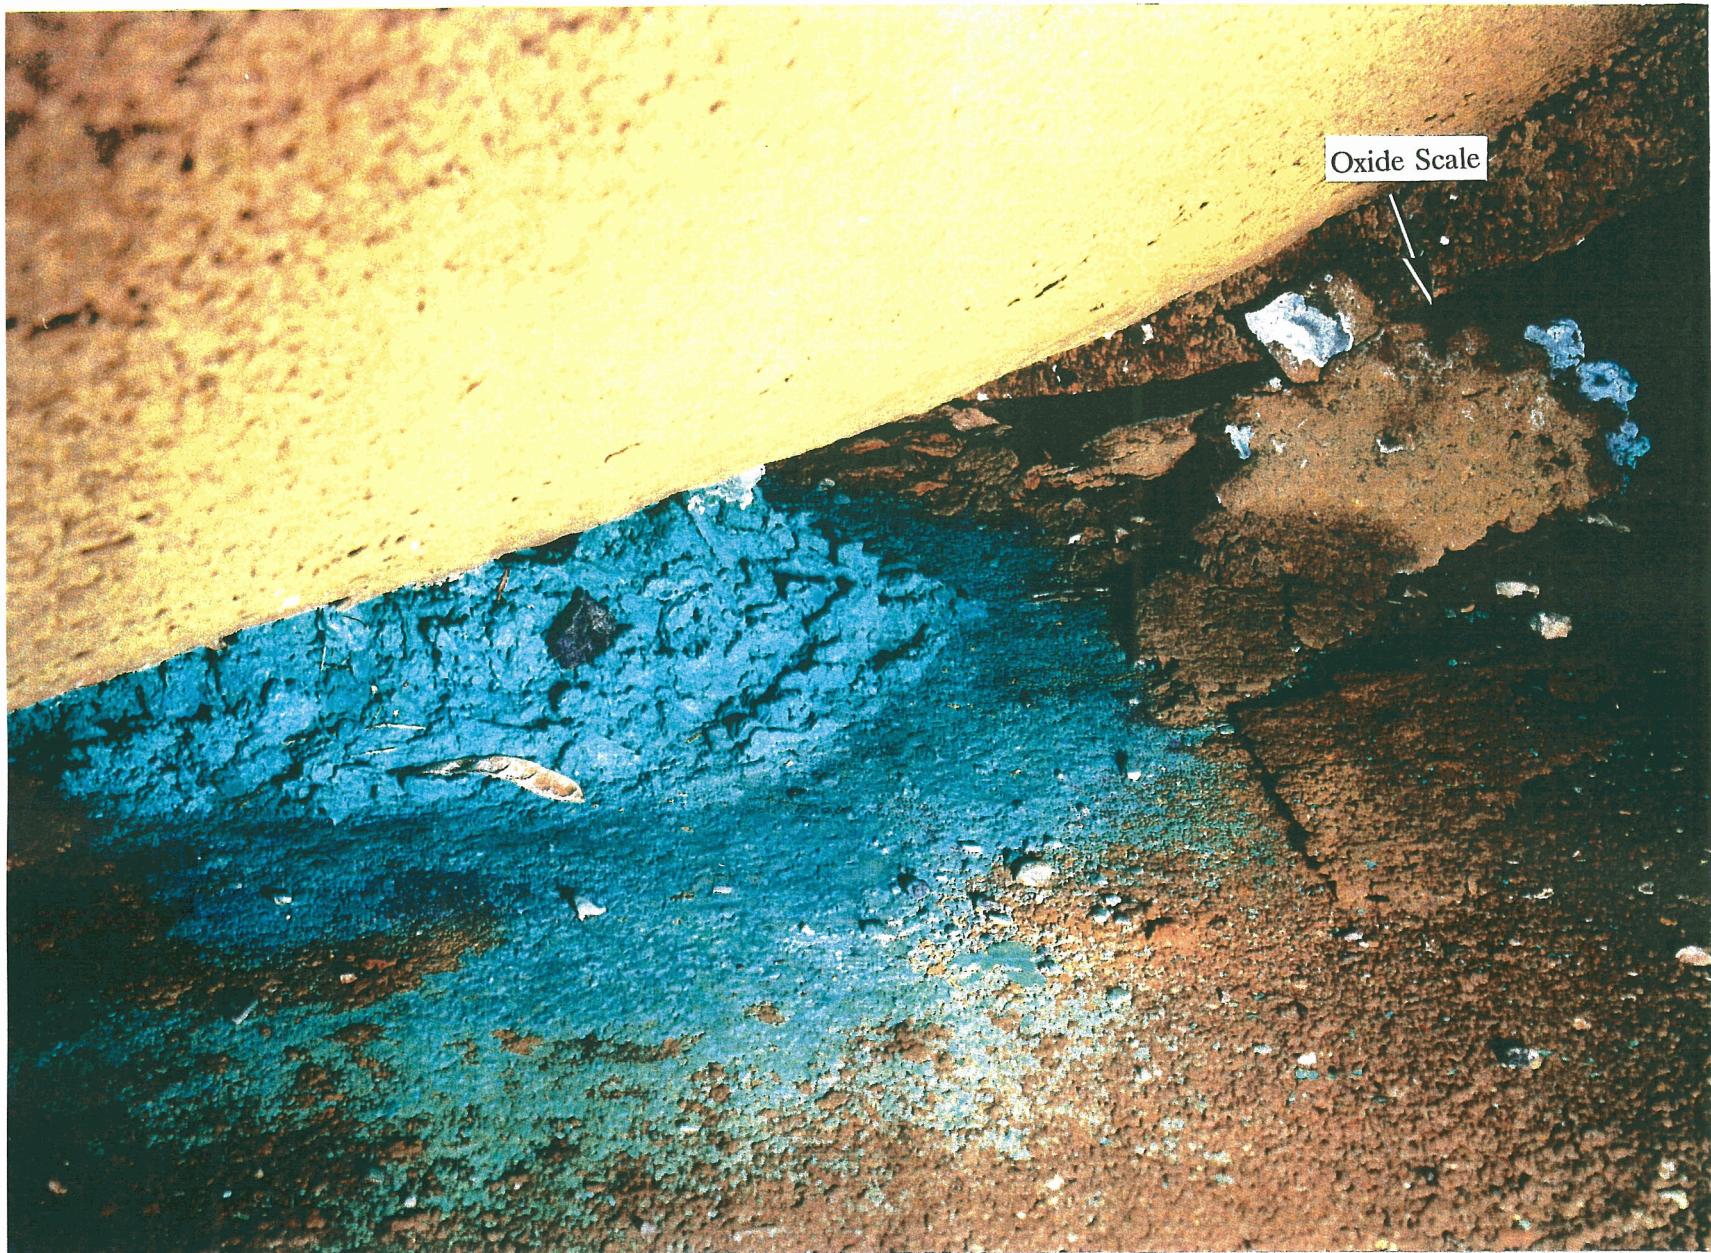
Fig. 9. Breached Cylinder 7953 as discovered. Note iron oxide scale on the concrete pad adjacent to green reaction products.
