Catastrophic Failure of Contaminated Fused Silica Optics at 355 nm

**This paper was prepared for submittal to
2nd Annual International Conference on Solid-State
Lasers for Applications to Inertial Confinement Fusion
Paris, France
October 22-25, 1996**

December 3, 1996

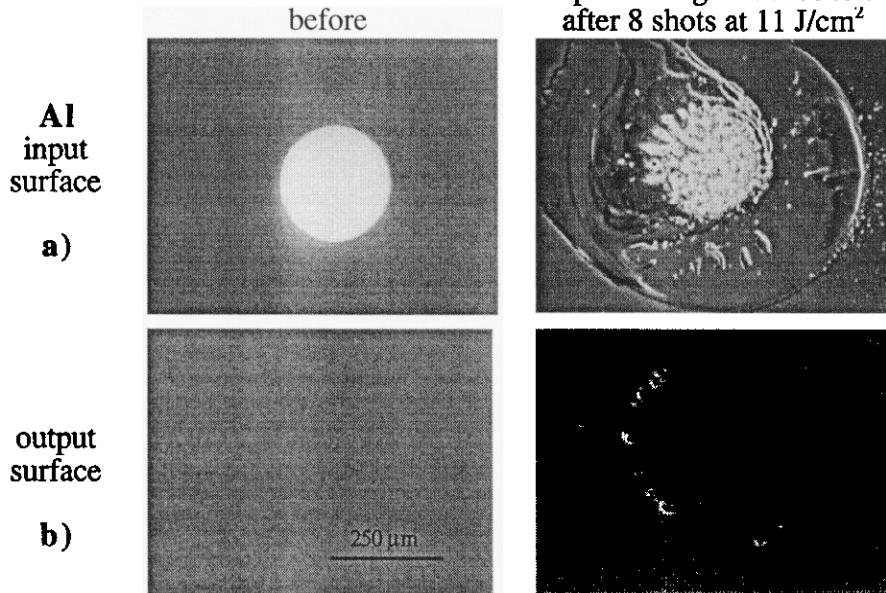
The output surface of the window can also be damaged. A plasma can often be observed at that location. In particular, at fluences above 5 J/cm², a print of the shape of the input surface contamination particle is sometimes recognizable on the output surface (see Figs. 2 and 6). For fluences higher than a given threshold (which varies with particle size), the exit surface is strongly attacked. The damage morphology is that of pits (see Fig. 2b) - 5b)). These pits on the output surface grow very quickly during repetitive illumination by drilling upstream of the light into the bulk; such damage is referred as to catastrophic. The damaged region seems to couple to the light easily and the fused silica is further damaged after each shot.

Fig. 2: Nomarski optical micrograph of the damage morphology of a) the input and b) output surfaces of the fused silica window after 8 shots at 355 nm and 11 J/cm^2 . The damage was initiated by a sputtered Al particle located on the *input surface*. The particle was 1 μm thick and 250 μm in diameter. The input surface damage is massive. The output surface damage would have grown catastrophically during subsequent shots . The output surface damage follows the outline of the input surface particle.

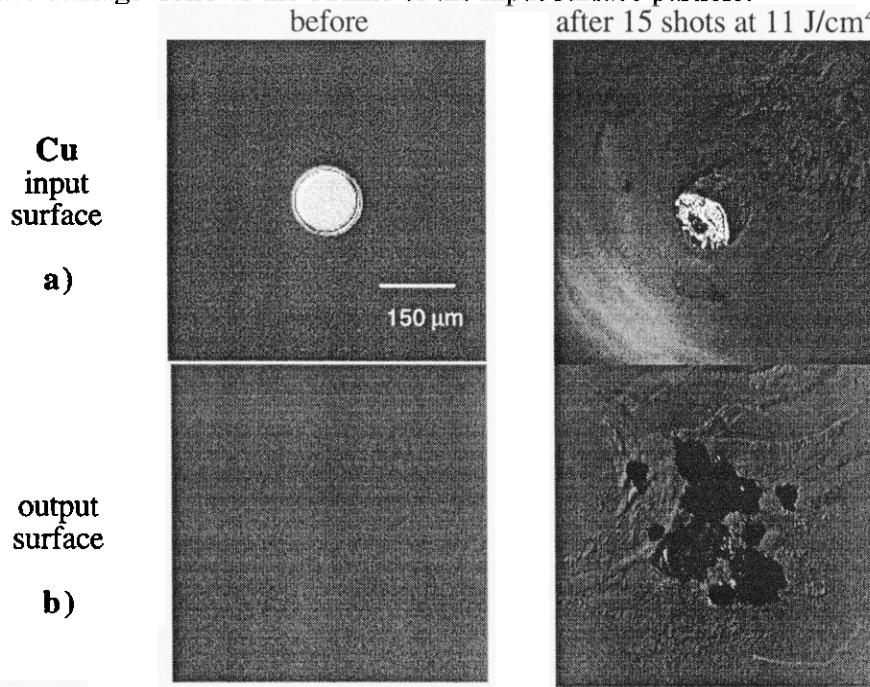
Fig. 3: Nomarski optical micrograph of the damage morphology of a) the input and b) output surfaces of the fused silica window after 15 shots at 355 nm and 11 J/cm^2 . The damage was initiated by a sputtered Cu particle located on the *input surface*. The particle was 1 μm thick and 150 μm in diameter. The output surface damage is catastrophic.

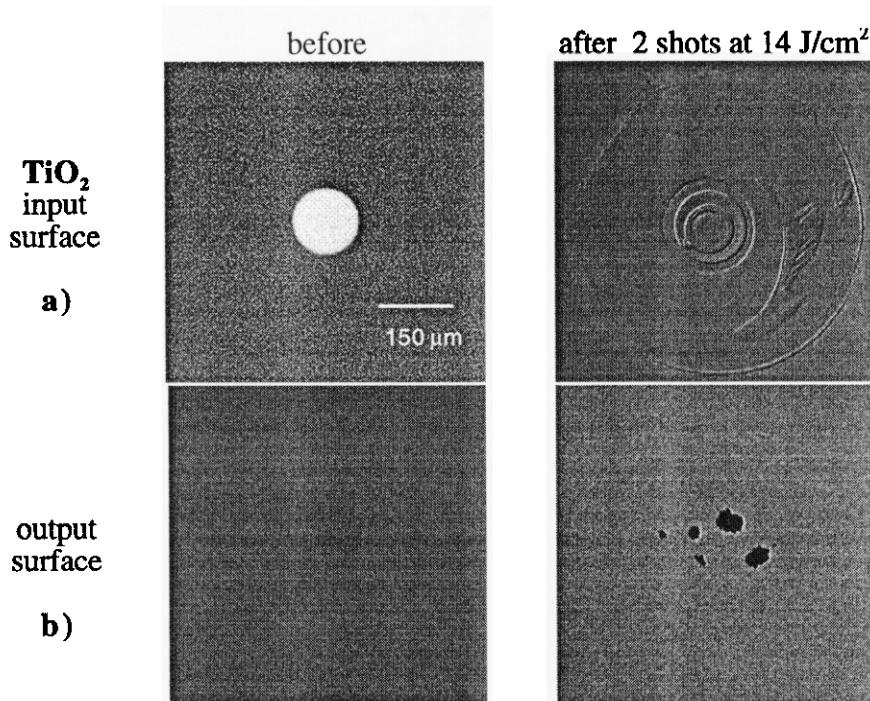
Fig. 4: Nomarski optical micrograph of the damage morphology of a) the input and b) output surfaces of the fused silica window after 2 shots at 355 nm and 14 J/cm². The damage was initiated by a sputtered TiO₂ particle located on the *input surface*. The particle was 1 μm thick and 150 μm in diameter. The output surface damage is catastrophic.

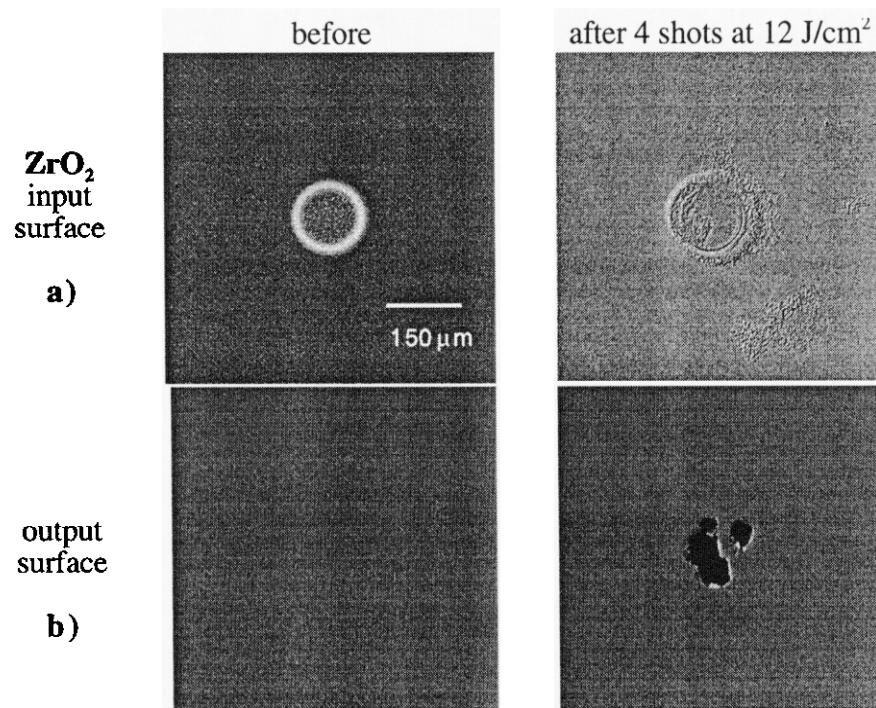
Fig. 5: Nomarski optical micrograph of the typical damage morphology of the input and output surfaces of the fused silica window after 4 shots at 355 nm and 12 J/cm². The damage was initiated by a sputtered ZrO₂ particle located on the *input surface*. The particle was 1 μm thick and 150 μm in diameter. The output surface damage is catastrophic.

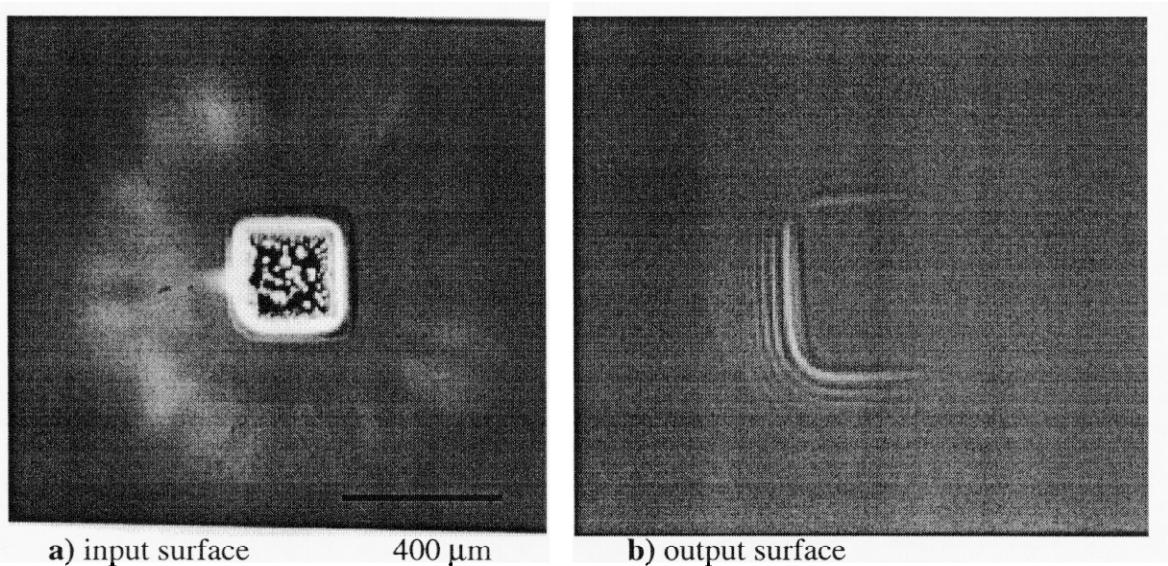
Fig. 6: Nomarski optical micrograph of the typical damage morphology of the fused silica a) input and b) output surface after 1 shot at 355 nm and 12.9 J/cm². The damage was initiated by a square particle (1 μm thick and 360 μm wide) located on the *input surface*. The damage on the output surface clearly follows the shape of the input surface contamination particle.

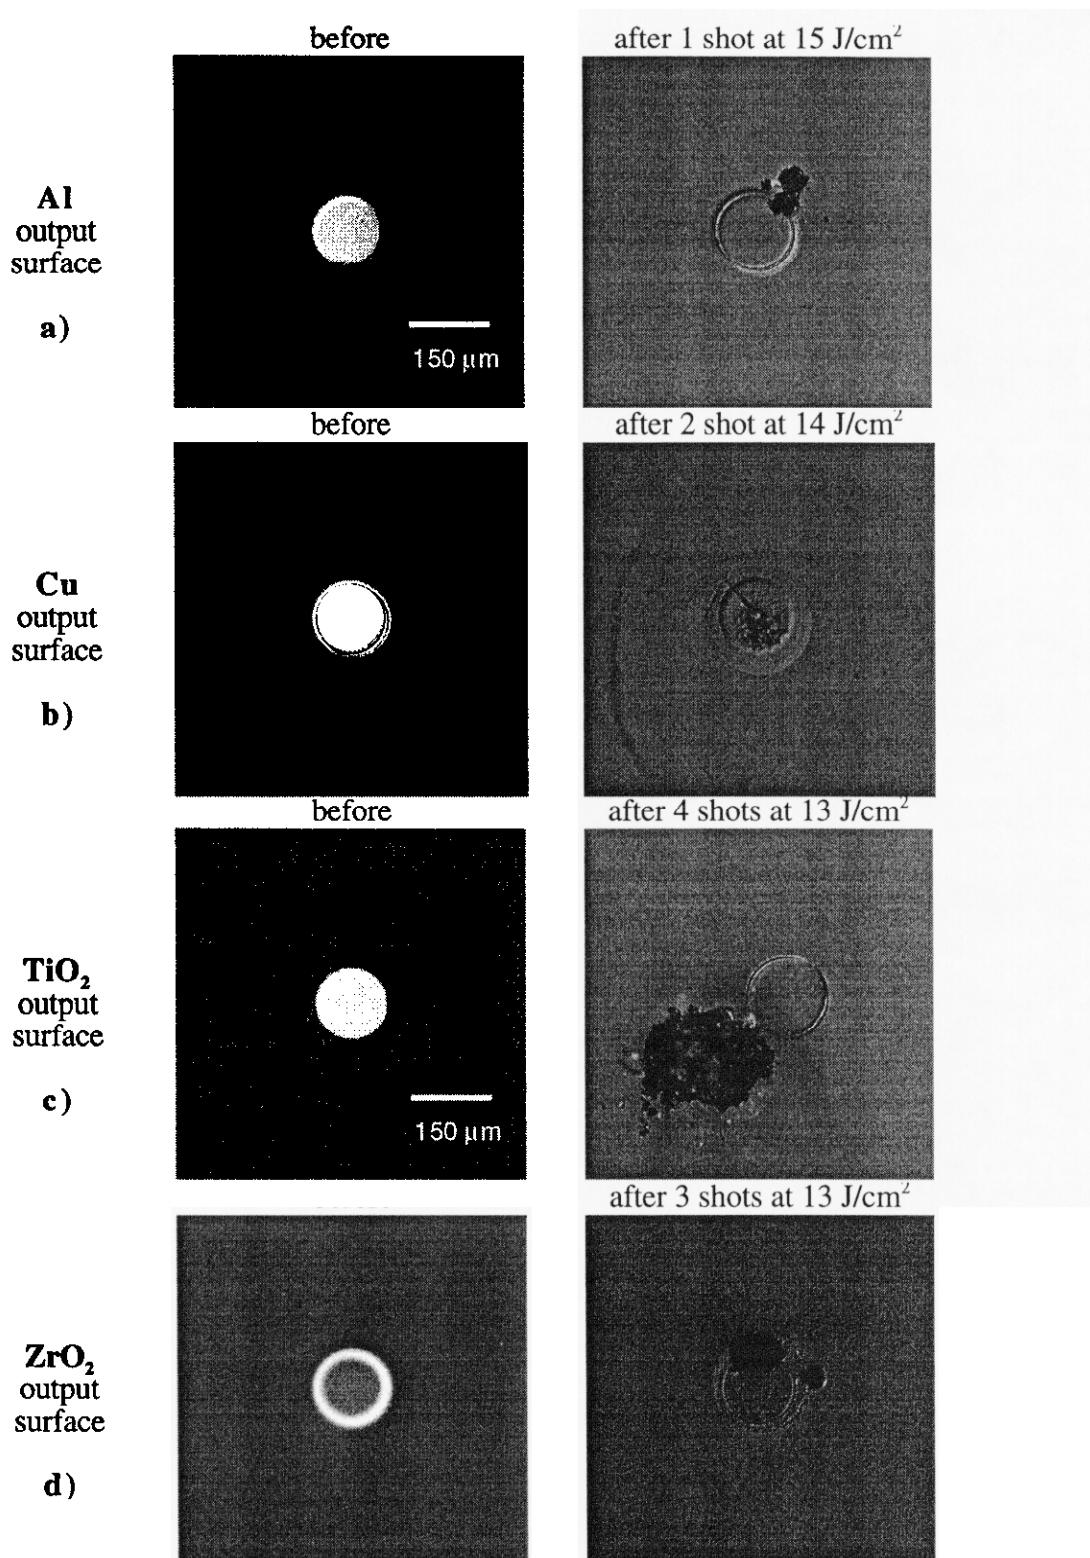
Output surface contamination behaves differently from input surface contamination. The particle is usually ablated on the initial shot leaving a damaged area that traces the shape of the particle (see Figs. 8a - d)).

Fig. 8: Nomarski optical micrographs of the damage morphology at 355 nm of the output surface of the fused silica windows for particles of a) Al after 1 shot at 15 J/cm^2 , b) Cu after 2 shot at 14 J/cm^2 , c) TiO_2 after 4 shots at 13 J/cm^2 , and d) ZrO_2 after 3 shots at 13 J/cm^2 . All the particles (located on the *output surface*) were $1 \mu\text{m}$ thick and $150 \mu\text{m}$ in diameter. For these test conditions, the output surface damage is catastrophic.

The first shot usually ignites a plasma at the particle. Subsequent shots do not usually produce plasmas and no further damage on the surface occurs. However, if the silica surface is cracked during a given shot, the damage is very likely to grow catastrophically at some points as shown in Fig. 8.
