SAND2019-7871C

# Nanofocus X-ray Computed Tomography and Ultrasonic Inspection of Barely Visible Impact Damage in Carbon Fiber Reinforced Polymers

Elliott Jost—July 17, 2019—QNDE 2019

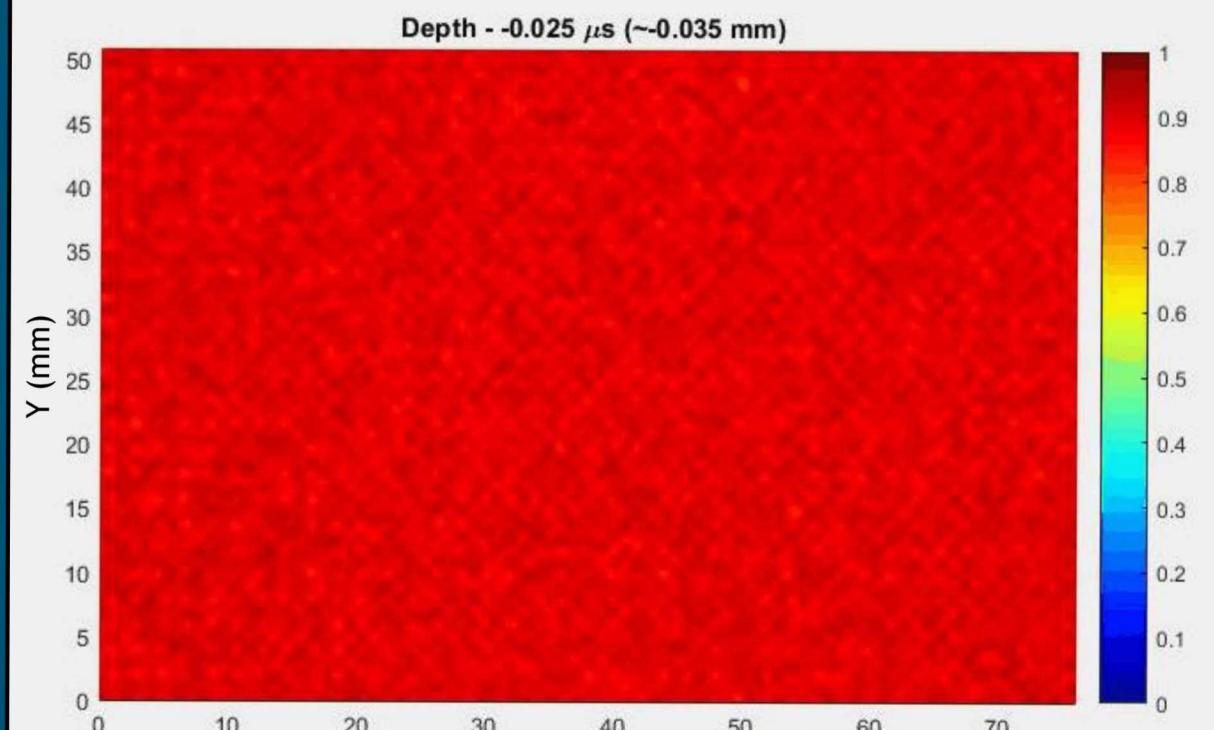
7.5J

Damage location and approximate bonding region is clear, but ***extent and type of damage is unclear.***

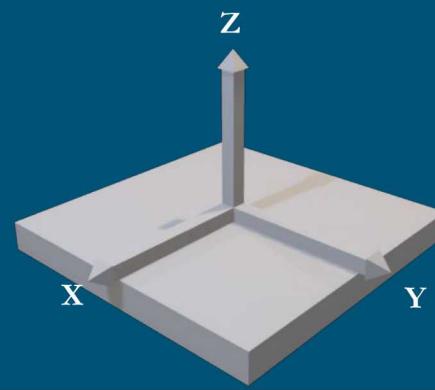
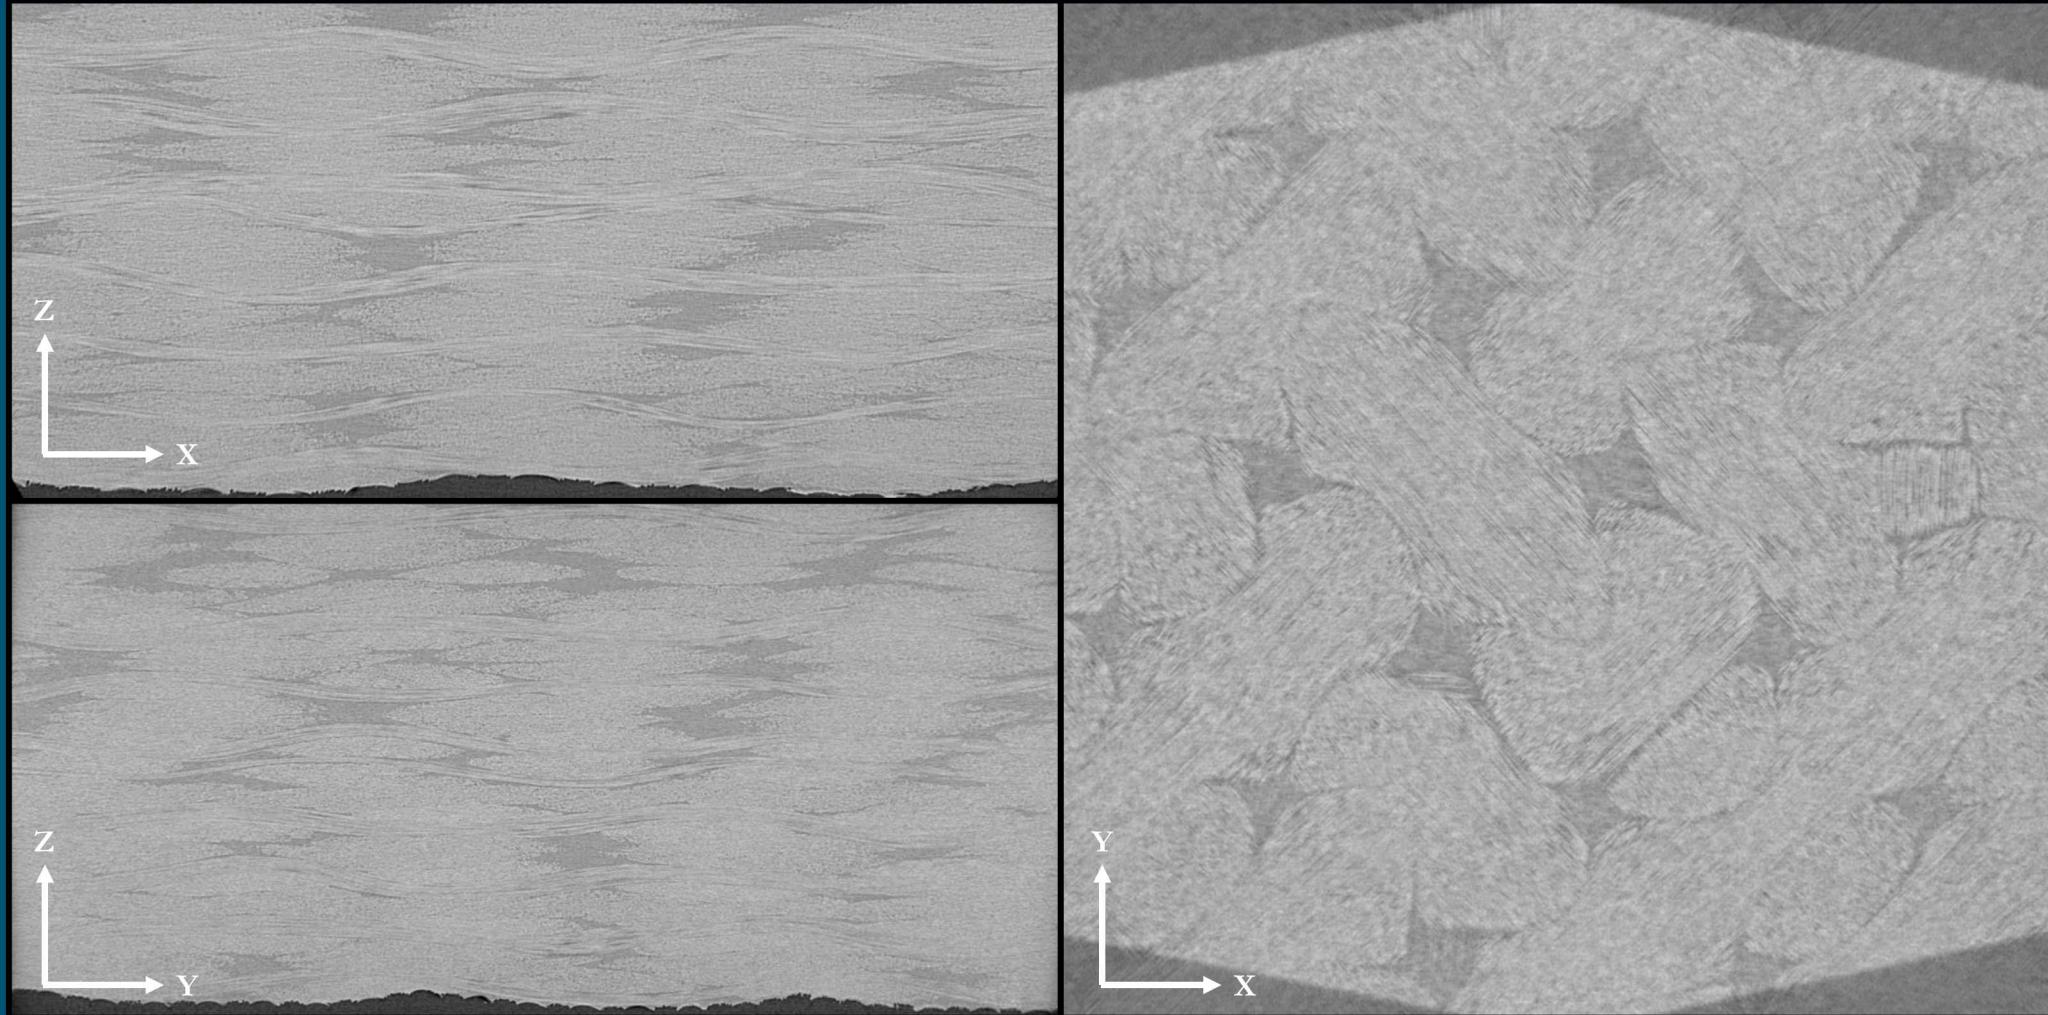
Undamaged CFRP was inspected to create a control inspection.

No delamination or other damage was observed.

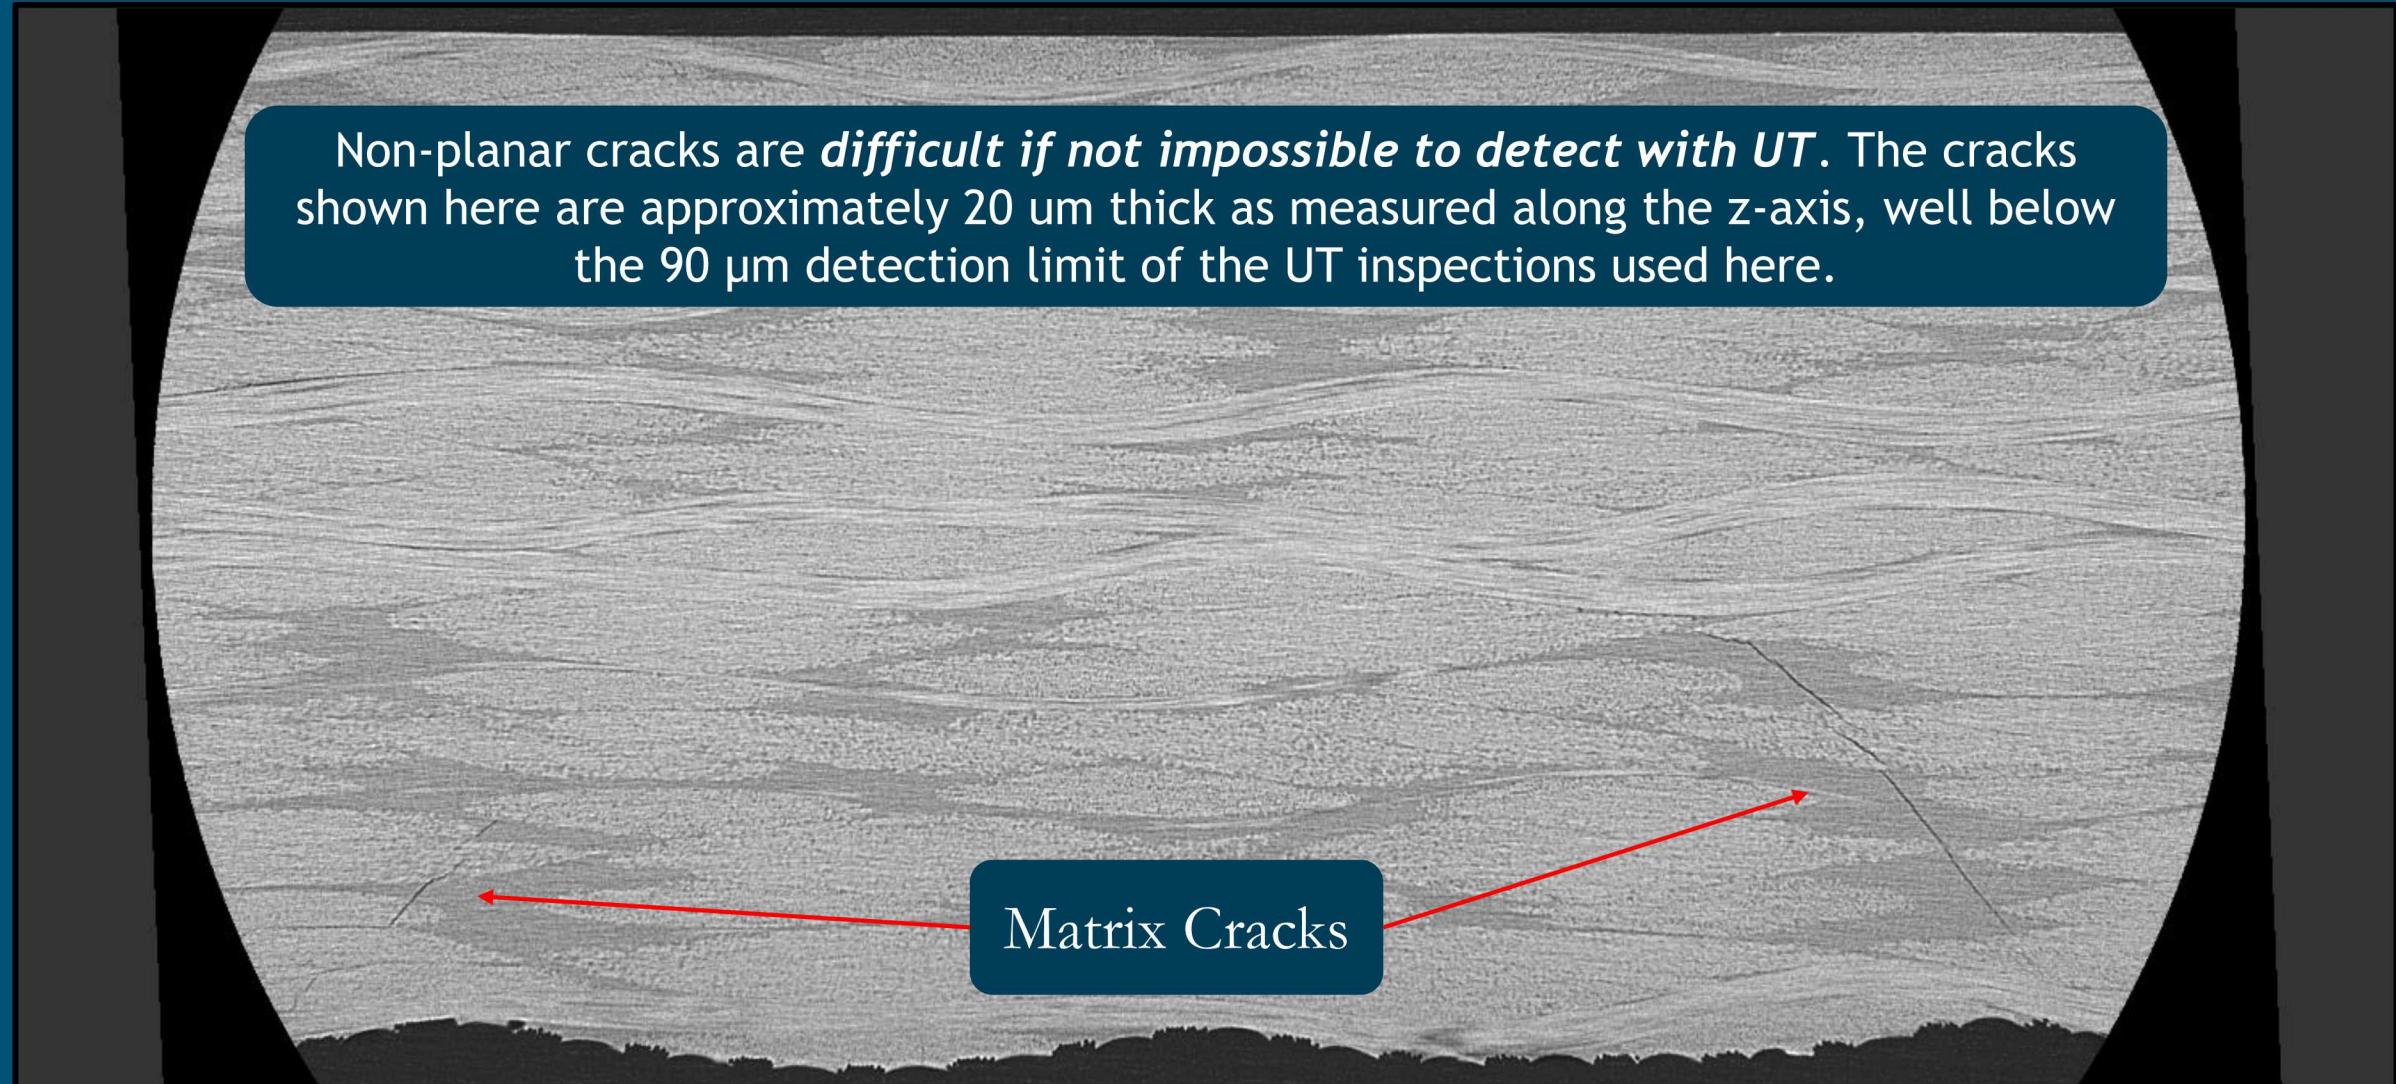
Matrix Cracks

Non-planar cracks are *difficult if not impossible to detect with UT*. The cracks shown here are approximately 20  $\mu\text{m}$  thick as measured along the z-axis, well below the 90  $\mu\text{m}$  detection limit of the UT inspections used here.

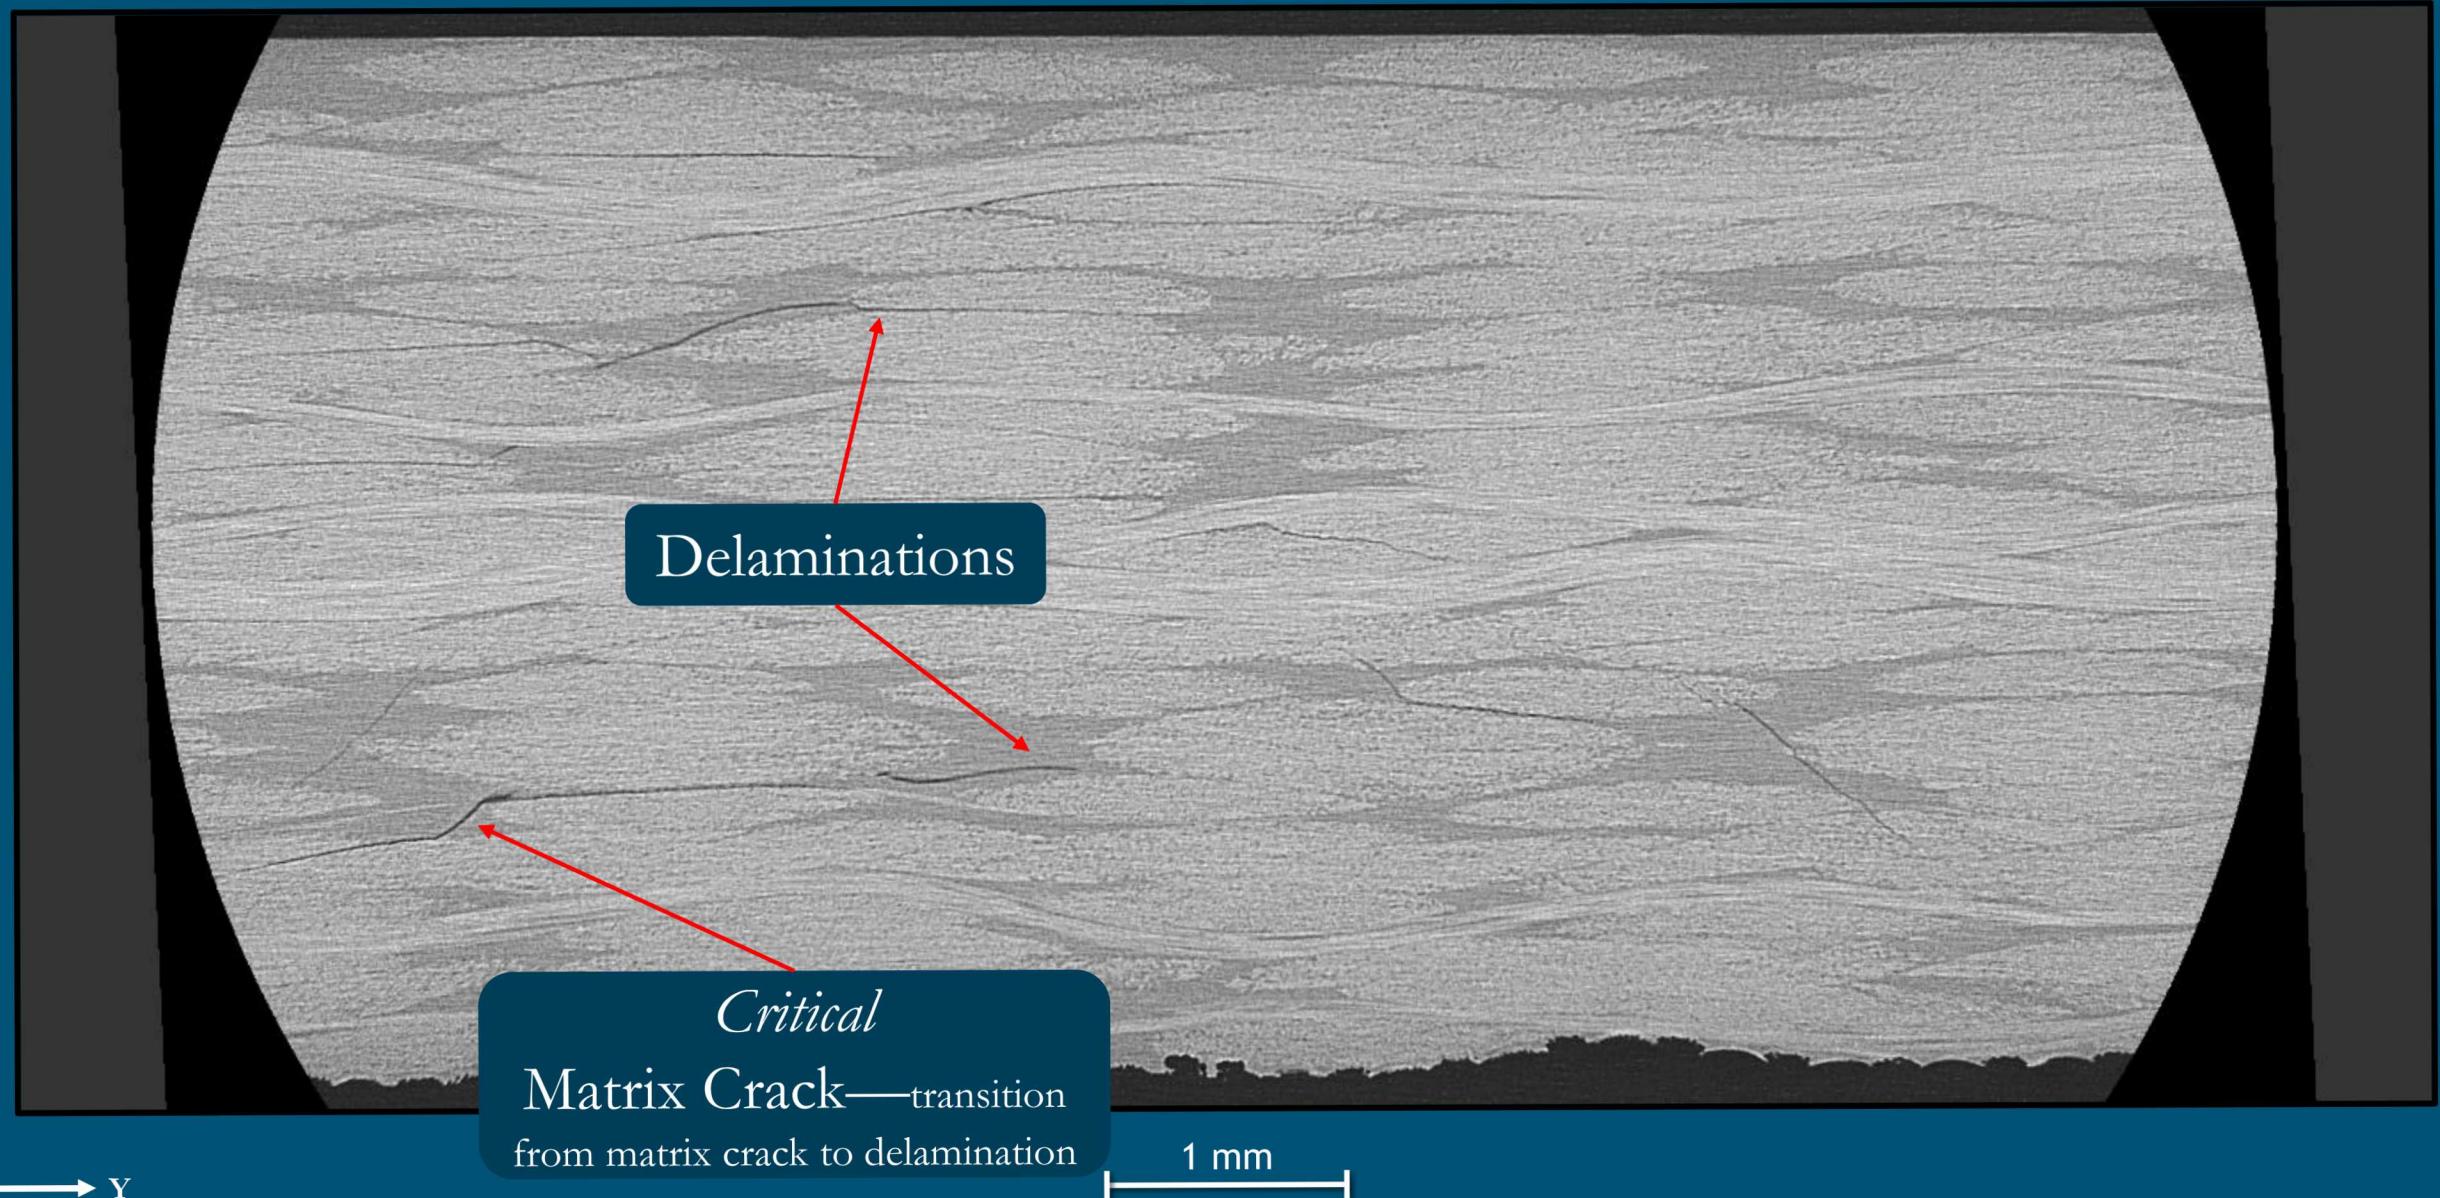
Delaminations

*Critical*  
Matrix Crack—transition  
from matrix crack to delamination

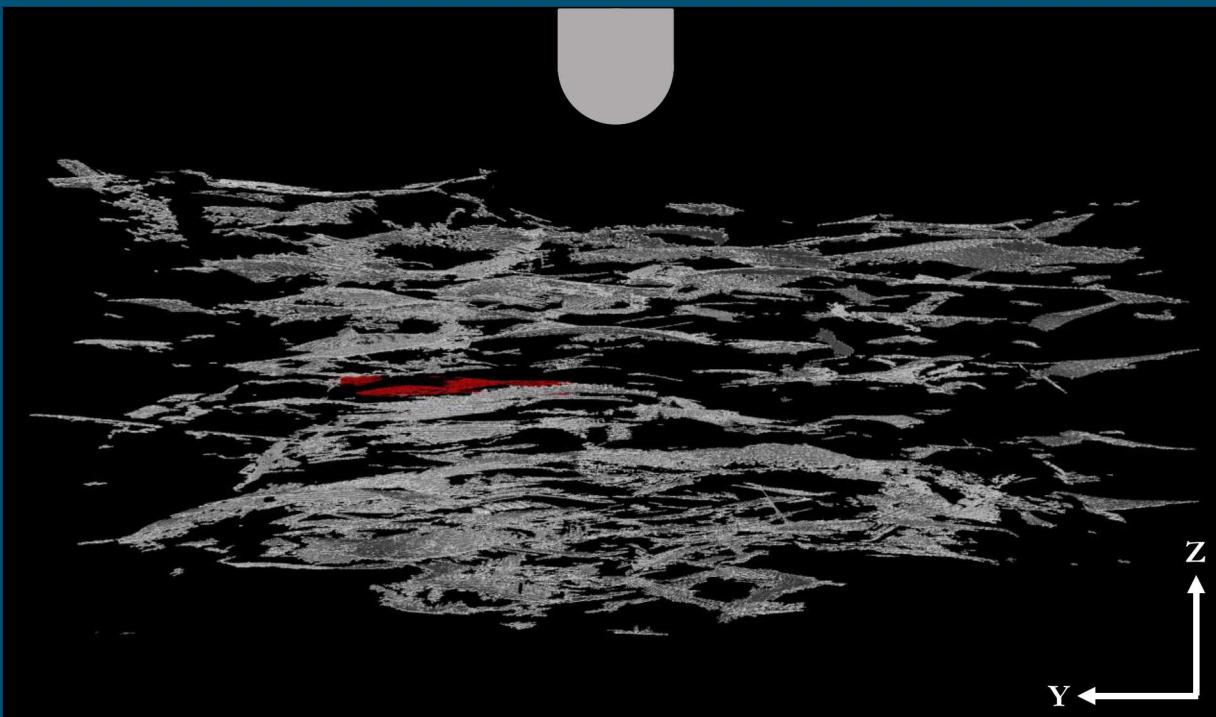
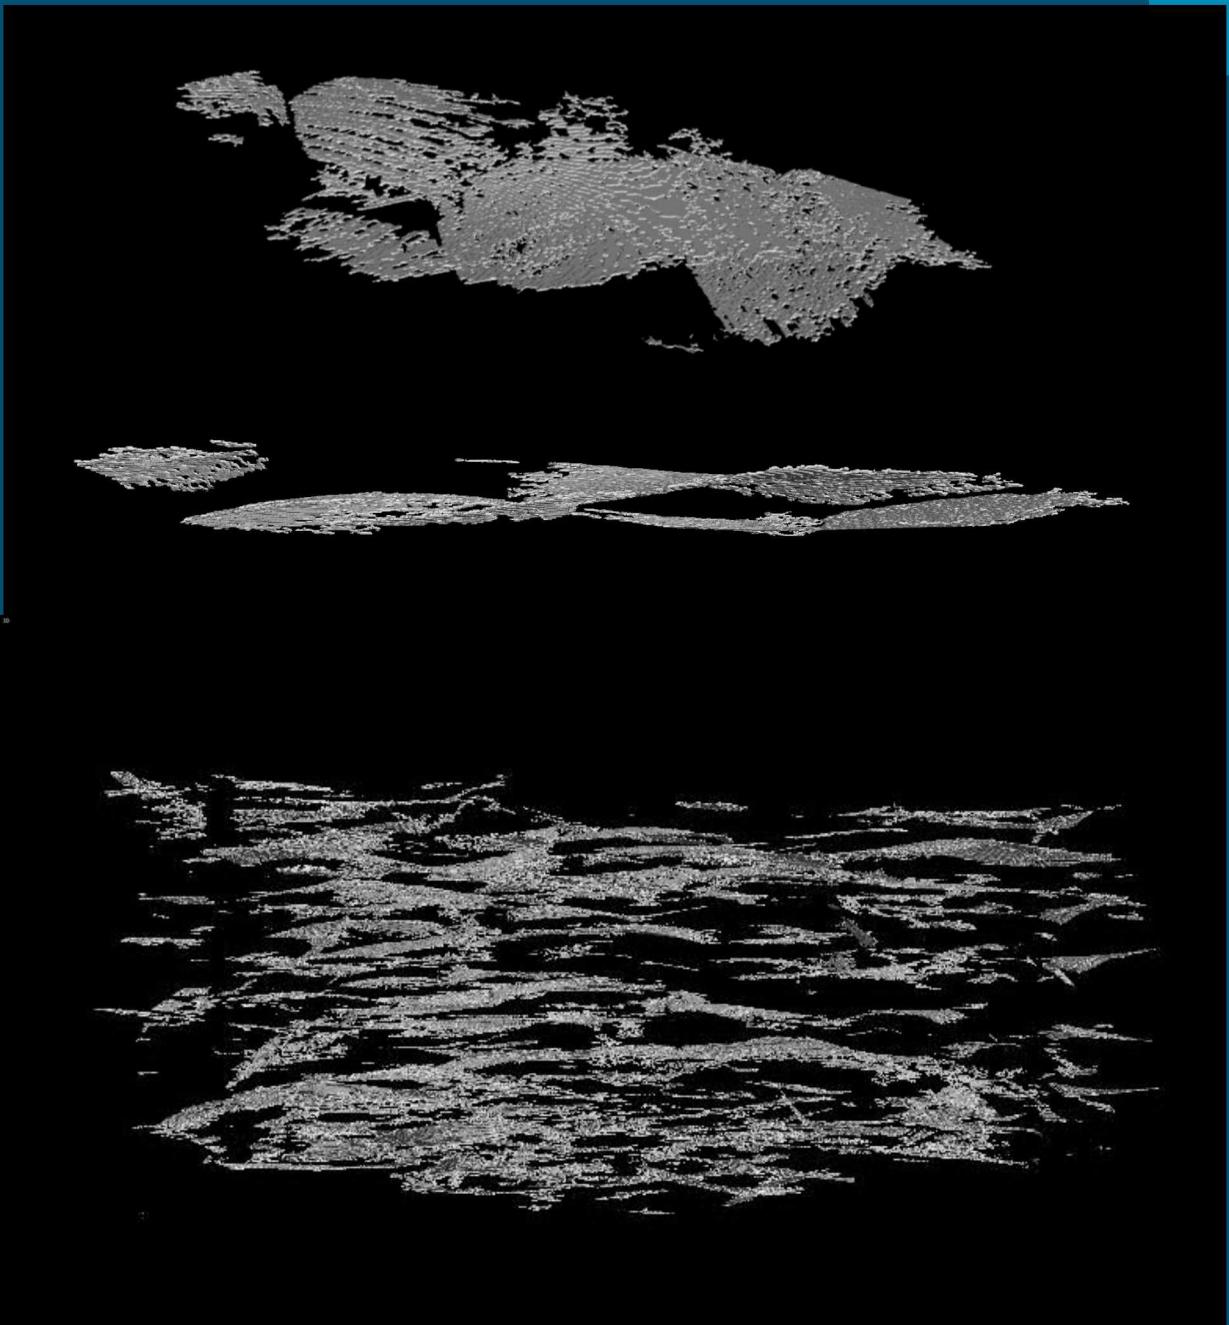
Delaminations are easily identified in 3D damage visualization.

Microcracks may not be captured in this visualization, as they appear as noise during segmentation.

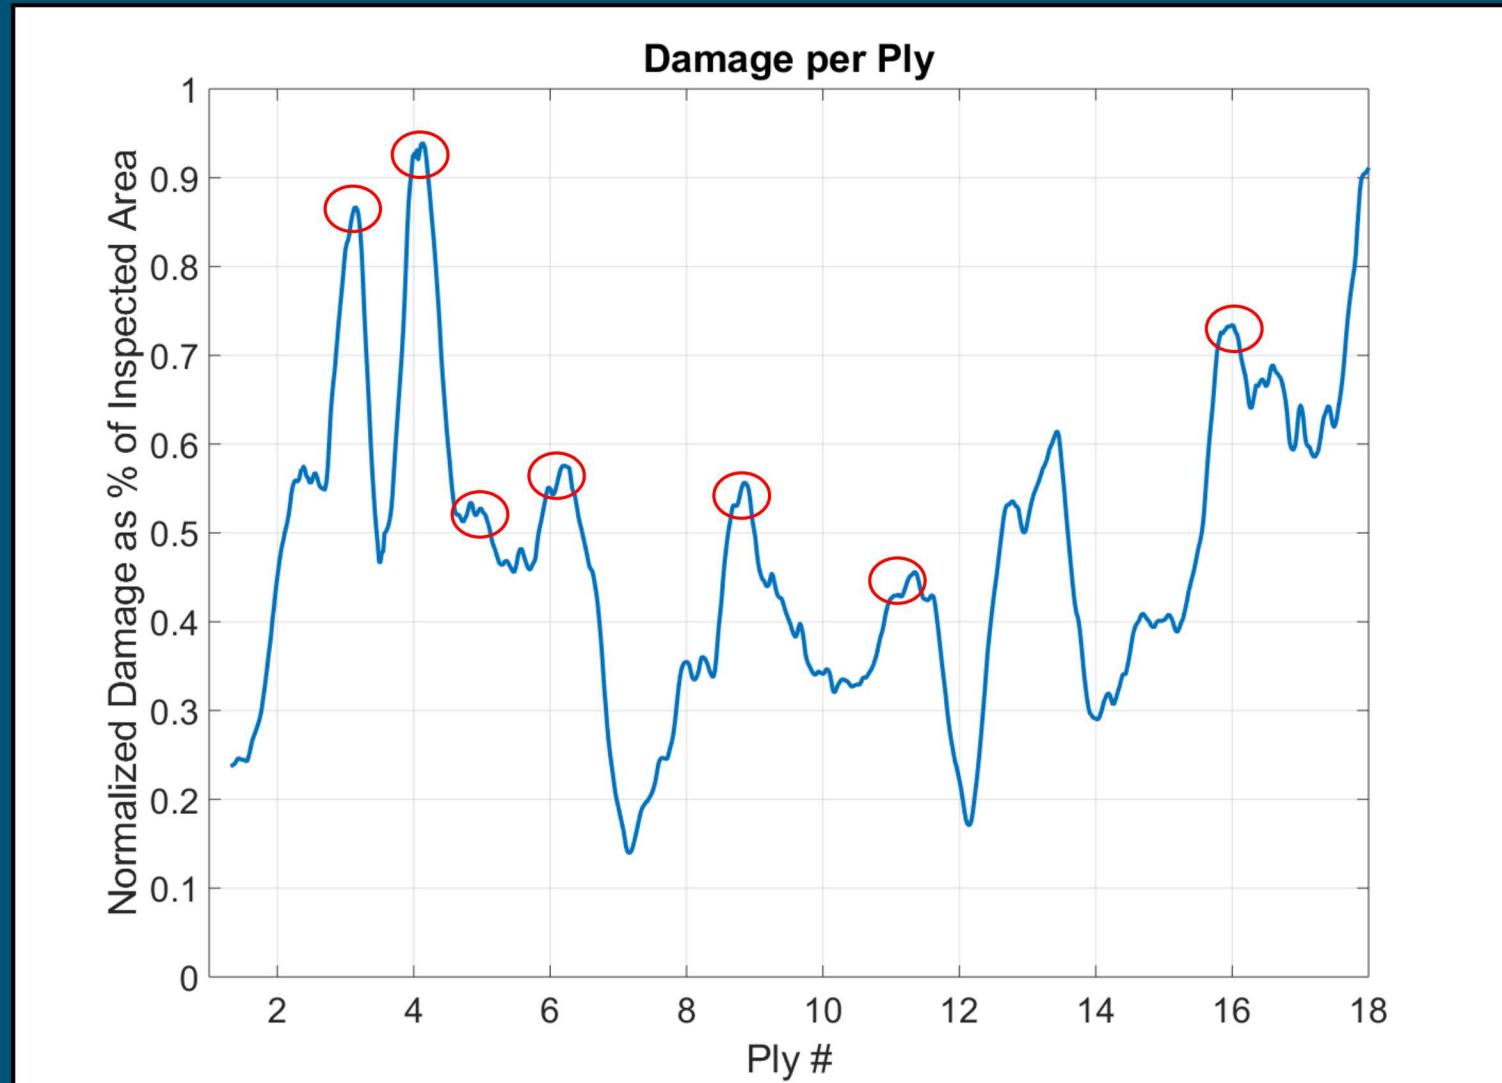
Damage was plotted as a function of depth and mapped to ply based 51 CT slices per ply.

Damage approximated by summing detected damage for each CT slice and calculating a % Area of damage.

Most damage (shown by local maxima) occurs between plies as delaminations.

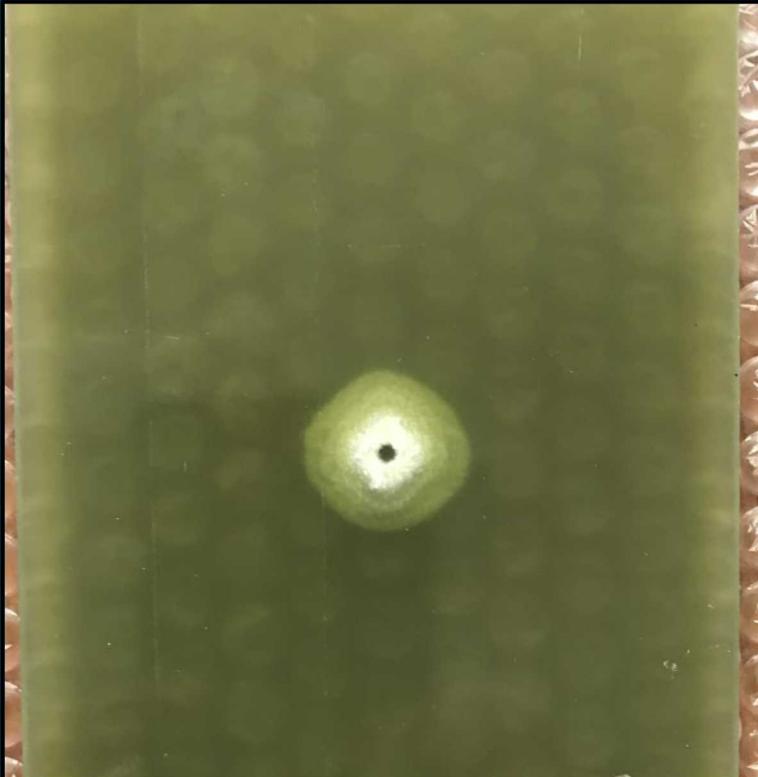
Fiberglass composite was impacted at 10J with hemispherical impactor.

Damage can easily be seen with naked eye

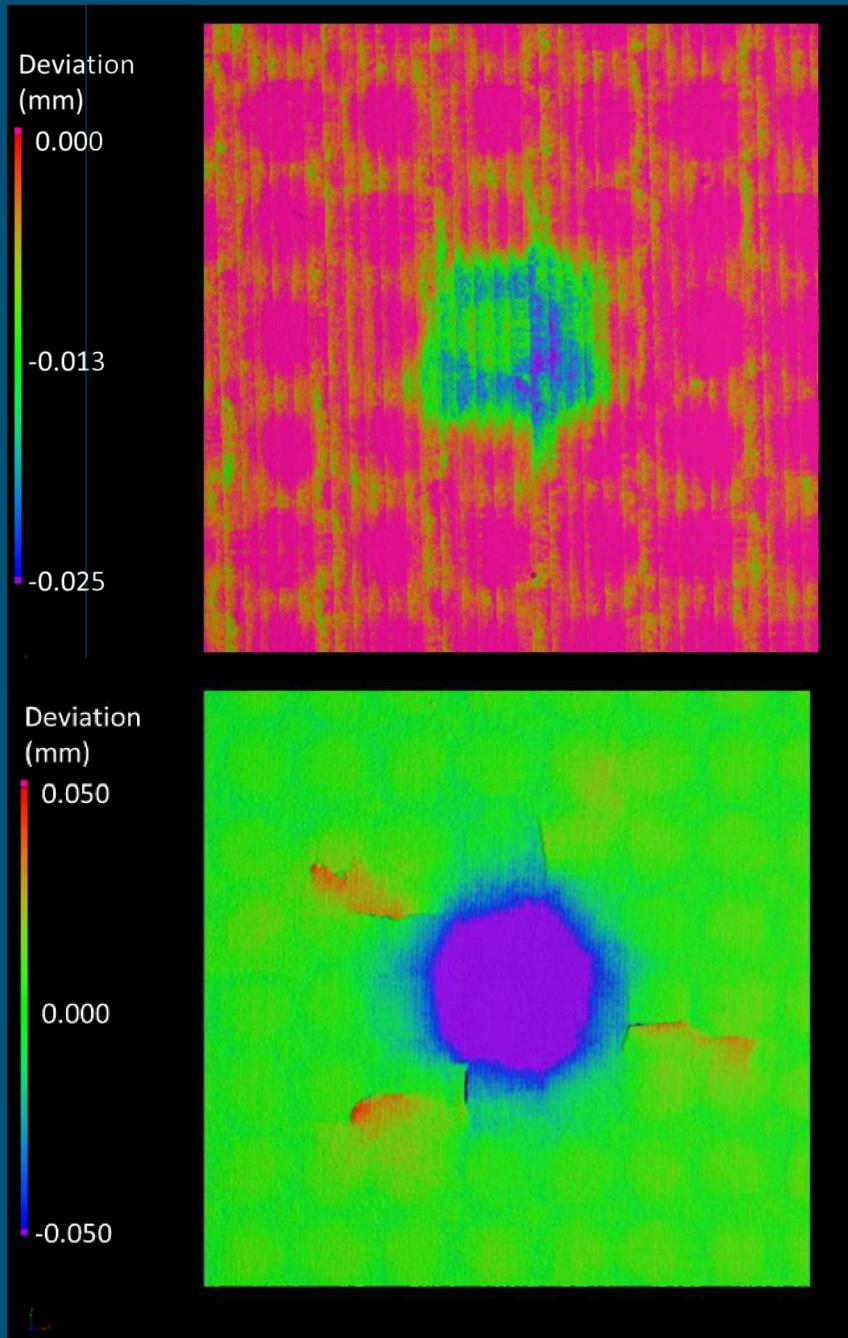
Using microfocus CT, nominal surface was compared to actual CT data and indent map was created.

Clear surface cracking observed in 9.5J impact sample

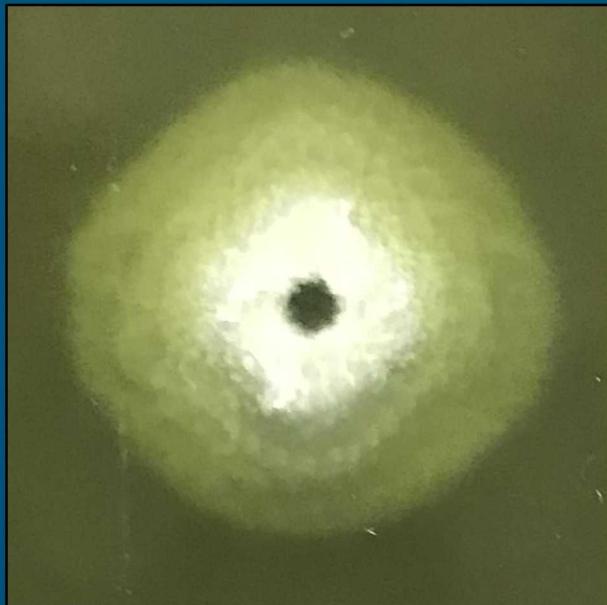
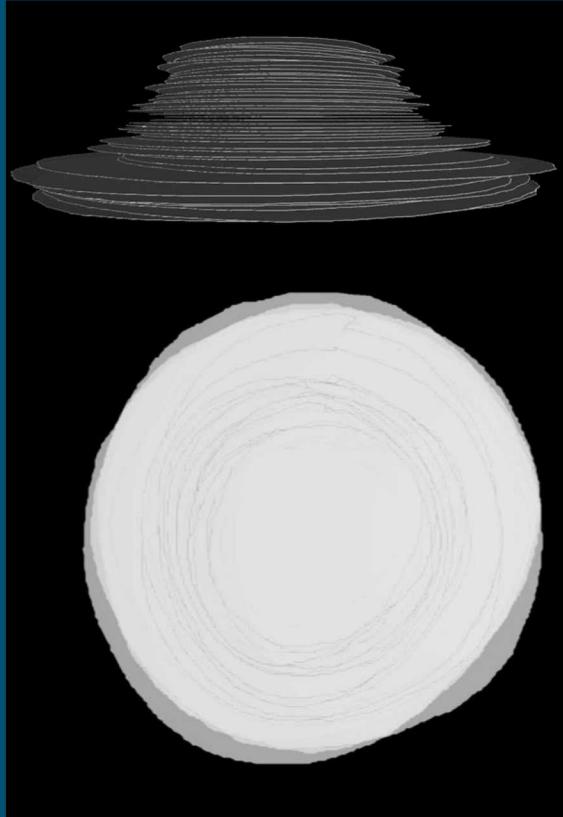
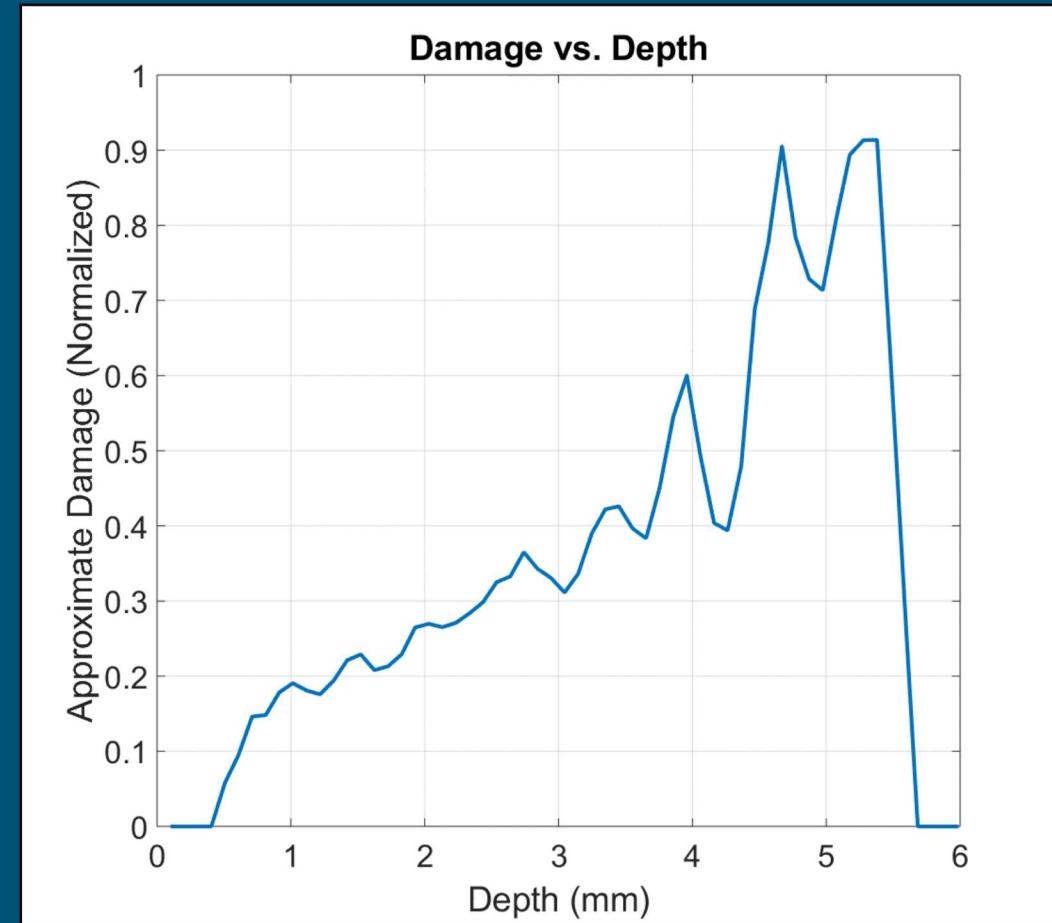
Damage perimeter in X-Y CT slices was traced and subsequent images were thresholded.

3D visualization of damage shows cone-like shape.

FGRPs provide significantly less contrast than CRFPs
