Characterization of Failure Modes in Deep UV and Deep Green LEDs Utilizing Advanced Semiconductor Localization Techniques

Mary A. Miller, Edward I. Cole Jr.,
and Paiboon Tangyunyong

Outline

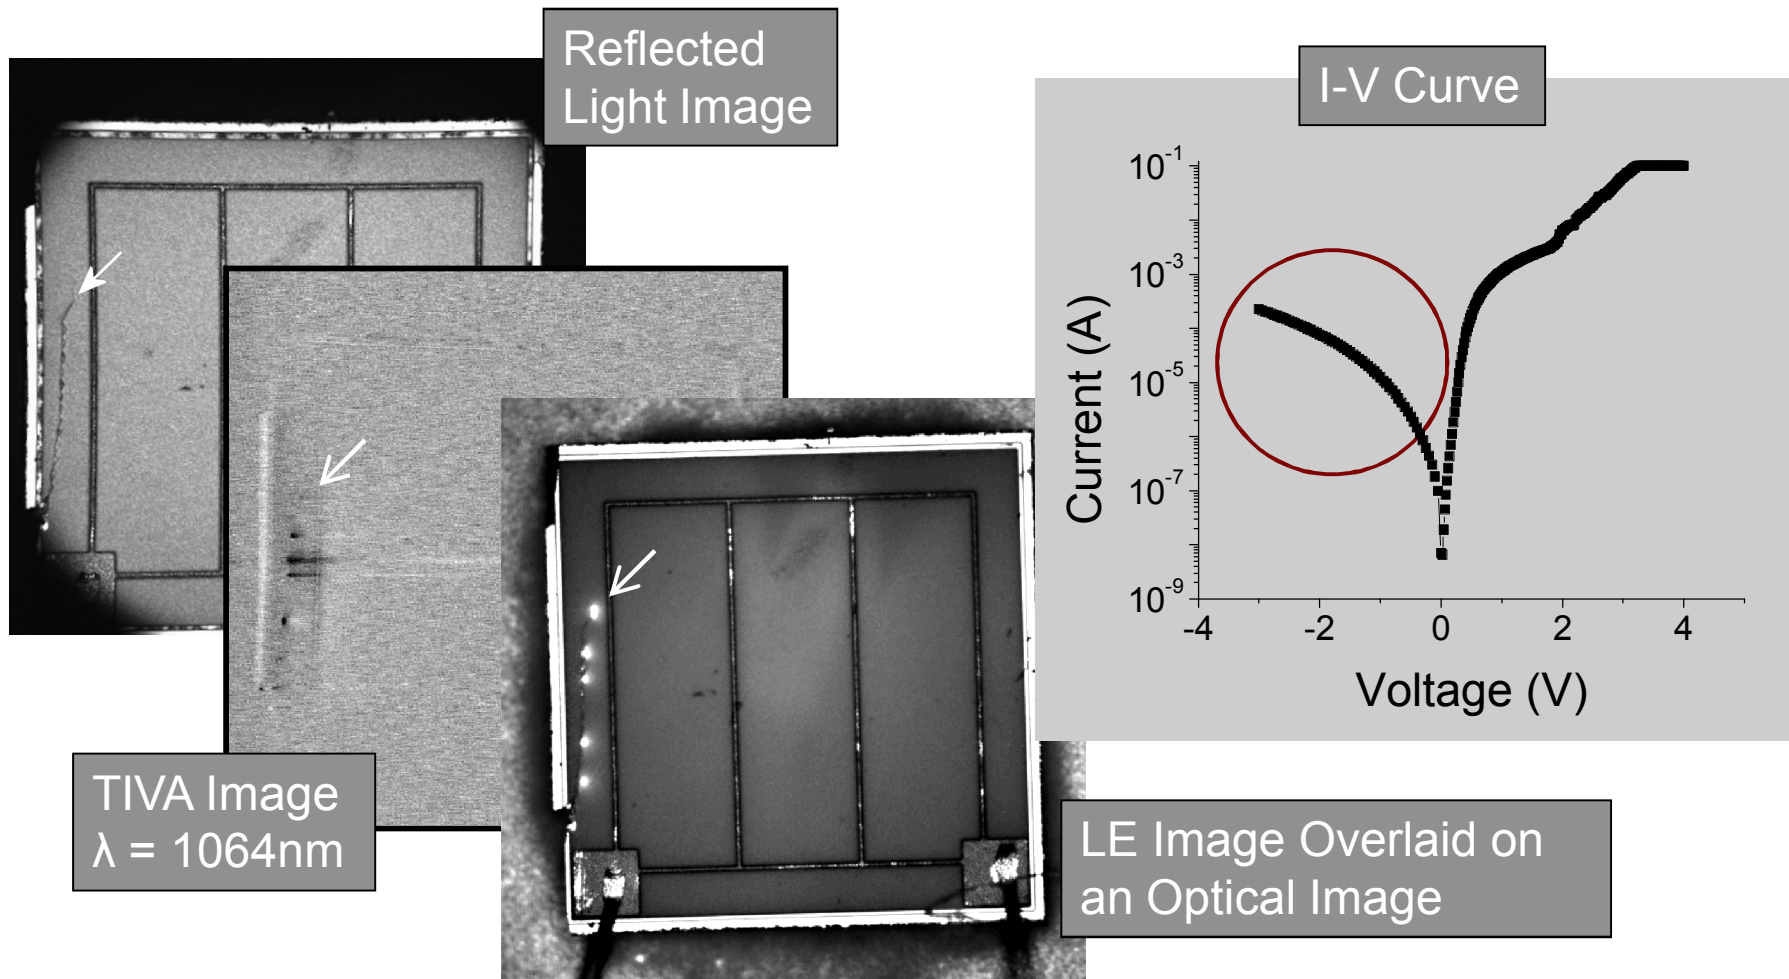
- 5 of the 24 LEDs had strong leakage currents
- Each LED had strong defect signals at 1064nm and 1340nm (TIVA signals)
- LE and IV curves also gave indications of leakage paths

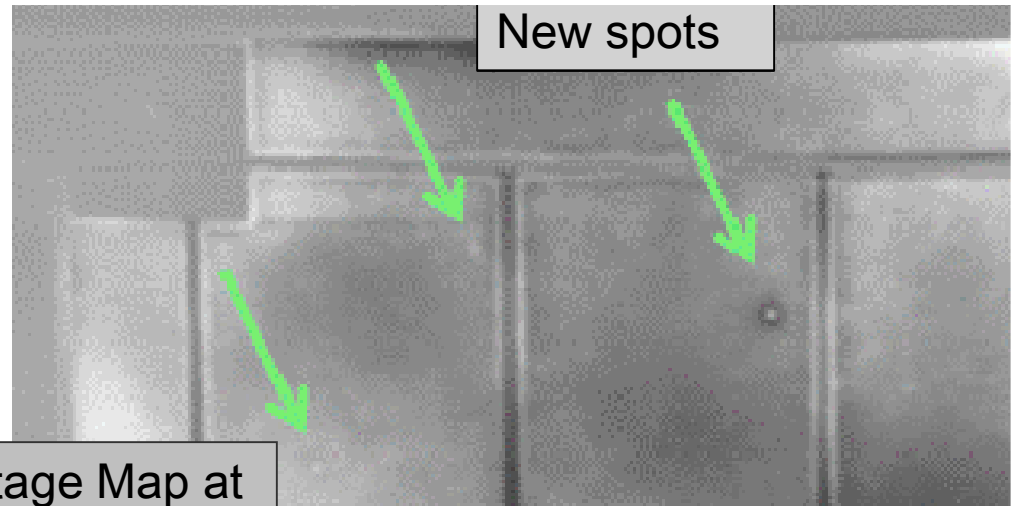
1. No change
2. Catastrophic shorts
3. Haze
4. Water spots
5. New spots

Haze near the bondpads

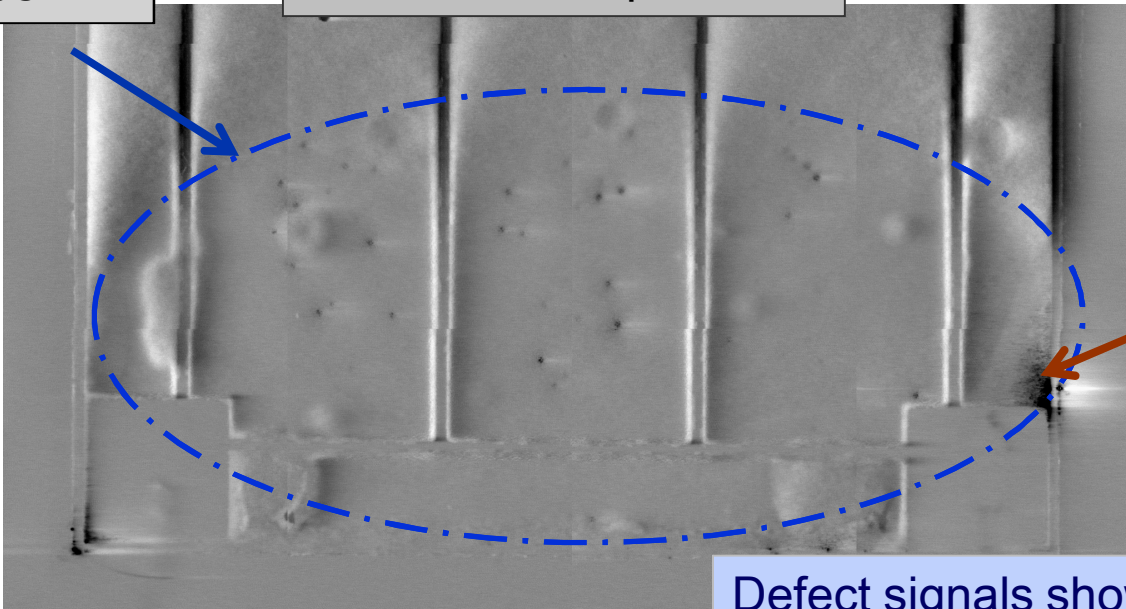
Applied Voltage Map at
 $\lambda=532\text{nm}$, $100\mu\text{A}$, 5hrs

Shoring path—
observed under all
laser wavelengths

Defect signals shown here are stress-activated; they were not visible at time zero

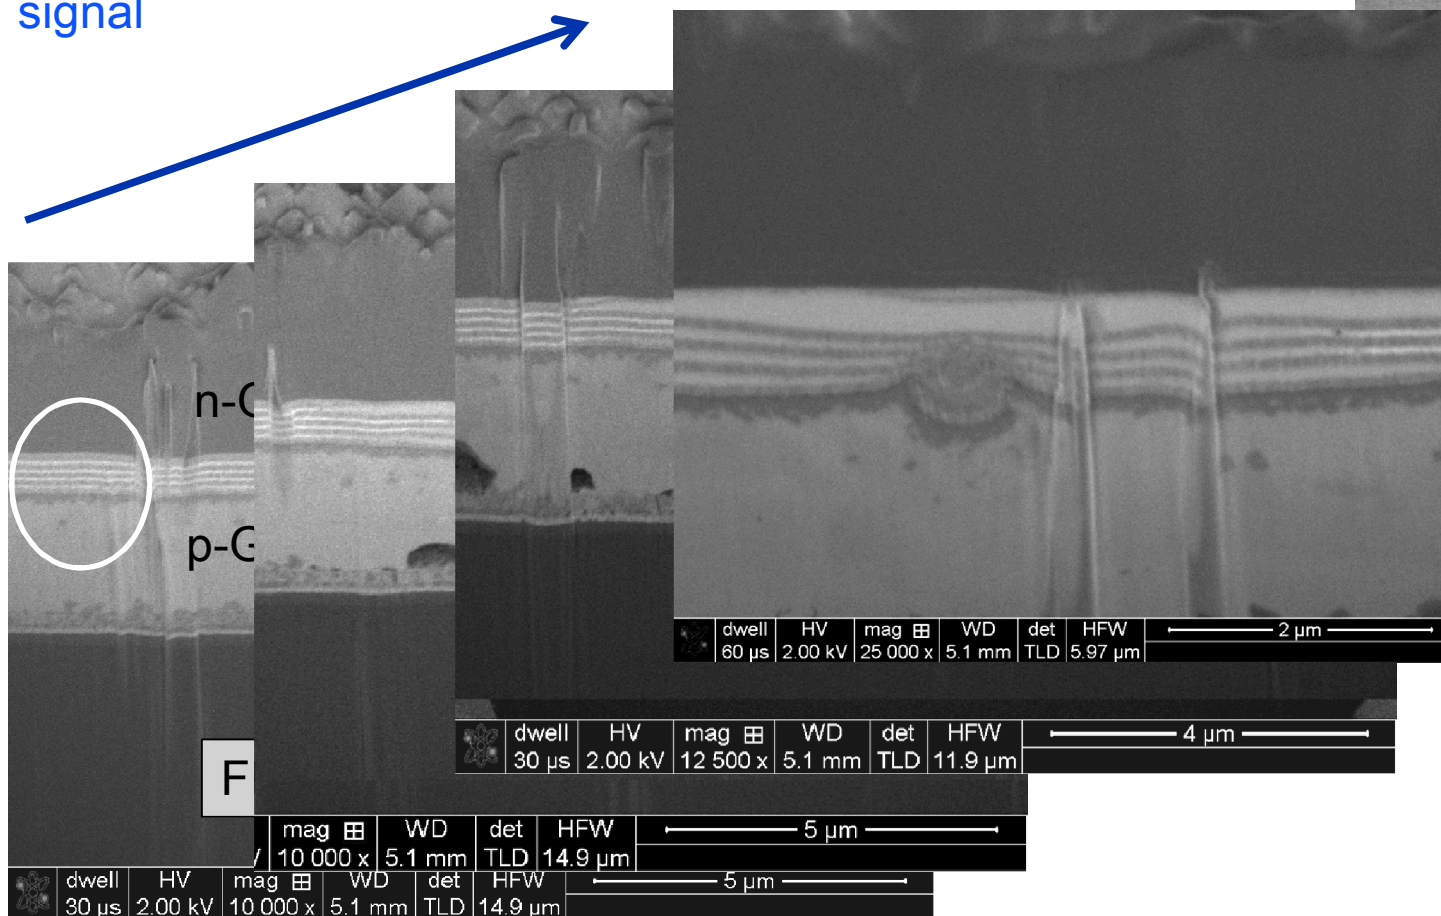
High mag LIVA map at $\lambda=532\text{nm}$

Utilized a focused ion beam to cut through the stress-induced defect site (water spot) to determine origin of LIVA signal

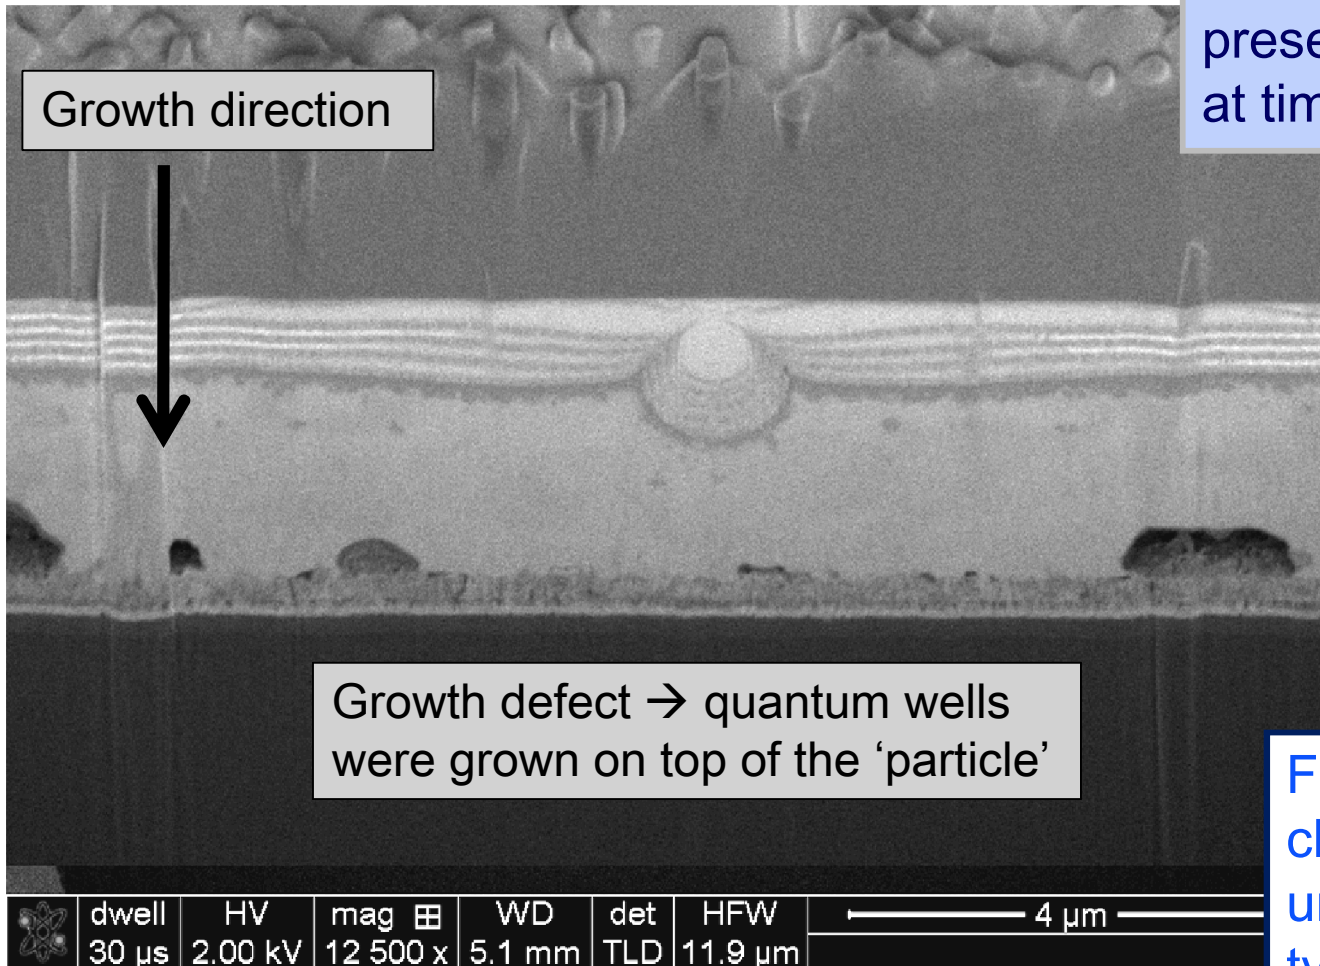
Cross-section of Stress-Induced Defect Site in Green LEDs

Growth defect found in commercial part → could present a reliability concern as a potential shorting path

-IVA signal was not present for this defect at time zero

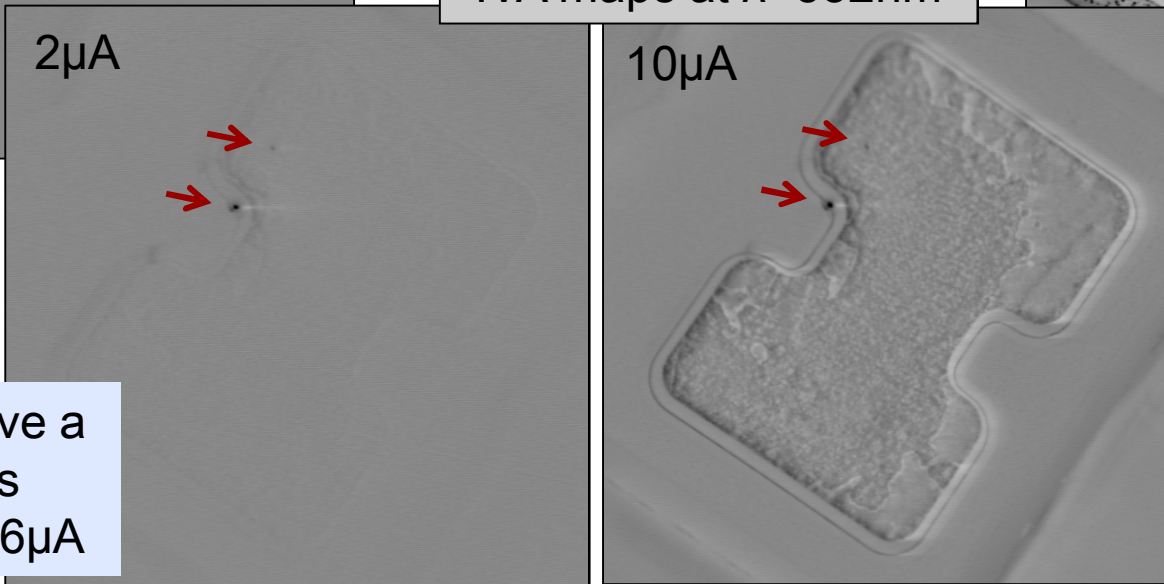
Defects have a
turn-on bias
near 0.4-0.6 μA

Defects are lost in
the background
signal at higher
currents (typically
>1mA)

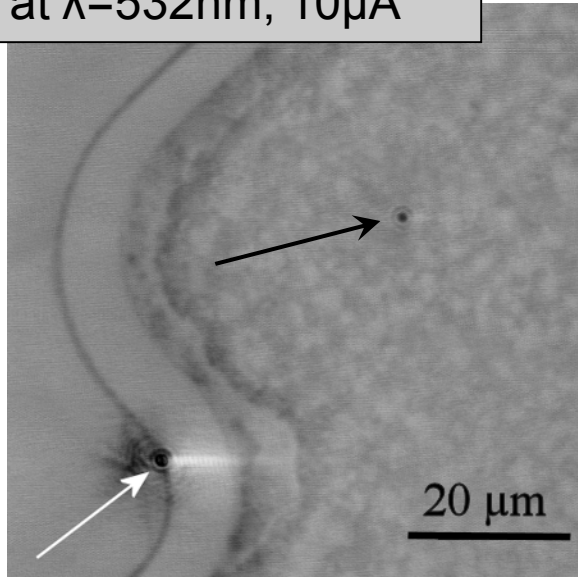
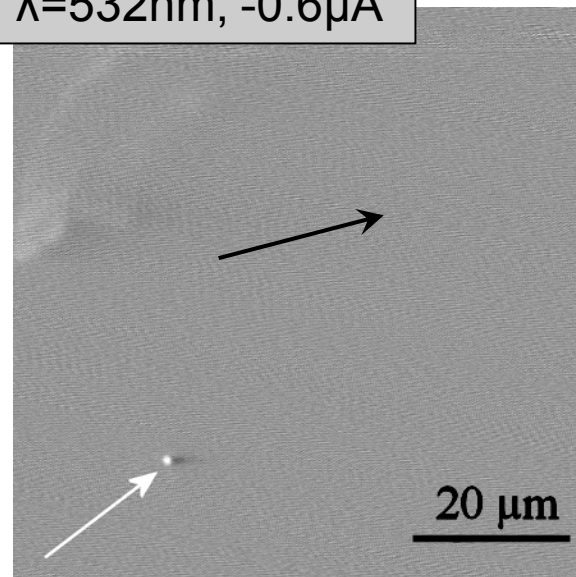
After 19 hours of aging at 30mA ($\sim 100\text{Acm}^{-2}$), changes were detected in the $-IVA$ map

- Bright signal appears at negative bias
- Bright signal has a turn on voltage
- Not all defect spots changed with time

Suggests different types of defects are present in UV LEDs

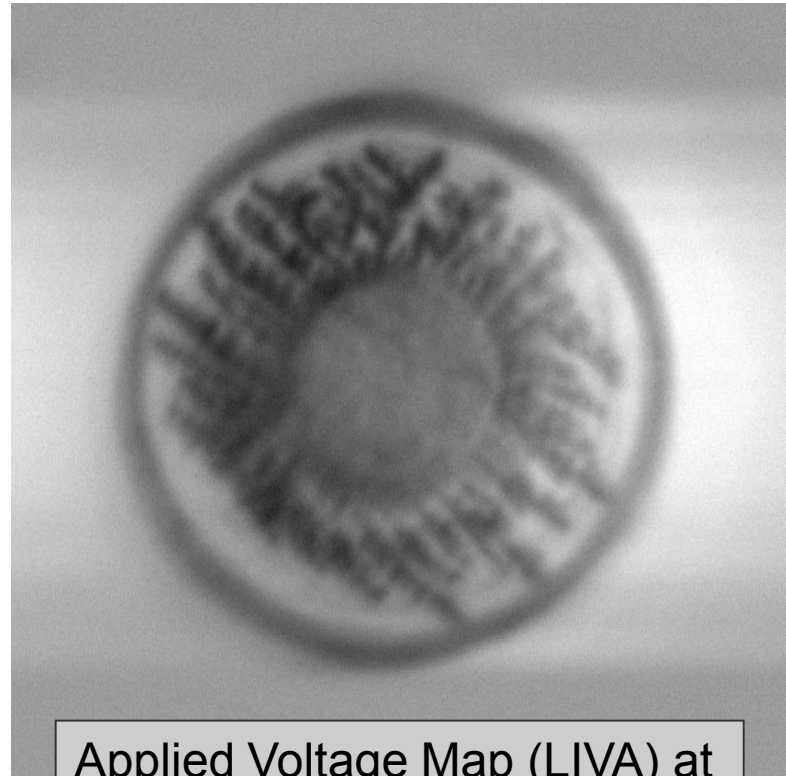
Applied Voltage Map (LIVA) at
 $\lambda=1064\text{nm}$, zero applied bias

- TIVA/LIVA was successfully applied to VCSEL technology
- Dislocation networks were localized in failed parts
