Failure of a Lithium-filled Target and Some Implications for Fusion Components

Abstract: In preparation for testing a Li-He heat exchanger at Sandia, unexpected rapid failure of the mild steel lithium preheater occurred when Li at ~ 400 °C flowed into the preheater then at ~ 200 °C.

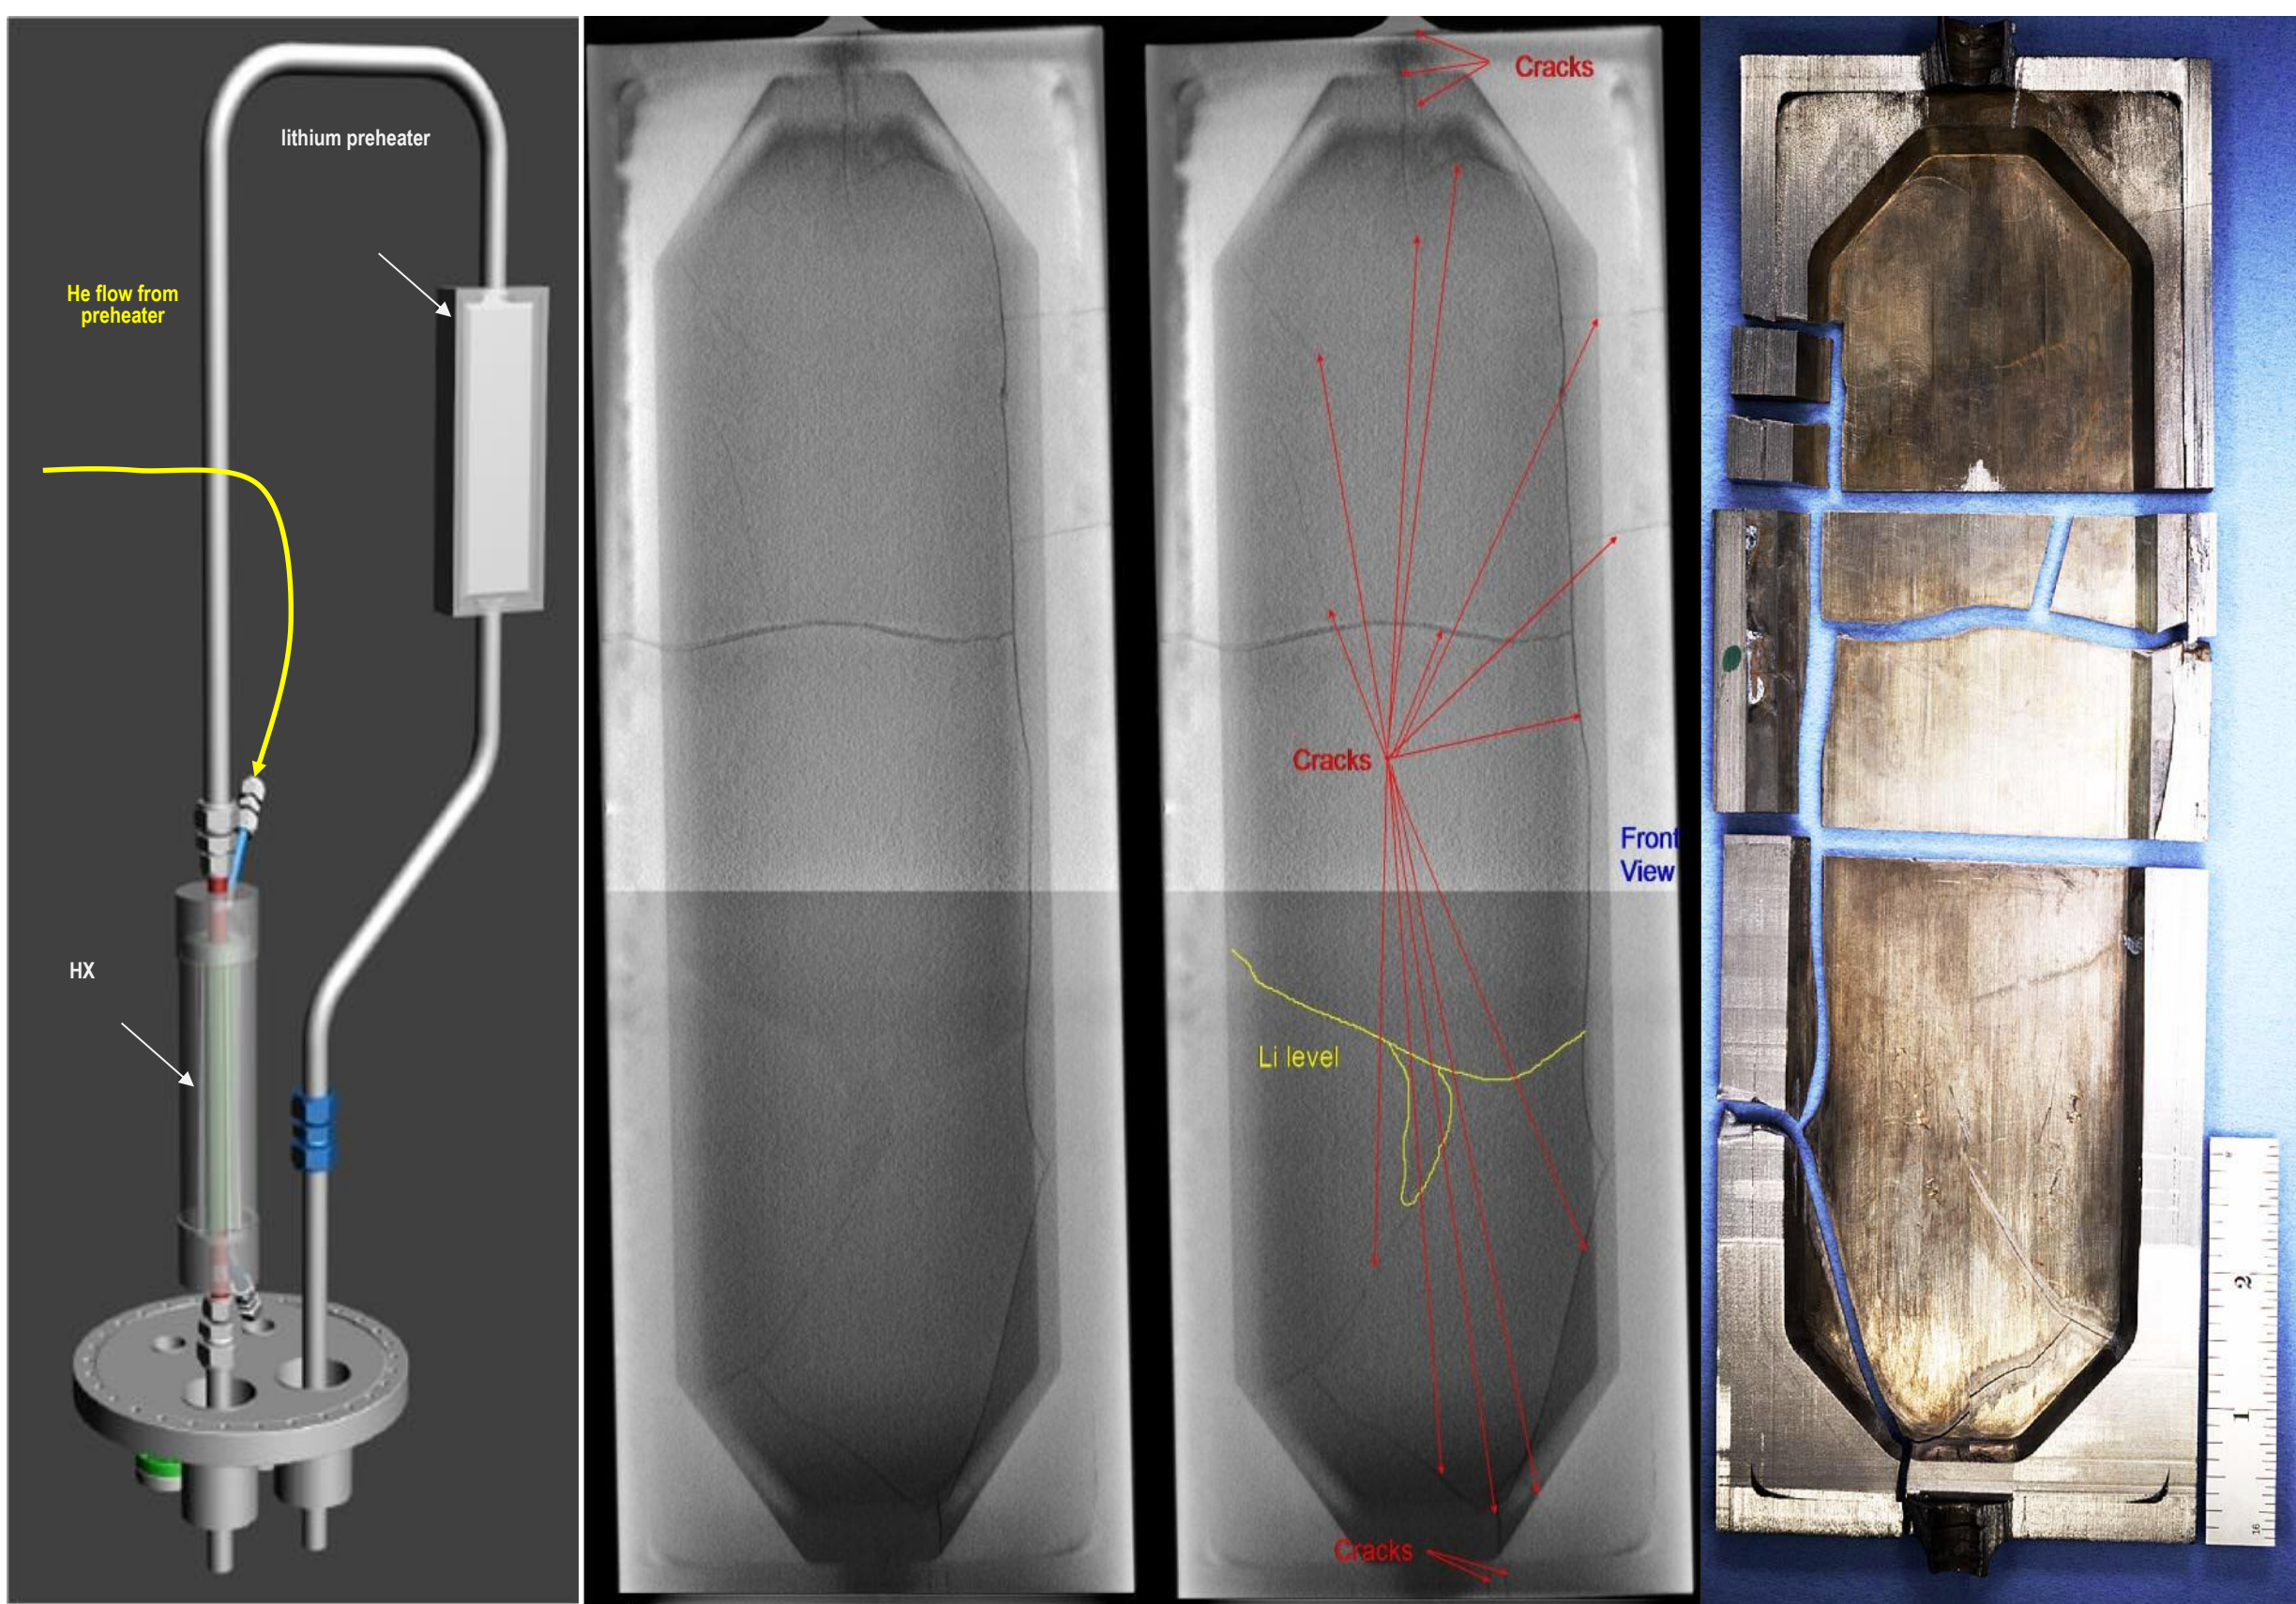
a. experimental arrangement, b-c. neutron radiographs of the body of the preheater from the back (left) and front (right); yellow line shows level of liquid lithium when analyzed; red lines indicate cracks, d. photo, inside of failed unit.
The separation into pieces resulted from sectioning for evaluation.

- Radiography showed numerous cracks.
- SEM examination showed brittle fracture patterns with strong directional features for crack propagation.

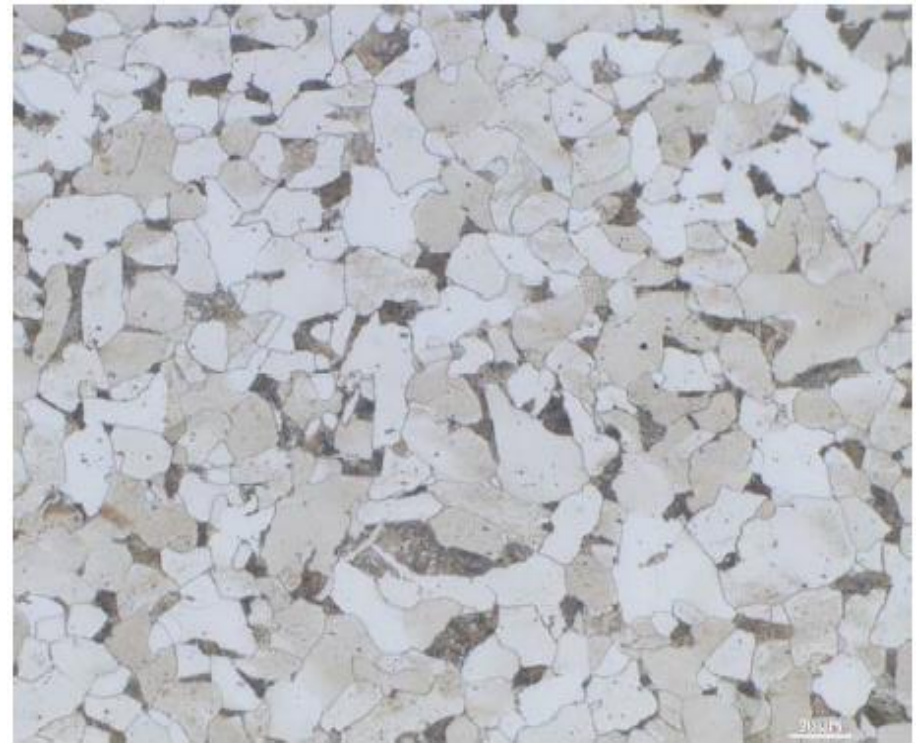
Figure 2. Optical microscope images of polished and etched cross section of the lid of the second Li pre-heater.

Metallographic and elemental analyses at Sandia confirmed the materials were as specified, i.e., 0.15-0.20 C, 0.6-0.9 Mn, 0.15–0.30 Si and bal Fe (wt%) is consistent with 1018 steel and the microstructure contained the expected ferrite and pearlite regions. These are respectively the dark and light regions in Fig. 2, a micrograph from a second unused Li preheater. The hardness values of the preheater body, which averaged 86 HRB for the case and 91 HRB for the lid, indicate the material was in cold rolled or formed.

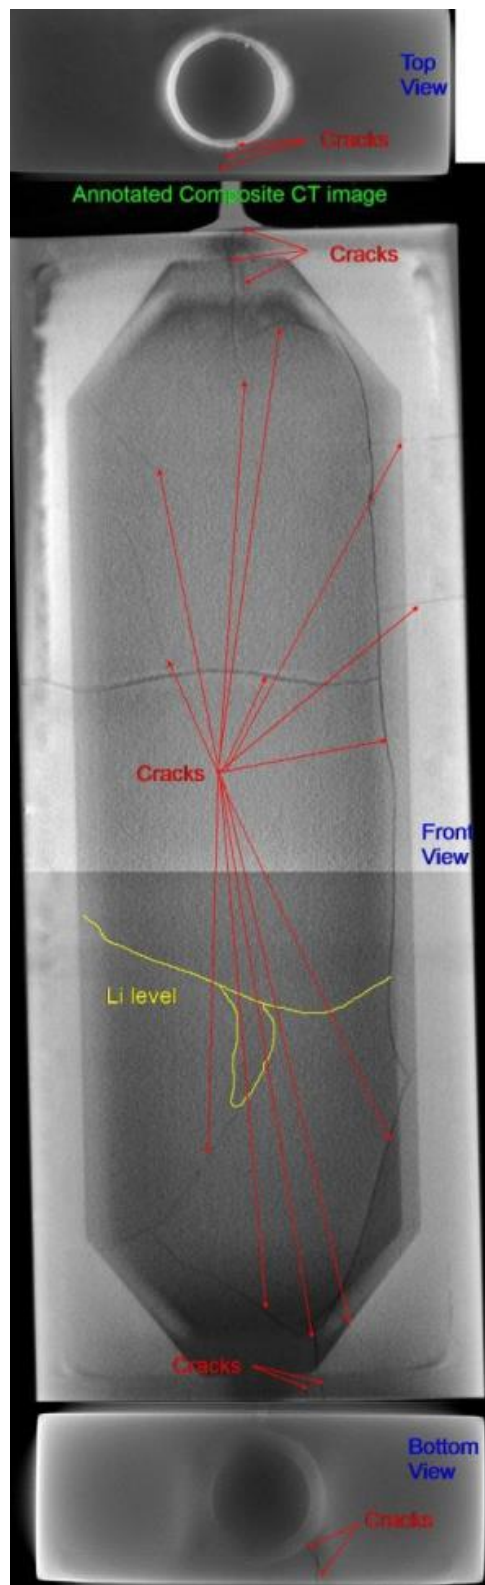
■ Failure sequence (conclusions from evaluation)

- During pre-test checkout prior to e-beam operation, differential gas pressure (LIMITS pump off) moved Li at $\sim 400^{\circ}\text{C}$ from LIMITS into the Li preheater which was at $\sim 200^{\circ}\text{C}$ which induced some thermal stress.
- The 1018 steel cover plate 6-mm thick cracked rapidly (seconds) due to stress-induced liquid metal embrittlement.
- Li at $\sim 8\text{-}12$ psia streamed into the EB1200 chamber and reached the alumina insulator in beam 2.
- Molten Li attacked the alumina (exothermic). Holes or cracks released water and propylene glycol that cause further exothermic reaction, produced hydrogen and the fire.

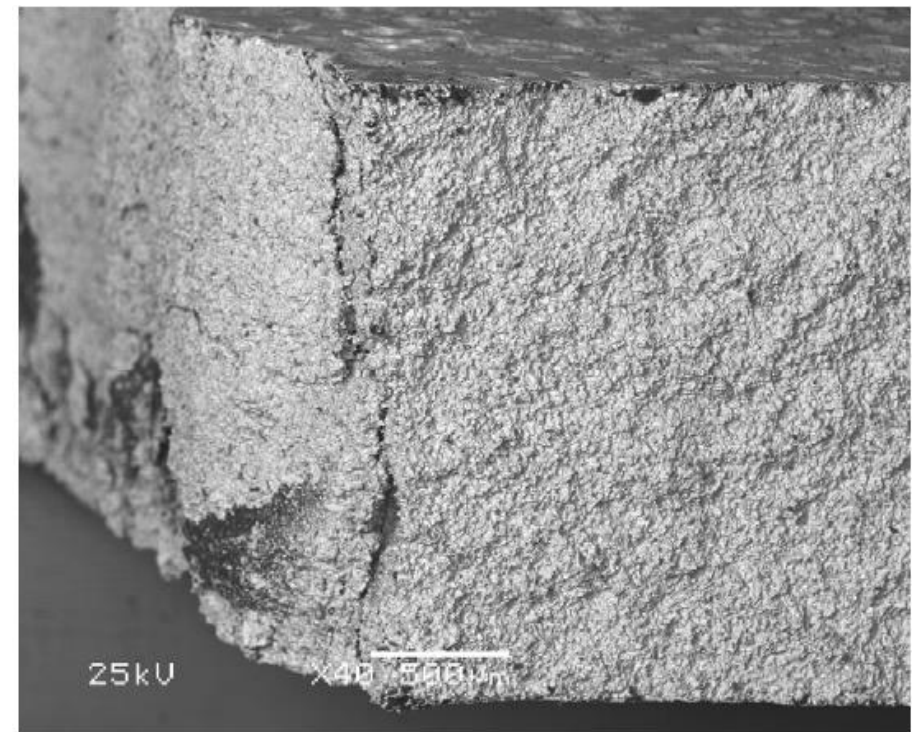
Typically with failures in 1018 steel the fracture surface are more ductile in appearance and more deformation is usually observed than in the case of the failed pre-heater where little ductility or deformation was found. Figure 3 shows a representative fracture surface. In general, the fracture surfaces not obscured by Li reaction products exhibited intergranular failure, i.e., the fracture path followed grain boundaries and seldom propagated into the interior of grains.

In brittle failure of the type observed for the lithium preheater, the crack growth proceeds primarily along the surfaces of grain boundaries, and a pattern of chevron-like features indicates the direction of the crack growth. By observing these features, one can backtrack to the origin of the crack. This type of evaluation indicated the possibility of a flaw or precrack in or near the weld (evaluation was complicated by the damage in this area), and weld penetration at that location was poor. We do not go into those details here but instead focus on other issues.
