Subject: ***Certification and Submittal of Assessment Report on the Newly-Identified or Suspected Release of Hazardous Waste at Building 897, Sandia National Laboratories/New Mexico (SNL/NM)***

ASSESSMENT REPORT FOR BUILDING 897 HAZARDOUS WASTE RELEASE**Introduction**

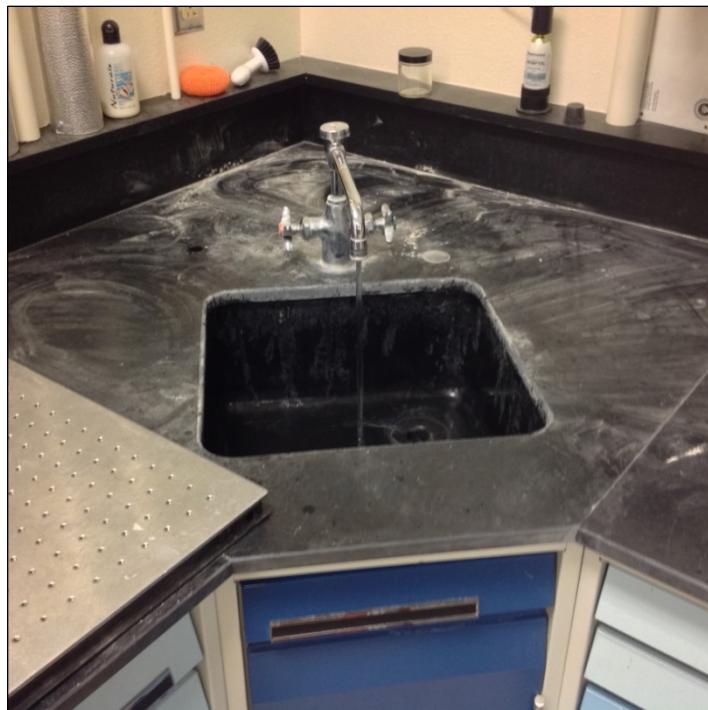
The two laboratory personnel who were present at the time heard a sound and noted that the glass bottle had cracked. The bottle broke and released the contents on the table and into the sink. The personnel placed disposable towels and absorbent on the spilled solvent, left the room, and contacted Sandia emergency response personnel. The affected area on the table is shown in Figure 2.

Sandia emergency personnel responded to Laboratory 3005 and observed the area. The entire gallon bottle of waste solvent mixture was emptied. The sink, the area surrounding the sink, and the table, including an area under a work platform located on the table, were affected. The broken bottle was placed in another container.

Sandia safety personnel determined the glass container had inadvertently been overfilled and most likely failed due to increased pressure. An evaluation of other containers in this laboratory and within other laboratories at SNL/NM was performed and, when deemed appropriate, the contents were transferred to additional containers to minimize any potential for recurrence.

Photo Number 1. Sink and surrounding work area following release. The white residue on the surfaces is the remaining absorbent.

Personnel cleaned up using the disposable towels and absorbent, removed the work platform, and then cleaned the affected area, including the underside of the platform, the table, and the sink, with detergent and water, as shown in Figure 3. The sink and drain were flushed with water.
