Subject: ***Certification and Submittal of Assessment Report on the Newly-Identified or Suspected Release of Hazardous Waste at Building 897, Sandia National Laboratories/New Mexico (SNL/NM)***

ASSESSMENT REPORT FOR BUILDING 897 HAZARDOUS WASTE RELEASE**Introduction**

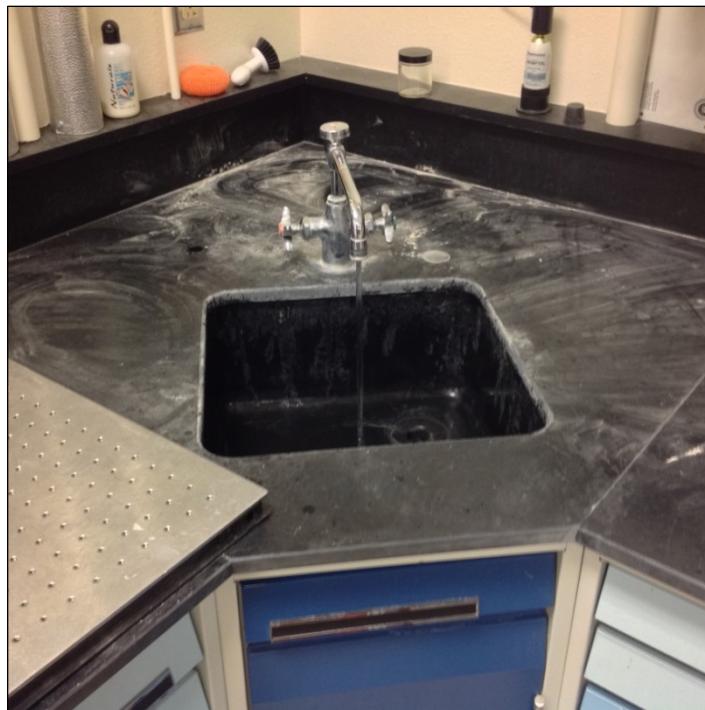
The two laboratory personnel who were present at the time heard a sound and noted that the glass bottle had cracked. The bottle broke and released the contents on the table and into the sink. The personnel placed disposable towels and absorbent on the spilled solvent, left the room, and contacted Sandia emergency response personnel. The affected area on the table is shown in Figure 2.

Sandia emergency personnel responded to Laboratory 3005 and observed the area. The entire gallon bottle of waste solvent mixture was emptied. The sink, the area surrounding the sink, and the table, including an area under a work platform located on the table, were affected. The broken bottle was placed in another container.

Sandia safety personnel determined the glass container had inadvertently been overfilled and most likely failed due to increased pressure. An evaluation of other containers in this laboratory and within other laboratories at SNL/NM was performed and, when deemed appropriate, the contents were transferred to additional containers to minimize any potential for recurrence.

Photo Number 1. Sink and surrounding work area following release. The white residue on the surfaces is the remaining absorbent.

Personnel cleaned up using the disposable towels and absorbent, removed the work platform, and then cleaned the affected area, including the underside of the platform, the table, and the sink, with detergent and water, as shown in Figure 3. The sink and drain were flushed with water.

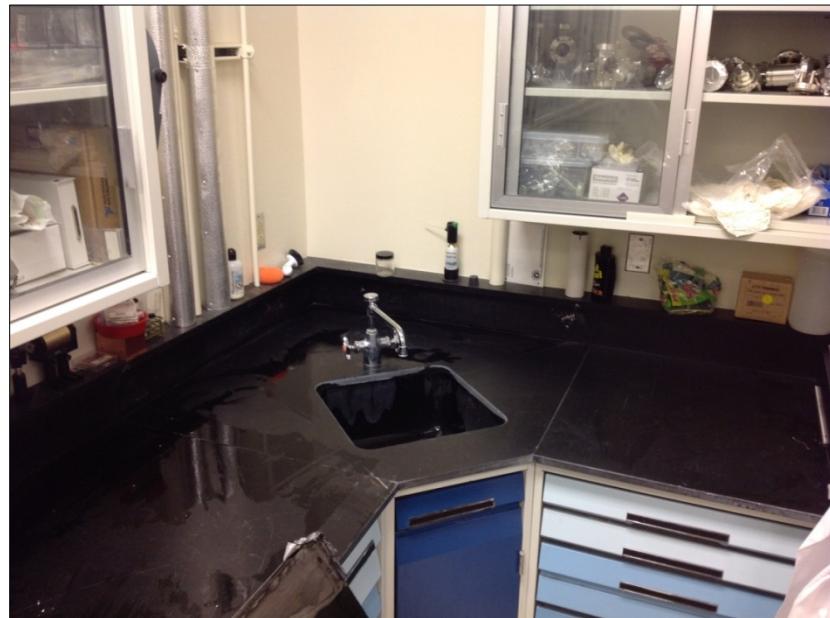
Photo Number 2. Sink and work area following decontamination. The surface of the work table has been cleaned but is not yet dry. The platform has been removed and placed against the cabinet for cleaning; the corner of the platform is visible at the bottom of the photograph, to the left of the sink.
