# Monitoring of Unvented Roofs with Fibrous Insulation, Diffusion Vents, and Interior Vapor Control in a Cold Climate

September 2020

*Prepared by:*  
Building Science Corporation  
70 Main Street  
Westford, MA 01886

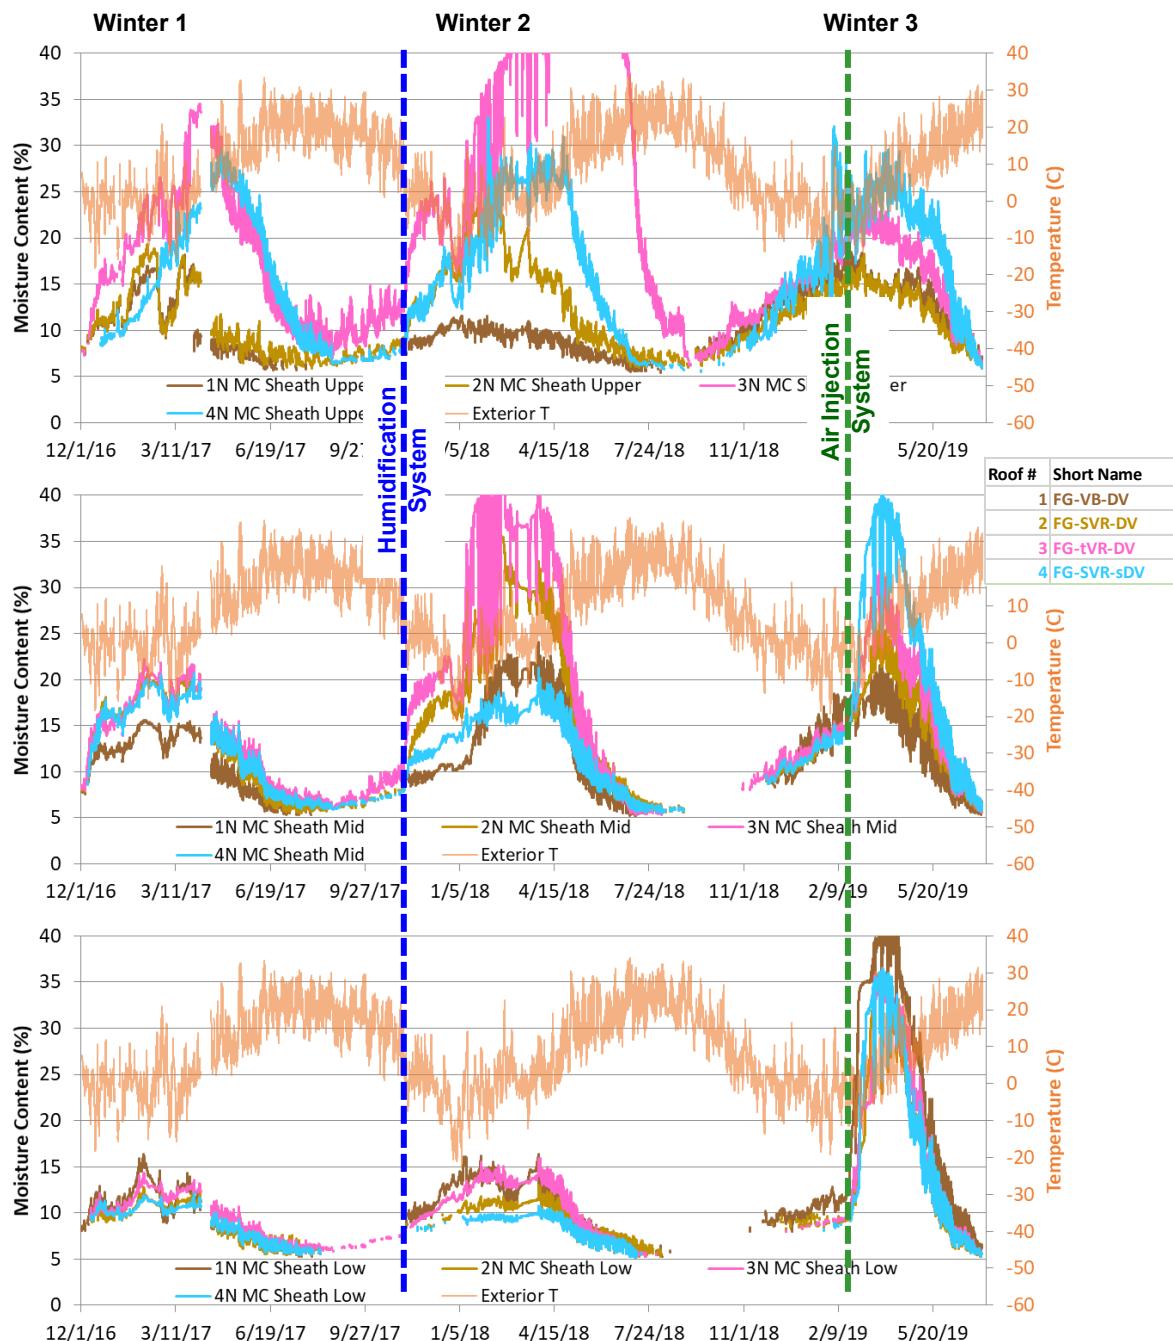
Overall, the Winter 3 north-side MC measurements indicate that a small (~0.5 CFM) air leak can result in significant wetting of the roof sheathing in these unvented roof assemblies.

**Figure 57. Fiberglass roofs' (1–4) sheathing MC north measurements**

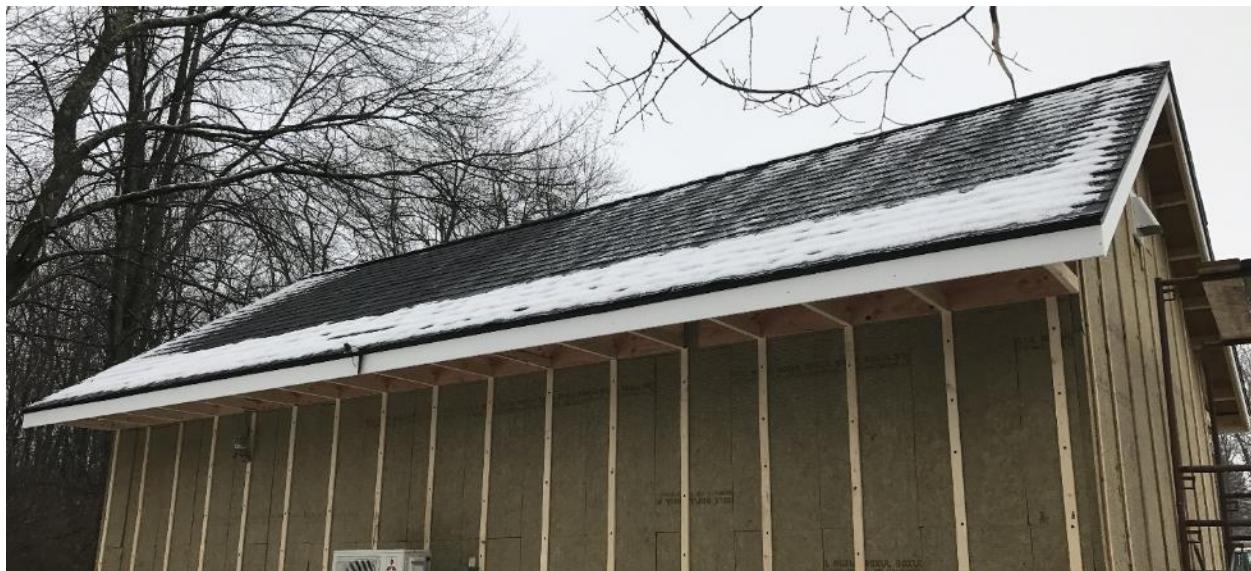
**Figure 109. Snow melt patterns on north-facing roof, showing rafter thermal bridging**

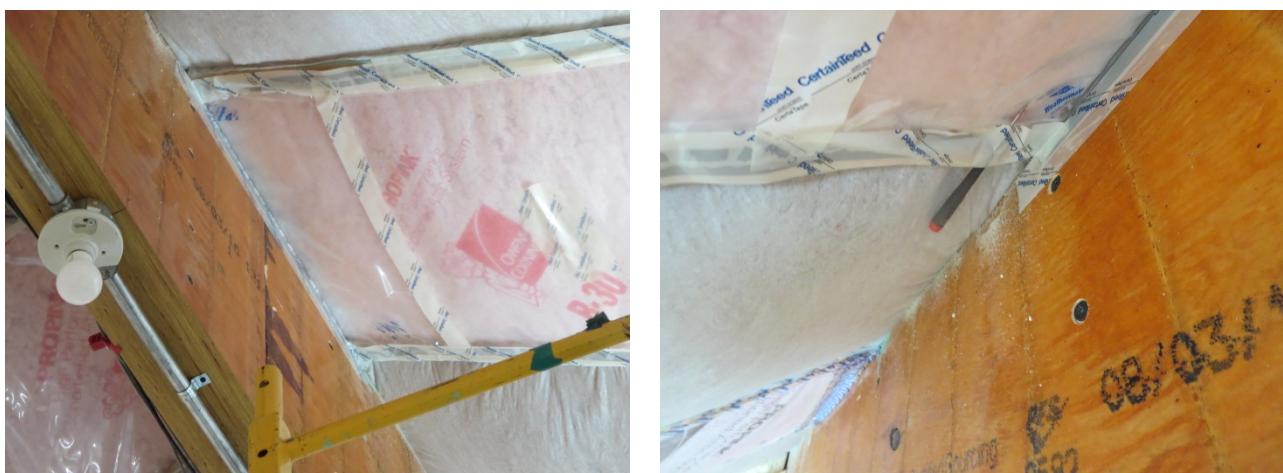
Figure 127. Roof 2, showing loss of adhesion of housewrap tape near ridge

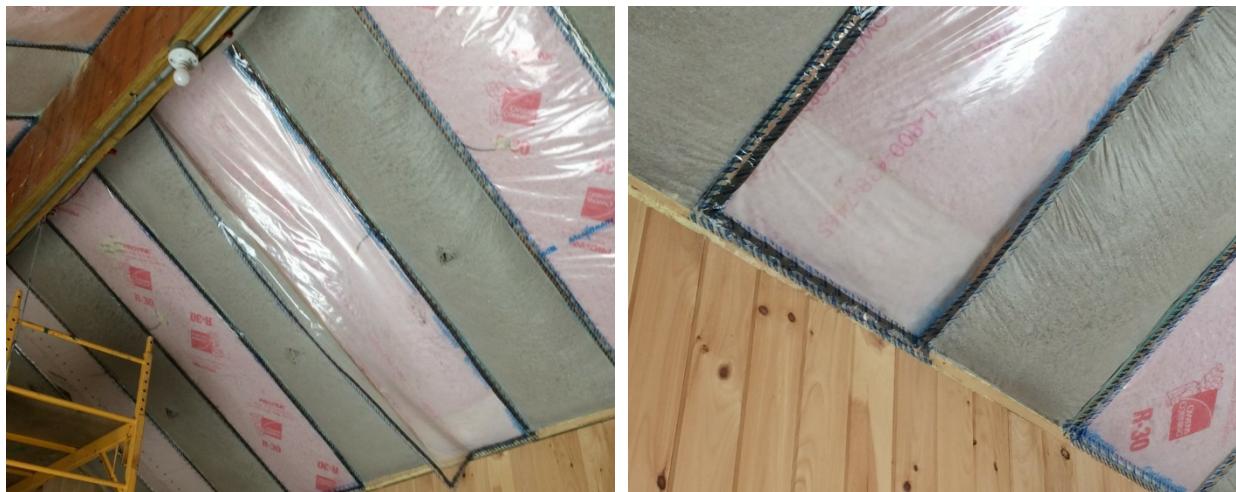
**Figure 129. Roof 3 north vapor retarder failure (October)**

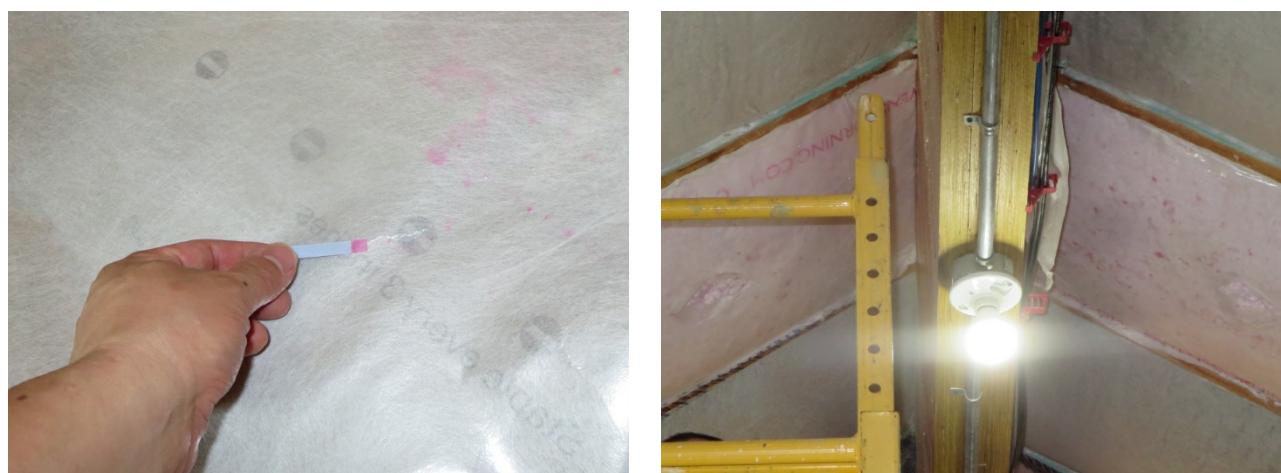
Figure 134. Roof 3 condensation wicking into water indicator paper, staining of insulation netting

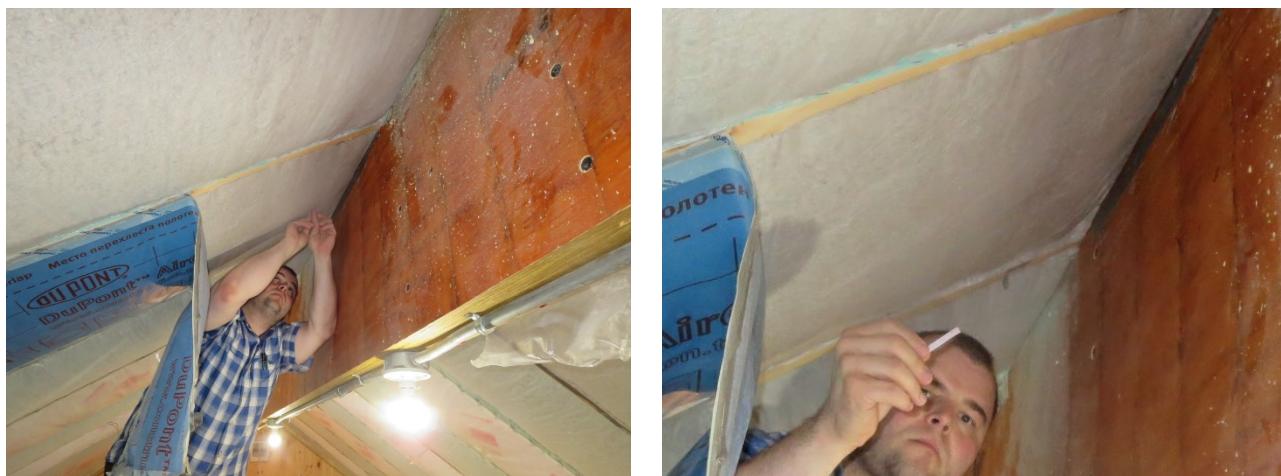
**Figure 135. Roof 5 wetness at vapor retarder-netting interface**

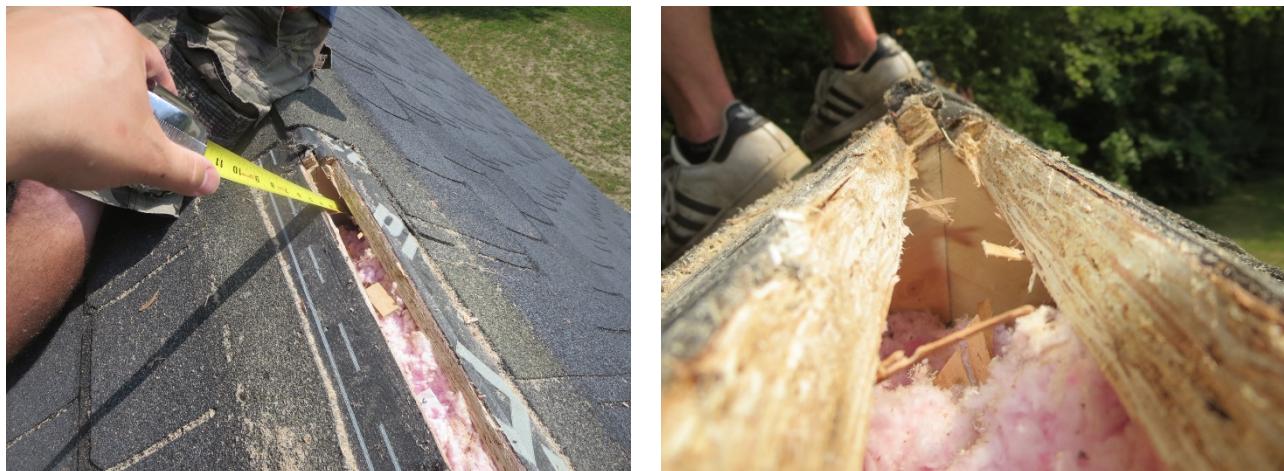
Figure 142. Settling of fiberglass insulation at ridge, Roof 4

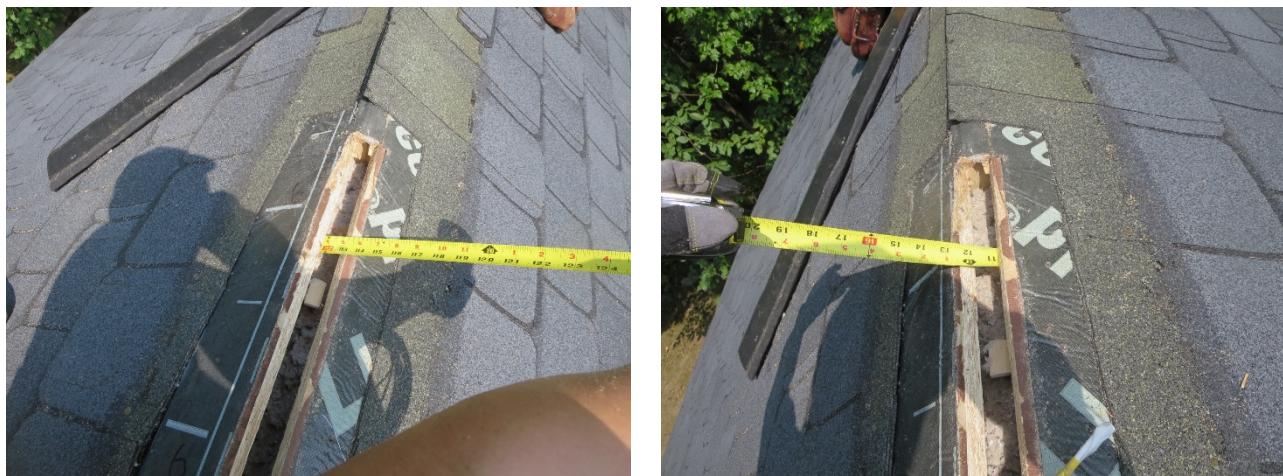
Figure 146. Settling of cellulose insulation on north (left) and south (right) slopes, Roof 6

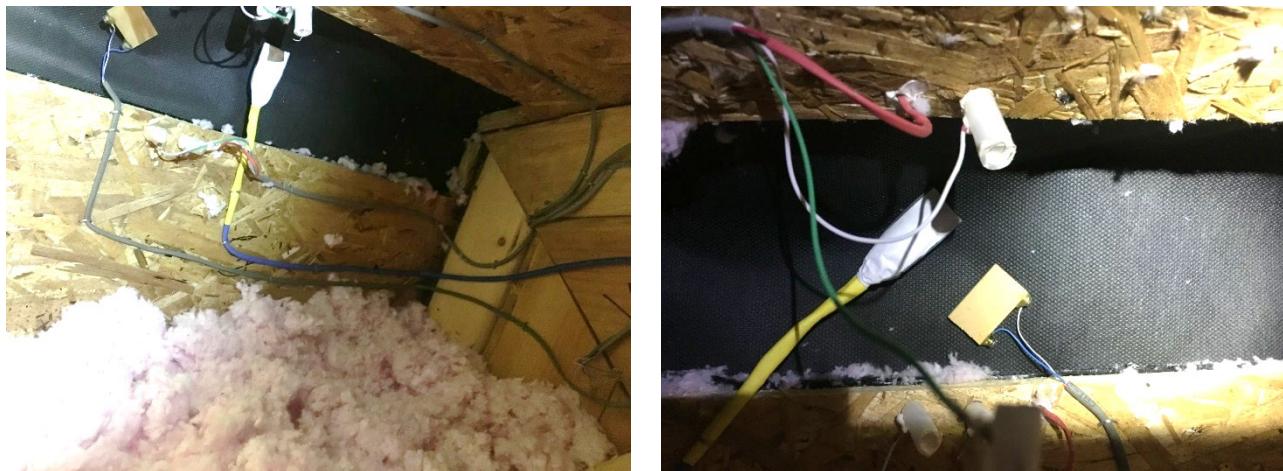
Figure 149. Sensor replacement (left) and repair of failed MC pin (right)

One MC pin had been knocked out of place from the sheathing; it was replaced and redriven (Figure 149, right).

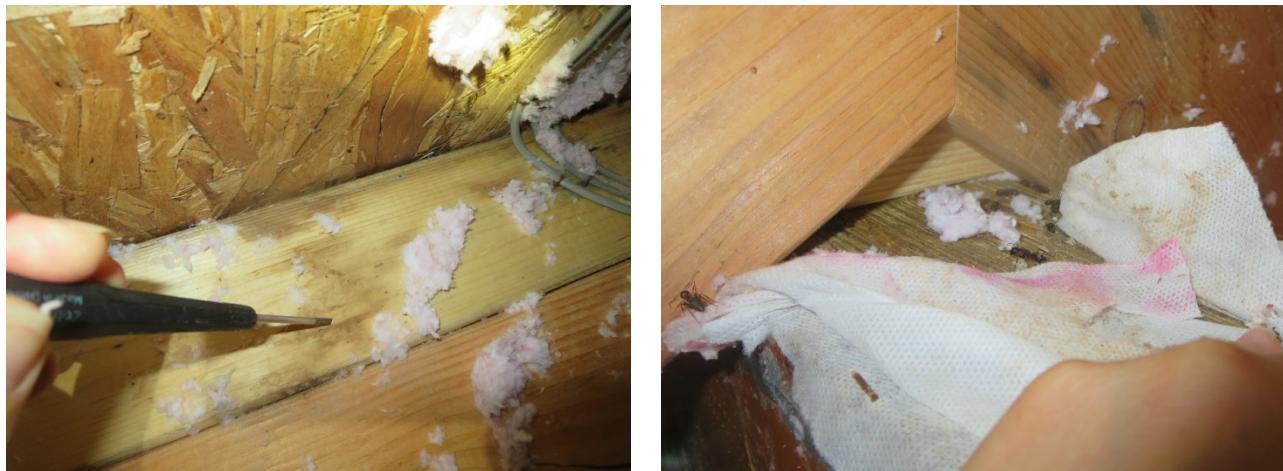
**Figure 155.** Roof 3 close-up of water staining on east rafter (left) ant infestation from adjacent bay (right)

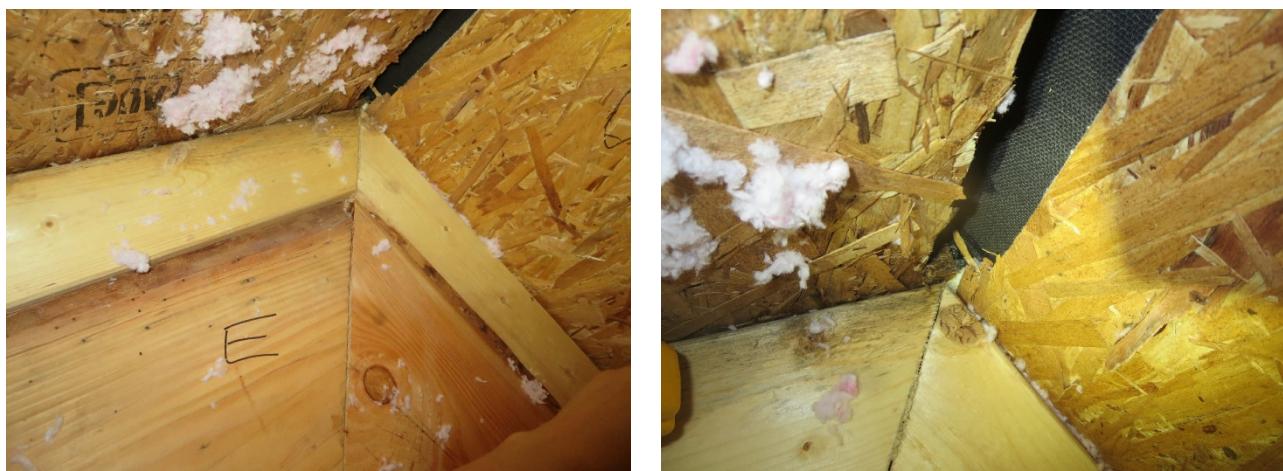
**Figure 156.** Roof 4 mold and staining on east rafter (left) close-up of east rafter and sheathing stains (right)

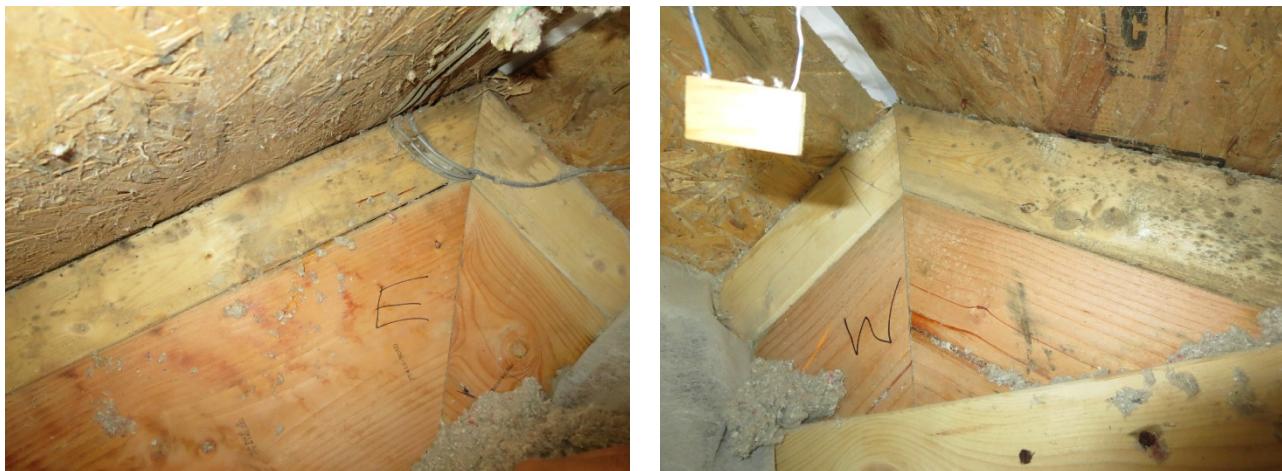
Figure 158. Roof 5 significant mold spotting on both east rafter (left) and west rafter (right)

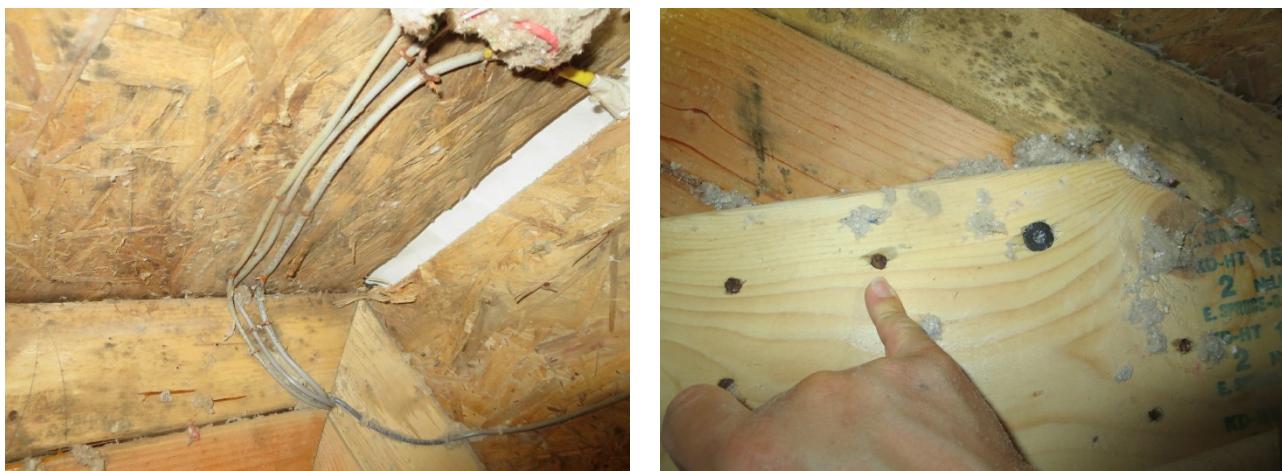
Figure 159. Roof 5 sheathing damage, east-side (left) collar tie rusted nails, rafter mold (right)

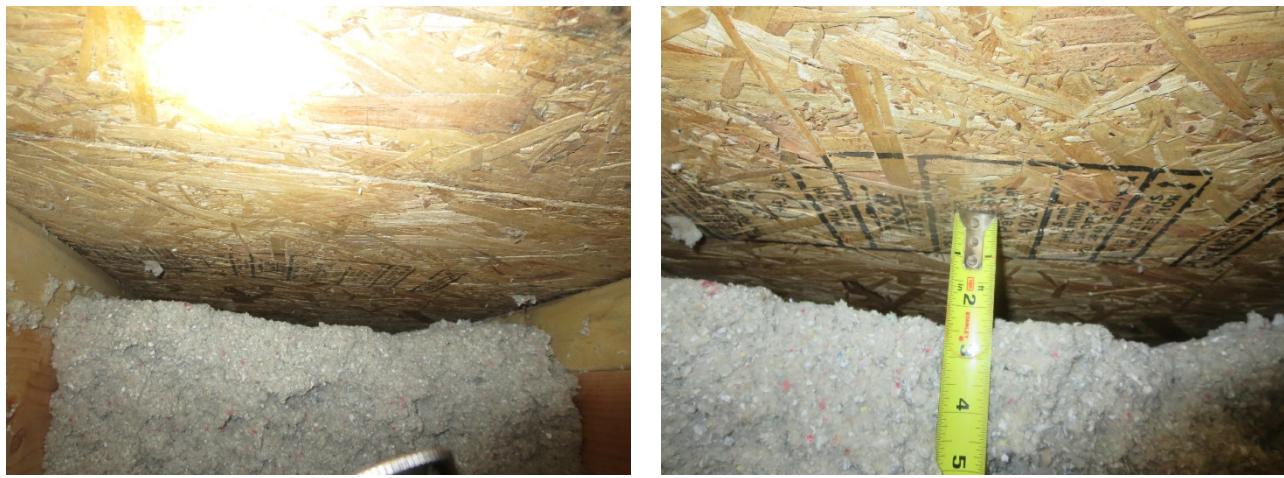
Figure 160. Roof 5 north-side cellulose settling (left); gap size 2 to 2.5 in. (right)

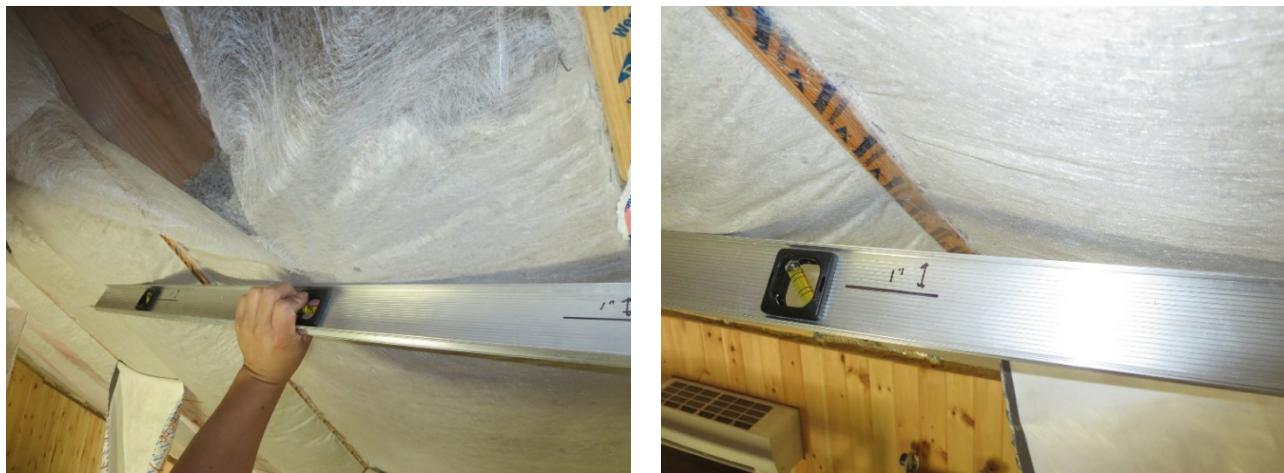
Figure 161. Cellulose netting belly (left); belly depth ~1 to 1.5 in. (right)

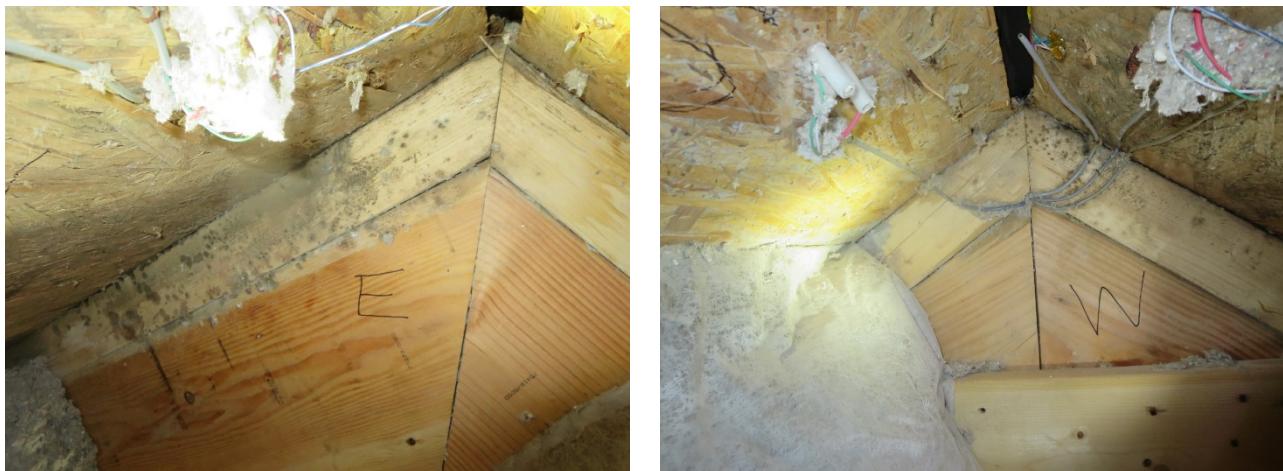
**Figure 163. Roof 6 mold and staining on east rafter (left) and west rafter (right)**

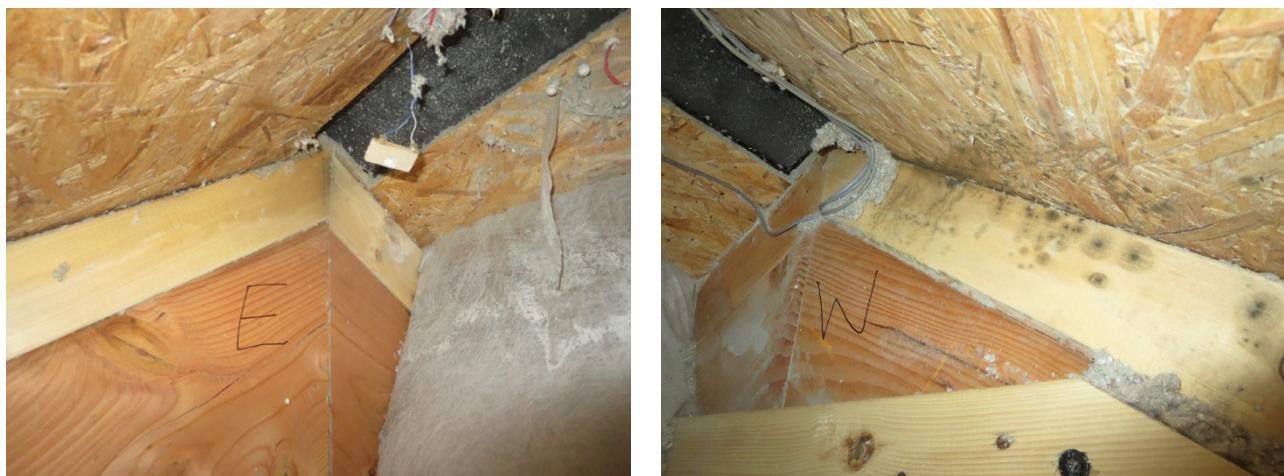
**Figure 165. Roof 7 minimal damage to east rafter (left); mold and staining on west rafter (right)**

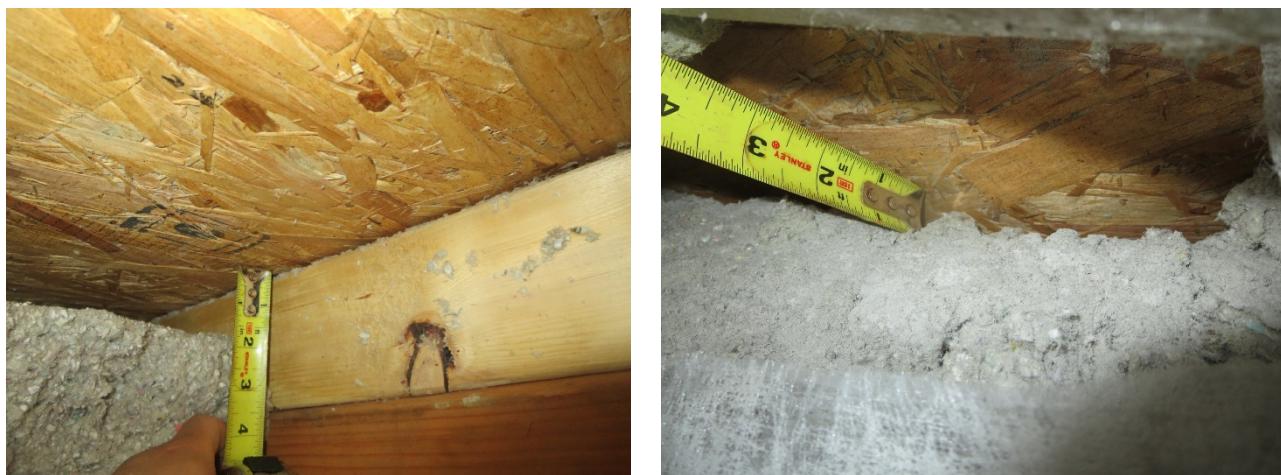
Figure 166. Roof 7 cellulose settling at north rafter bay (left) and south rafter bay (right)

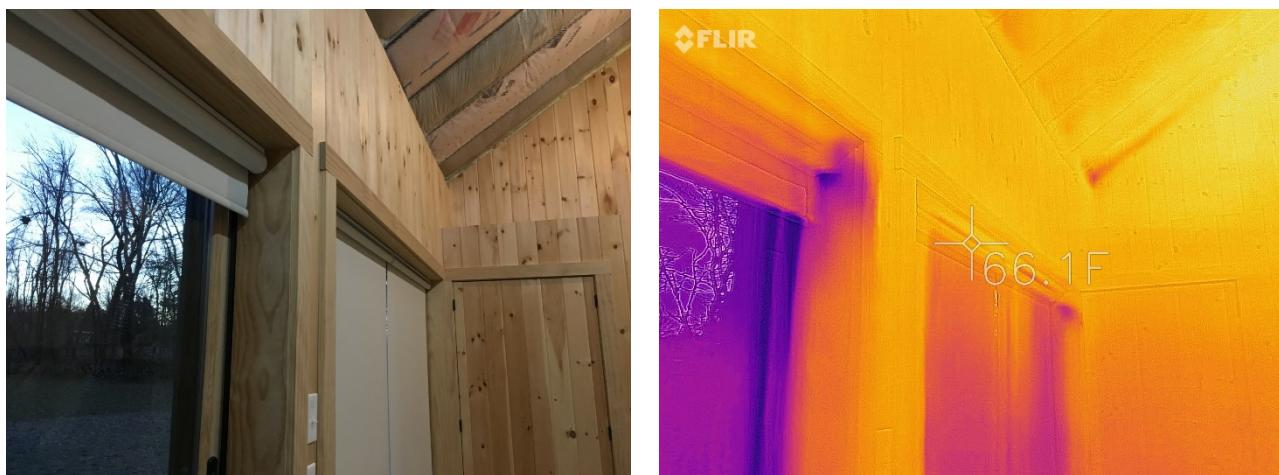
Figure 175. Visual and infrared image of air leakage at sliding glass door corner
