**Contamination Source Review for Building E3641,
Edgewood Area, Aberdeen Proving Ground, Maryland**

Contamination Source Review for Building E3641, Edgewood Area, Aberdeen Proving Ground, Maryland

S.D. Zellmer, A.K. Draugelis, J. Rueda, and R.E. Zimmerman

September 1995

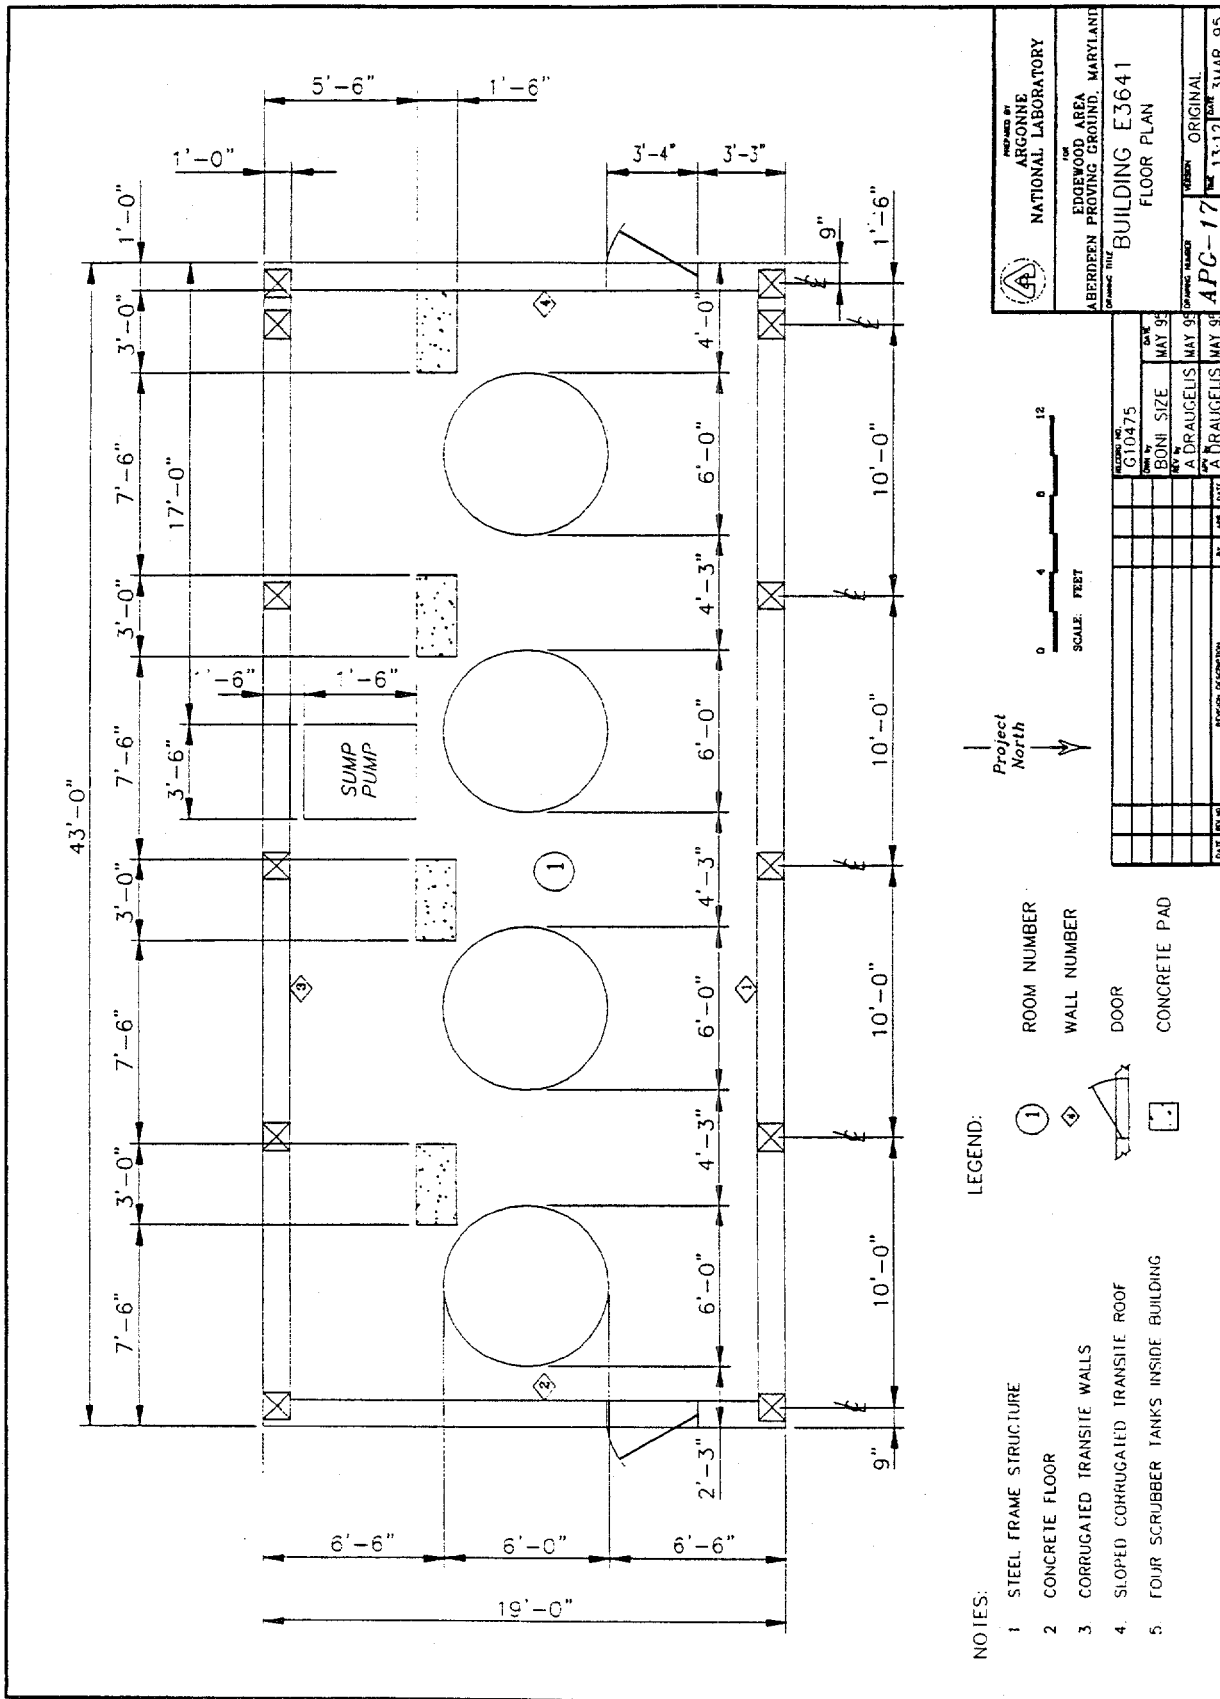
FIGURE 3 Building E3641 Floor Plan

The exterior dimensions of the building are 43 ft by 19 ft (Figure 3). The height of the eaves is about 8 ft, and the height at the peak of the gable is about 11 ft.

A sump is located beneath the floor, along the south wall, near the center of the building (Figure 3). This sump, which collected waste water from the scrubber system, is connected to the Building E3640 process laboratory chemical waste water system and to an exterior sump northeast of Building E3640. Effluent from the exterior sump flowed into the Building E3640 storm drain system that discharged into Kings Creek via an open ditch (U.S. Army CRDEC undated).

Two doors measuring 3 ft 4 in. wide were observed in the building. One doorway is 3 ft 3 in. from the northeast corner in the east wall; the other is 3 ft 3 in. from the northwest corner in the west wall of the building (Figure 3).
