subject: Safety Review Board review of explosive pressing initiation event

On June 30, 2020, a 0.87 gram PETN charge being pressed in the Rapid Prototyping Facility (RPF), room 1313 of the Explosive Components Facility (ECF; building 905), unexpectedly initiated, resulting in destruction of the pressing fixture but no injuries or facility damage^{1,2}. In response to a request from Leanna Minier, manager of organization 2554 at the time, the Explosives Technologies Group (ETG) Safety Review Board (SRB) met on Aug. 13, 2020 and Oct. 1, 2020 to review information collected following the incident, consider likely direct causes, and form recommendations.

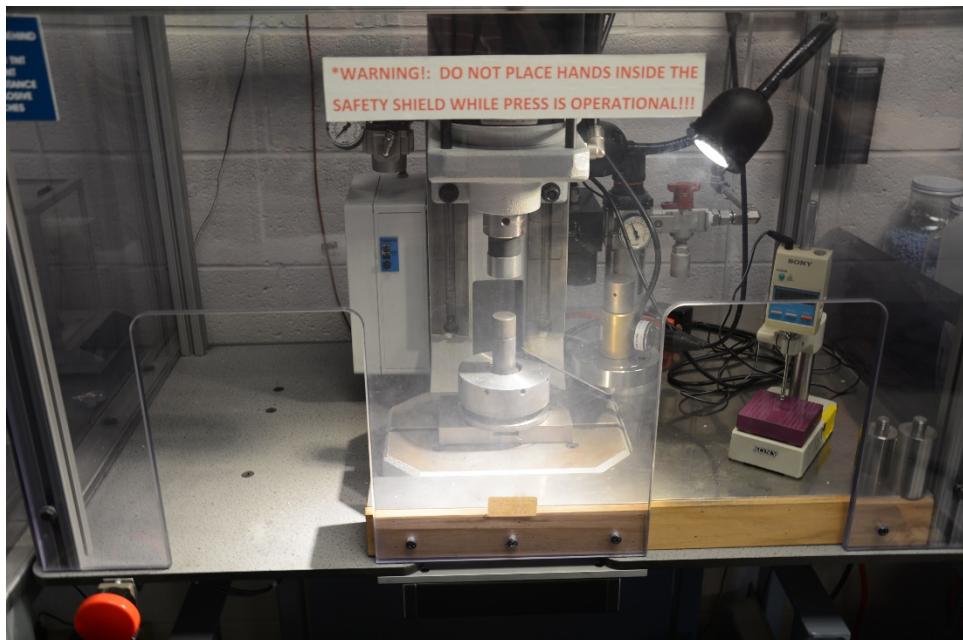
As described by the operator, the press ram descended onto the loading fixture, the shim moved slightly, a “tink” noise was heard, and the PETN initiated resulting in a loud report, bright flash, and smoke. A safety monitor in the nearby assembly room and a technologist in a neighboring lab heard the event and came to check on the operator, who was startled but not injured. Figure 2 shows the workstation after the event. The loading fixture was externally intact and the shield was undamaged.

Figure 2. Pressing workstation following the initiation event.

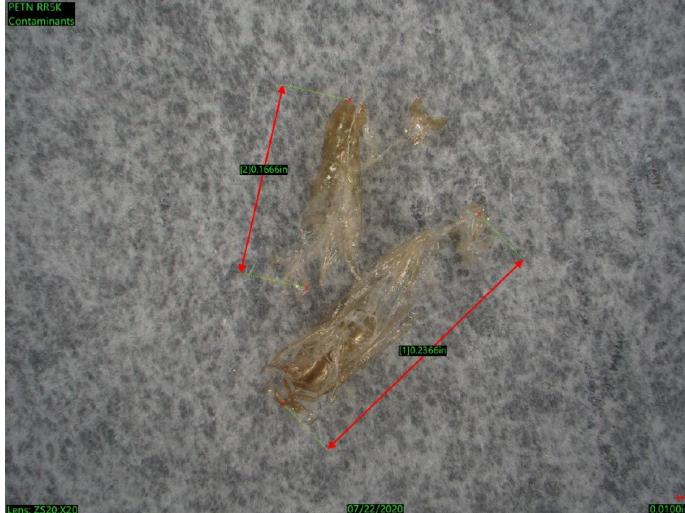
Some discoloration of the PETN submitted for SSST characterization was noted but not considered by the press operator to be unusual. Contamination (Figure 3), consistent with fibrous filter media and frequently found in explosive powders, was also noted.

Figure 3. Contaminants removed from the RR5K PETN. Fig. 2 from Ref. 5.

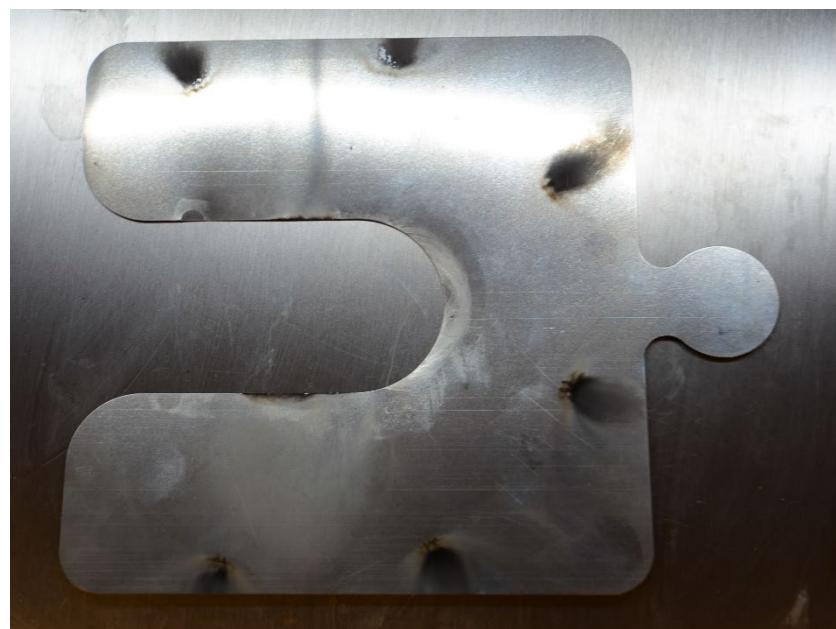
1. The shim had a pattern of soot marks indicating that it was on top of the loading fixture Cap, rather than between the Funnel and Ram, when the initiation occurred (Figure 4).
2. The Cap was visibly bowed upward (Figure 5).
3. Two pieces broke off the Funnel (Figure 6).
4. The Pin was in at least eight pieces inside the powder cavity and on the surface of the SITI Flange (Figure 7).
5. No unreacted PETN was visible.

Figure 4. Shim during disassembly showing soot marks corresponding to spanner wrench holes in the Cap.

5. Fabricate and use “Donut” Shims in place of the U-shaped shims used previously. By capturing the Ram, these Shims will not be able to fall off the fixture.

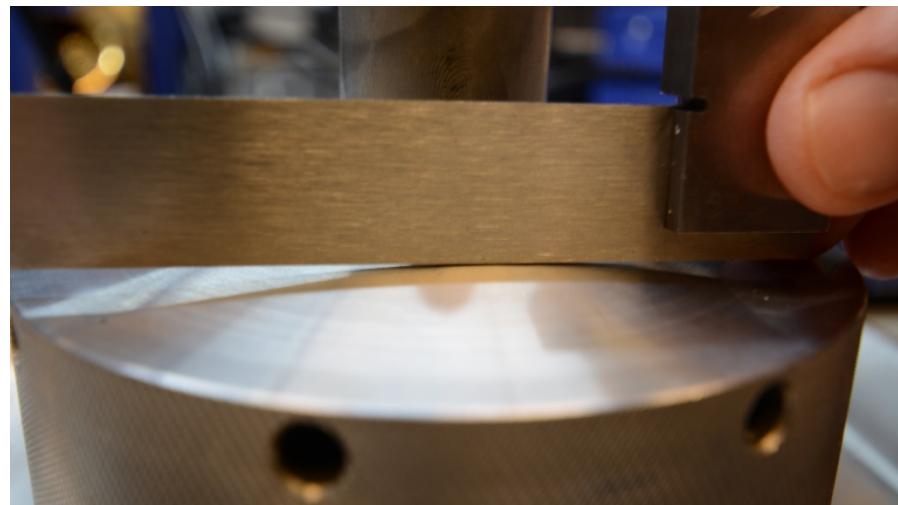
Figure 5. Loading fixture Cap showing curvature resulting from explosion.

2. Use a spanner wrench to tighten the Cap during alignment. This will help prevent the Funnel from moving relative to the Flange after alignment.
3. Create and use an Alignment Ram, similar to but longer than the pressing Ram (V31516-600) to provide greater engagement with the SITI Flange. One flat extending to the end will prevent suction when the Alignment Ram is removed.

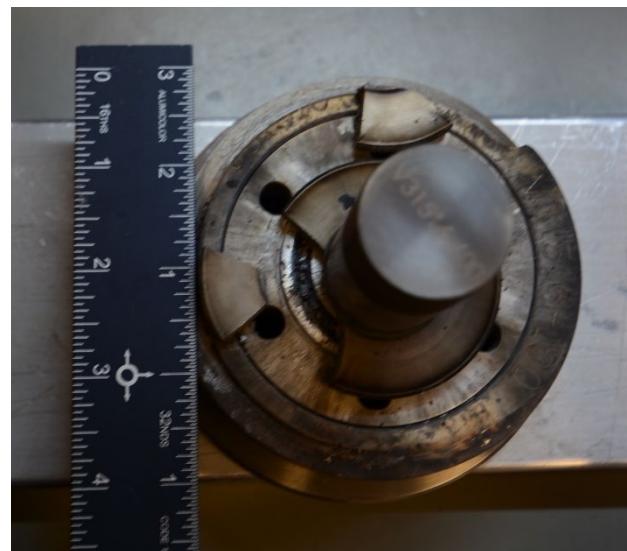
Figure 6. Loading fixture Base, Funnel, and Ram and SITI Flange showing broken Funnel.

Prior to disassembly, misalignment of the Funnel and Flange was considered a likely contributing factor. Interference between the Ram and SITI Flange would result in sliding friction, plastic deformation, or fracture of the aluminum flange resulting in local heating. Alignment relies on 0.010" of engagement between the Ram and SITI Flange and clamping force between the threaded Cap and Base. Review of the SITI Flange drawings found that the edge of the powder cavity is specified to be broken (chamfered) between 0.005" and 0.010". This reduces the effectiveness of the alignment process. However, misalignment resulting from this broken edge will not cause interference between the Ram and SITI

1. Provide and use a mechanism for repeatable alignment of the Loading Fixture under the Press. Although misalignment is not believed to have contributed to this incident, it can lead to uneven force, damage to fixture components, or the fixture “kicking out” from under the press.

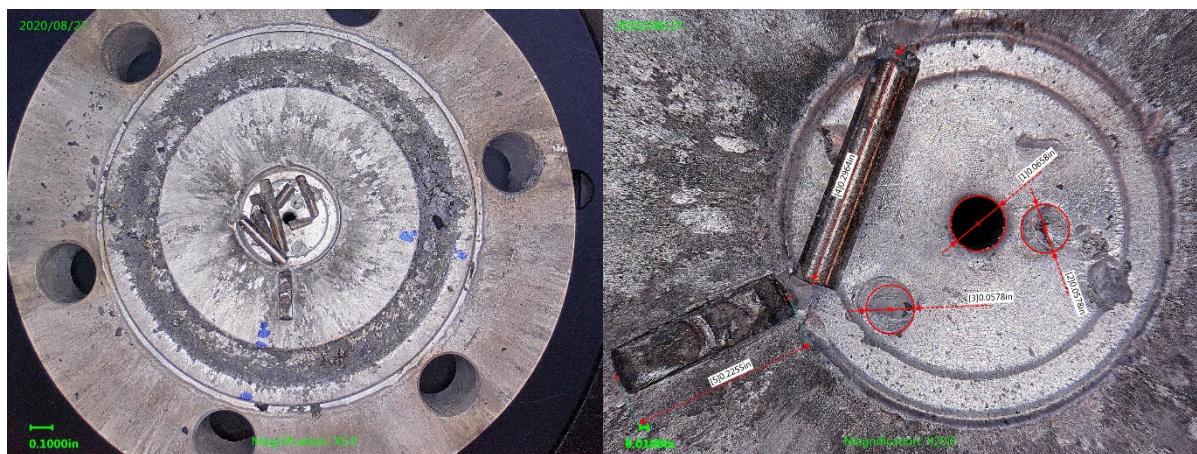
Figure 7. SITI Flange showing pieces of the Pin in the powder cavity and on the surface (left) and indentations in the bottom of the powder cavity (right).

The direct cause of the PETN initiation was apparent after disassembly. Finding the broken Pin inside the SITI Flange and between the Flange and Funnel indicated that it was in the powder cavity during the pressing operation rather than in the Flange tube. Apparently, upon compression by the Ram it broke into multiple pieces and created the indentations seen in the bottom of the cavity. The fracture of the Pin likely caused the “tink” noise heard by the operator just before the initiation. The exact mechanism is not known, but initiation of the PETN powder may have occurred when the Pin broke releasing elastic energy, by friction between the Pin and other surfaces, by local heating when the Pin and fragments indented the Flange, or a similar mechanism. In general, foreign object debris (FOD) in a pressing cavity, particularly large metal fragments, is likely to create favorable conditions for initiation.

The primary conclusion of the SRB is that the direct cause of the initiation of PETN was the presence of FOD (the Pin) inside the Funnel and SITI Flange during pressing.

6. Replace the constant diameter Pin with a Step Pin with a larger diameter below the SITI Flange tube. Such a Step Pin cannot be pulled into the powder cavity.

8. Visually inspect the powder cavity for FOD before loading powder. This can be accomplished with a borescope or similar device and will be effective for any type of FOD or gross misalignment in many pressing fixtures, not only the V31516 Loading Fixture.
9. Modify ETG-OP-0257 to specify cleaning of pressing fixture powder contact surfaces before each use. This will reduce the likelihood of friction initiation by removing residual powder.
