# Effect of Build Orientation and Post Machining on AM 316L Part Failure

Michael Heiden, David Saiz, Dan Tung, John Miers, David Moore, Bradley Jared

Sandia National Laboratories, Albuquerque, NM

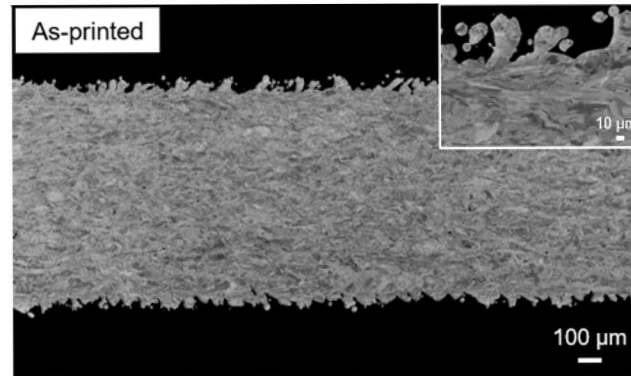
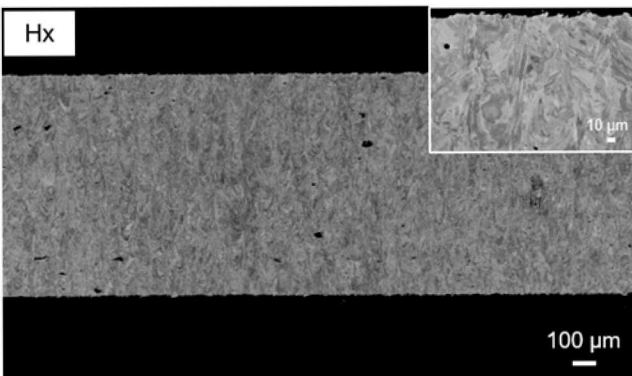
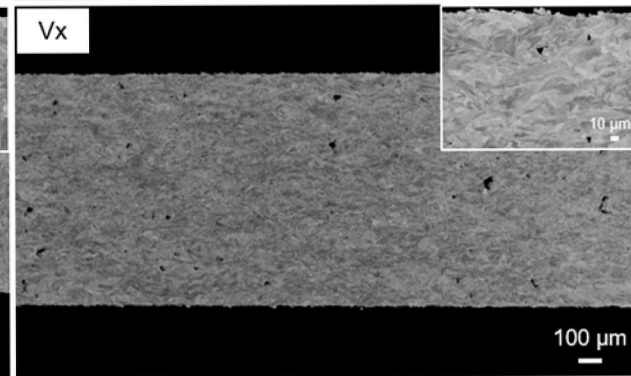
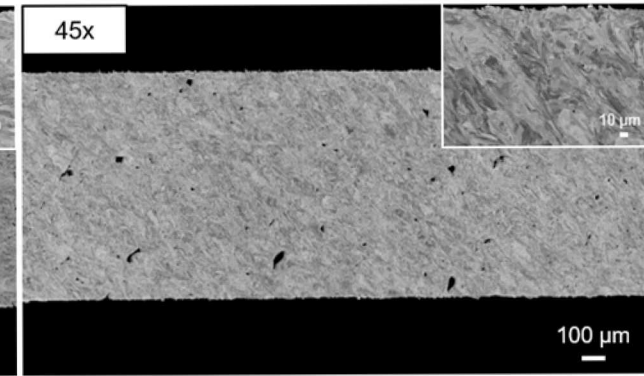
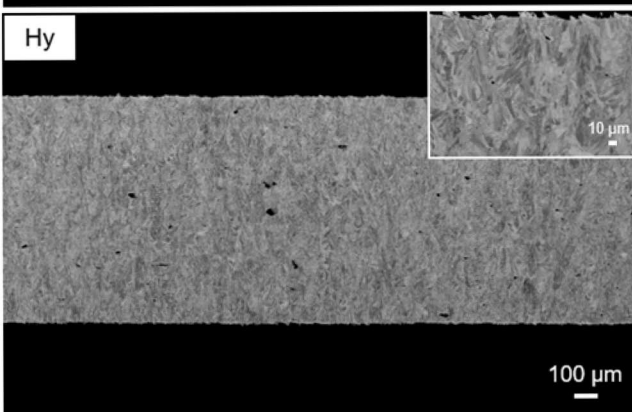
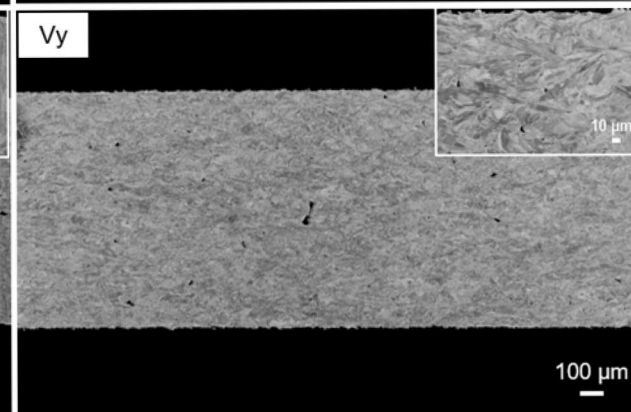
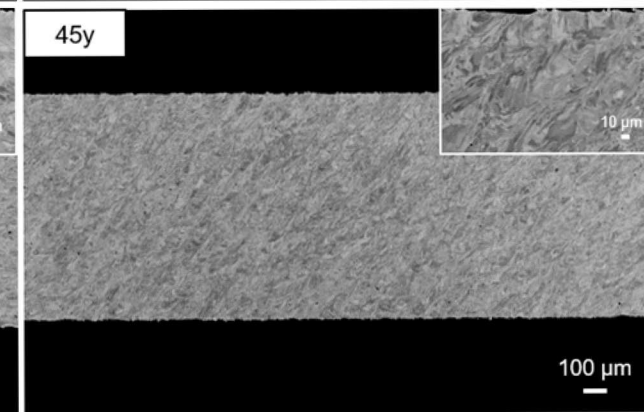
# High Surface Roughness for As-printed

- As-printed surface layer  $\sim 60 \mu\text{m}$  thick
- EDMed surface is  $\sim 5\text{-}10 \mu\text{m}$  thick

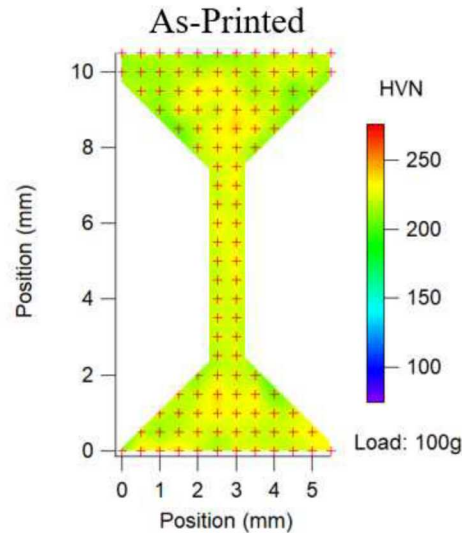
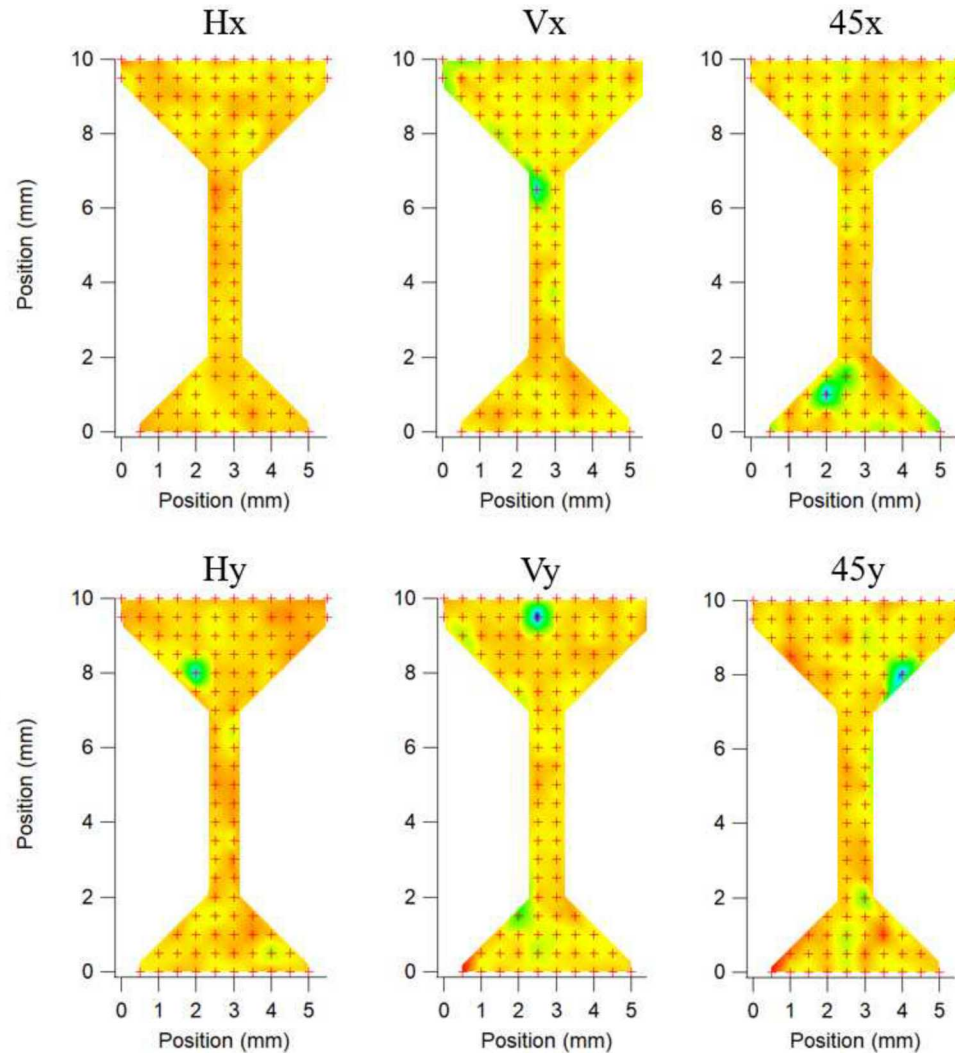
# Lower hardness for as-printed tensile samples

Keep this in mind for witness coupons and varying part thickness

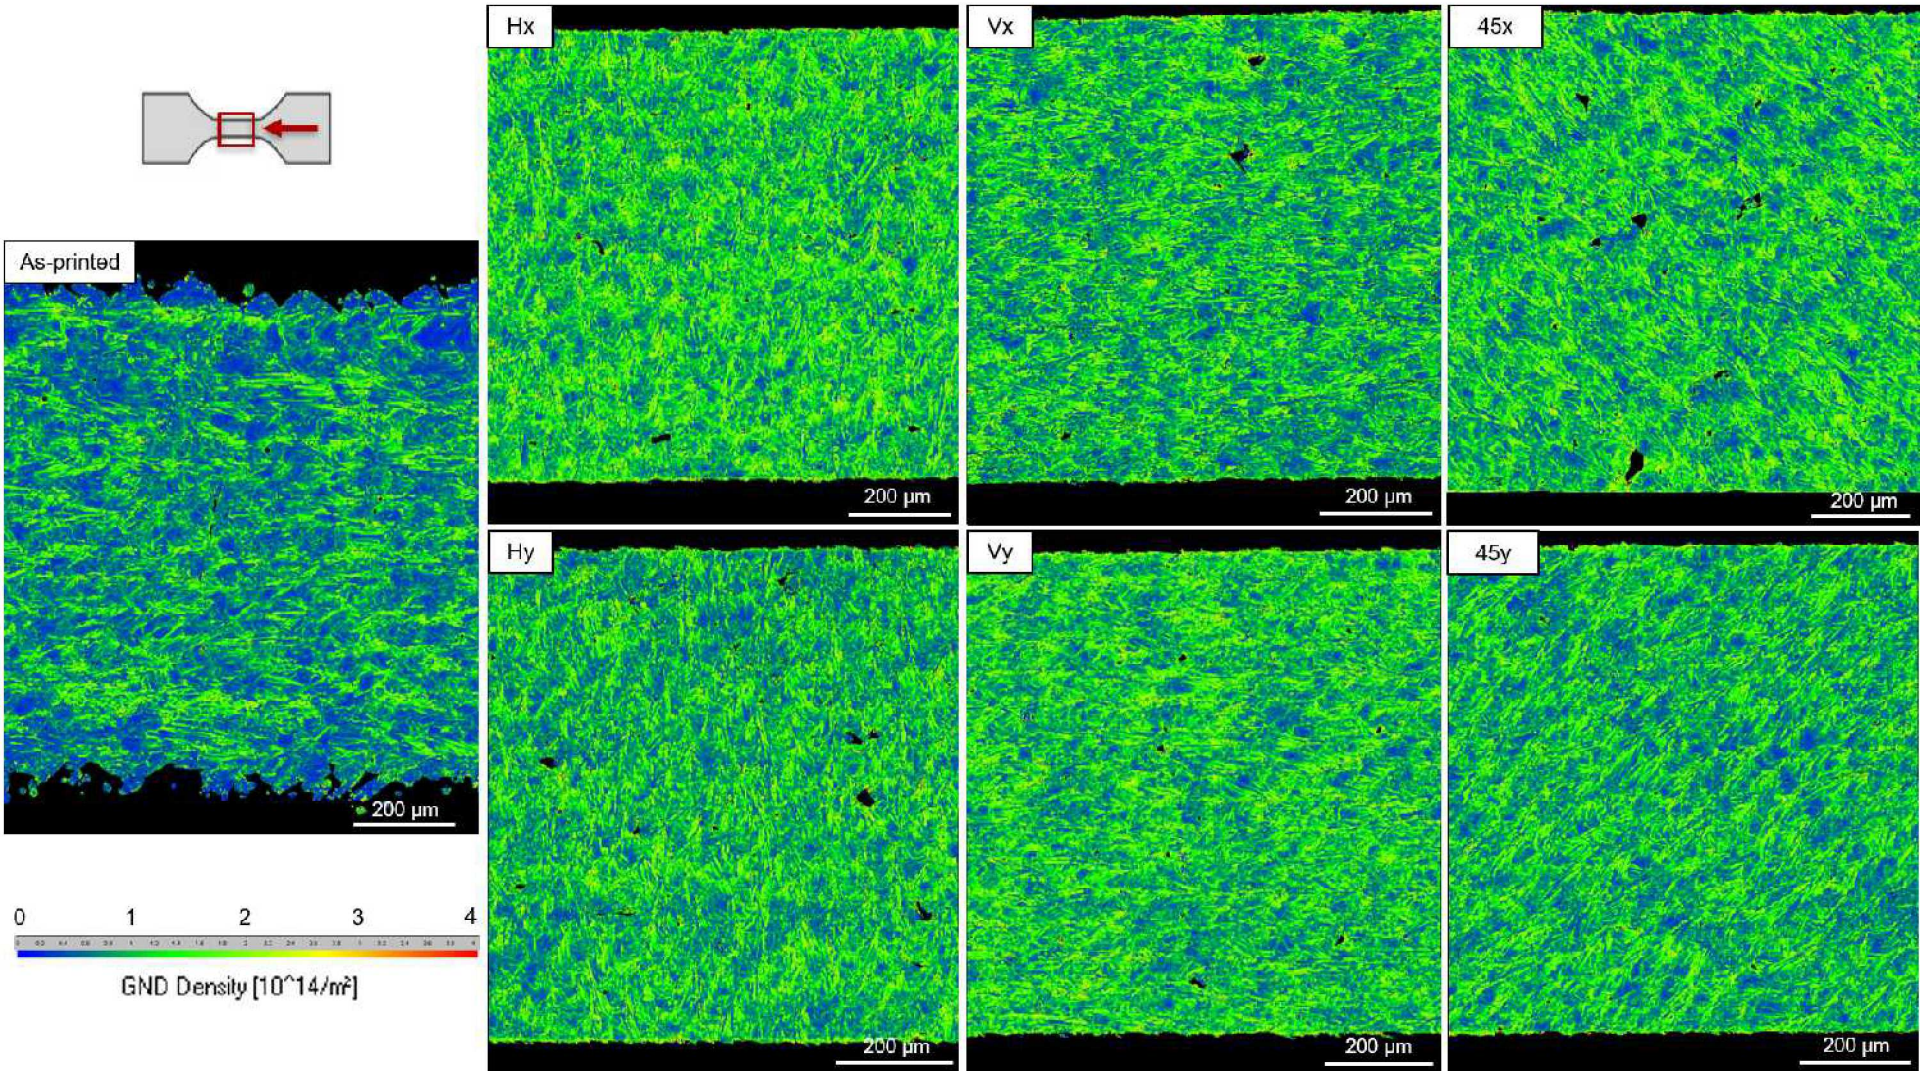
# Dislocations build up near grain boundaries and pores

- Geometrically necessary dislocations (GNDs) – Kernel Average Misorientation
- Higher dislocations in EDMed parts due to thermal gradient-driven residual stresses

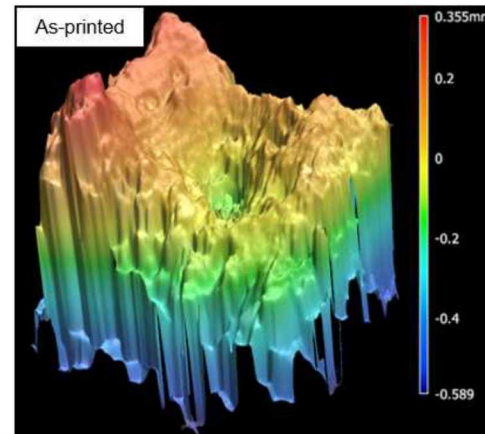
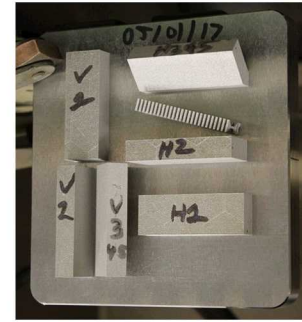
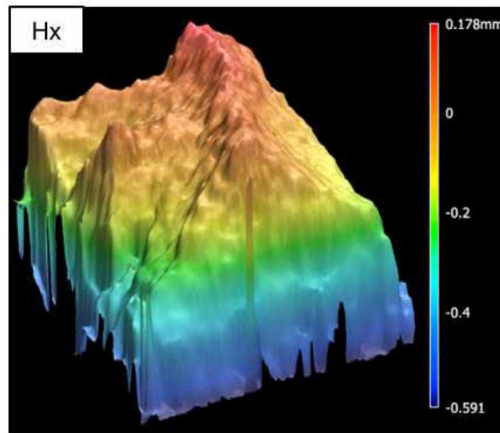
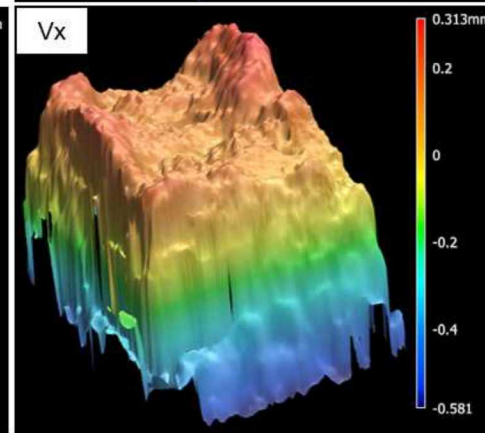
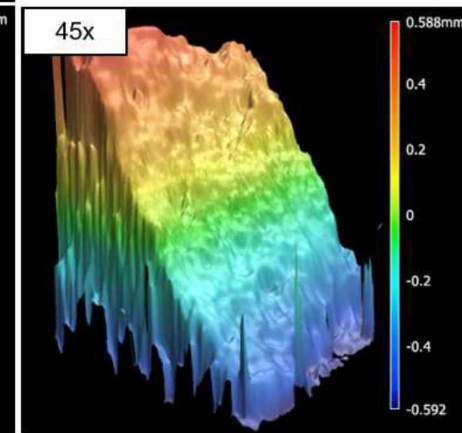
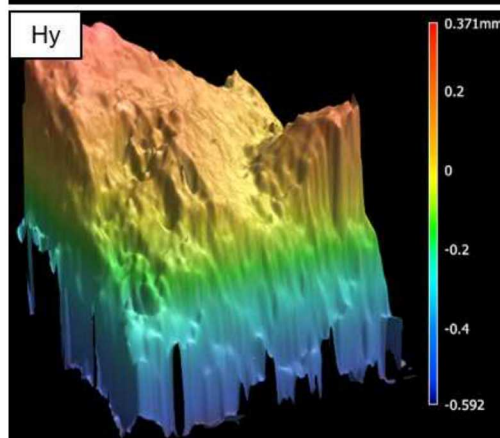
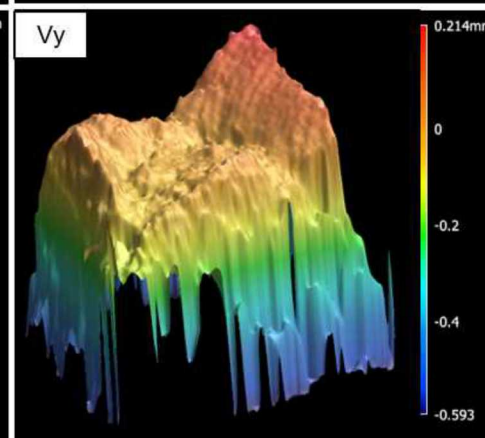
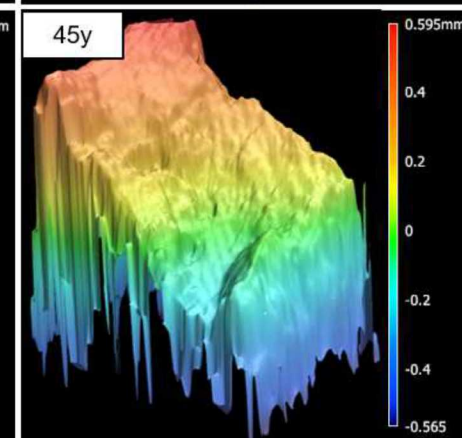
# Primarily ductile fracture

- More of a shear-like failure for parts built at a 45°
- Sharper shear plane for 45x

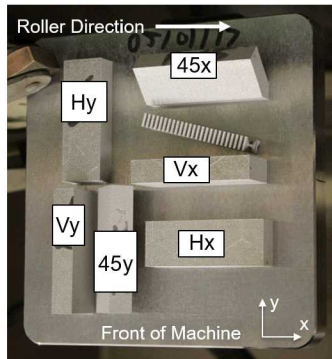
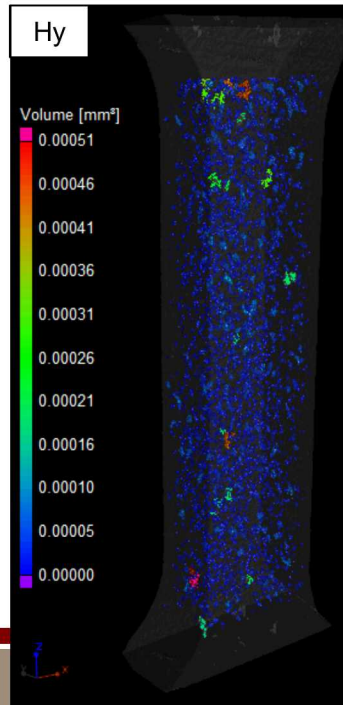
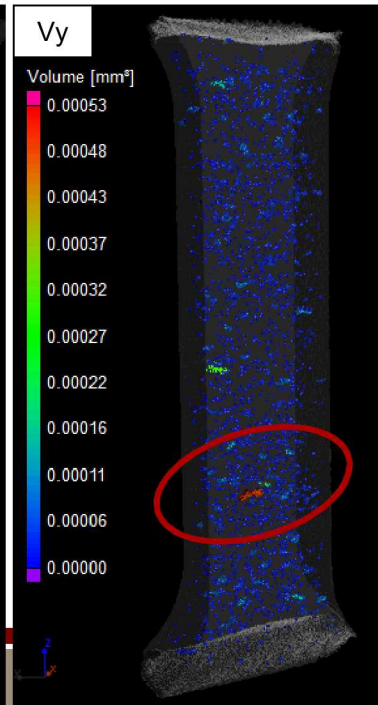
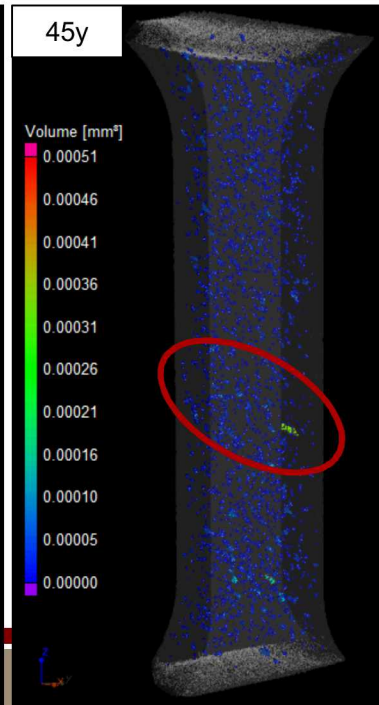
- Pores oriented perpendicular to build direction
- Higher concentration of large pores in Hx, Vx, Hy, and 45x

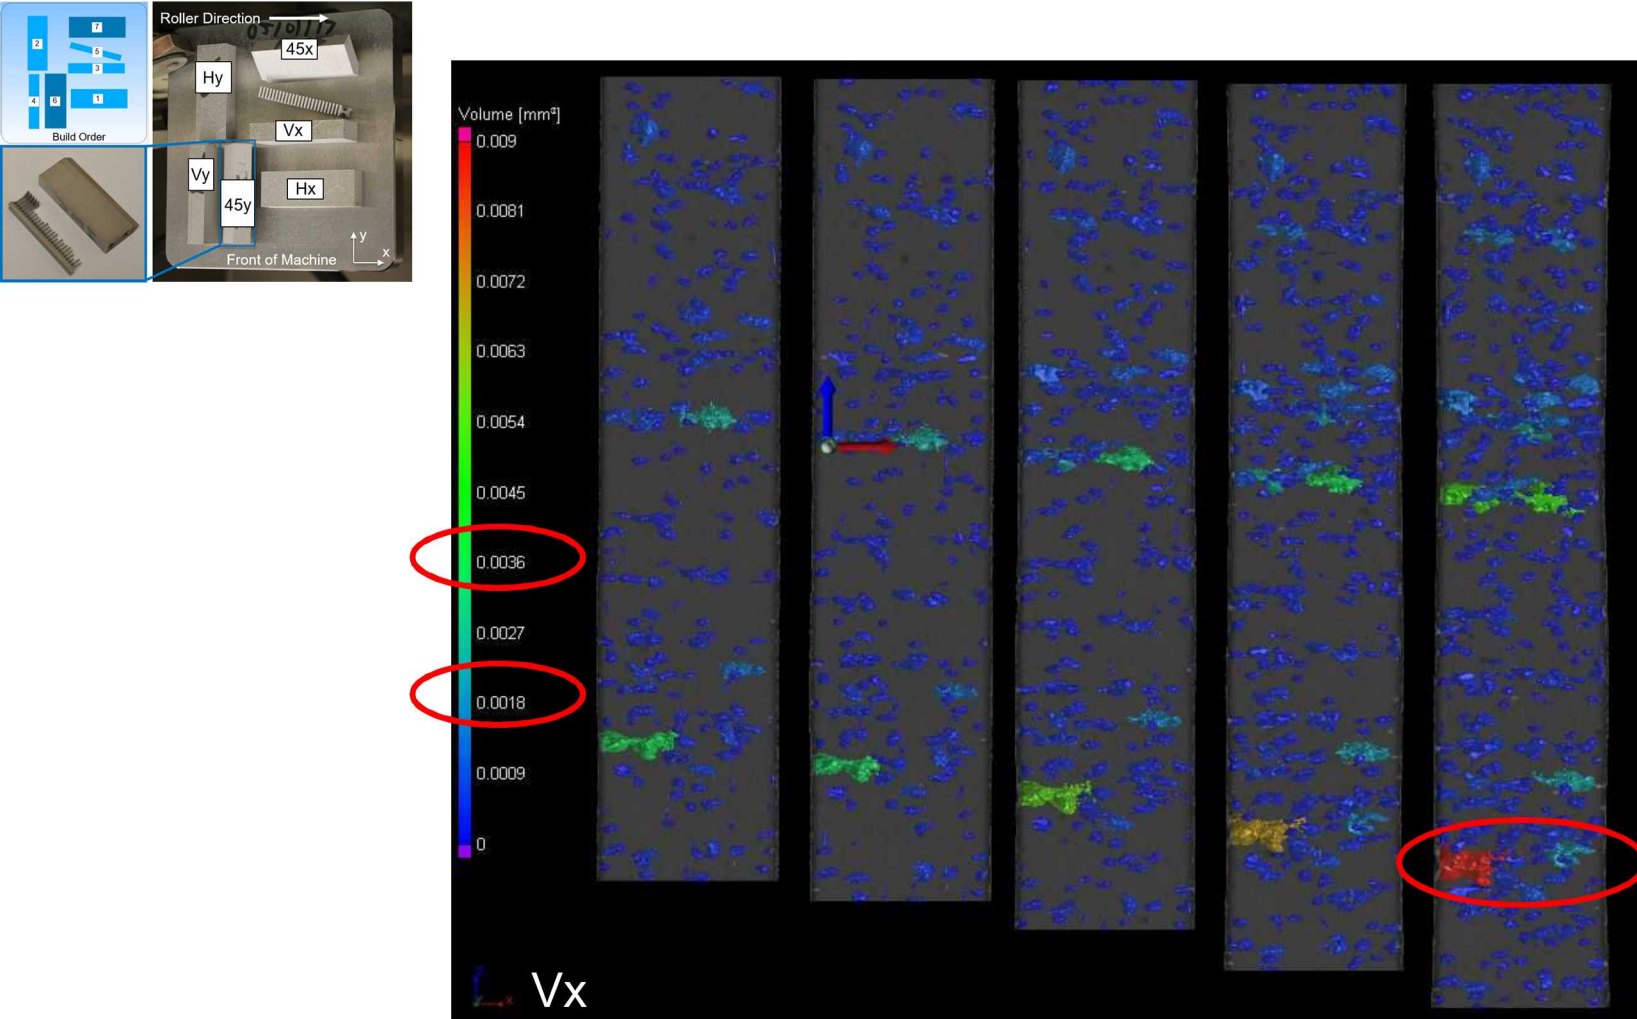
# Defects Grow and Coalesce with Nearby Pores

- Pores nearest to the surface dominate growth
- Necking and failure occurred near lower defect

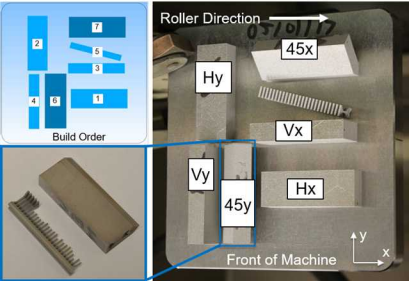
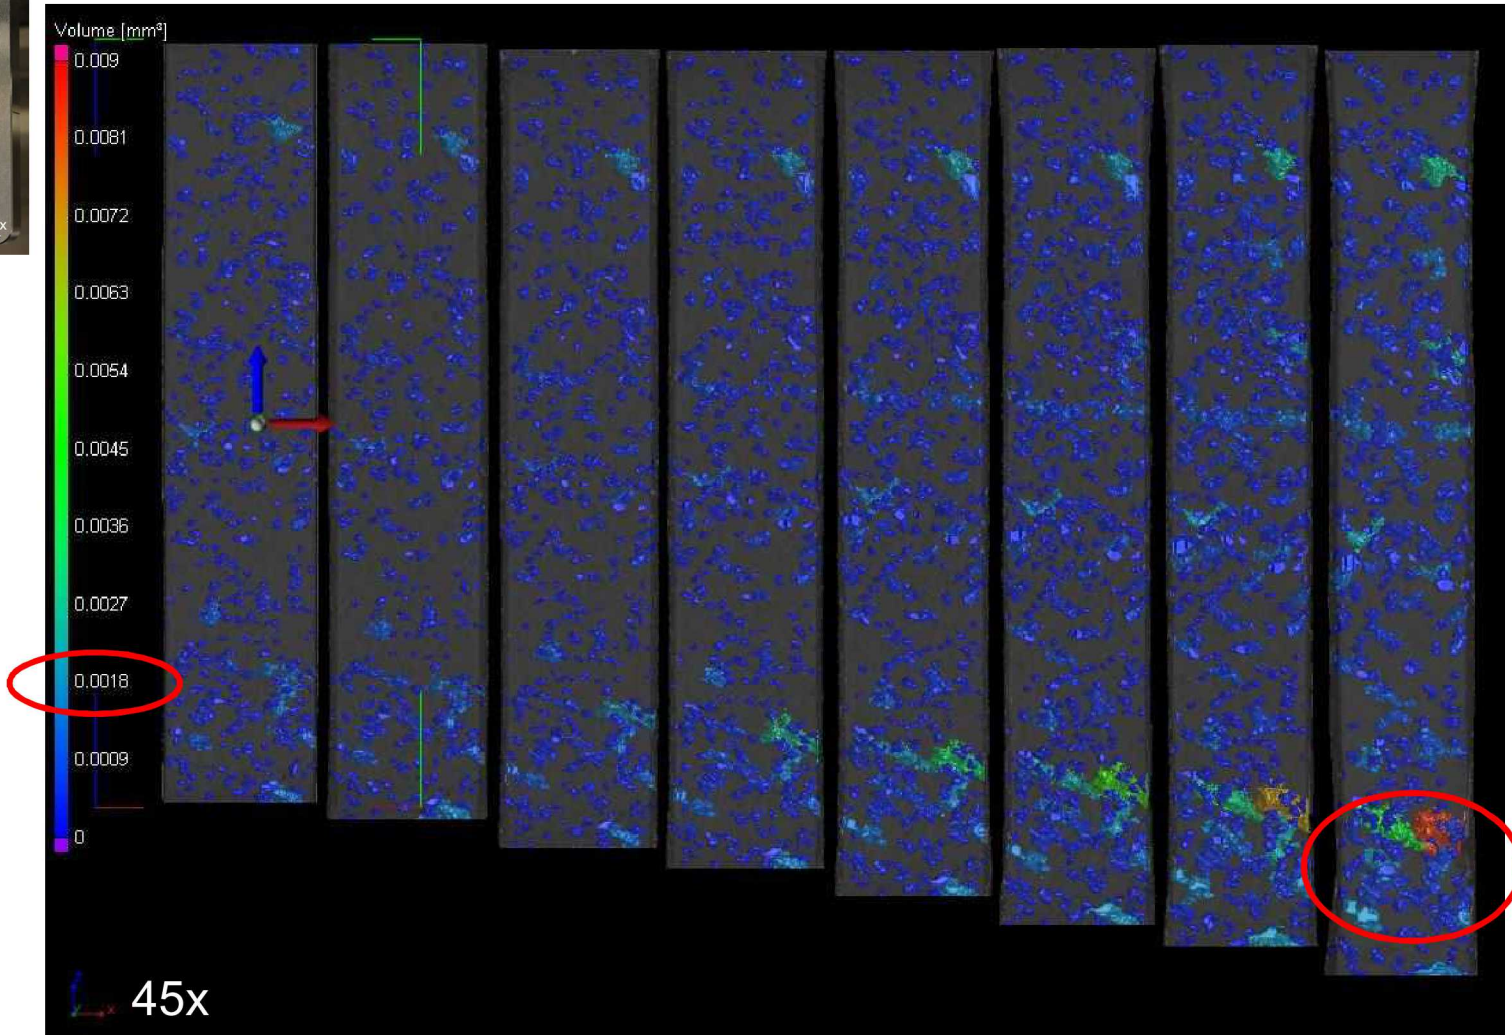
Pore volumes  
greater than  
 $0.001 \text{ mm}^3$  may  
lead to failure

$\sim 125 \mu\text{m}$   
diameter pores  
grow to failure

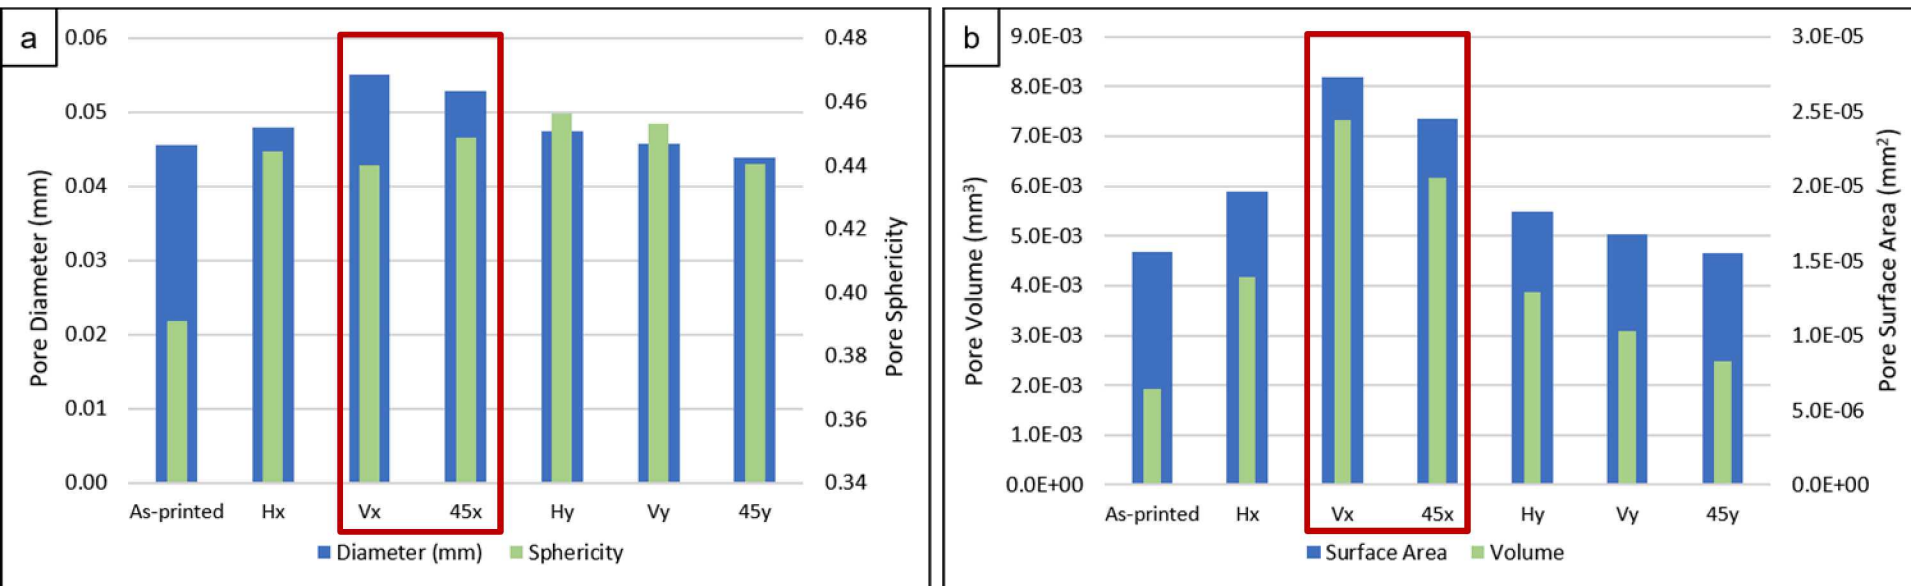
# High porosity in many “good” samples

- Hx, Vx, and Hy all have similar number of pores, yet Vx has lowest ductility
- 45x has more more pores than Vx, but has slightly greater properties
- Ductility appears influenced by larger pore diameter, volume, and surface area

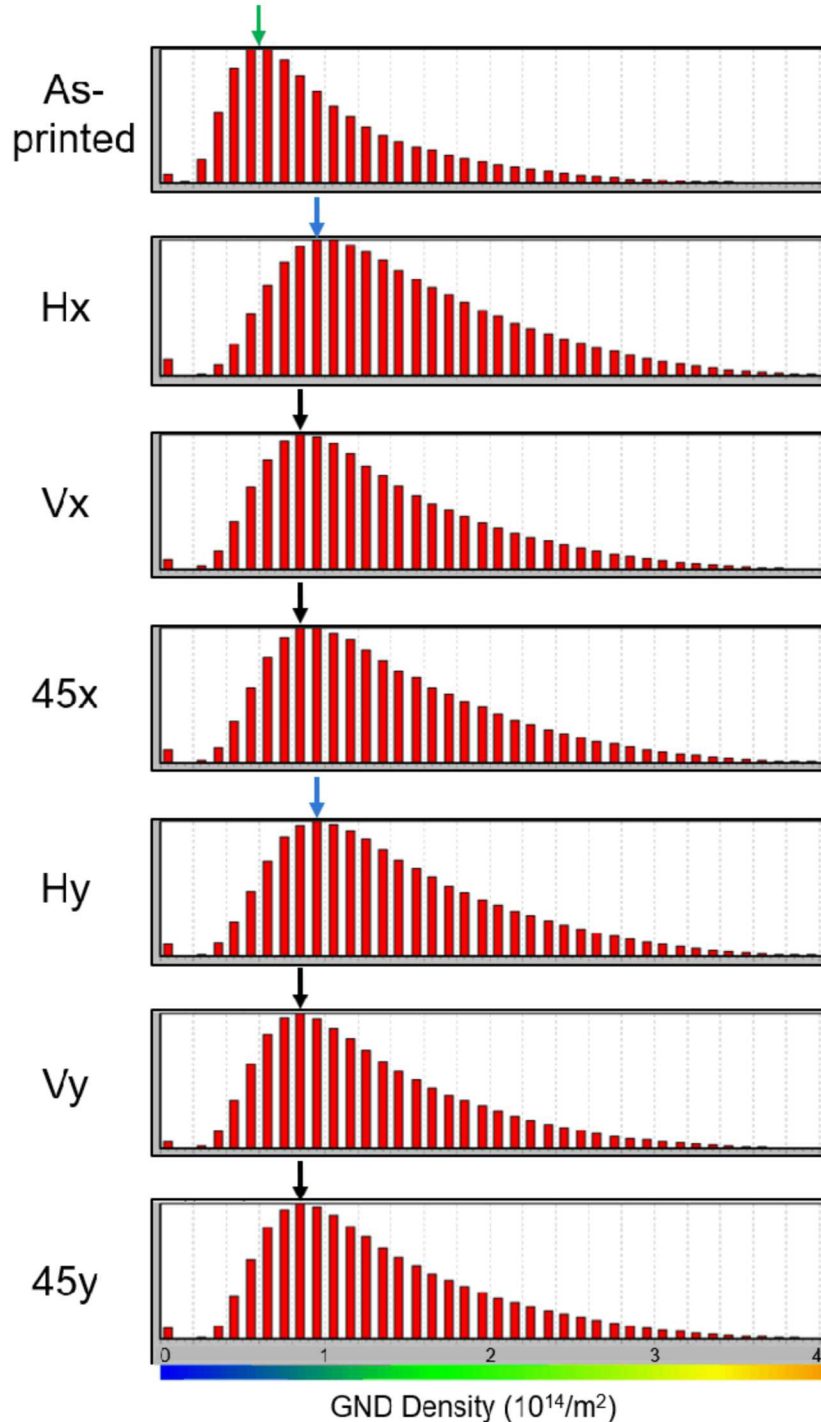
# GND density shift for horizontally-built samples

- As-printed part has much lower distribution of dislocations
- Slightly higher distribution of dislocations in horizontally-built parts compared to vertical and 45°

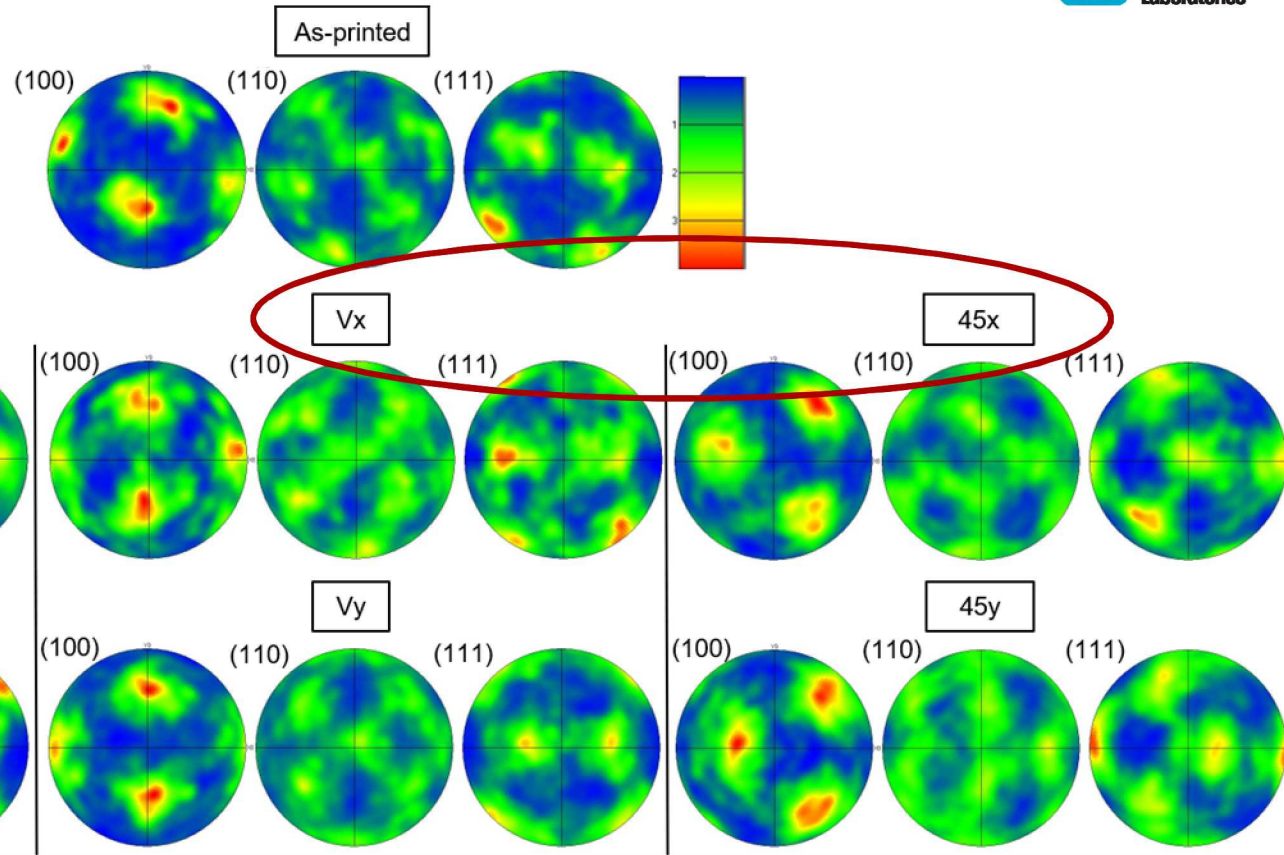
# Z-Plane Pole Figure

- H2, and V2 have similar textures
- H3-45 and V3-45 have similar textures
- V1 and As-printed are slightly rotated compared to H2 and V2
- H1 is very different
- Still doesn't explain why H2 and H3-45 have such reduced ductility

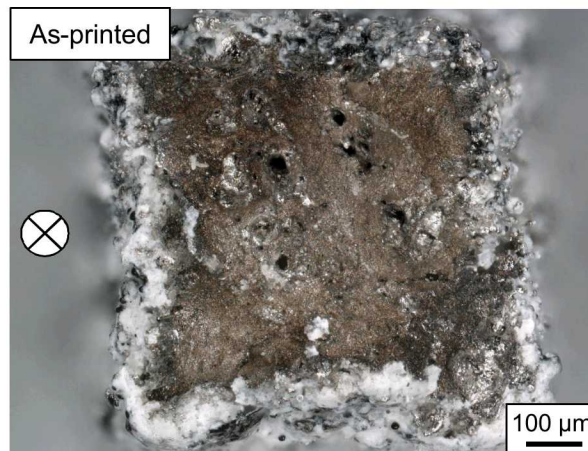
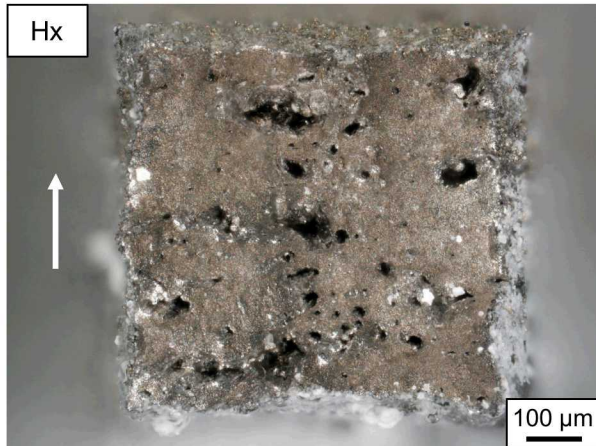
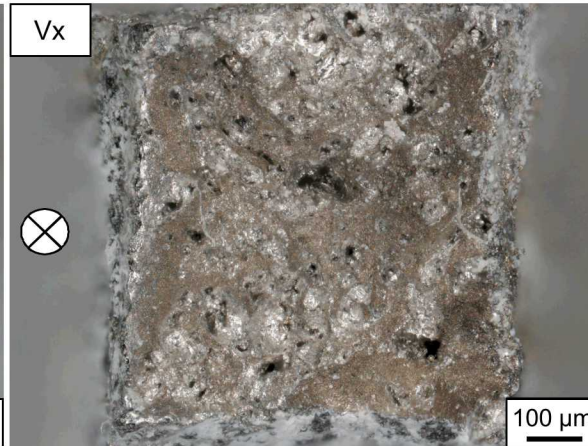
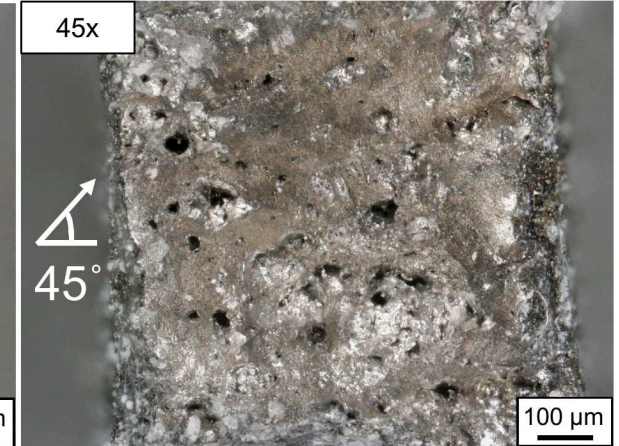
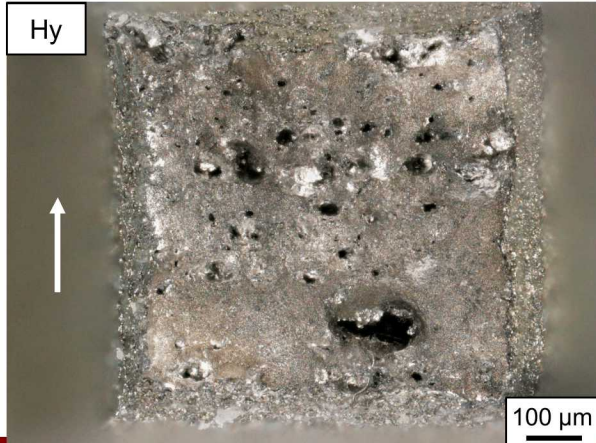
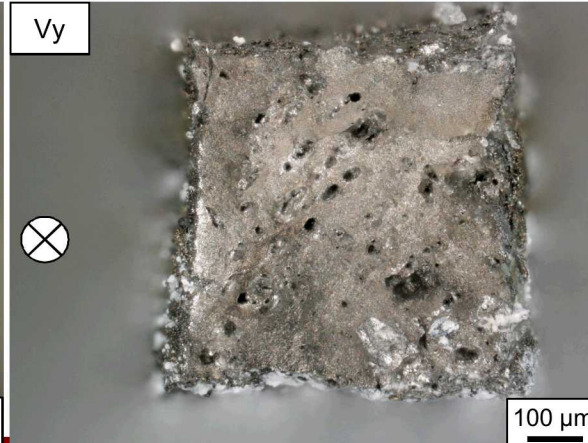
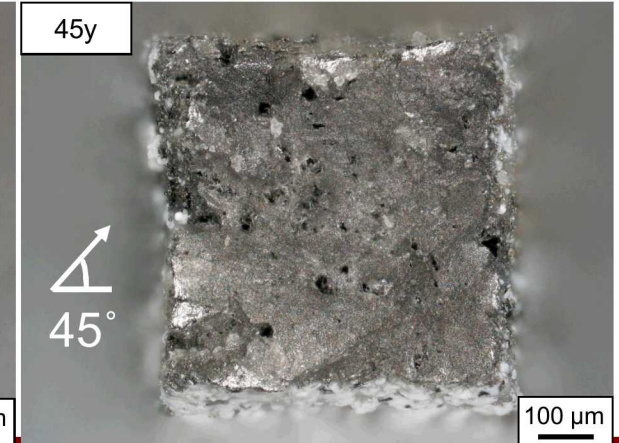
# Fractography

- 45° orientations fracture at that angle
- Out of page build direction  $\otimes$
