**Contamination Source Review for Building E5032,  
Edgewood Area, Aberdeen Proving Ground, Maryland**

## **Contamination Source Review for Building E5032, Edgewood Area, Aberdeen Proving Ground, Maryland**

*Contamination Source Review  
Edgewood Area, Aberdeen Proving  
Ground, Maryland —  
Building E5032*

September 1995

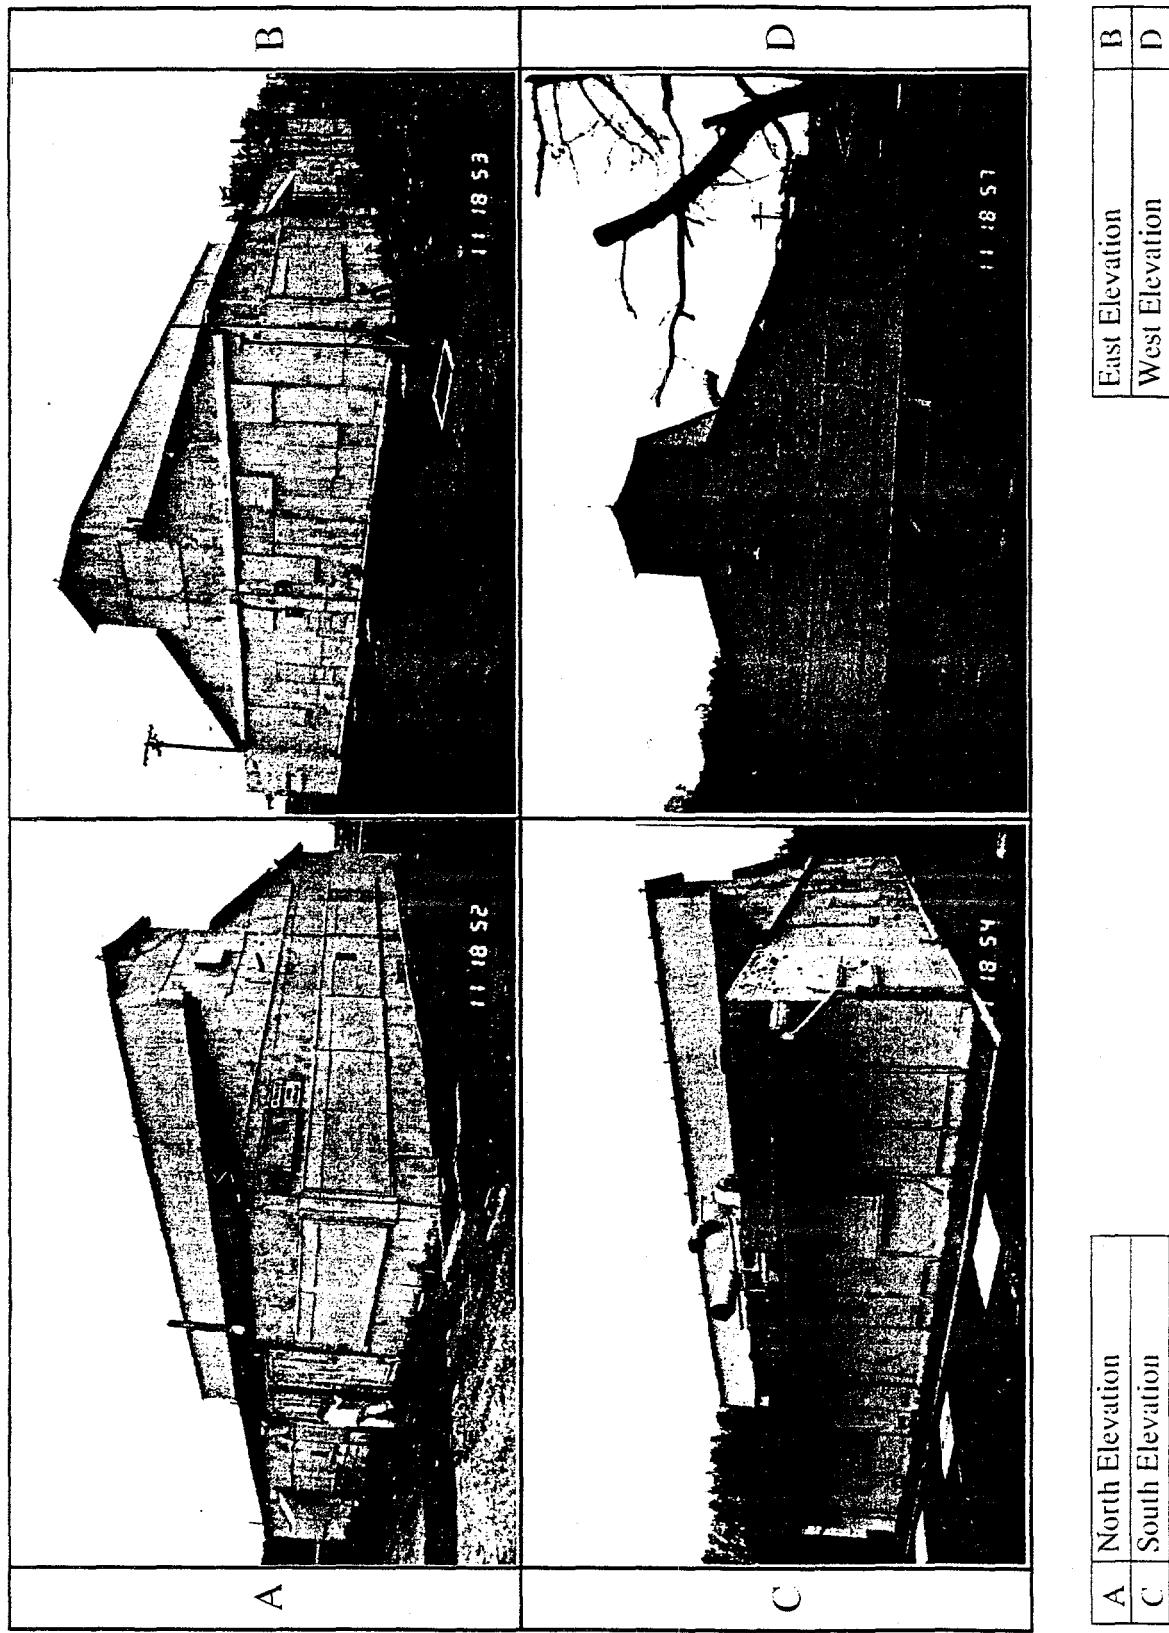
FIGURE 5 Photographs of Building E5032 Exterior

Numerous exterior concrete pads, sumps, aprons, and drainage ditches (troughs) were found near Building E5032. The building shows evidence of several major modifications during its history. The main building is constructed of a vertical I-beam steel structure with steel roof trusses. The exterior of the main building is covered by corrugated sheet metal. Numerous holes of varying sizes indicate that piping once passed through the exterior walls of the building. An addition along the south side of the main building, constructed of cinder blocks, consists of four small cubicles. These cubicles are accessible only through exterior double doors located at the center of each cubicle. Outside of the cubicles, a concrete slab extends approximately 6 ft to the south and 10 ft to the west. A 6-in.-high concrete curb frames the concrete slab on the east and south edges. Figure 3 shows a plot plan of Building E5032 and its vicinity. Figure 4 shows a floor plan of Building E5032, developed at the time of ANL's inspections. Photographs of the building exterior are presented in Figure 5.

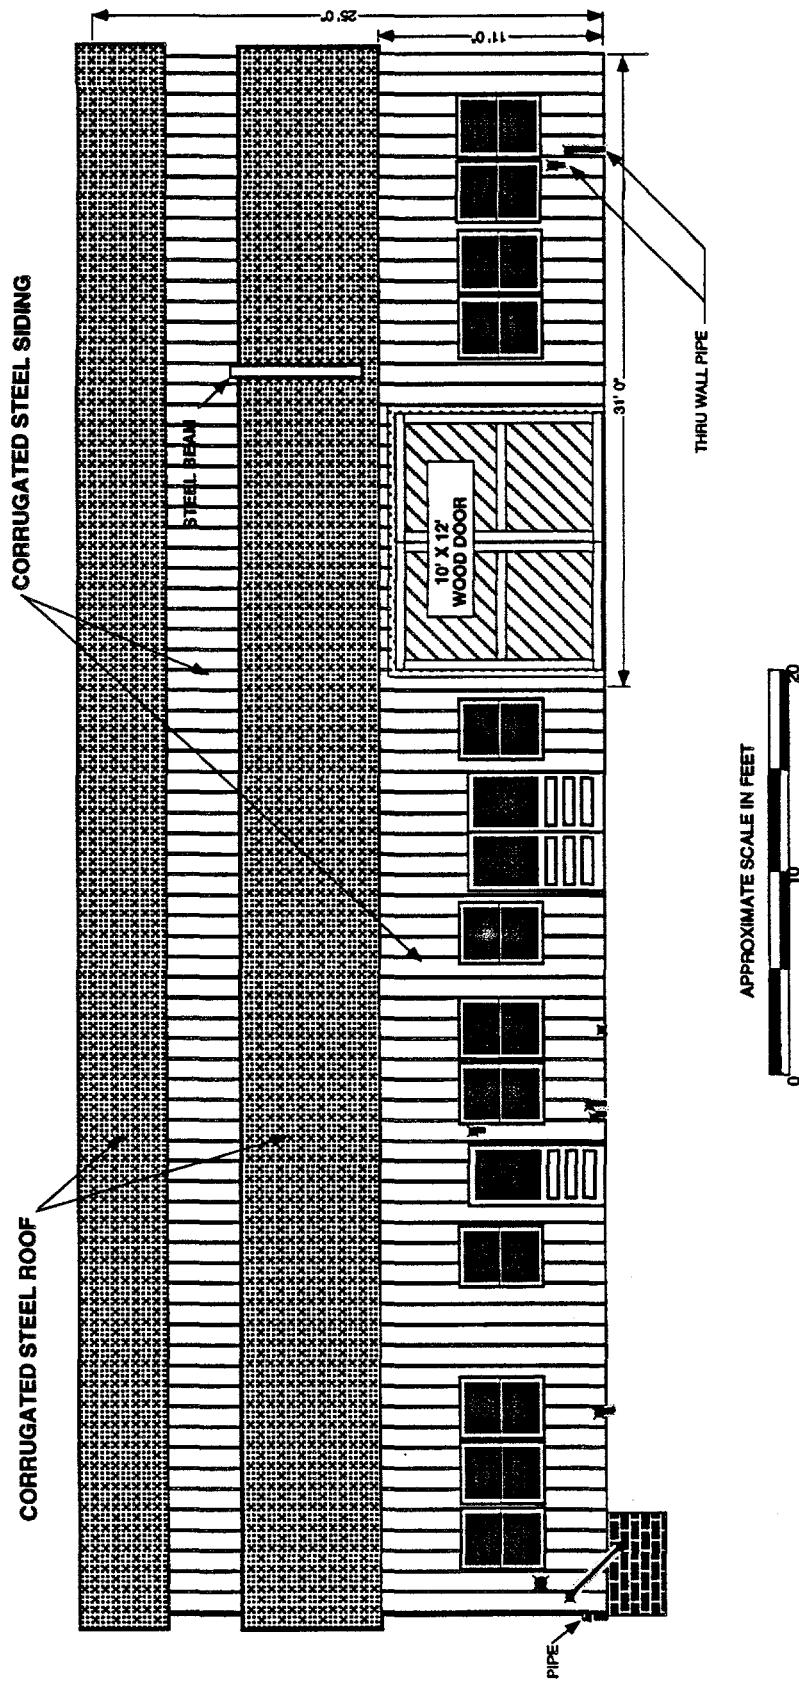
FIGURE 6 Building E5032 North Exterior Elevation

Remnants of pipes were observed along the north elevation (Figure 6).

The north exterior wall of the building (corrugated metal sheet) is severely deteriorated and, in some areas, rusted through. The doors and windows have also deteriorated.

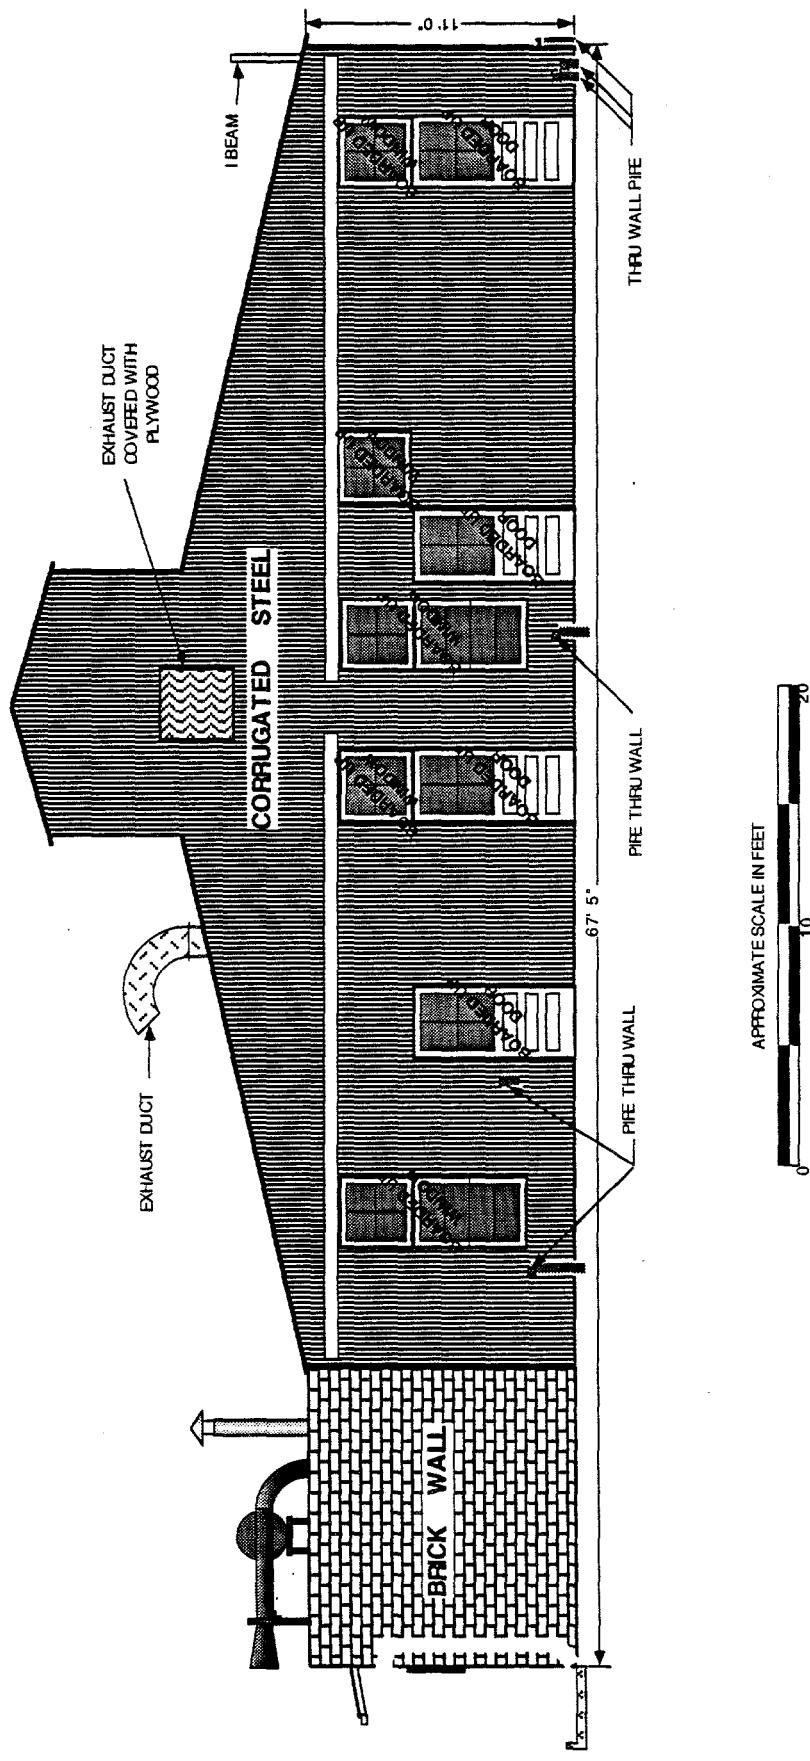
FIGURE 7 Building E5032 East Exterior Elevation

Remnants of pipes were observed on the east elevation (Figure 7).

The east exterior wall of the building (corrugated metal sheeting) is severely deteriorated and, in some areas, rusted through. The doors and windows have also deteriorated.

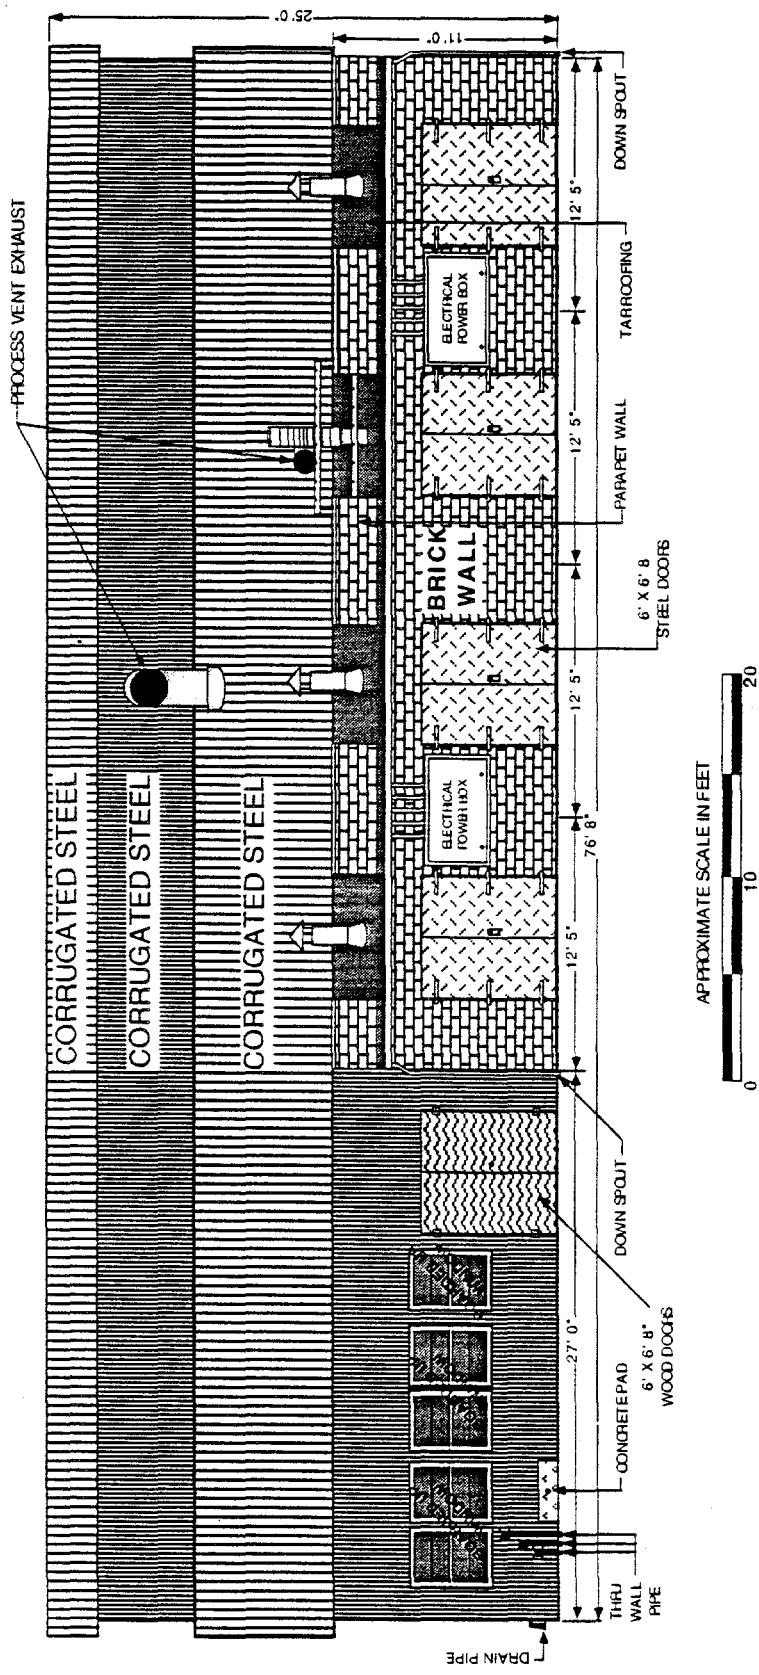
FIGURE 8 Building E5032 South Exterior Elevation

Remnants of pipes were observed on the south elevation (Figure 8).

The south exterior wall of the building (corrugated metal sheeting) is severely deteriorated and, in some areas, rusted through. The doors and windows have also deteriorated.

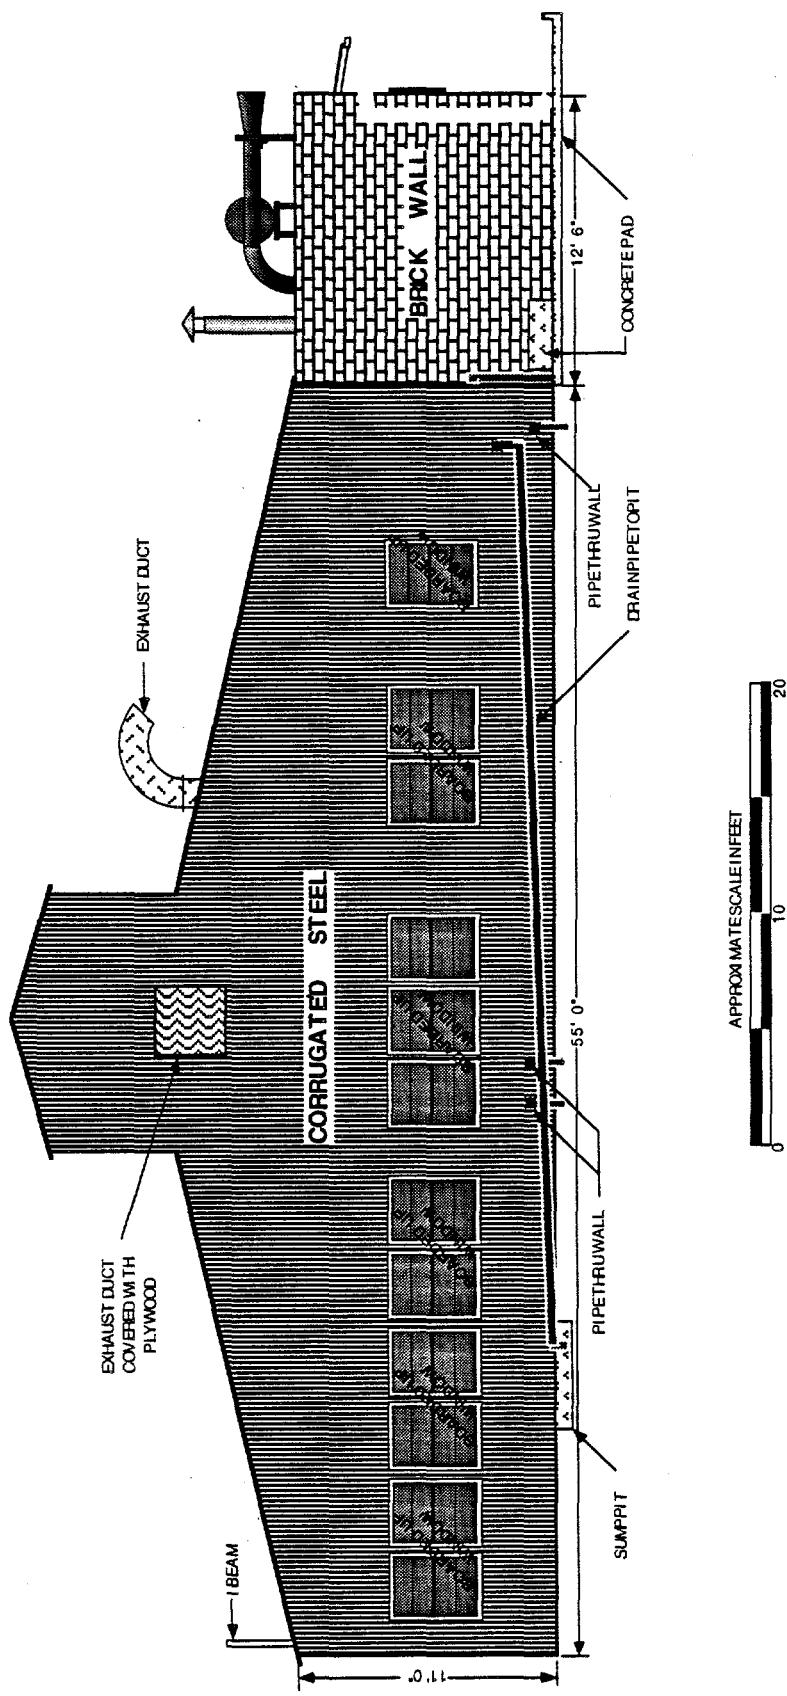
FIGURE 9 Building E5032 West Exterior Elevation

One drainage pipe leads to the sump pit. Other remnants of pipe were also observed (see Figure 9).

The west exterior wall of the building (corrugated metal sheeting) is severely deteriorated and, in some areas, rusted through. The windows have also deteriorated.

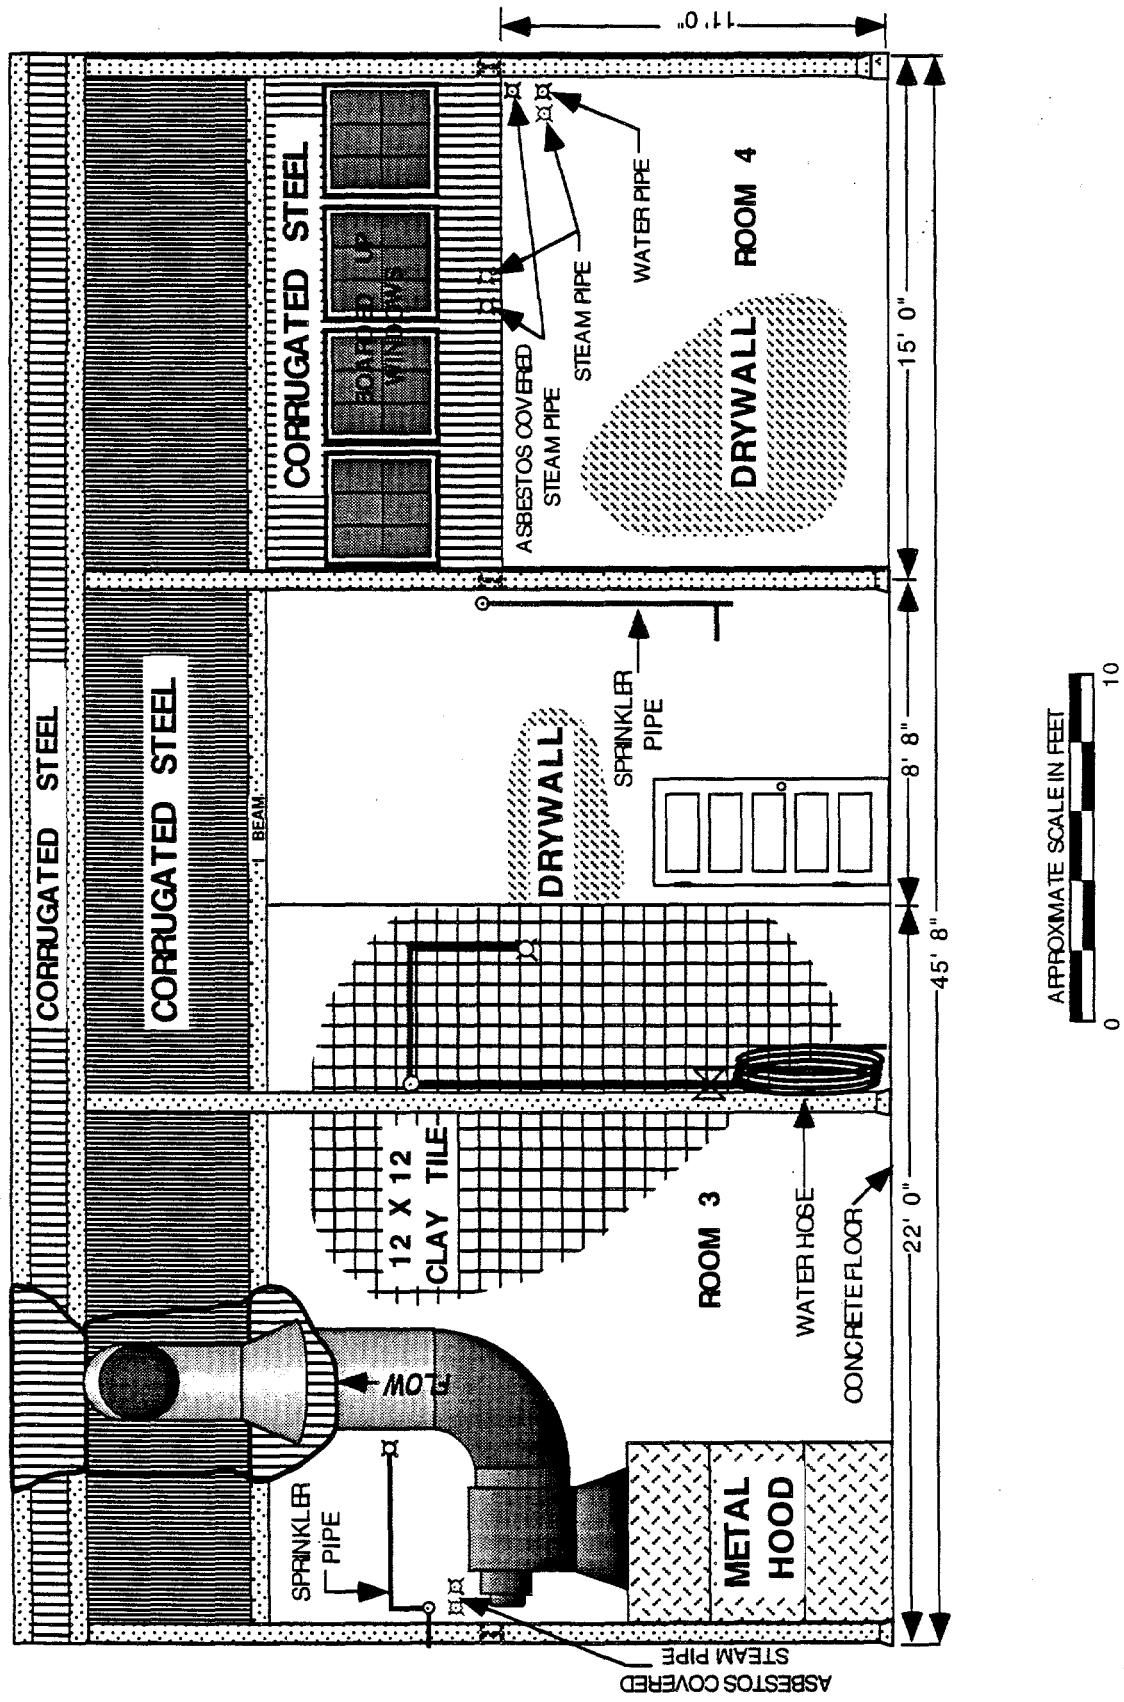
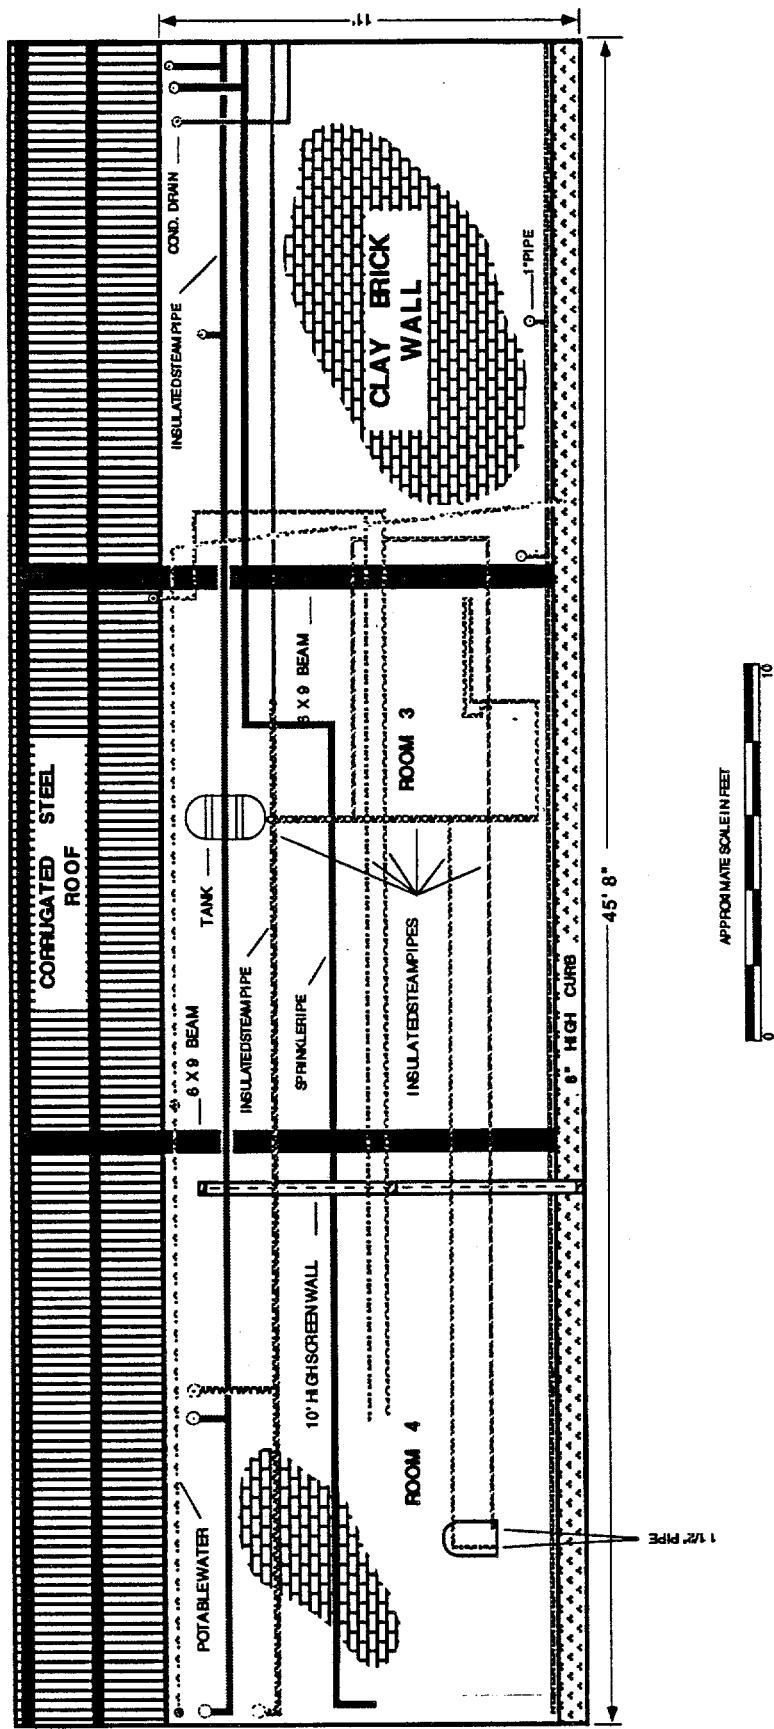
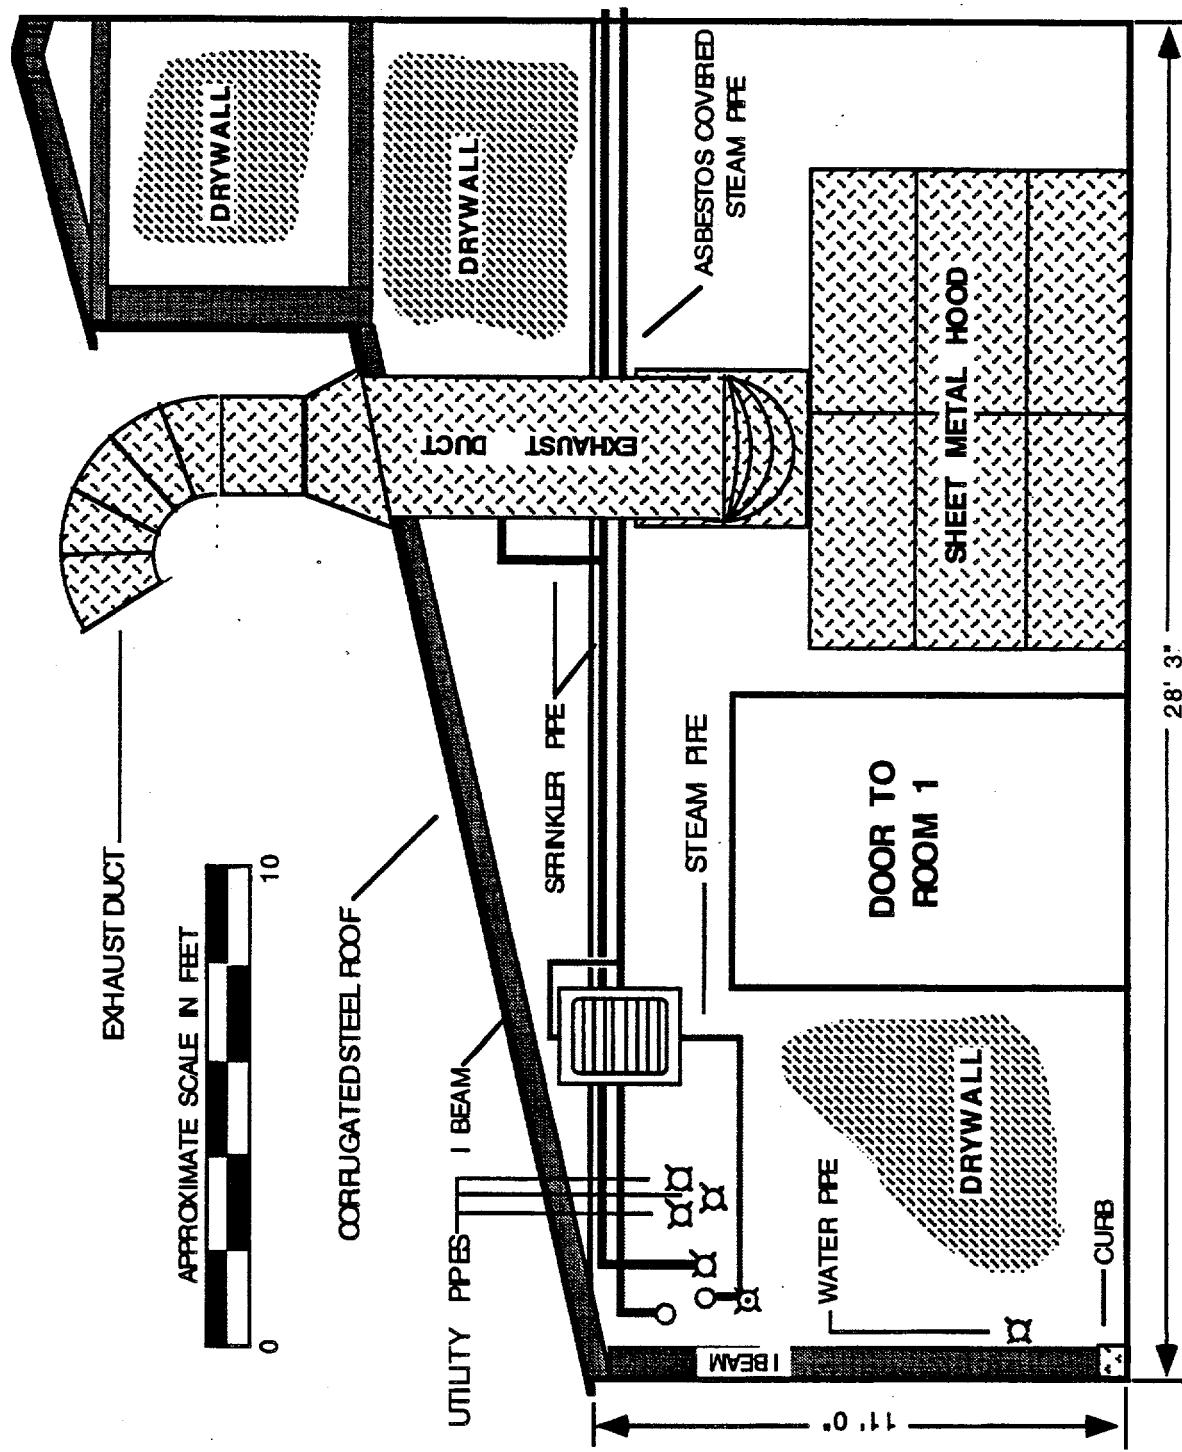
Room 3 contains various piping systems; many of the pipes were observed on the south wall (see Figures 22 through 24).

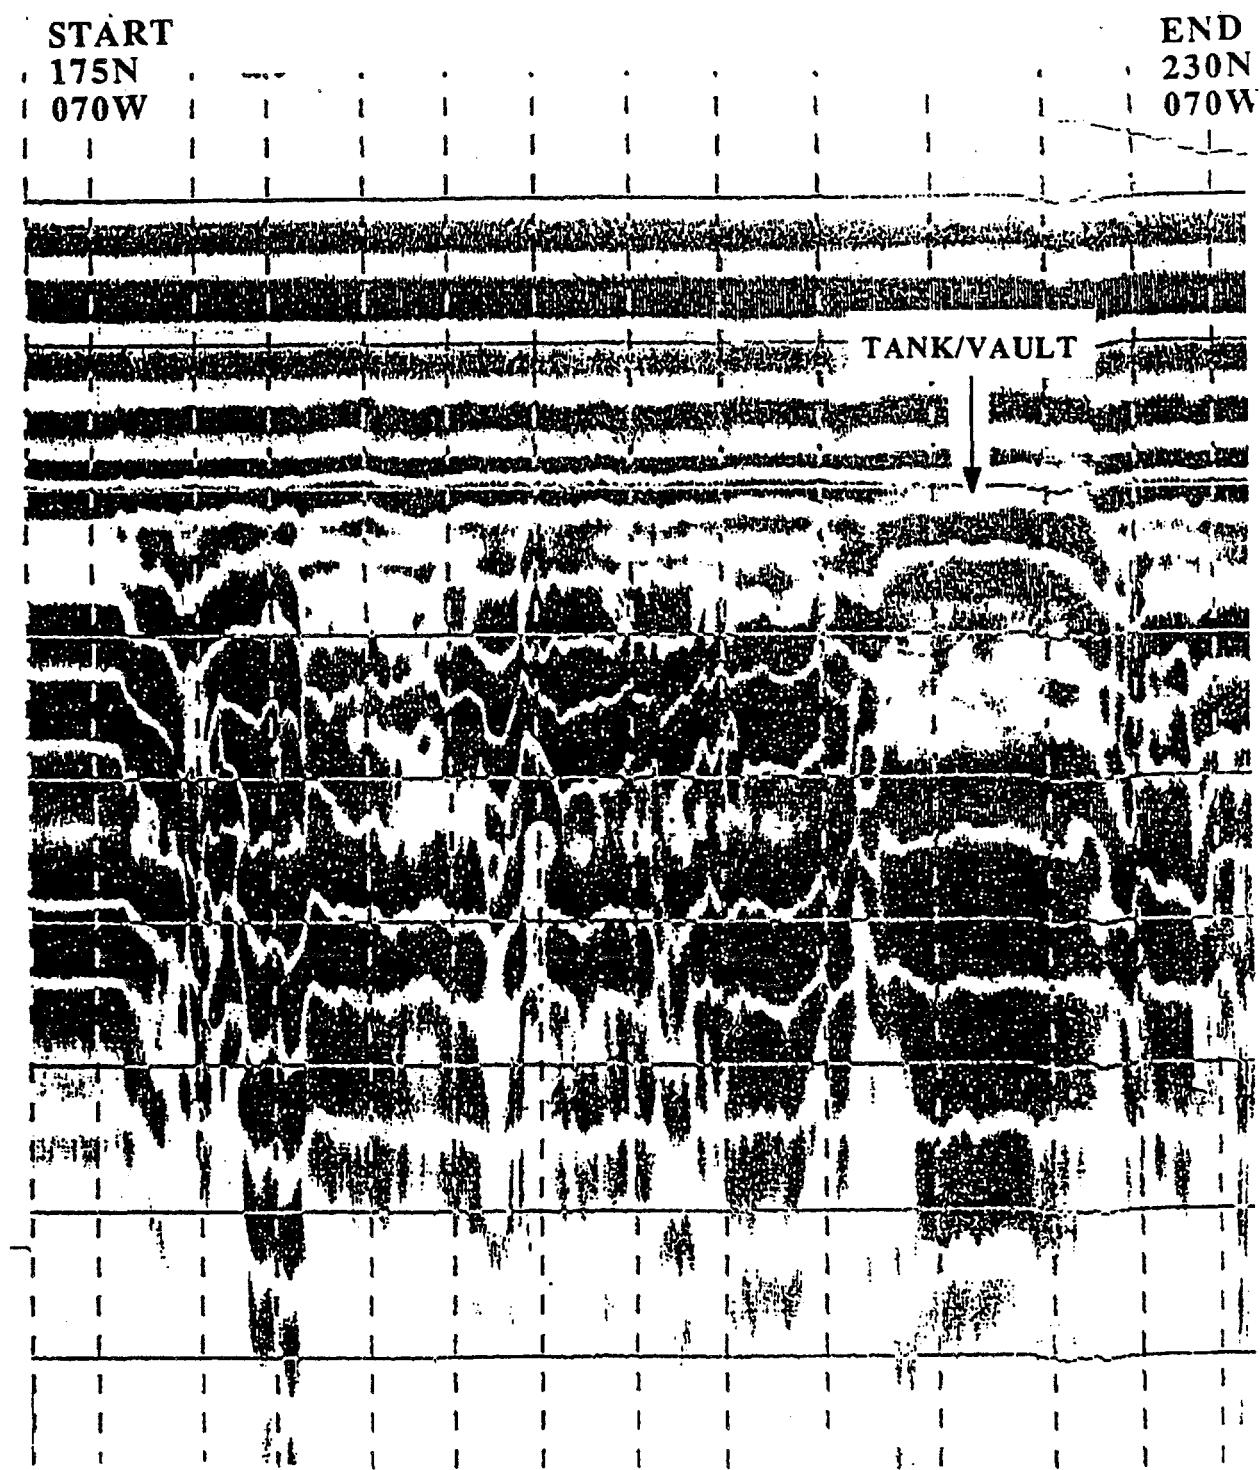
FIGURE 4 Ground-Penetrating-Radar (GPR) Signature over Buried Tank or Vault Centered at Coordinates 220N,065W along North-South Axis of the Object

- Geophysical measurements from magnetics, GPR, and resistivity survey data collected over a buried concrete slab approximately 130 ft north of Building E5032 reveal geophysical signatures interpreted to be caused by a large iron tank or vault. This feature may be the remnant of Building 91.
- Three magnetic anomalies centered at approximately 30 ft north and 10 ft west, 45 ft north and 10 ft west, and 45 ft north and 50 ft west (measured from the northeast corner of the building) appear to be caused by buried tanks.
