Assessment of Isolator Units Following Shock Testing

P. Vianco, S. Dickens, and C. Jaramillo

Sandia National Laboratories

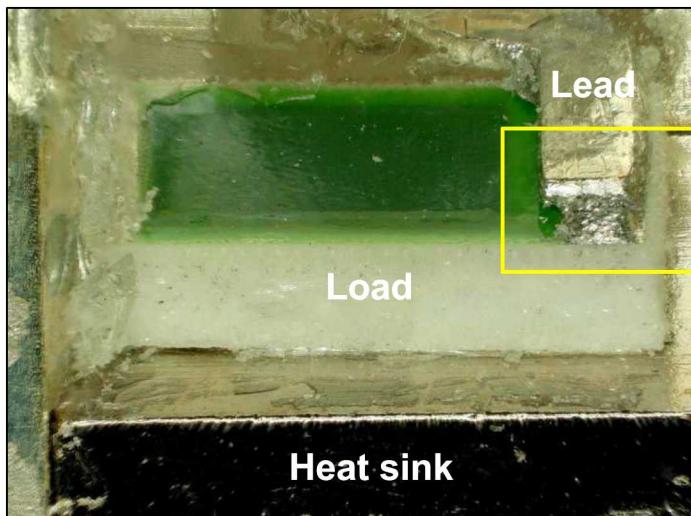
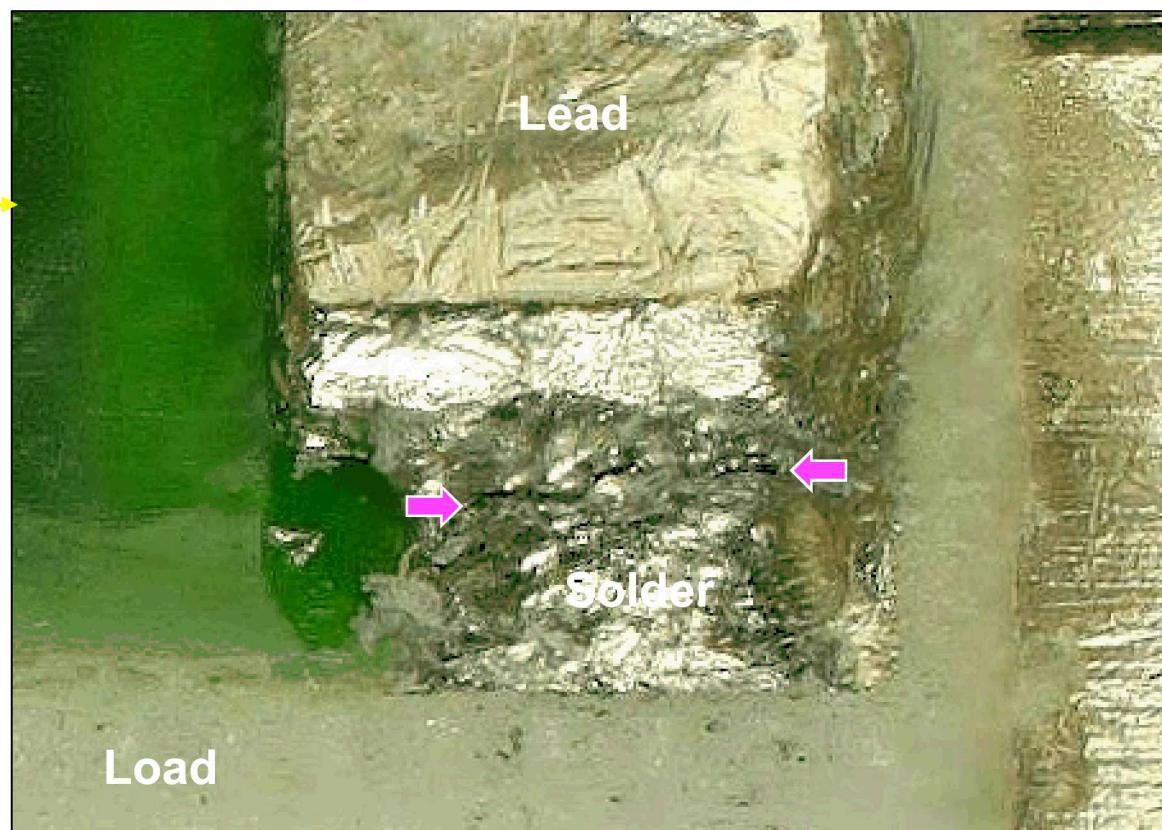
- ◆ The high-magnification photograph shows a crack (magenta arrows) in the solder fillet, which pinpointed the potential anomaly that was responsible for the electrical failure.

The vendor's technique for removing the RTV was particularly harsh, leaving many artifacts on critical areas of the solder joint.

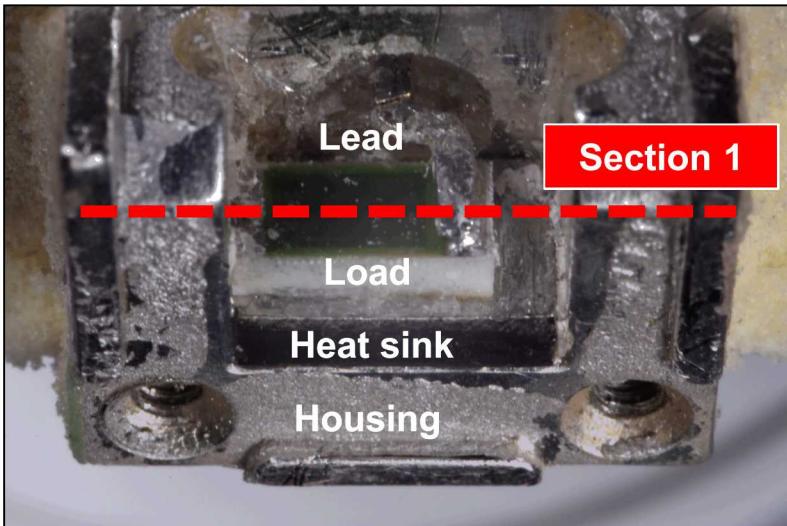
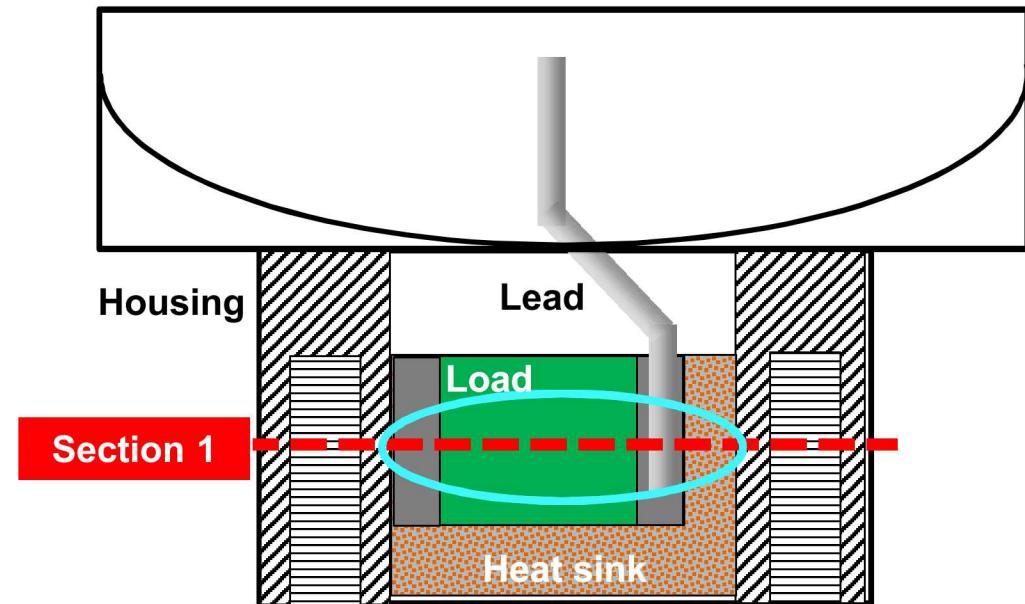
- Photograph (angle view) and schematic diagram (top-down view) show the isolator and the location of the cross section.

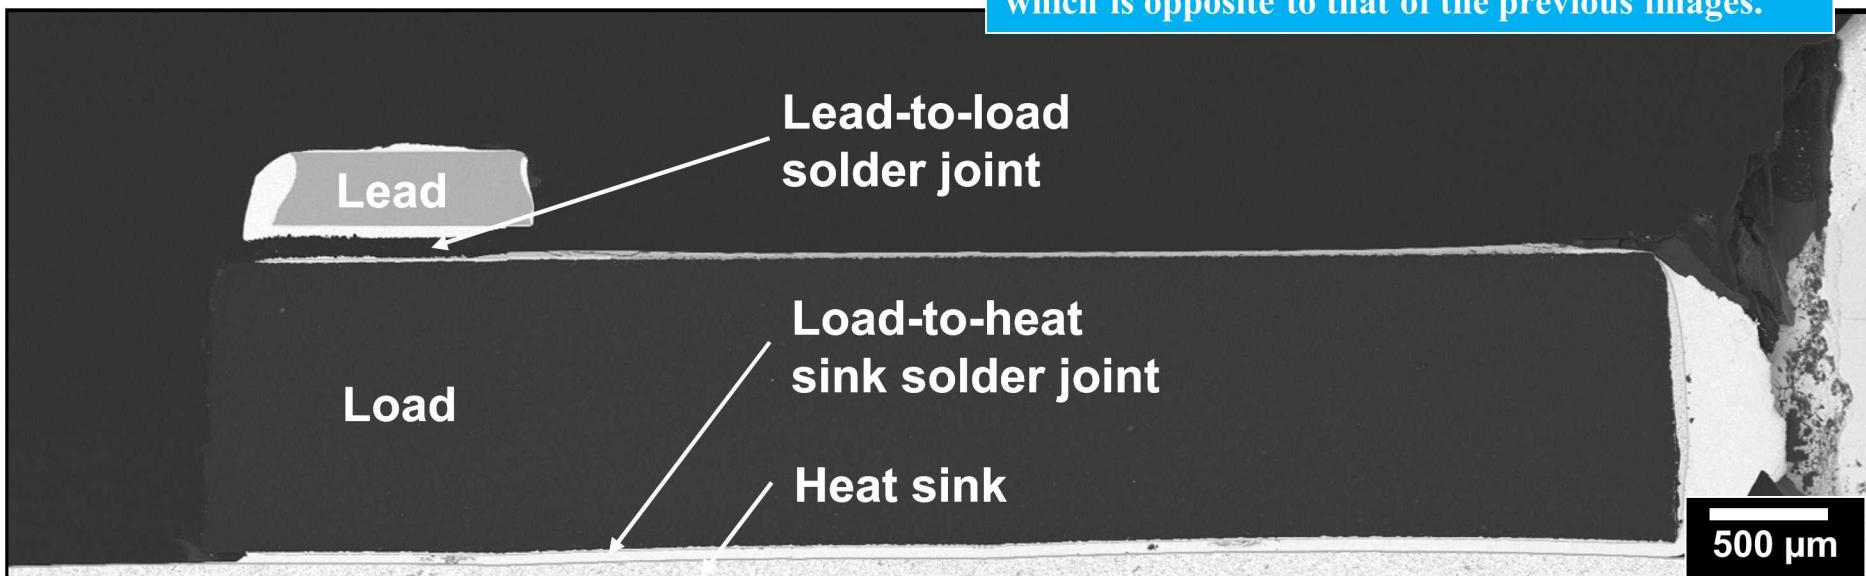
- ◆ The SEM montage shows the lead, the load, and the heat sink as well as the lead-to-load and load-to-heat sink solder joints.
 - The lead-to-load solder joint has failed, completely.
 - The load-to-heat sink solder joint showed excellent integrity.
 - Damage was not observed to the lead or to the load component.

The direction of view is from the back to the front, which is opposite to that of the previous images.

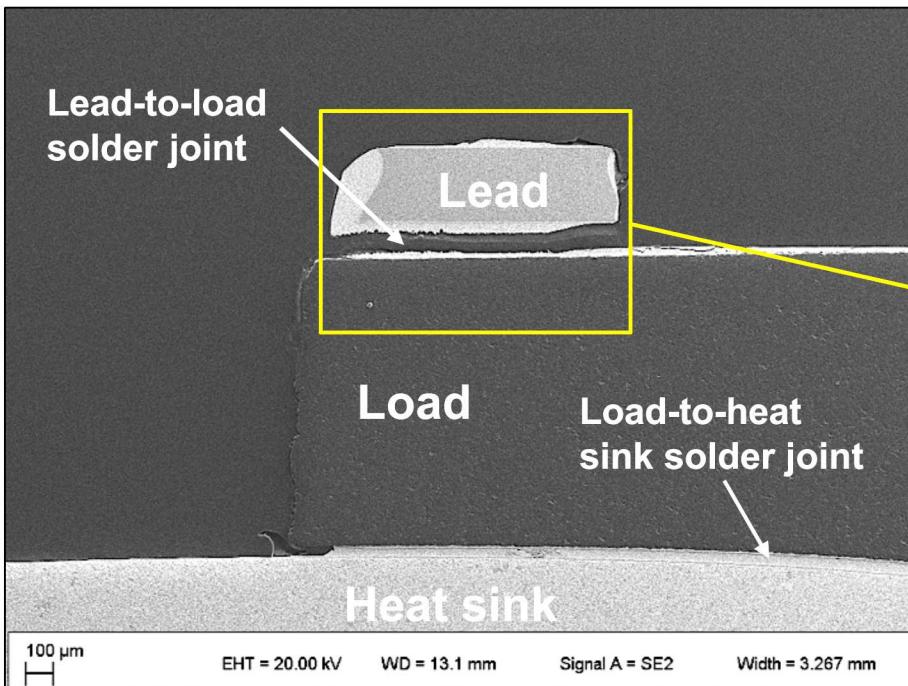
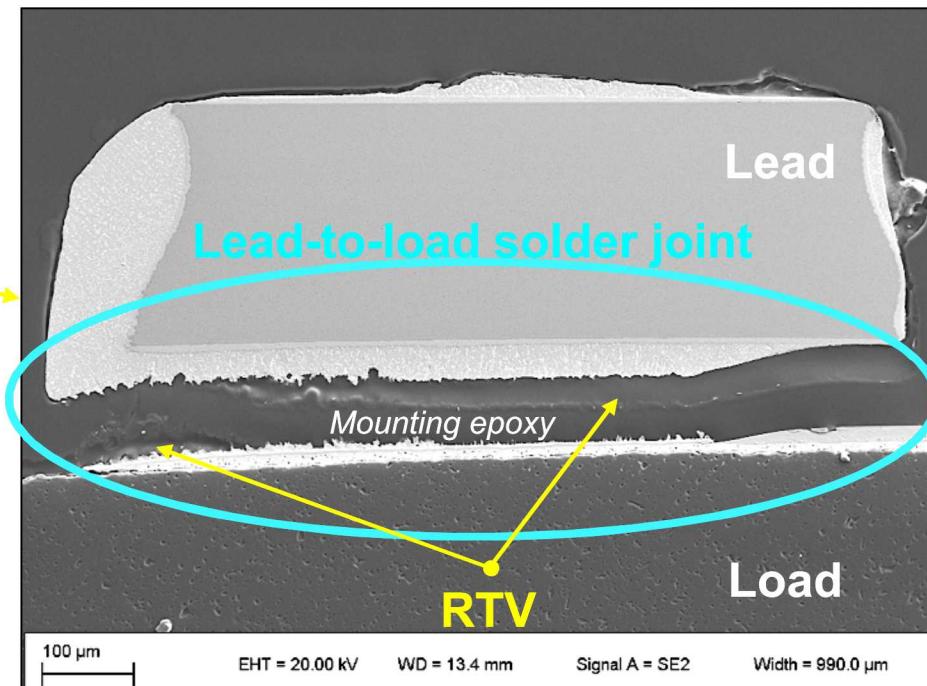
- ◆ The photographs show the failure of the lead-to-load solder joint.
- ◆ Of particular note was the presence of RTV in the gap.
 - The RTV was distinguished from the mounting epoxy that flowed into the gap during the pre-potting, sample preparation process step.

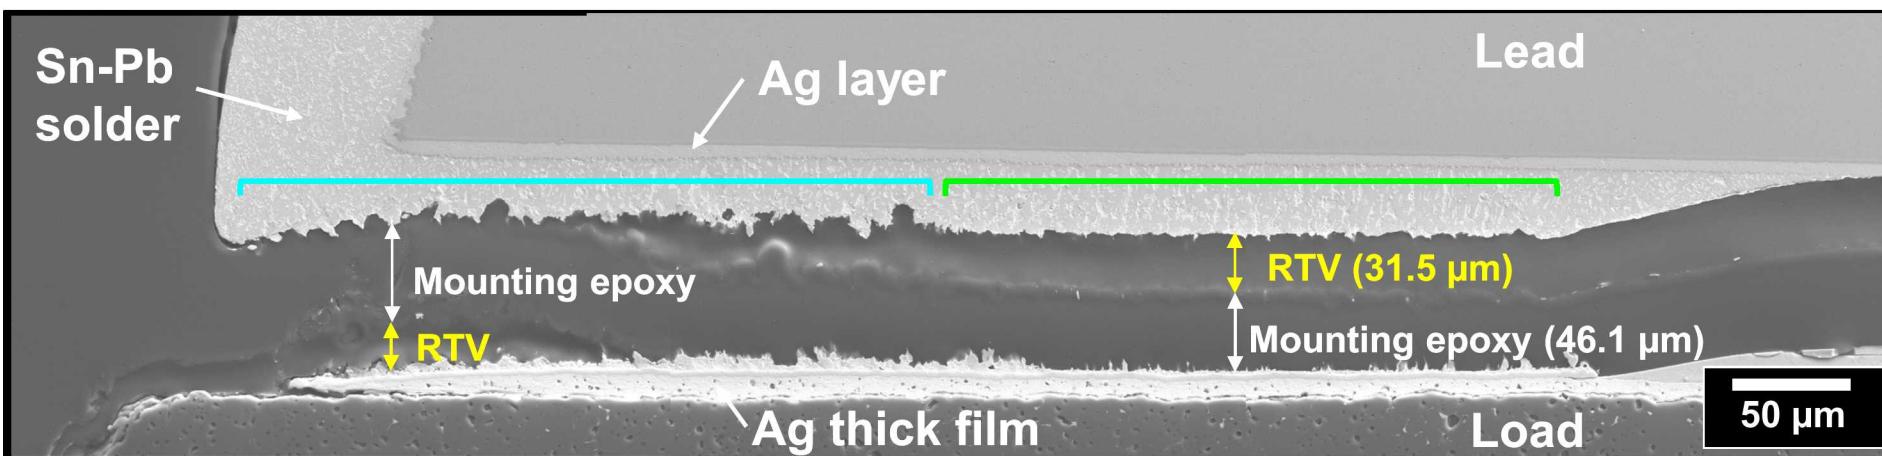
- Two morphologies were observed for the fracture surface both of which, indicated a **tensile overload stress** placed on the joint.
 - Green bracket**: relatively fast stain rate due to the crack path being located at the immediate solder/thick film (Ni layer) interface.
 - Cyan bracket**: relatively slow stain rate indicated by the crack path moving towards the center of the gap and increase plastic deformation.

- Assuming that the RTV thickness represents the original gap created by the separation, **the crack propagated right-to-left**.

- ◆ **Root-cause:** The solder joint was subjected to a tensile, overload stress that failed the Sn-Pb solder.
 - The presence of RTV in the solder joint gap implies that the overload stress and failure occurred prior to the introduction of RTV into the “room.”
 - The separation was widened further by the test regiments.
 - Note that metallographic cross sections represent a single plane; therefore, electrical conductivity (DC) could have been maintained at an unseen location into/out-of that plane.
 - The defect, or any evidence that would support a high likelihood of its recurrence in the future, was not detected in the other two units.

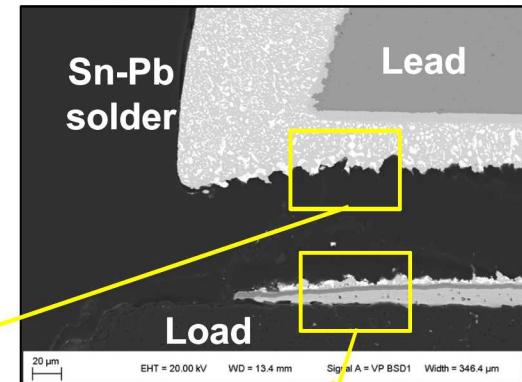
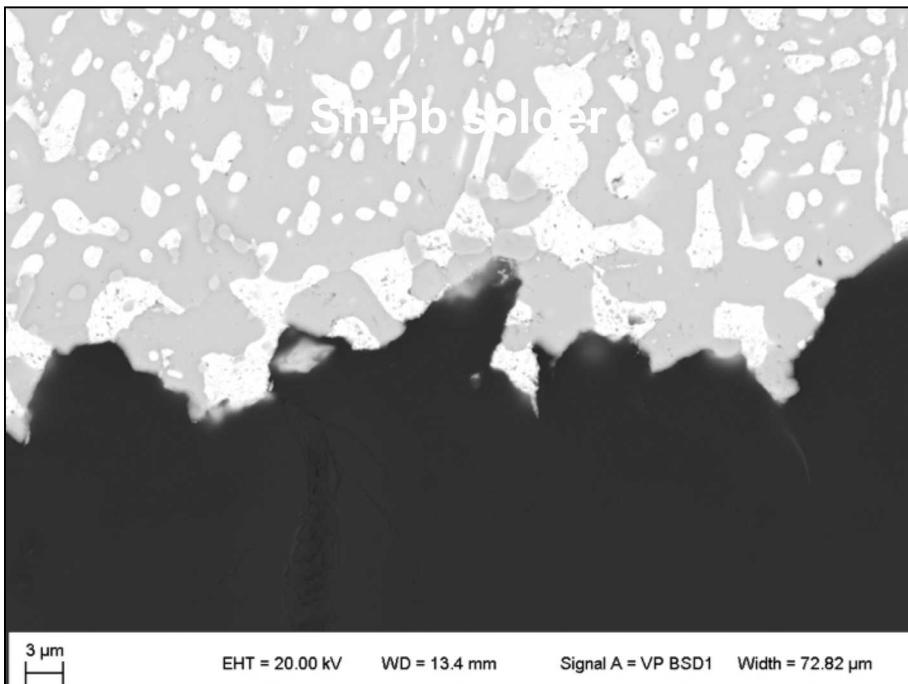
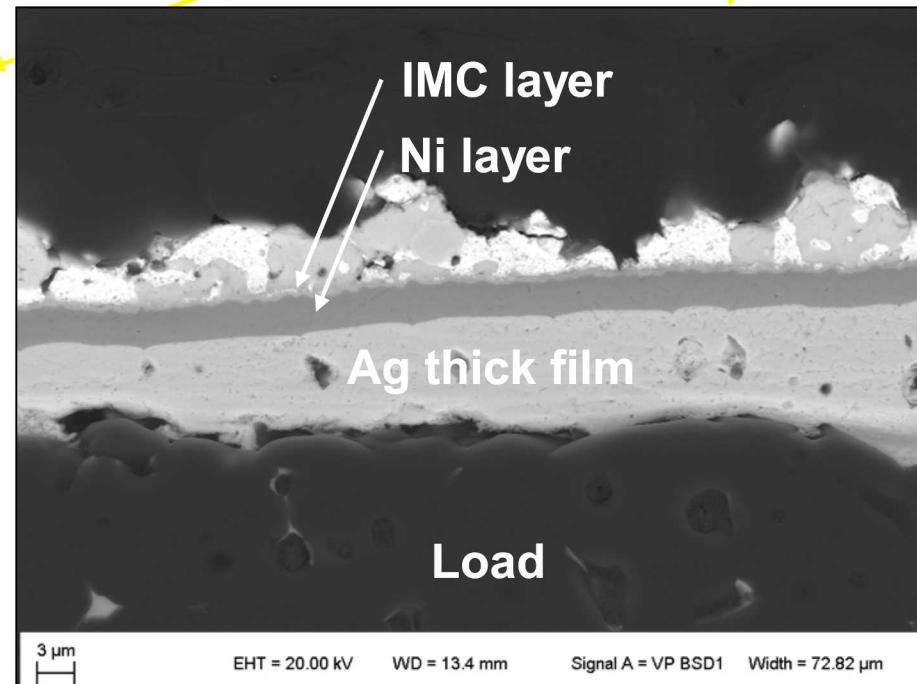
- ◆ A closer examination did not detect a defect in the materials set or solder assembly process.
- ◆ The Sn-Pb solder showed significant ductility and negligible Pb-rich coarsening, confirming *time-independent deformation*.

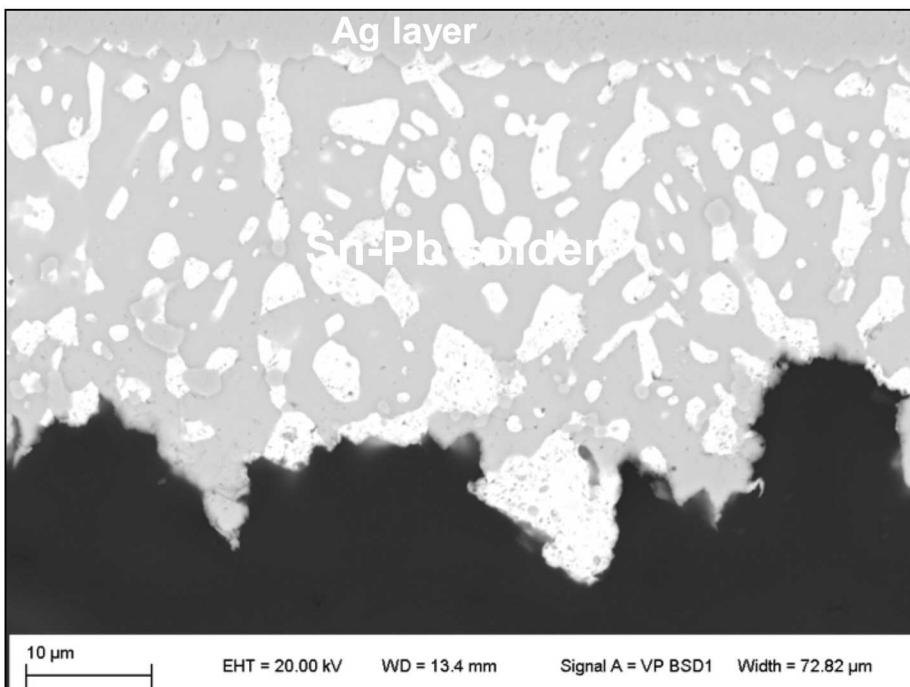
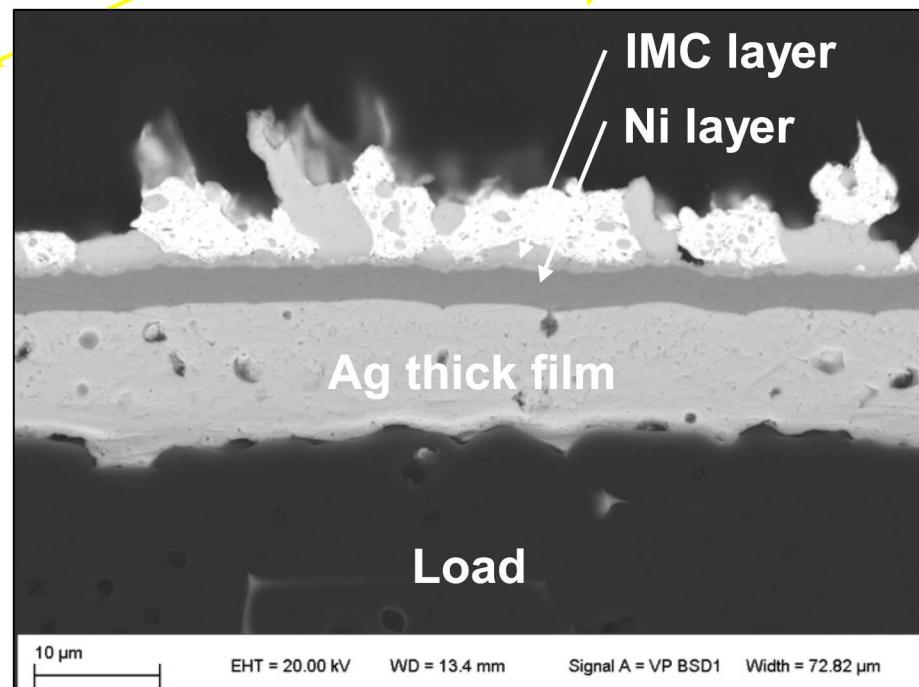
- ◆ A similar conclusion was drawn at this location of the fracture path, which marked the transition between the two morphologies.

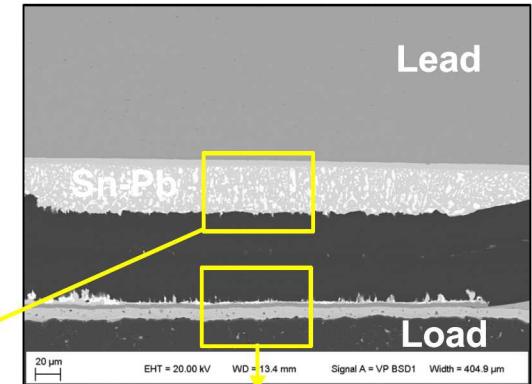
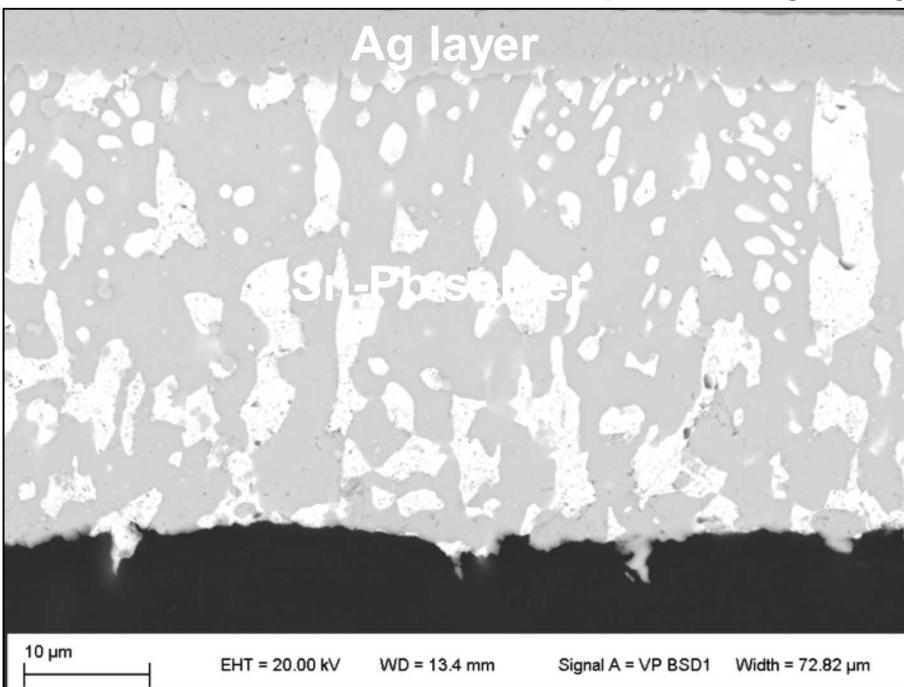
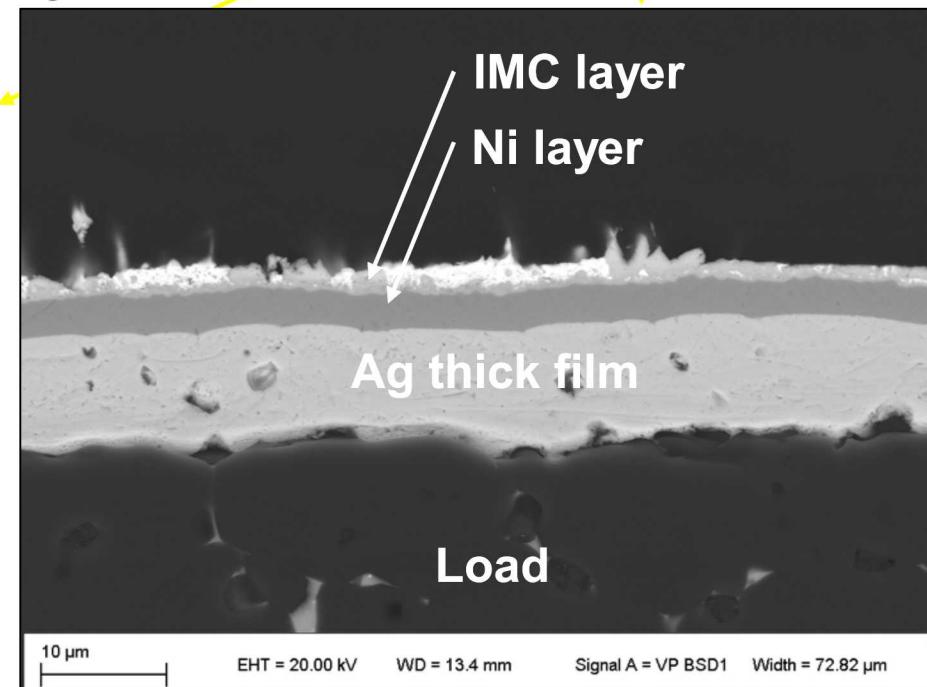
- ◆ The failure mode, although still based upon time-independent deformation, occurred at a faster strain rate.
- ◆ Although positioned closer to the interface, the fracture was not augmented by the presence of the intermetallic compound (IMC) layer.

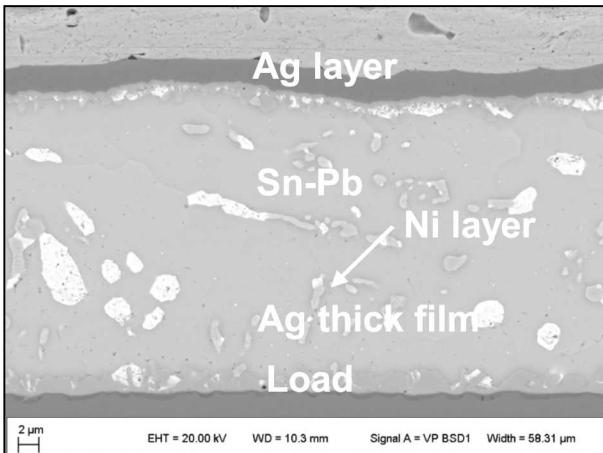
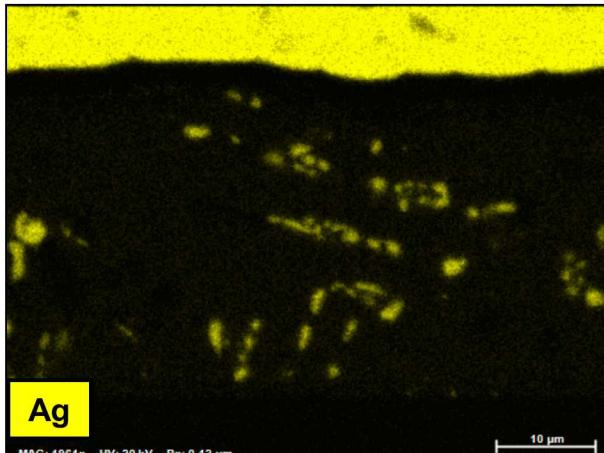
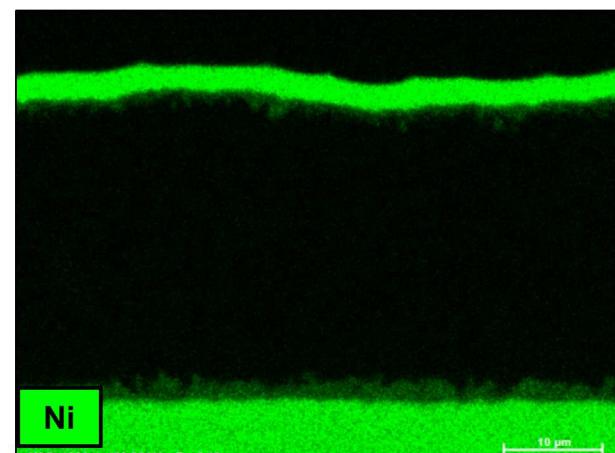
- ◆ The load-to-heat sink solder joint exhibited *excellent integrity*.
 - The Ni layer did not experience delamination from the the heat-sink.

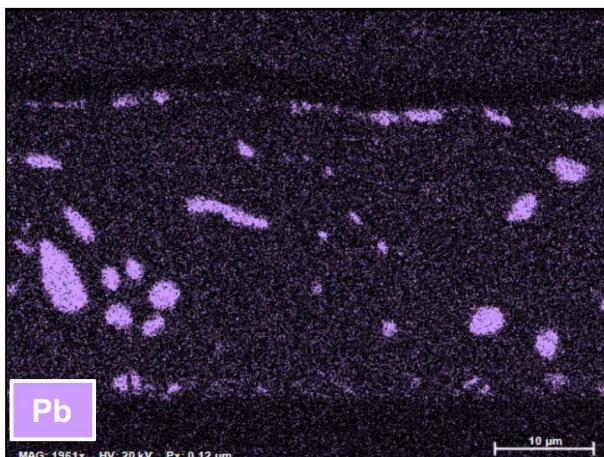
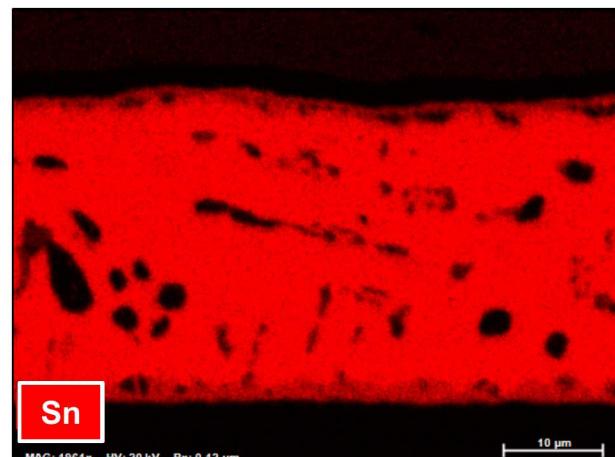
The Sn-Ag solder was contaminated with Pb from the soldering iron.

The extent of Pb *will not* degrade the long-term reliability of the joint.

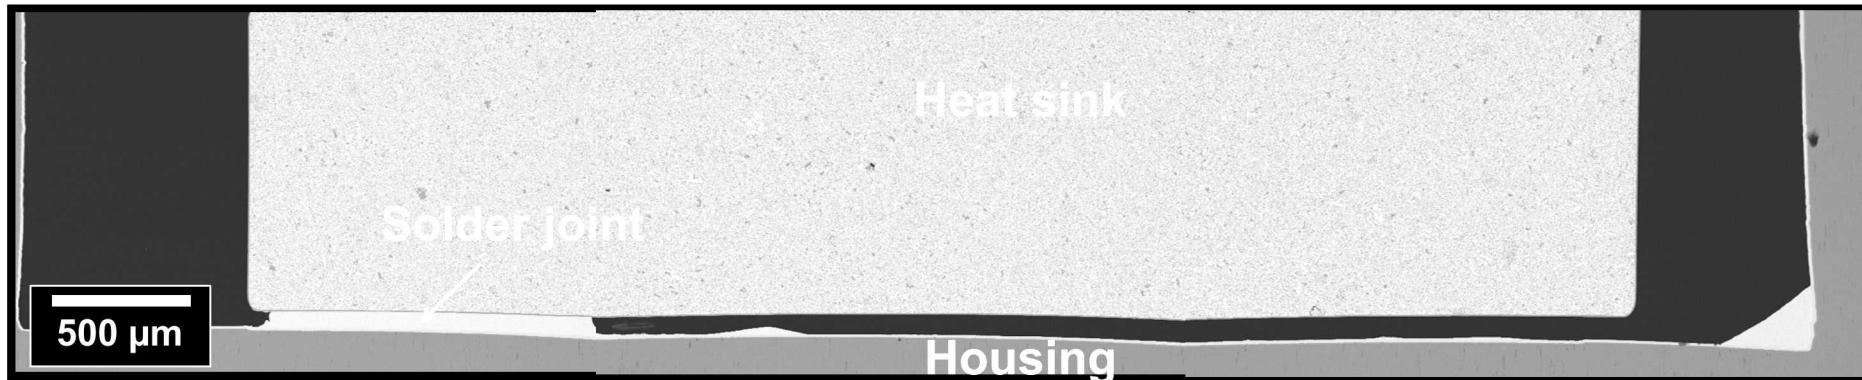
- ◆ A significant extent of filler metal was missing from the the heat sink-to-housing solder joint.
 - The portion of the solder joint, which was present, showed good solderability and an absence of defects.

All three instances of an incomplete heat sink-to-housing solder joint indicated simply *a lack of filler metal supplied to the joint* – evidence was not apparent at this point that there was a solderability problem with the surfaces of either the heat sink or the housing, which both had Ni solderable layers.

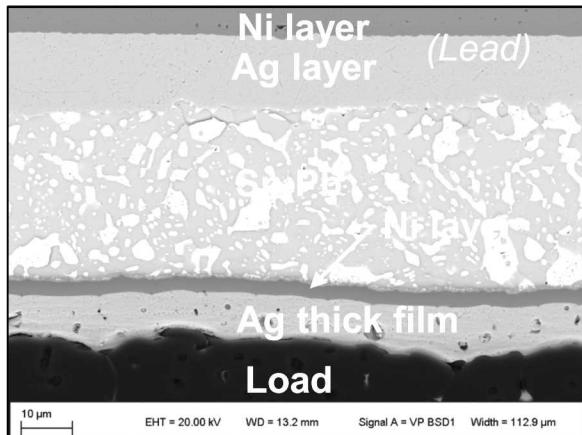
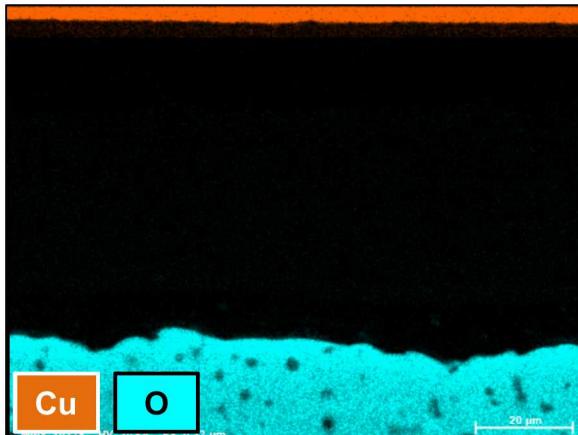
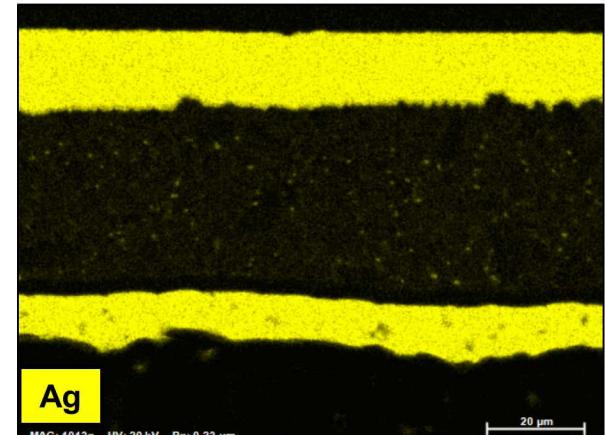
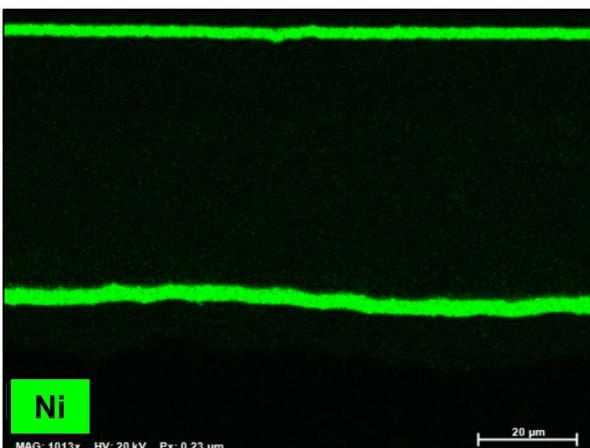
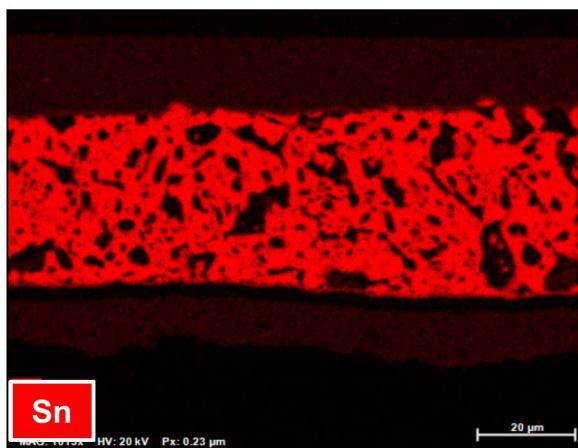
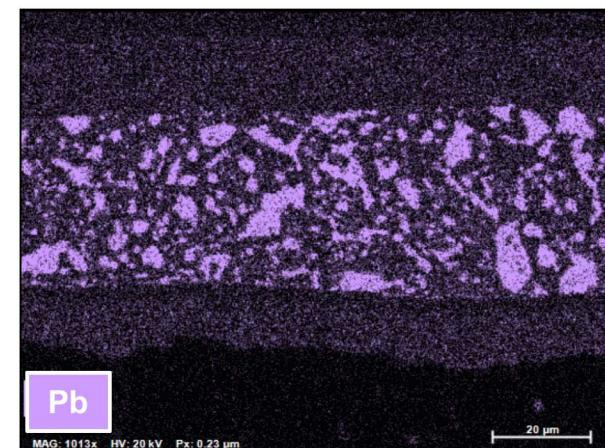
- ◆ The EDX analysis confirmed the composition of the solder joint structure between the lead and the load.

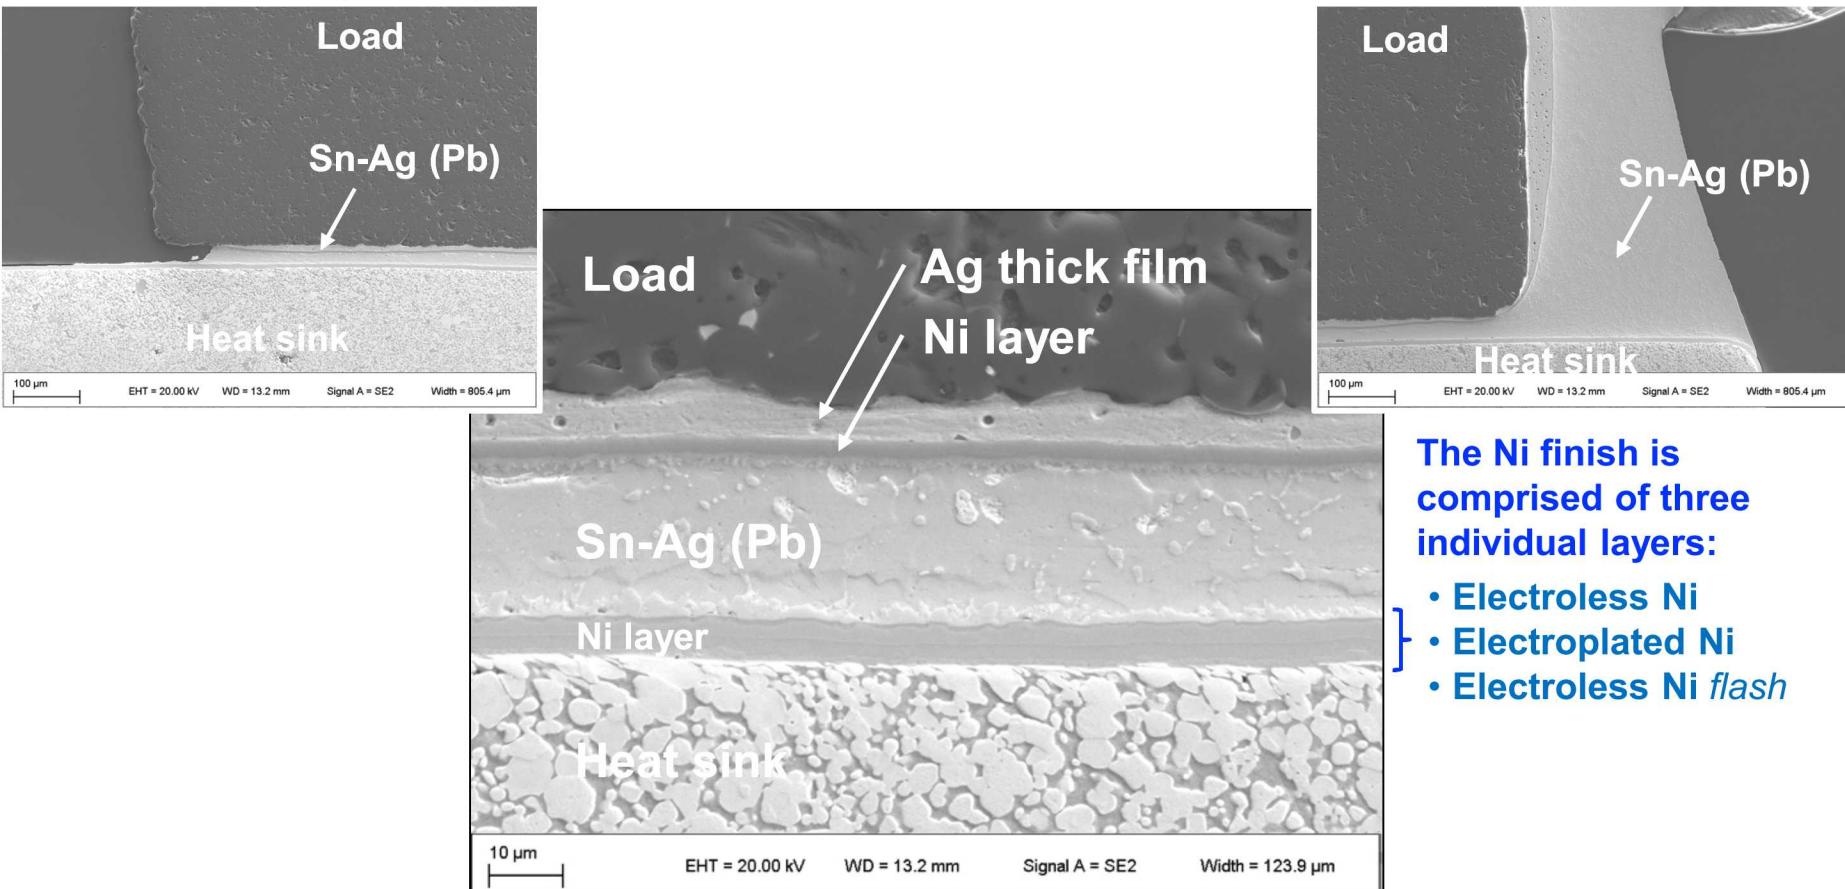
- ◆ The load-to-heat sink solder joint showed excellent integrity.
 - Past problems have been remedied with respect to poor Ni plating adhesion to the heat sink surface.

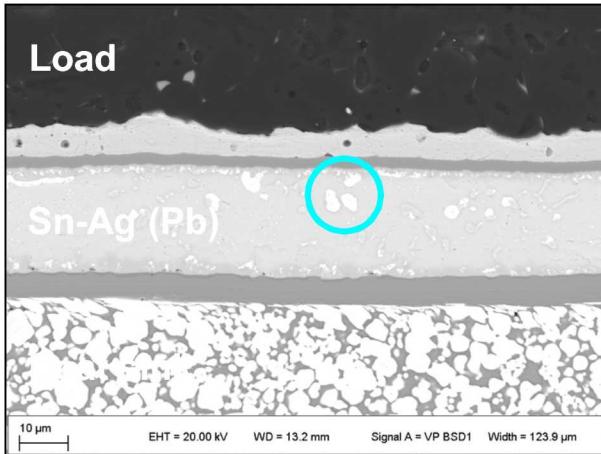
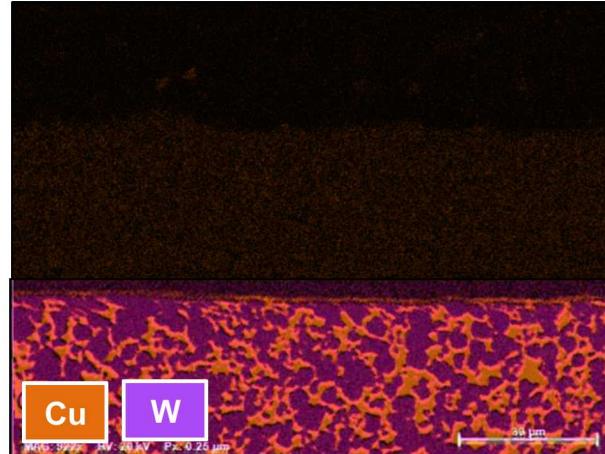
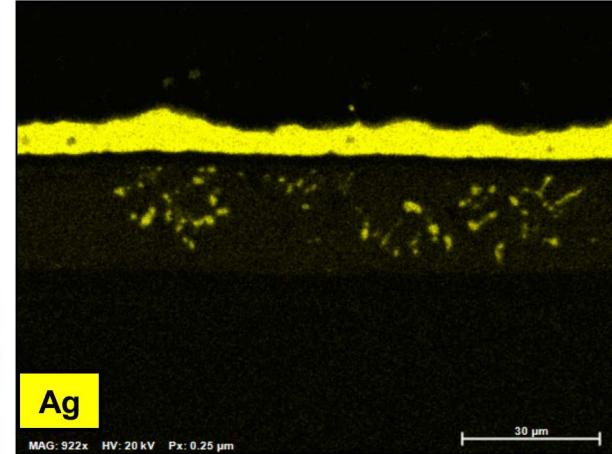
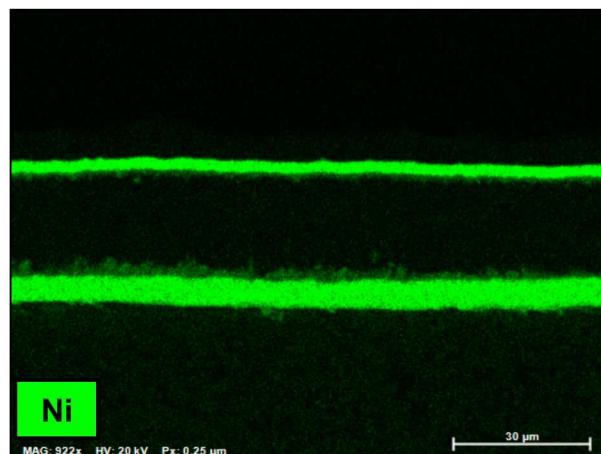
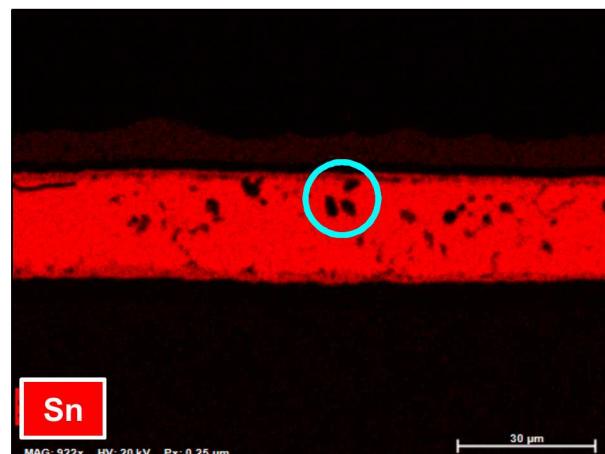
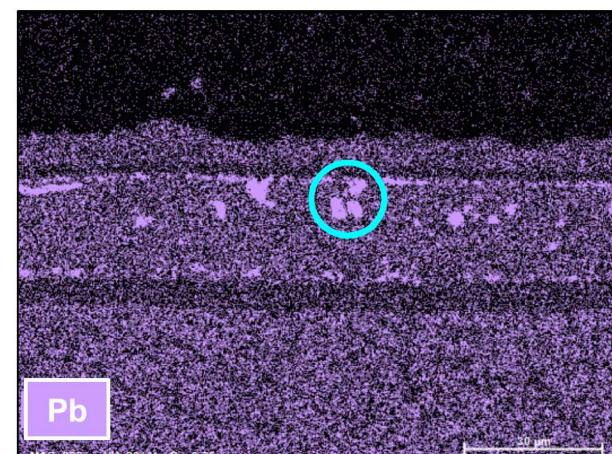
- ◆ The solder appears to be a Sn-Ag or Sn-Ag-Cu alloy that was contaminated with *traces of Pb* (cyan circle) from the soldering iron.

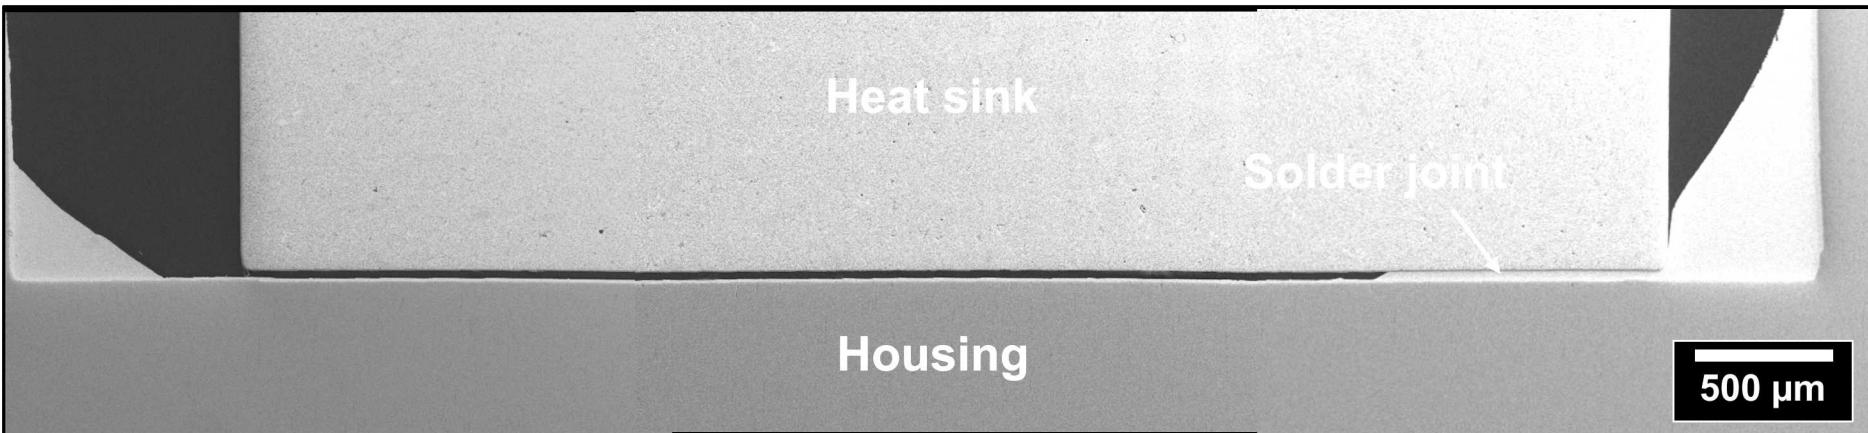
- ◆ A significant extent of filler metal was missing from the the heat sink-to-frame (housing) solder joint.

- ◆ The second baseline unit, S/N00913, showed the same defect.

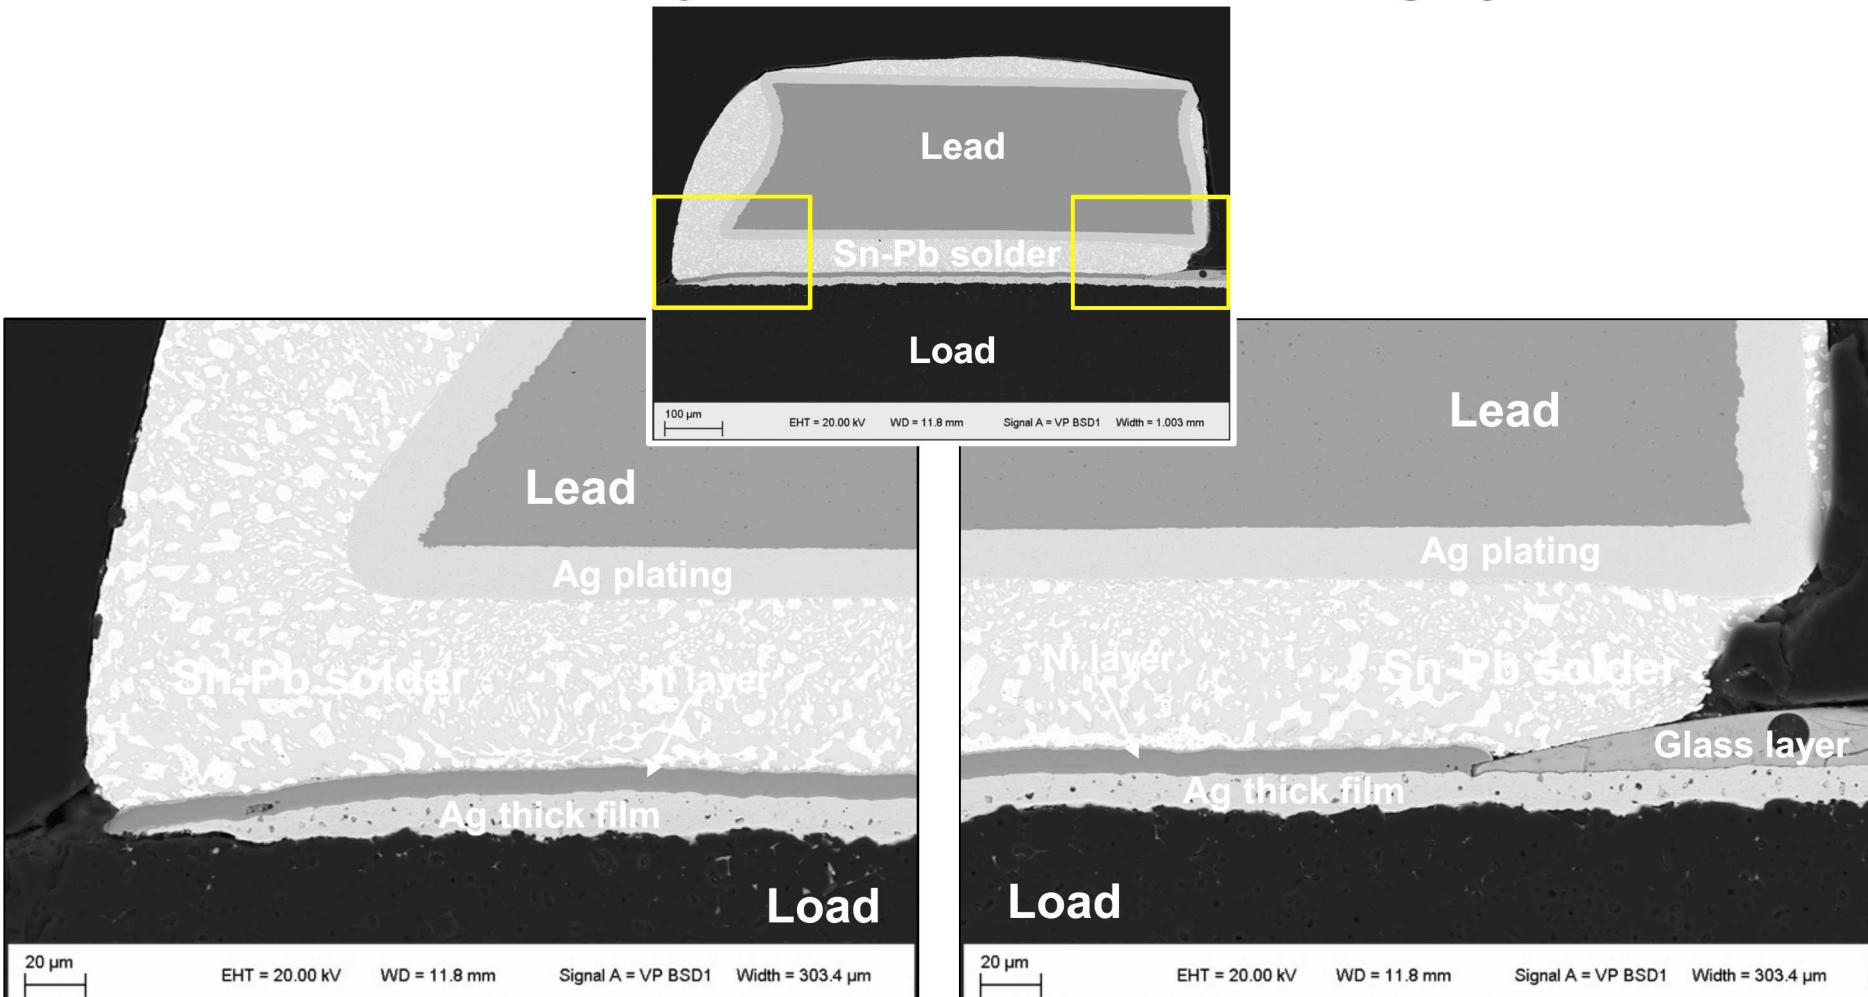
- ◆ The lead-to-load solder joint exhibited excellent integrity.

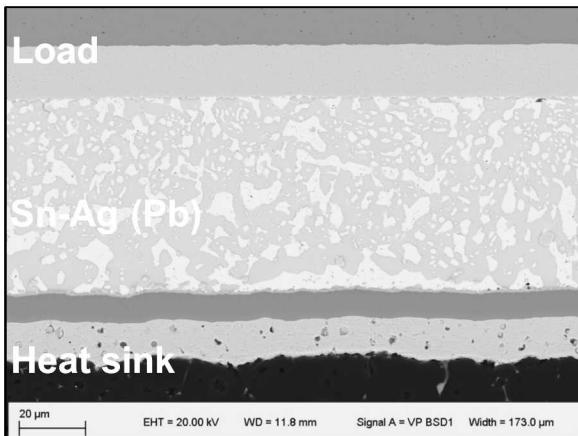
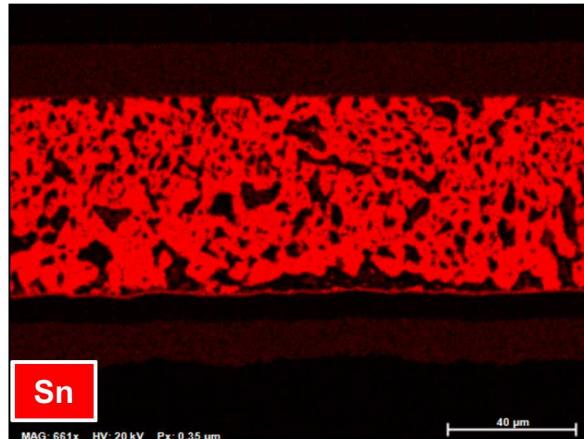
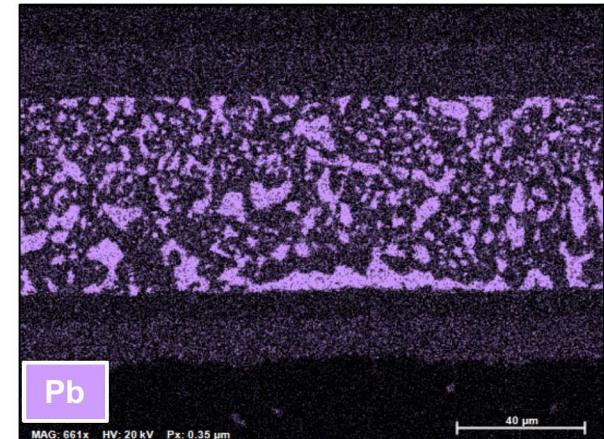
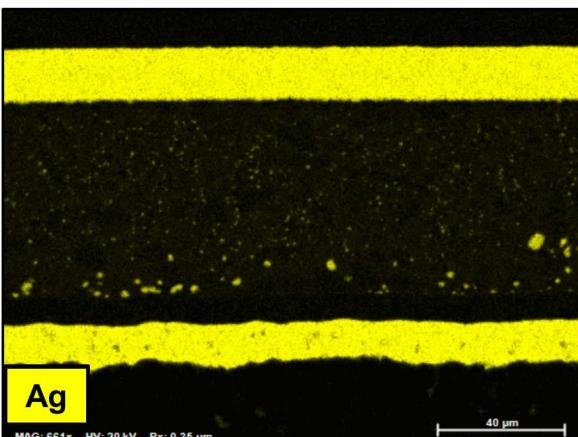
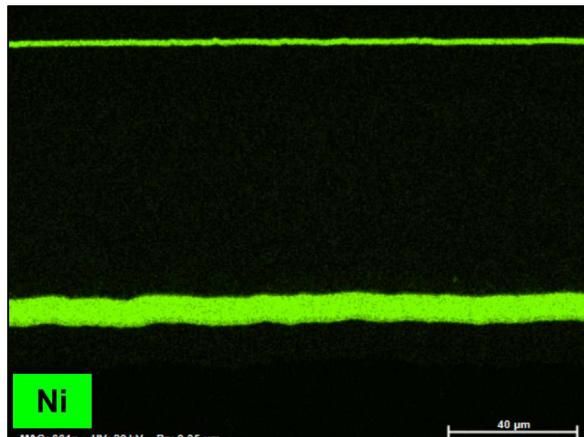
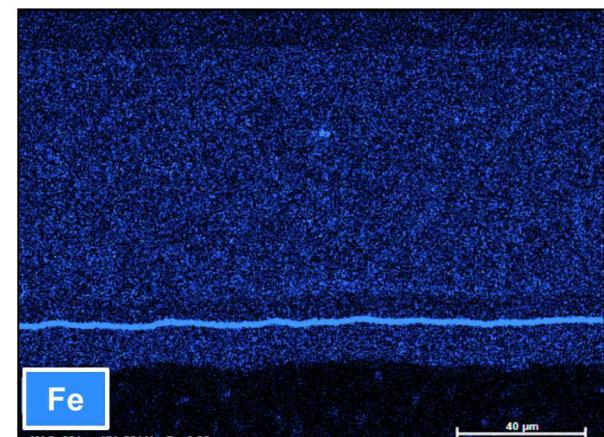
- ◆ An anomaly was the presence of an *electroplated iron (Fe) layer* between the Ni layer and the Ag thick film layer on the load.
